# FACILITY CONDITION ASSESSMENT

**Richmond Public Schools**  
301 North Ninth Street  
Richmond, VA 23219

Armstrong High School  
2300 Cool Lane  
Richmond, VA 23223

*May 8, 2024*

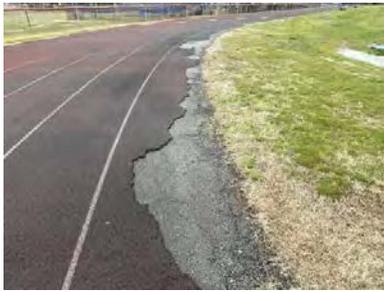
#### Athletic Surfaces & Courts in Failed condition.

Track Surface, Rubber  
Site Armstrong High School Site

Running track is eroded on outside edge and inside edge to the point of becoming a trip hazard - AssetCALC ID: 7401264

Uniformat Code: G2050  
Recommendation: **Replace in 2024**

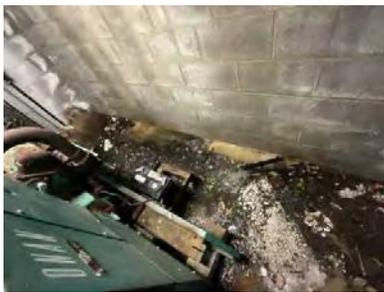
#### Roofing in Failed condition.

Asphalt Shingle, 30-Year Premium  
Main Building Armstrong High School  
Generator room

Roofing has failed. Water is leaking directly into generator room. - AssetCALC ID: 7401489

Uniformat Code: B3010  
Recommendation: **Replace in 2024**

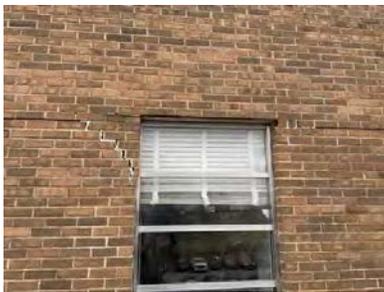
#### Exterior Walls in Poor condition.

Brick  
Main Building Armstrong High School Main  
Building

Vertical, horizontal and diagonal cracks in the brick on the western wall 2nd floor. - AssetCALC ID: 7401466

Uniformat Code: B2010  
Recommendation: **Repair in 2024**

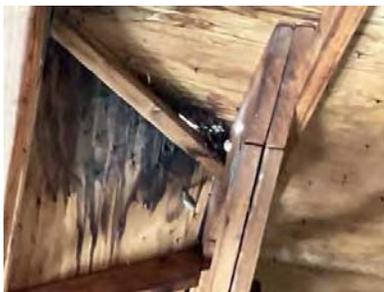
#### Roofing in Poor condition.

Concrete Tile  
Stadium Concession Armstrong High School  
Roof

Roofing leaks, broken, missing tiles. - AssetCALC ID: 7401545

Uniformat Code: B3010  
Recommendation: **Replace in 2025**

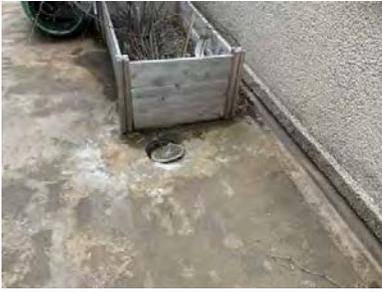
**Roofing in Failed condition.**

EDM. Roofing has an applied coding on top of roofing material with patches of hot tar. Roofing has holes and cracks. - AssetCALC ID: 7401289

Uniformat Code: B3010  
Recommendation: **Replace in 2024**

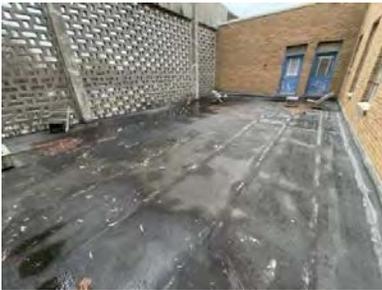
**Roofing in Poor condition.**

Aged, standing water and reported leaks. - AssetCALC ID: 7401486

Uniformat Code: B3010  
Recommendation: **Replace in 2025**

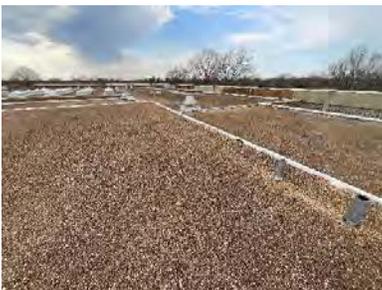
**Roofing in Poor condition.**

Roofing is very aged with lots of patches, standing water and reported leaks. - AssetCALC ID: 7469321

Uniformat Code: B3010  
Recommendation: **Replace in 2025**

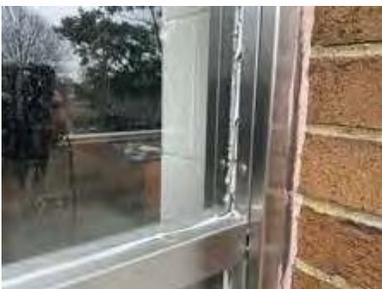
**Glazing in Poor condition.**

Caulking is degraded on exterior single pain windows. - AssetCALC ID: 7401393

Uniformat Code: B2020  
Recommendation: **Replace in 2025**

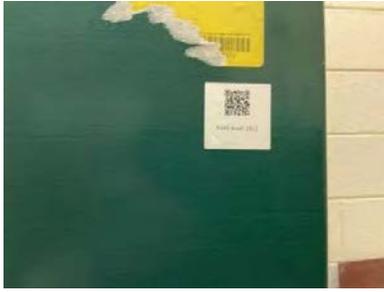
**Elevator Controls in Poor condition.**

Automatic, 1 Car  
Main Building Armstrong High School Elevator

Elevator is not currently operational - AssetCALC ID: 7401317

Uniformat Code: D1010  
Recommendation: **Replace in 2025**

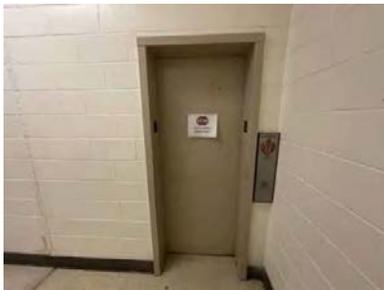
**Passenger Elevator in Poor condition.**

Hydraulic, 2 Floors  
Main Building Armstrong High School Elevator

Estimated, elevator is not currently operational - AssetCALC ID: 7401236

Uniformat Code: D1010  
Recommendation: **Renovate in 2025**

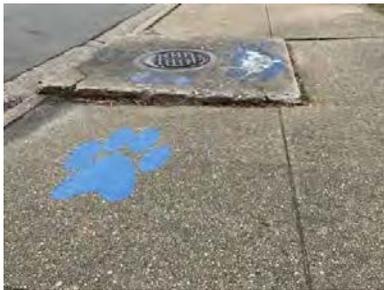
**Sidewalk in Poor condition.**

Concrete, Large Areas  
Site Armstrong High School Site

Sidewalks have heaved and sunk and are cracked or missing concrete - AssetCALC ID: 7401335

Uniformat Code: G2030  
Recommendation: **Replace in 2025**

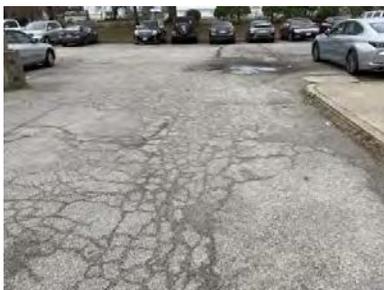
**Parking Lots in Poor condition.**

Pavement, Asphalt  
Site Armstrong High School Site

Alligator asphalt, potholes - AssetCALC ID: 7401378

Uniformat Code: G2020  
Recommendation: **Mill & Overlay in 2025**

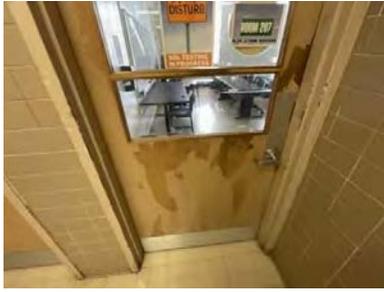
**Interior Door in Poor condition.**

Wood, Solid-Core  
Main Building Armstrong High School  
Throughout building

Majority of classroom doors door skin is delaminating - AssetCALC ID: 7401214

Uniformat Code: C1030  
Recommendation: **Replace in 2025**

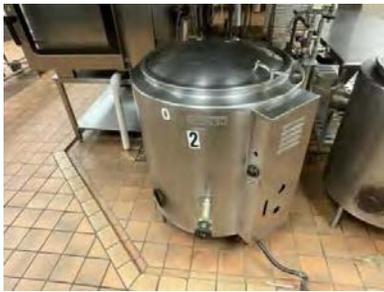
**Foodservice Equipment in Failed condition.**

Steam Kettle  
Main Building Armstrong High School Kitchen

Very aged and not operational - AssetCALC ID: 7401410

Uniformat Code: E1030  
Recommendation: **Replace in 2024**

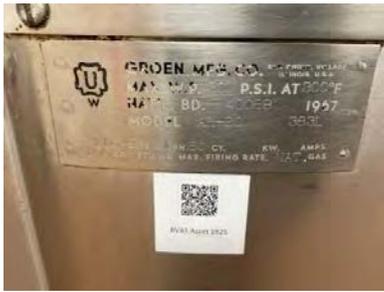
**Foodservice Equipment in Failed condition.**

Steam Kettle  
Main Building Armstrong High School Kitchen

Very aged and not operational - AssetCALC ID: 7401422

Uniformat Code: E1030  
Recommendation: **Replace in 2024**

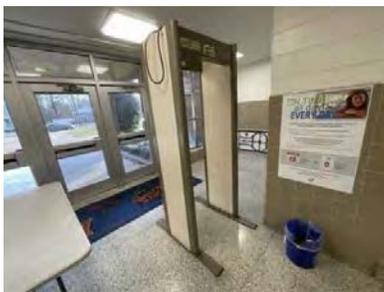
**Entry Security in Failed condition.**

Metal Detector, Full Body Walkthrough  
Main Building Armstrong High School Main  
Entry

Reported by staff that it is no longer functional - AssetCALC ID: 7401403

Uniformat Code: D7010  
Recommendation: **Replace in 2024**

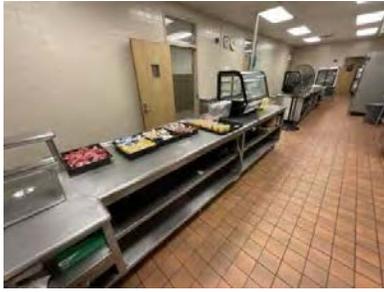
**Commercial Kitchen in Poor condition.**

Service Line  
Main Building Armstrong High School Kitchen

Three service lines, not functional - AssetCALC ID: 7401441

Uniformat Code: E1030  
Recommendation: **Replace in 2025**

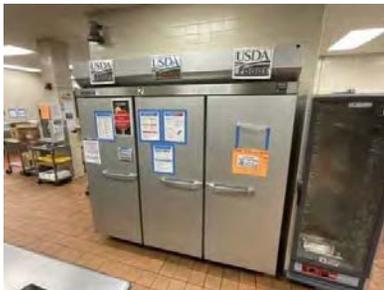
**Foodservice Equipment in Poor condition.**

Freezer, 3-Door Reach-In  
Main Building Armstrong High School Kitchen

Not currently operational, awaiting repair - AssetCALC ID: 7401381

Uniformat Code: E1030  
Recommendation: **Replace in 2025**

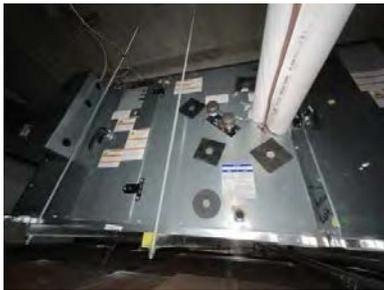
**Air Handler in Poor condition.**

Interior AHU, Easy/Moderate Access  
Main Building Armstrong High School Kitchen

Staff reports that the air handler is not operational - AssetCALC ID: 7401357

Uniformat Code: D3050  
Recommendation: **Replace in 2025**

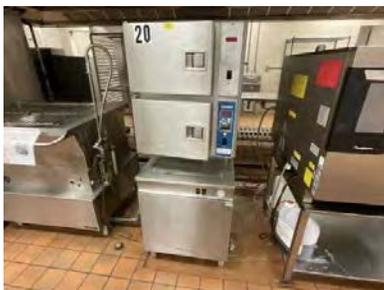
**Foodservice Equipment in Poor condition.**

Steamer, Freestanding  
Main Building Armstrong High School Kitchen

Not currently operational - AssetCALC ID: 7401387

Uniformat Code: E1030  
Recommendation: **Replace in 2025**

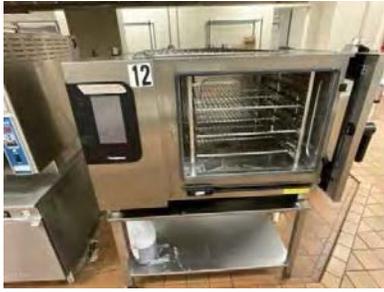
**Foodservice Equipment in Poor condition.**

Steamer, Freestanding  
Main Building Armstrong High School Kitchen

Not currently operational - AssetCALC ID: 7401453

Uniformat Code: E1030  
Recommendation: **Replace in 2025**

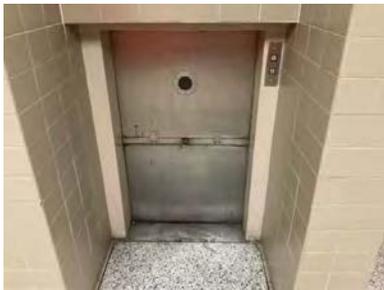
**Dumbwaiter in Poor condition.**

Electric, up to 5 Stories  
Main Building Armstrong High School Main Building

Not operational - AssetCALC ID: 7401390

Uniformat Code: D1010  
Recommendation: **Renovate in 2025**

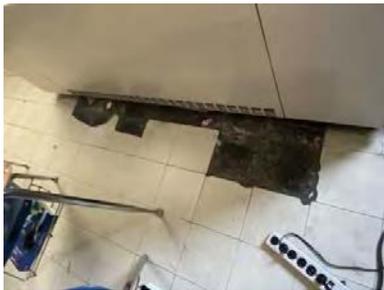
**Flooring in Poor condition.**

Vinyl Tile (VCT), w/ Asbestos Abatement  
Main Building Armstrong High School Classrooms

Aged, loose and missing tiles. - AssetCALC ID: 7401273

Uniformat Code: C2030  
Recommendation: **Replace in 2025**

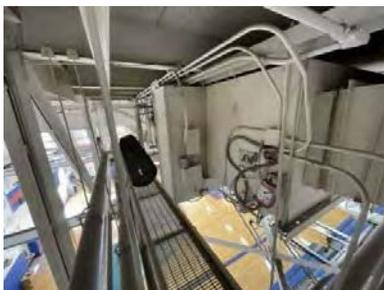
**Air Handler in Poor condition.**

Interior AHU, Easy/Moderate Access  
Main Building Armstrong High School Gymnasium

Not currently operational, estimated size - AssetCALC ID: 7401374

Uniformat Code: D3050  
Recommendation: **Replace in 2025**

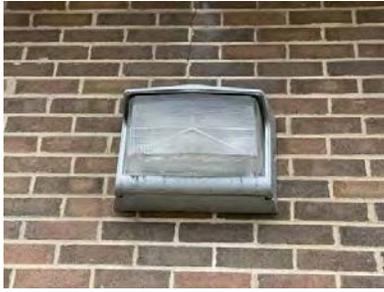
**Exterior Fixture w/ Lamp in Poor condition.**

any type, w/ LED Replacement  
Main Building Armstrong High School Building exterior

Reported that exterior lighting is insufficient. - AssetCALC ID: 7401313

Uniformat Code: G4050  
Recommendation: **Replace in 2025**

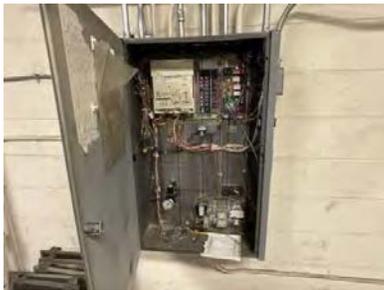
**BAS/HVAC Controls in Poor condition.**

Extensive/Robust BMS or Smart Building System  
Main Building Armstrong High School  
Throughout building

BAS system is a combination of modern and air controls, reported that the BAS system does not maintain temperature properly. - AssetCALC ID: 7401411

Uniformat Code: D8010  
Recommendation: **Upgrade/Install in 2025**

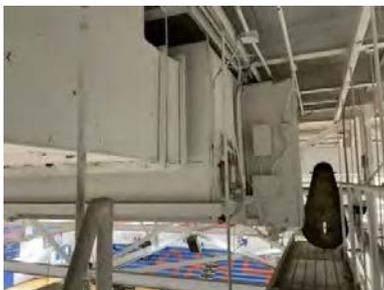
**Air Handler in Poor condition.**

Interior AHU, Easy/Moderate Access  
Main Building Armstrong High School  
Gymnasium

Not currently operational, estimated size - AssetCALC ID: 7401359

Uniformat Code: D3050  
Recommendation: **Replace in 2025**

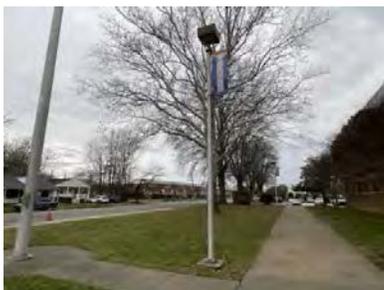
**Pole Light Fixture w/ Lamps in Poor condition.**

any type 20' High, w/ LED Replacement  
Site Armstrong High School Site

Reported that site lighting is insufficient. - AssetCALC ID: 7401468

Uniformat Code: G4050  
Recommendation: **Replace/Install in 2025**

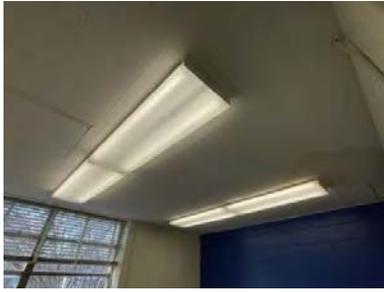
### Suspended Ceilings in Poor condition.

Hard Tile, Replacement w/ ACT  
Main Building Armstrong High School  
Throughout building

Lots of stained and missing tiles - AssetCALC ID: 7401339

Uniformat Code: C1070  
Recommendation: **Replace in 2025**

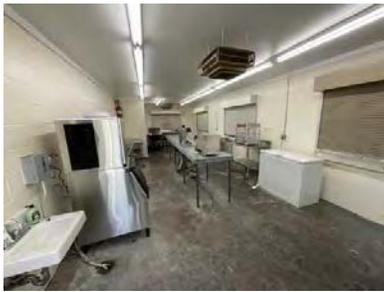
### Flooring in Poor condition.

any surface, w/ Epoxy Coating  
Stadium Concession Armstrong High School  
Restrooms

Uniformat Code: C2030  
Recommendation: **Prep & Paint in 2025**

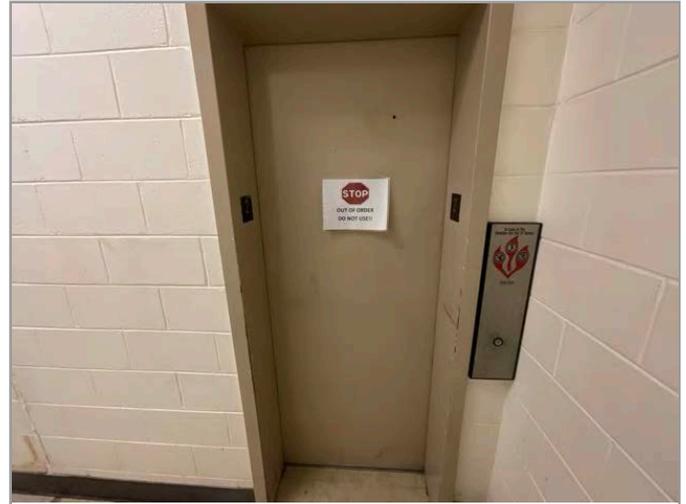
ELEVATOR NOT OPERATIONAL

Question		Yes	No	NA	Comments
1	Are hallway call buttons configured with the "UP" button above the "DOWN" button?	✘			
2	Is accessible floor identification signage present on the hoistway sidewalls on each level ?		✘		
3	Do the elevators have audible and visual arrival indicators at the lobby and hallway entrances?				Elevator is not currently operational
4	Do the elevator hoistway and car interior appear to have a minimum compliant clear floor area ?				Elevator is not currently operational
5	Do the elevator car doors have automatic re-opening devices to prevent closure on obstructions?				Elevator is not currently operational
6	Do elevator car control buttons appear to be mounted at a compliant height ?				Elevator is not currently operational
