FACILITY CONDITION ASSESSMENT

Richmond Public Schools
301 North Ninth Street
Richmond, VA 23219

River City Middle School
6300 Hull Street Road
Richmond, VA 23224

June 3, 2024

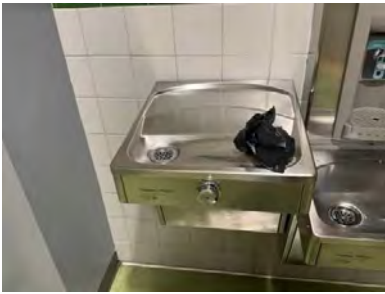
Drinking Fountain in Failed condition.

Wall-Mounted, Single-Level
Main Building River City Middle School E Wing

Uniformat Code: D2010
Recommendation: **Replace in 2024**
