FACILITY CONDITION ASSESSMENT

Richmond Public Schools 301 North Ninth Street Richmond, VA 23219

Woodville Elementary School 2000 North 28th Street Richmond, VA 23223

May 29, 2024

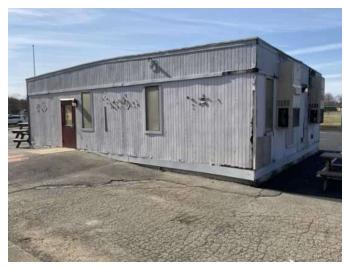
17 - MODULAR CLASSROOM

Modular building is in very poor condition, siding is falling apart, roof leaks, excessive age - AssetCALC ID: 7450347

Recommendation: Replace in 2024
