May 17, 2024

Geno Mazzali  
Facilities Manager  
ISD 197  
1897 Delaware Avenue  
Mendota Heights, MN 55118

**RE: District-Wide  
Short-Term Radon Testing Results  
IEA Project #202311027**

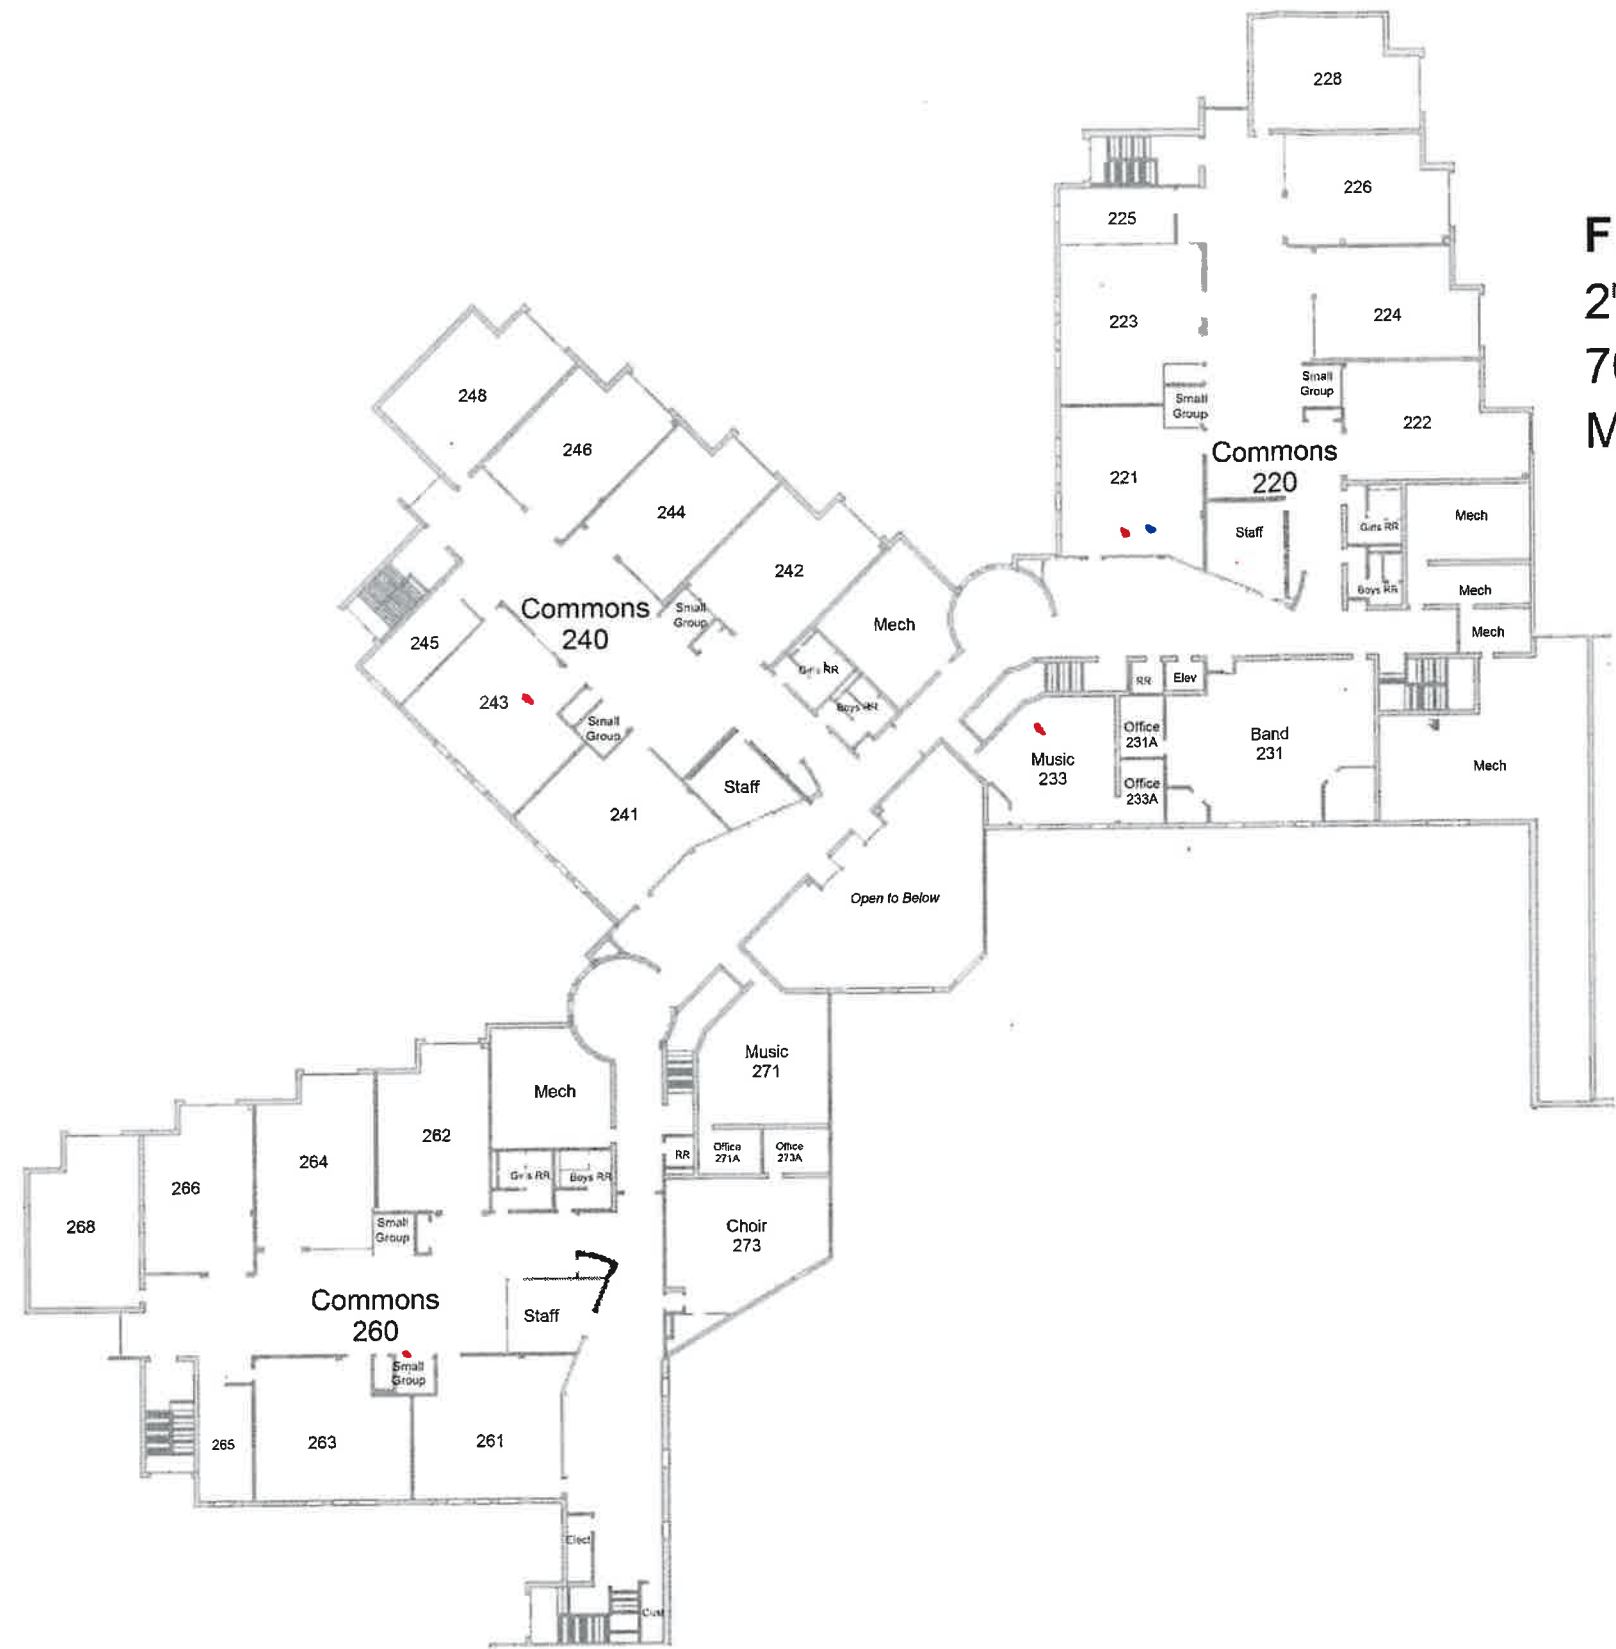
**Friendly Hills Middle School**  
 2<sup>nd</sup> Floor  
 701 Mendota Heights Rd.  
 Mendota Heights, MN 55120

A total of 95 test kits were placed in 82 locations at Friendly Hills Middle School. There were 2 test kits in Rooms 120F and 103S that were missing when the test kits were collected. The number of missing test kits did not exceed allowance in the ANSI/AARST MA-MFLB 2023 standard.

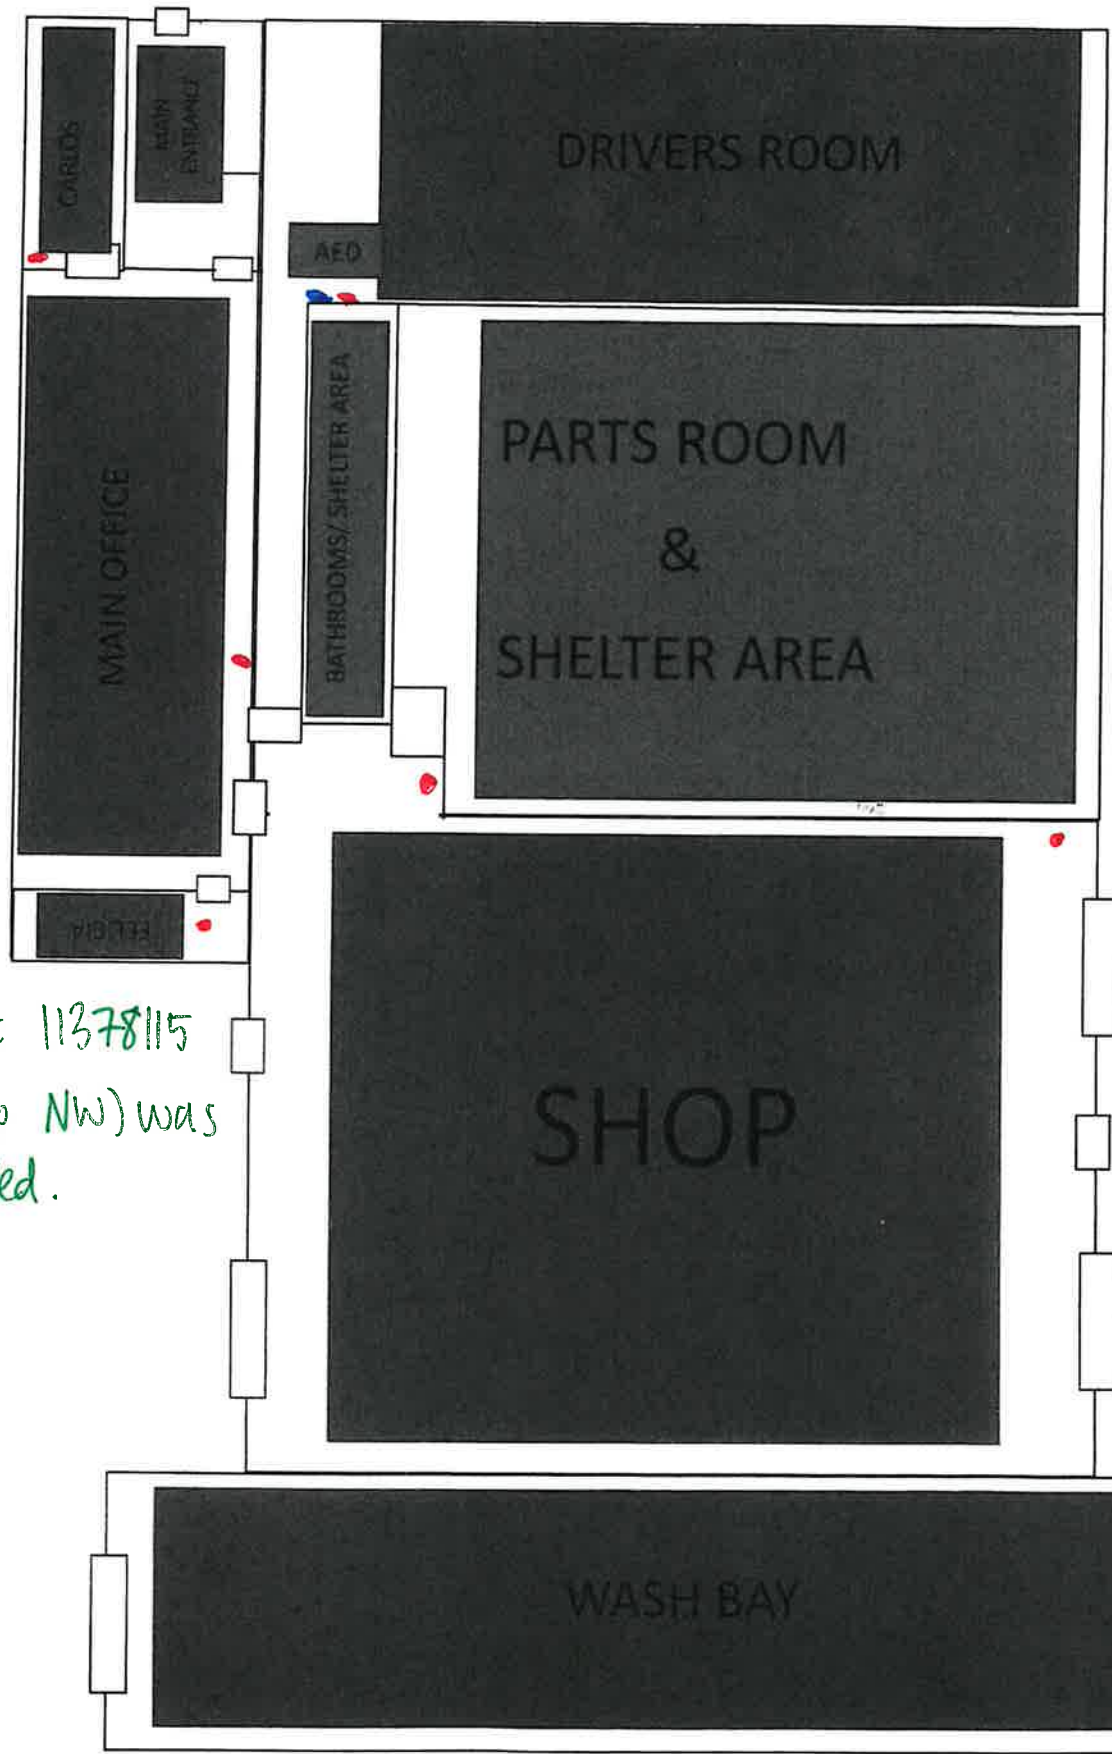
Bus  
Garage  
Building  
Map

A total of 9 test kits were placed in 8 locations at Transportation Building. There was 1 test kit in Shop NW that was found to have been moved when the test kits were collected. The number of missing/damaged test kits did not exceed allowance in the ANSI/AARST MA-MFLB 2023 standard.

test 11378115  
(Shop NW) was  
moved.
