School District of Jefferson  
District-wide Facility Assessment

October 2020

## District-Wide Facility Assessment

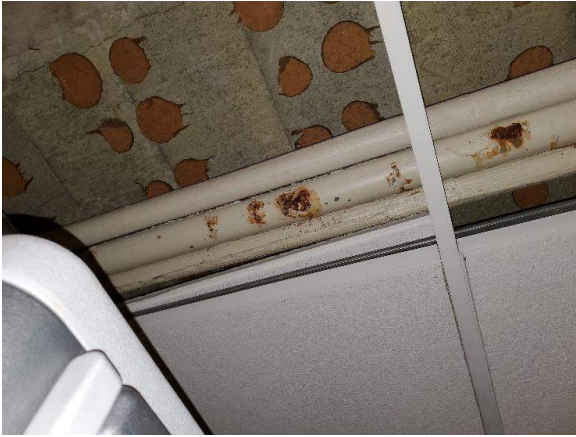
Photo 1: Corroding sanitary drain piping

| Plumbing Piping | Issue | Recommendations | Priority |
|---|---|---|---|
| Sanitary and Storm Piping | Sanitary drain piping is showing signs of rust and corrosion resulting in leaks. (See photo 1) | Replace existing metallic piping with plastic piping. | 2 |

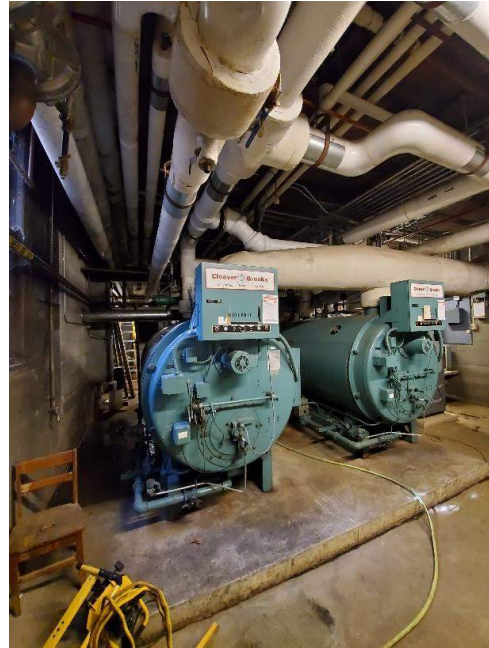
Photo 2: Boilers

| HVAC Equipment | Issue | Recommendations | Priority |
|---|---|---|---|
| Boilers (B-1, 2, and 3) | There are three boilers that serve this school. All boilers are hot water style boilers. Two of the boilers are Cleaver Brooks firetube boilers. These boilers have been in service many years and are in good condition for their age. The other boiler is an Aerco condensing boiler. This boiler is also in good condition. Make up water supply to boiler is provided with filtration and chemical dosing to extend equipment life. (See photo 2) | No action recommended | n/a |

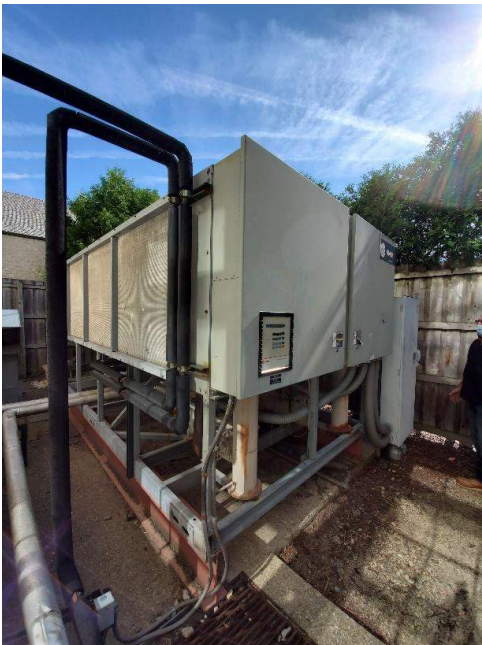
Photo 3: Chiller

| HVAC Equipment | Issue | Recommendations | Priority |
|---|---|---|---|
| Chiller (CH-1) | This unit is operational, but is approaching the end of its typical service life. It is reasonable to expect additional maintenance in the near future to keep the existing chiller operational. (See photo 3) | Replace Chiller | 2 |

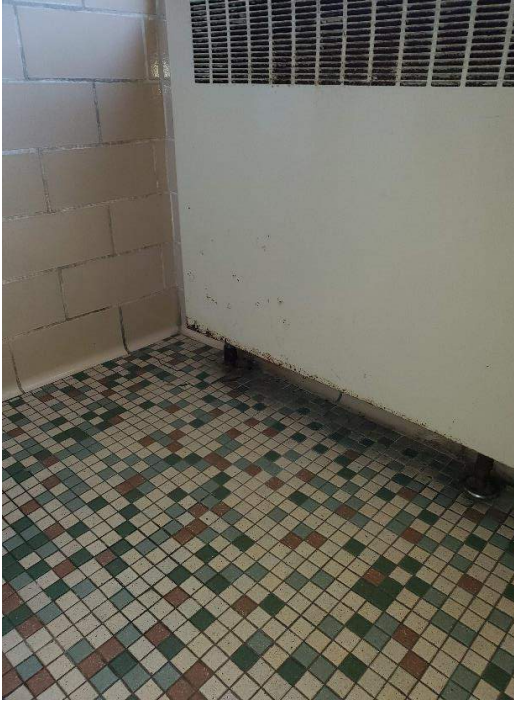
Photo 5: Floor beneath cabinet unit heater

| Cabinet Unit Heaters | These units are located in the stairwells, vestibules, and restrooms. These units produce corrosion in the summer, which leaks onto the floor and causes damage. (See photo 5) | Provide insulation for all exposed piping. | 2 |

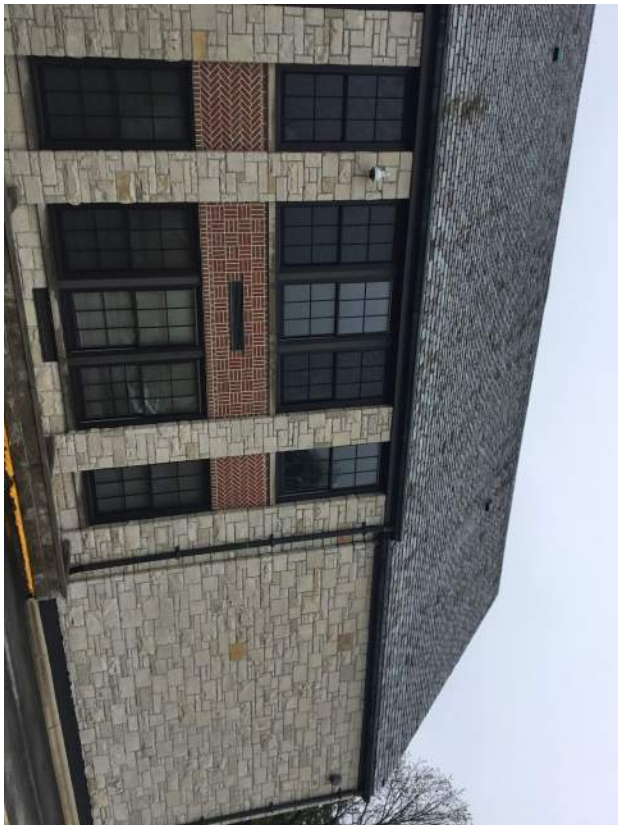
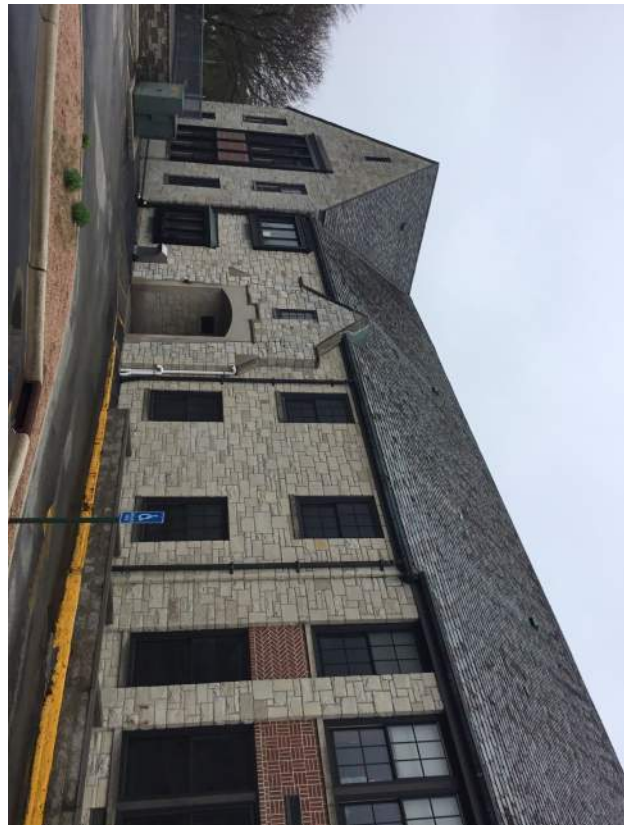
### #6 Replace slate roof

| BUILDING ENVELOPE SUMMARY | | | |
|---|---|---|---|
| Roofing | Slate roof is failing and portions are falling off. Copper standing seam roof in courtyard area is also failing and causing water issues. | Recommend replacing entire roof | 2 |

Replace all roof areas. 99' Roof is in better shape. All other roofs need replacement.

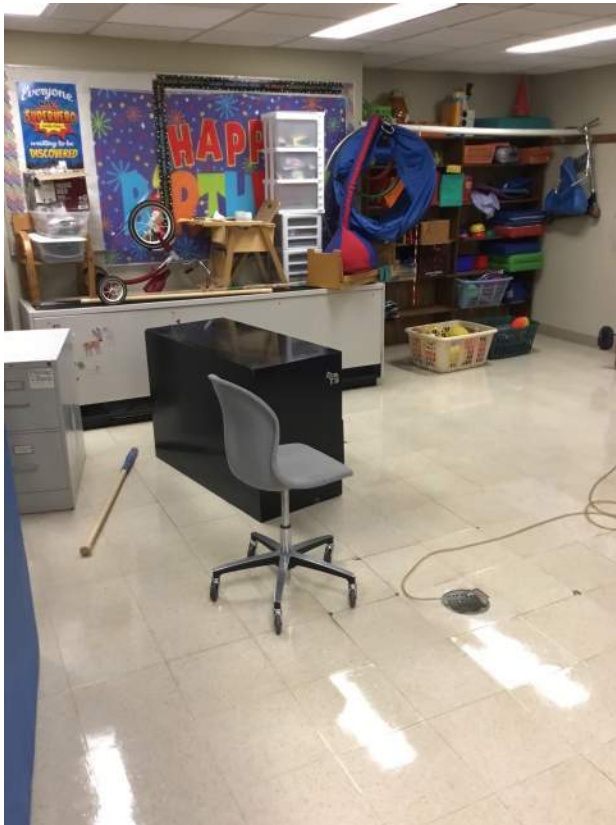
## #34 Flooring replacement water damage

Flooring Damage in basement  
due to water infiltration

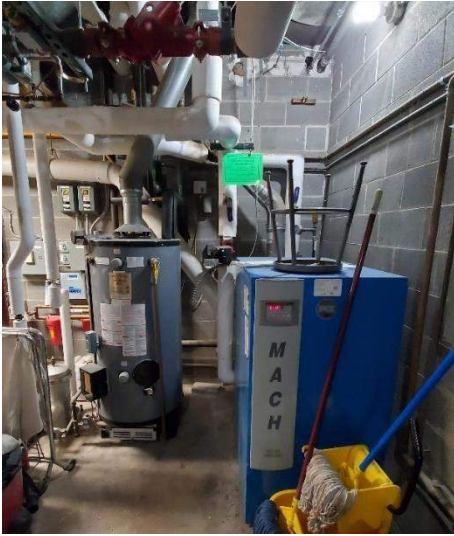
Photo 1: Water heater and boiler

| PLUMBING SUMMARY | | | |
|---|---|---|---|
| Water Heater | Unit is natural gas fired and a natural draft style heater. Unit is less than or equal to 5 years old. Unit is in good condition. (See photo 1) | Water heater will likely need to be replaced in 4 to 5 years. | 3 |

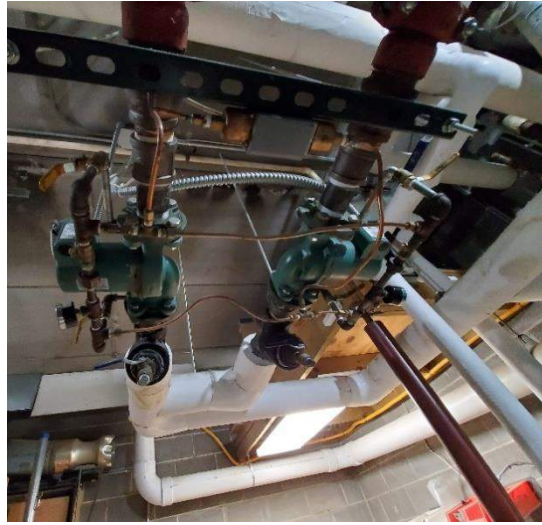
Photo 2: Hot water pumps

| Heating Hot Water Pumps (HWP-1 and 2) | Hot water pumps are undersized and have issues heating the building during winter months. (See photo 2) | Replace pumps with upsized pumps. | 2 |

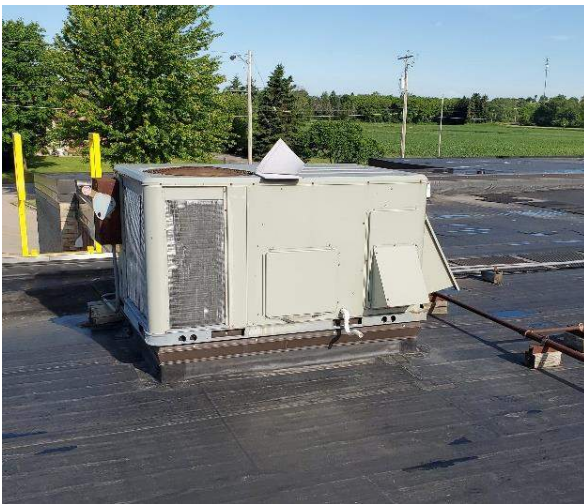
Photo 3: RTU-3

| Rooftop Air Handling Units (RTU-1, 2, 3, and 4) | RTU-2 is new (installed in 2019) and is in good condition. RTU-3 and 4 are in fair condition but are approaching the end of their typical service life. RTU-1 is the main air handling unit. Unit is in good condition for its age. (See photo 3) | Replace RTU-3 and 4 when the heat exchangers fail. | 3 |

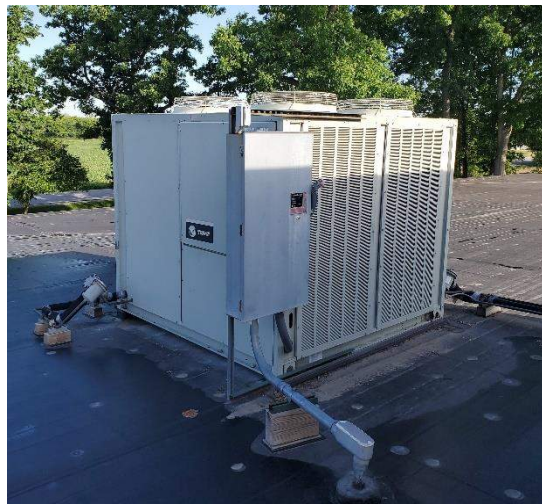
Photo 4: Condensing unit

| Condensing Unit (ACCU-1) | The condensing unit serves RTU-1. The unit recently had refrigerant leaks that were repaired. Unit uses R-22 refrigerant, which is no longer used in the industry. (See photo 4) | Replace equipment. | 4 |

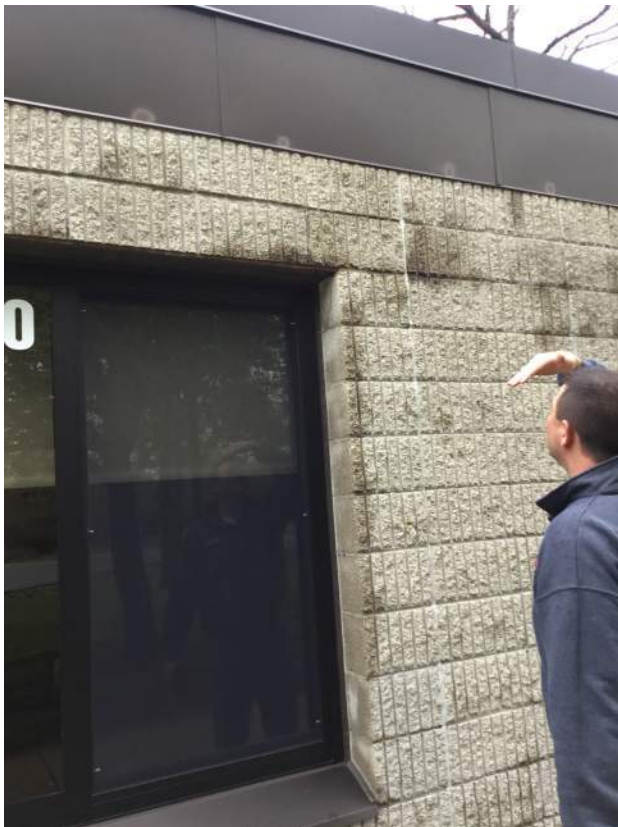
## #36 Lintel damage at each window

| BUILDING ENVELOPE SUMMARY | | | |
|---|---|---|---|
| Windows | Lintels above windows are failing | Replace lintels and repair adjacent mortar | 2 |

Replace warped/bowing lintels  
and block at each window head.

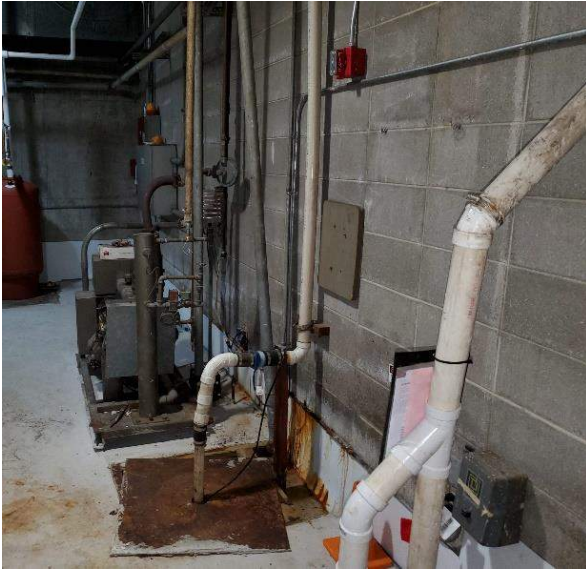
Photo 1: West Elementary sump pump

| Fire Protection | Issue | Recommendations | Priority |
|---|---|---|---|
| Others | The sump pump is approaching the end of its typical service life (See photo 2). | Replace sump pump | 3 |

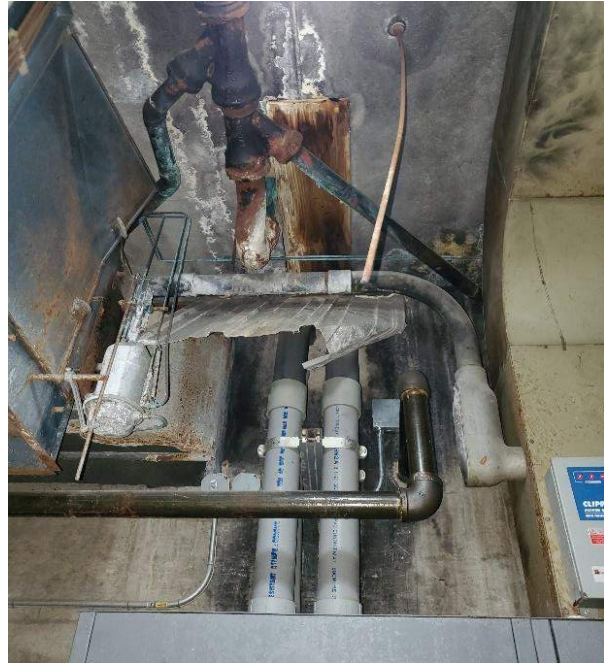
Photo 2: West Elementary drain above electrical service

| Fire Protection | Issue | Recommendations | Priority |
|---|---|---|---|
| Sanitary and Storm Piping | Sanitary drain piping located above electrical service entrance should be relocated. (See photo 1) | Relocate drain piping above electrical service entrance | 1 |

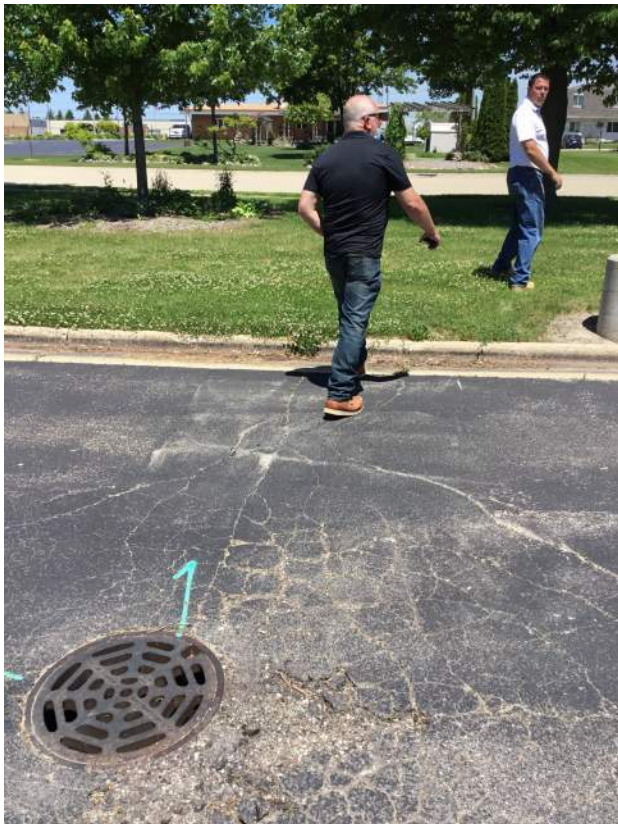
Storm line backs up into the building during heavy rains.  
Suggest adding check valve in building

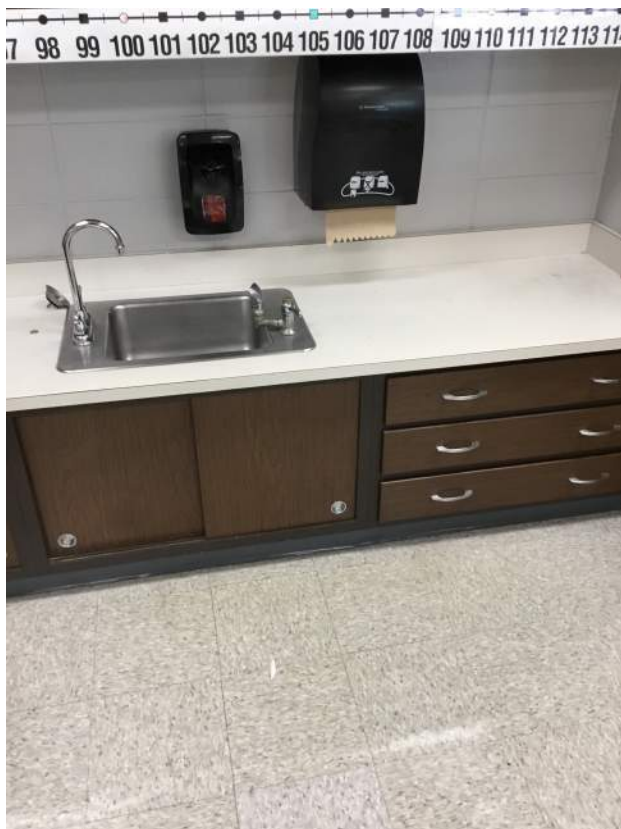
Replace older cabinetry, counters and sinks to match all rooms throughout building. Certain rooms have newer cabinets/counters.

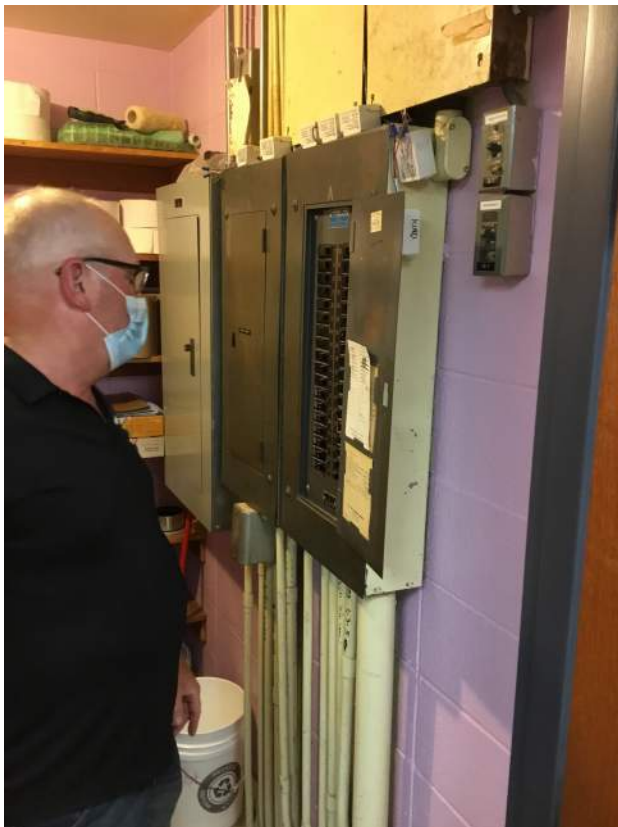
Breaker outdated and parts are no longer readily available.

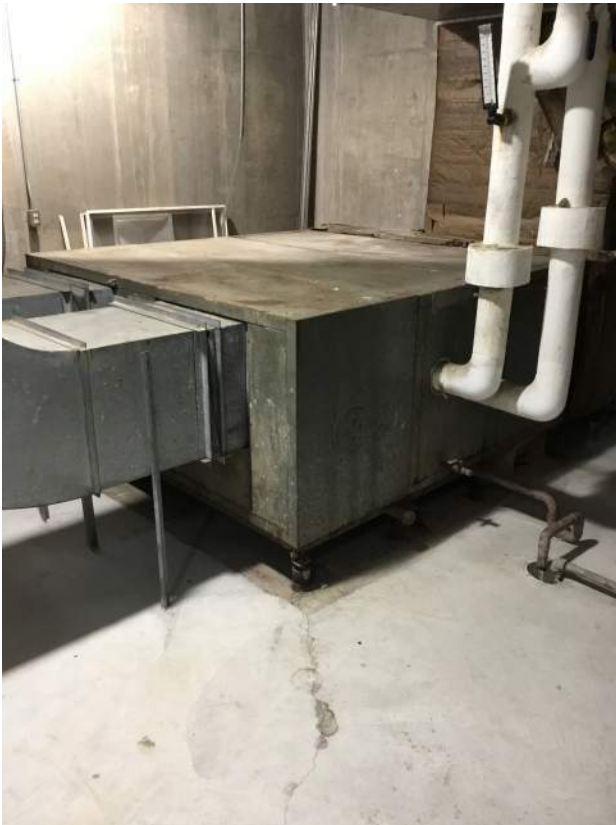
1968 Air Handler. 10 year replacement plan.

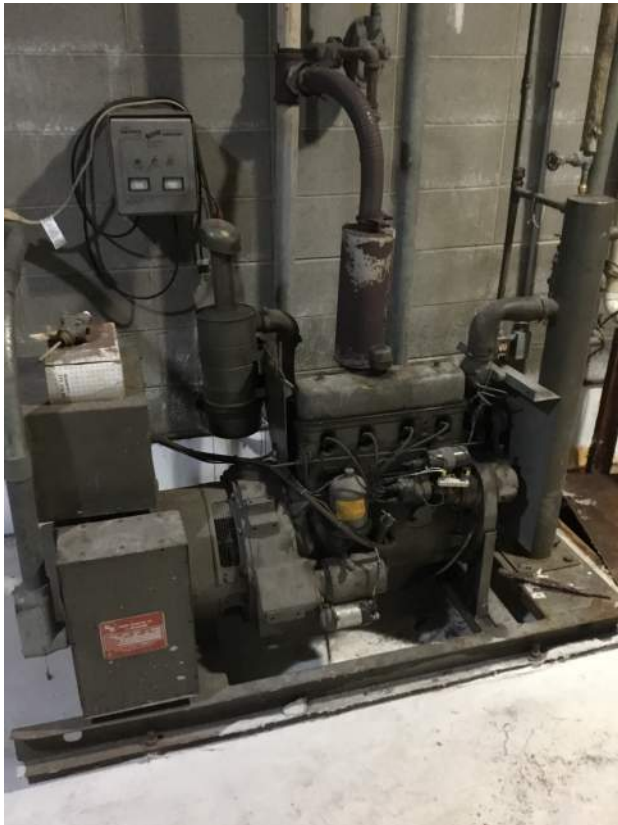
Needed to maintain sump pump operational and safety lighting

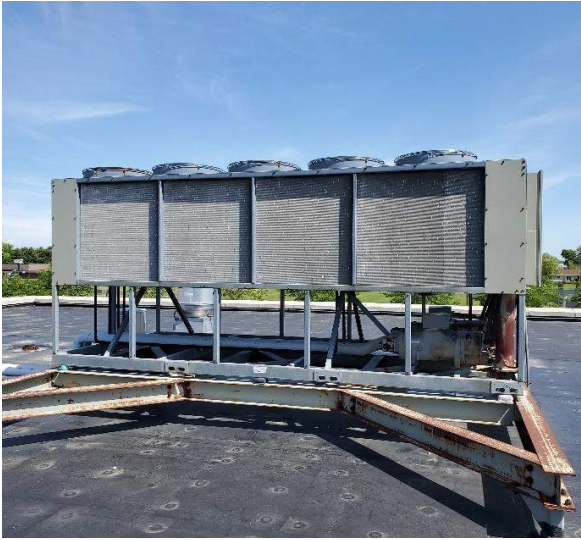
Photo 1: Chiller

| HVAC SUMMARY | | | |
|---|---|---|---|
| Chiller (CH-1) | This unit is approaching the end of its typical service life. It is reasonable to expect additional maintenance in the future to keep existing chiller operational. (See photo 1) | Replace Chiller | 4 |

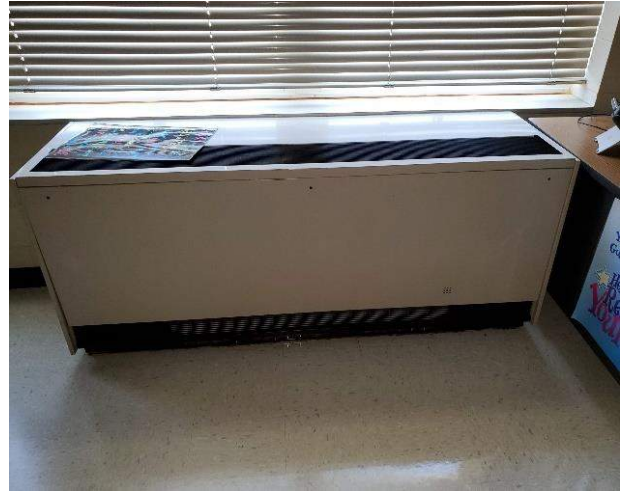
Photo 2: Unit ventilator

| HVAC SUMMARY | | | |
|---|---|---|---|
| Unit Ventilators | These units are in good condition but could benefit from some control modifications. (See photo 2) | Retro commission unit ventilator controls | 3 |

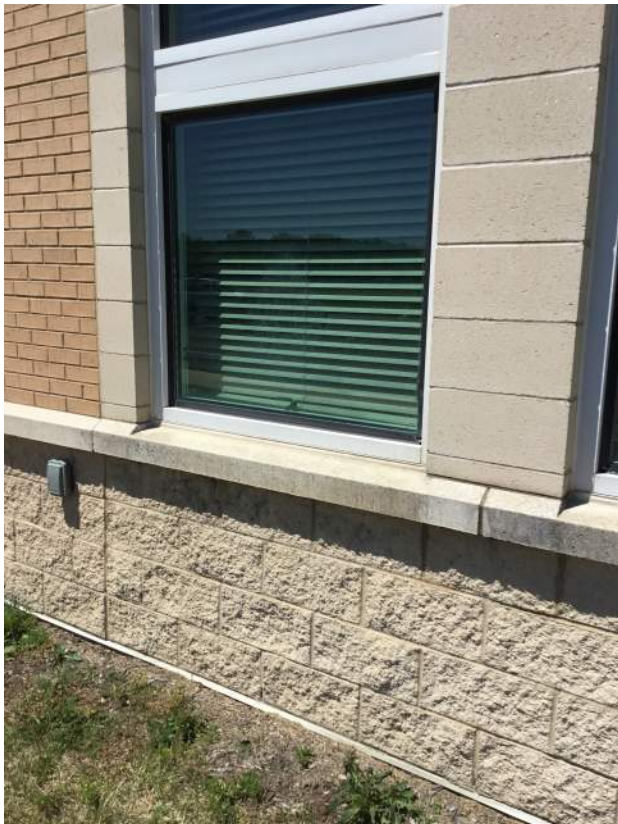
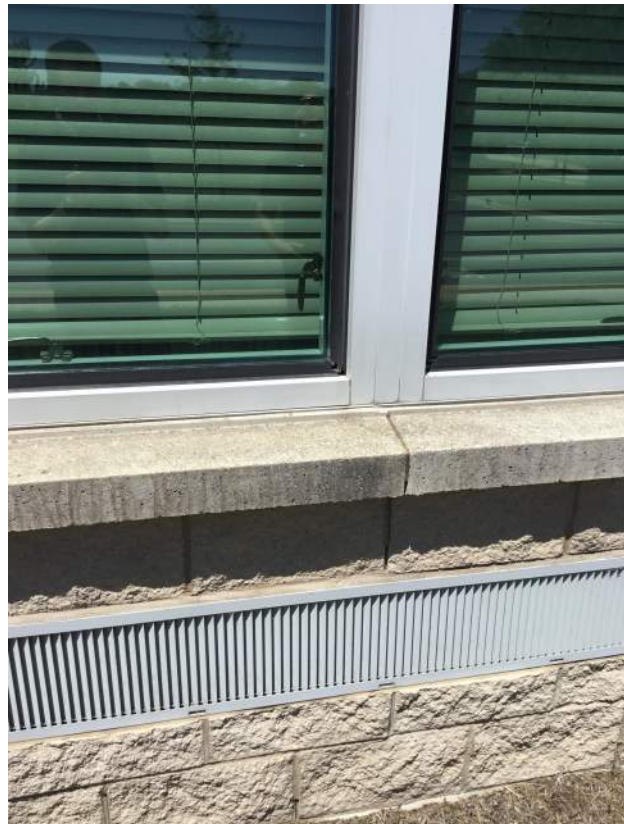
Close inspection of windows show the majority are pulling apart. Frames are separating and likely causing air infiltration.

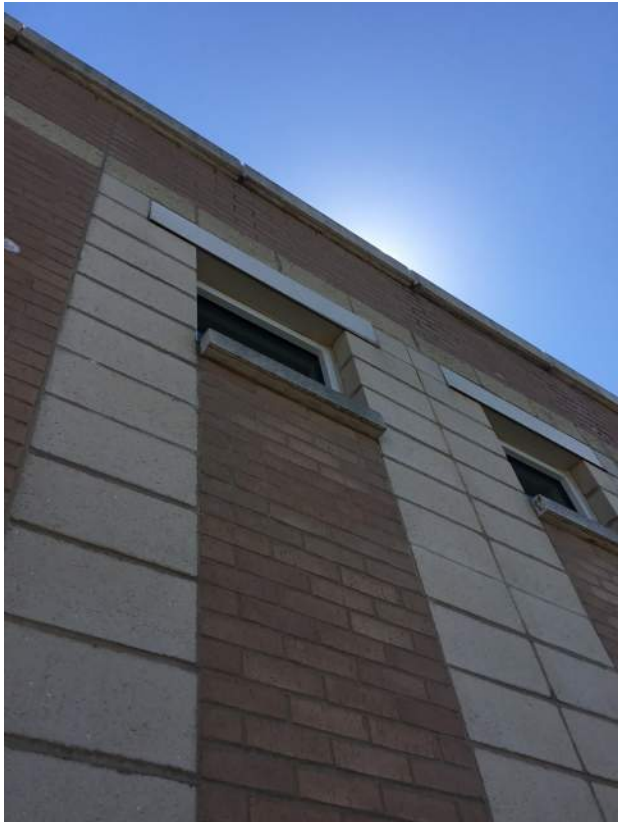
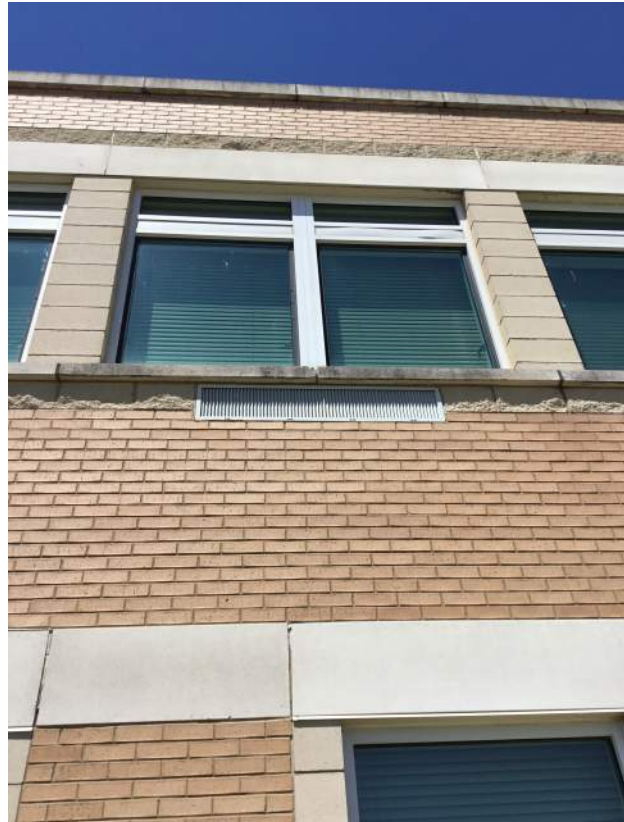
Remainder of building to be caulked. Being addressed currently through capital maintenance.

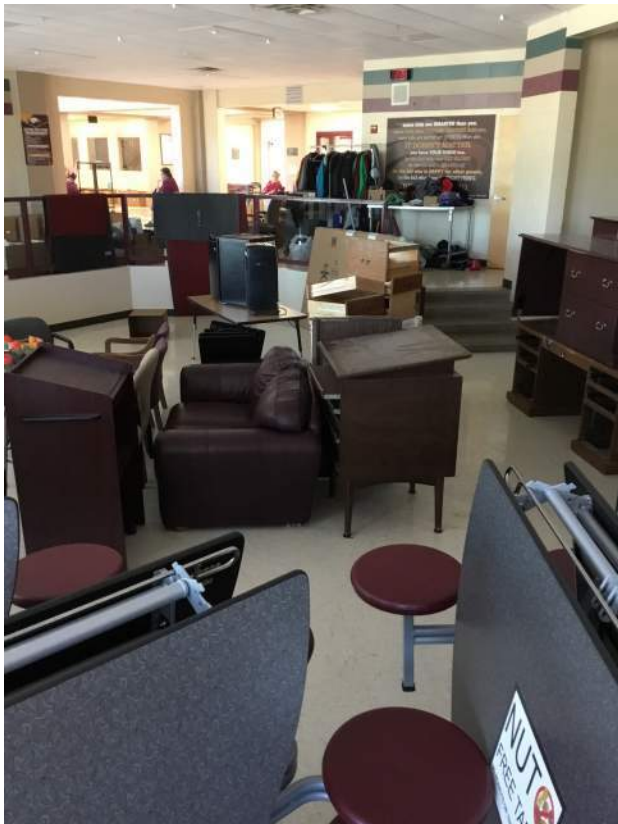
Tim described area as under utilized as it was designed. Also, hazardous for custodial staff moving tables into area.

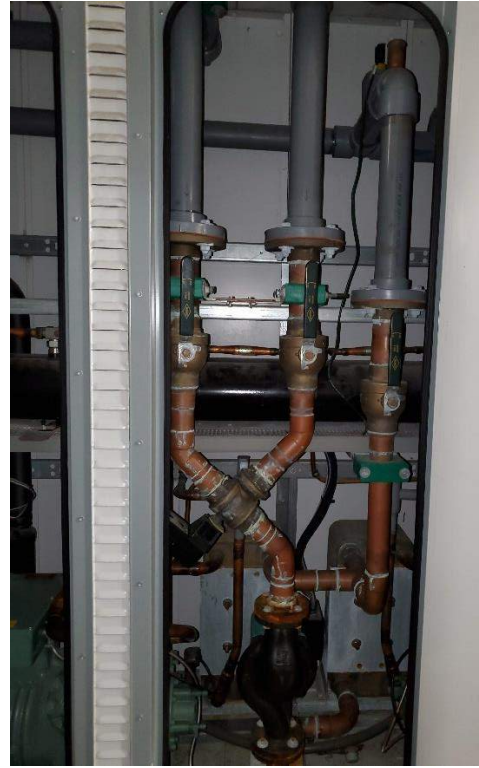
Photo 2: Pool water unit

| Pool Air Handling Unit (PDU-01) | Equipment is functioning well. Unit has some issues with internal water flow. (See photo 2) | Rebalance water piping within unit | 4 |

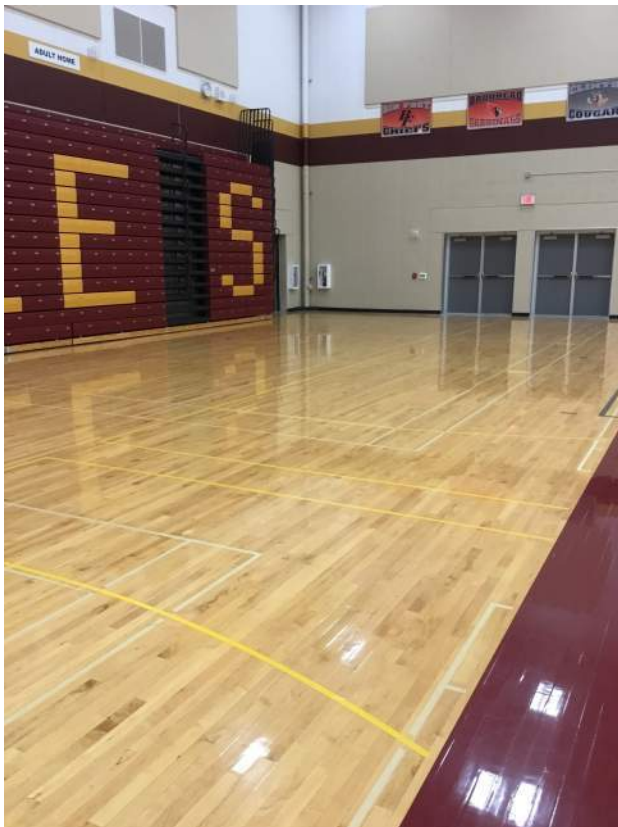
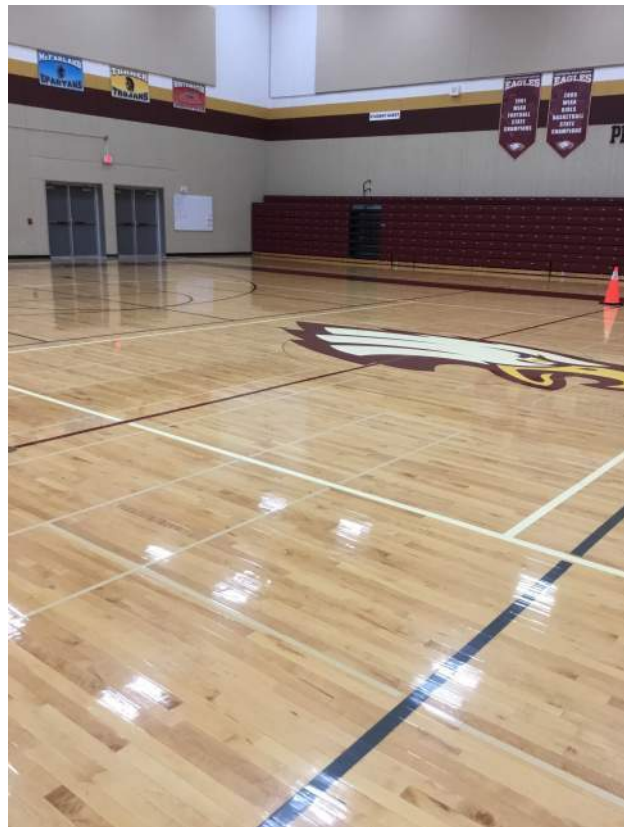
Refinish both gym floors.  
\$45000 estimate obtained.

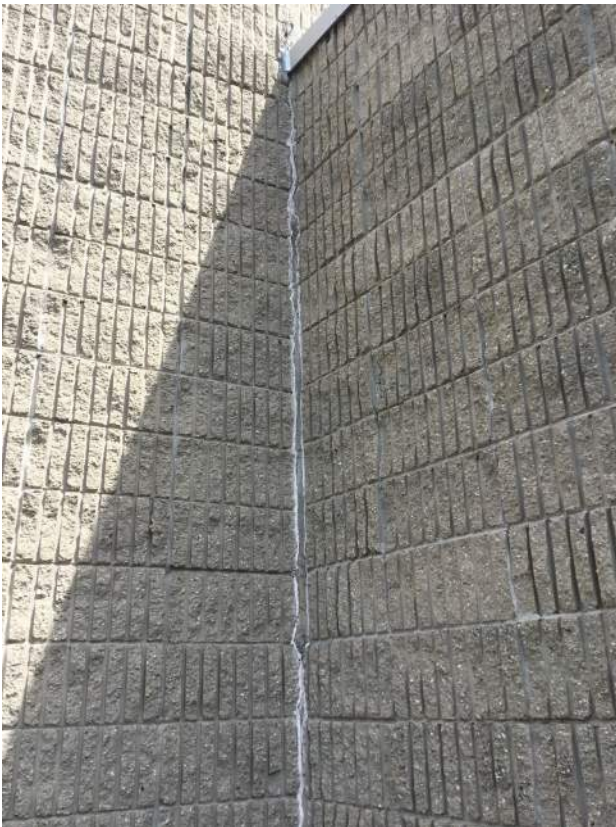
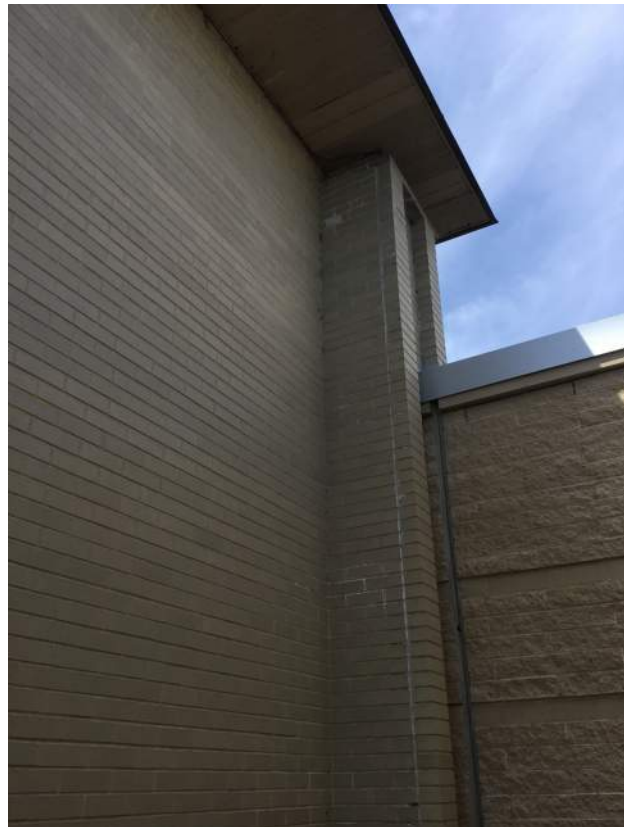
Tuck point and caulk east elevation of addition, roofs and auditorium

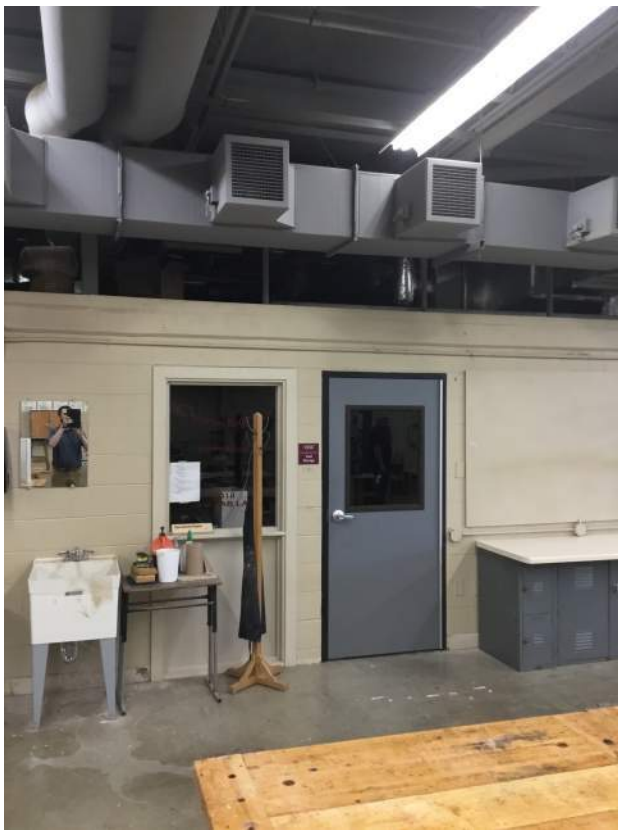
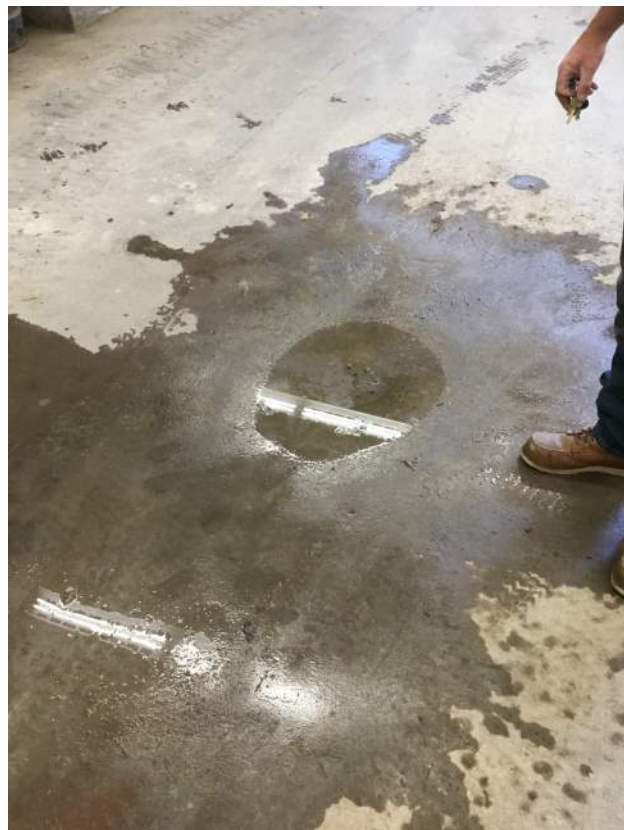
Remove wall and drain cleanout

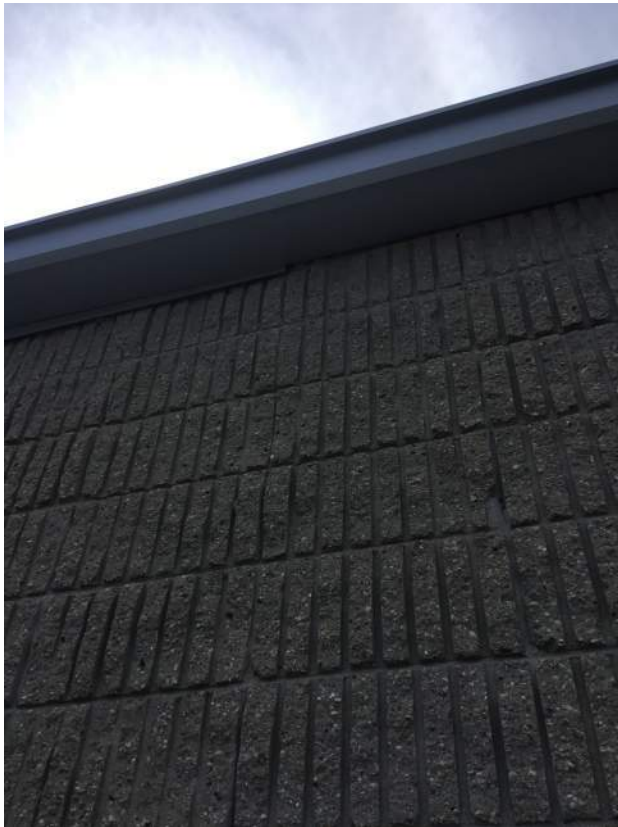
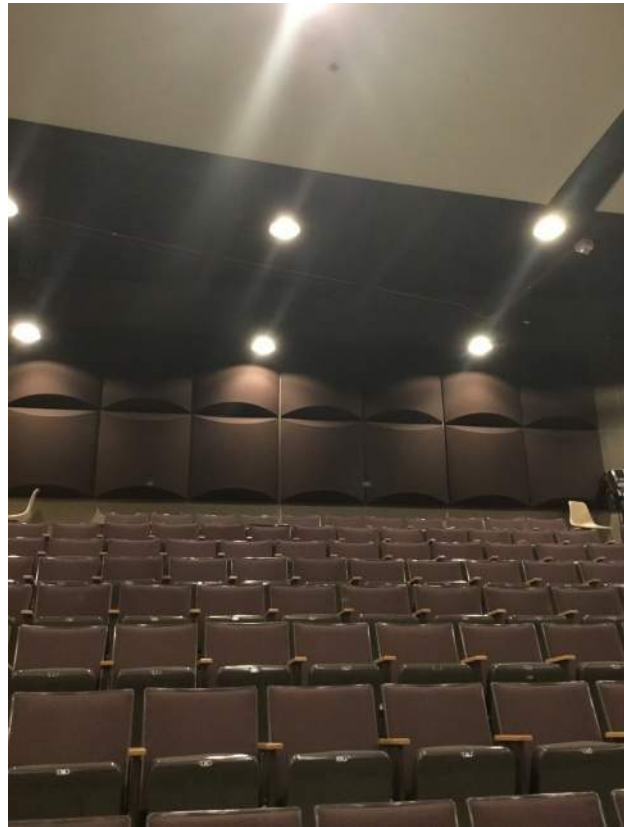
Outside light is visible from inside

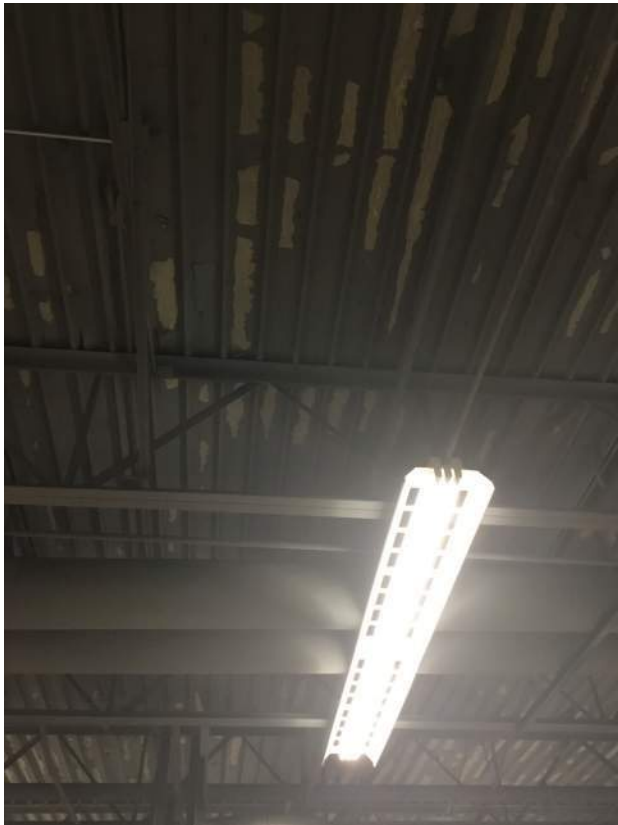
Paint doesn't stick and falls throughout year
