## Specifications for: Roncalli Demolition

## **ITB 25-02 RONCALLI STEM ACADEMY ABATEMENT & DEMOLITION**

Pueblo School District 60 is seeking bids from qualified firms to perform abatement work and demolition services at Roncalli STEM Academy (closed building), located at 4209 Highway 78, Pueblo, Colorado 81005.

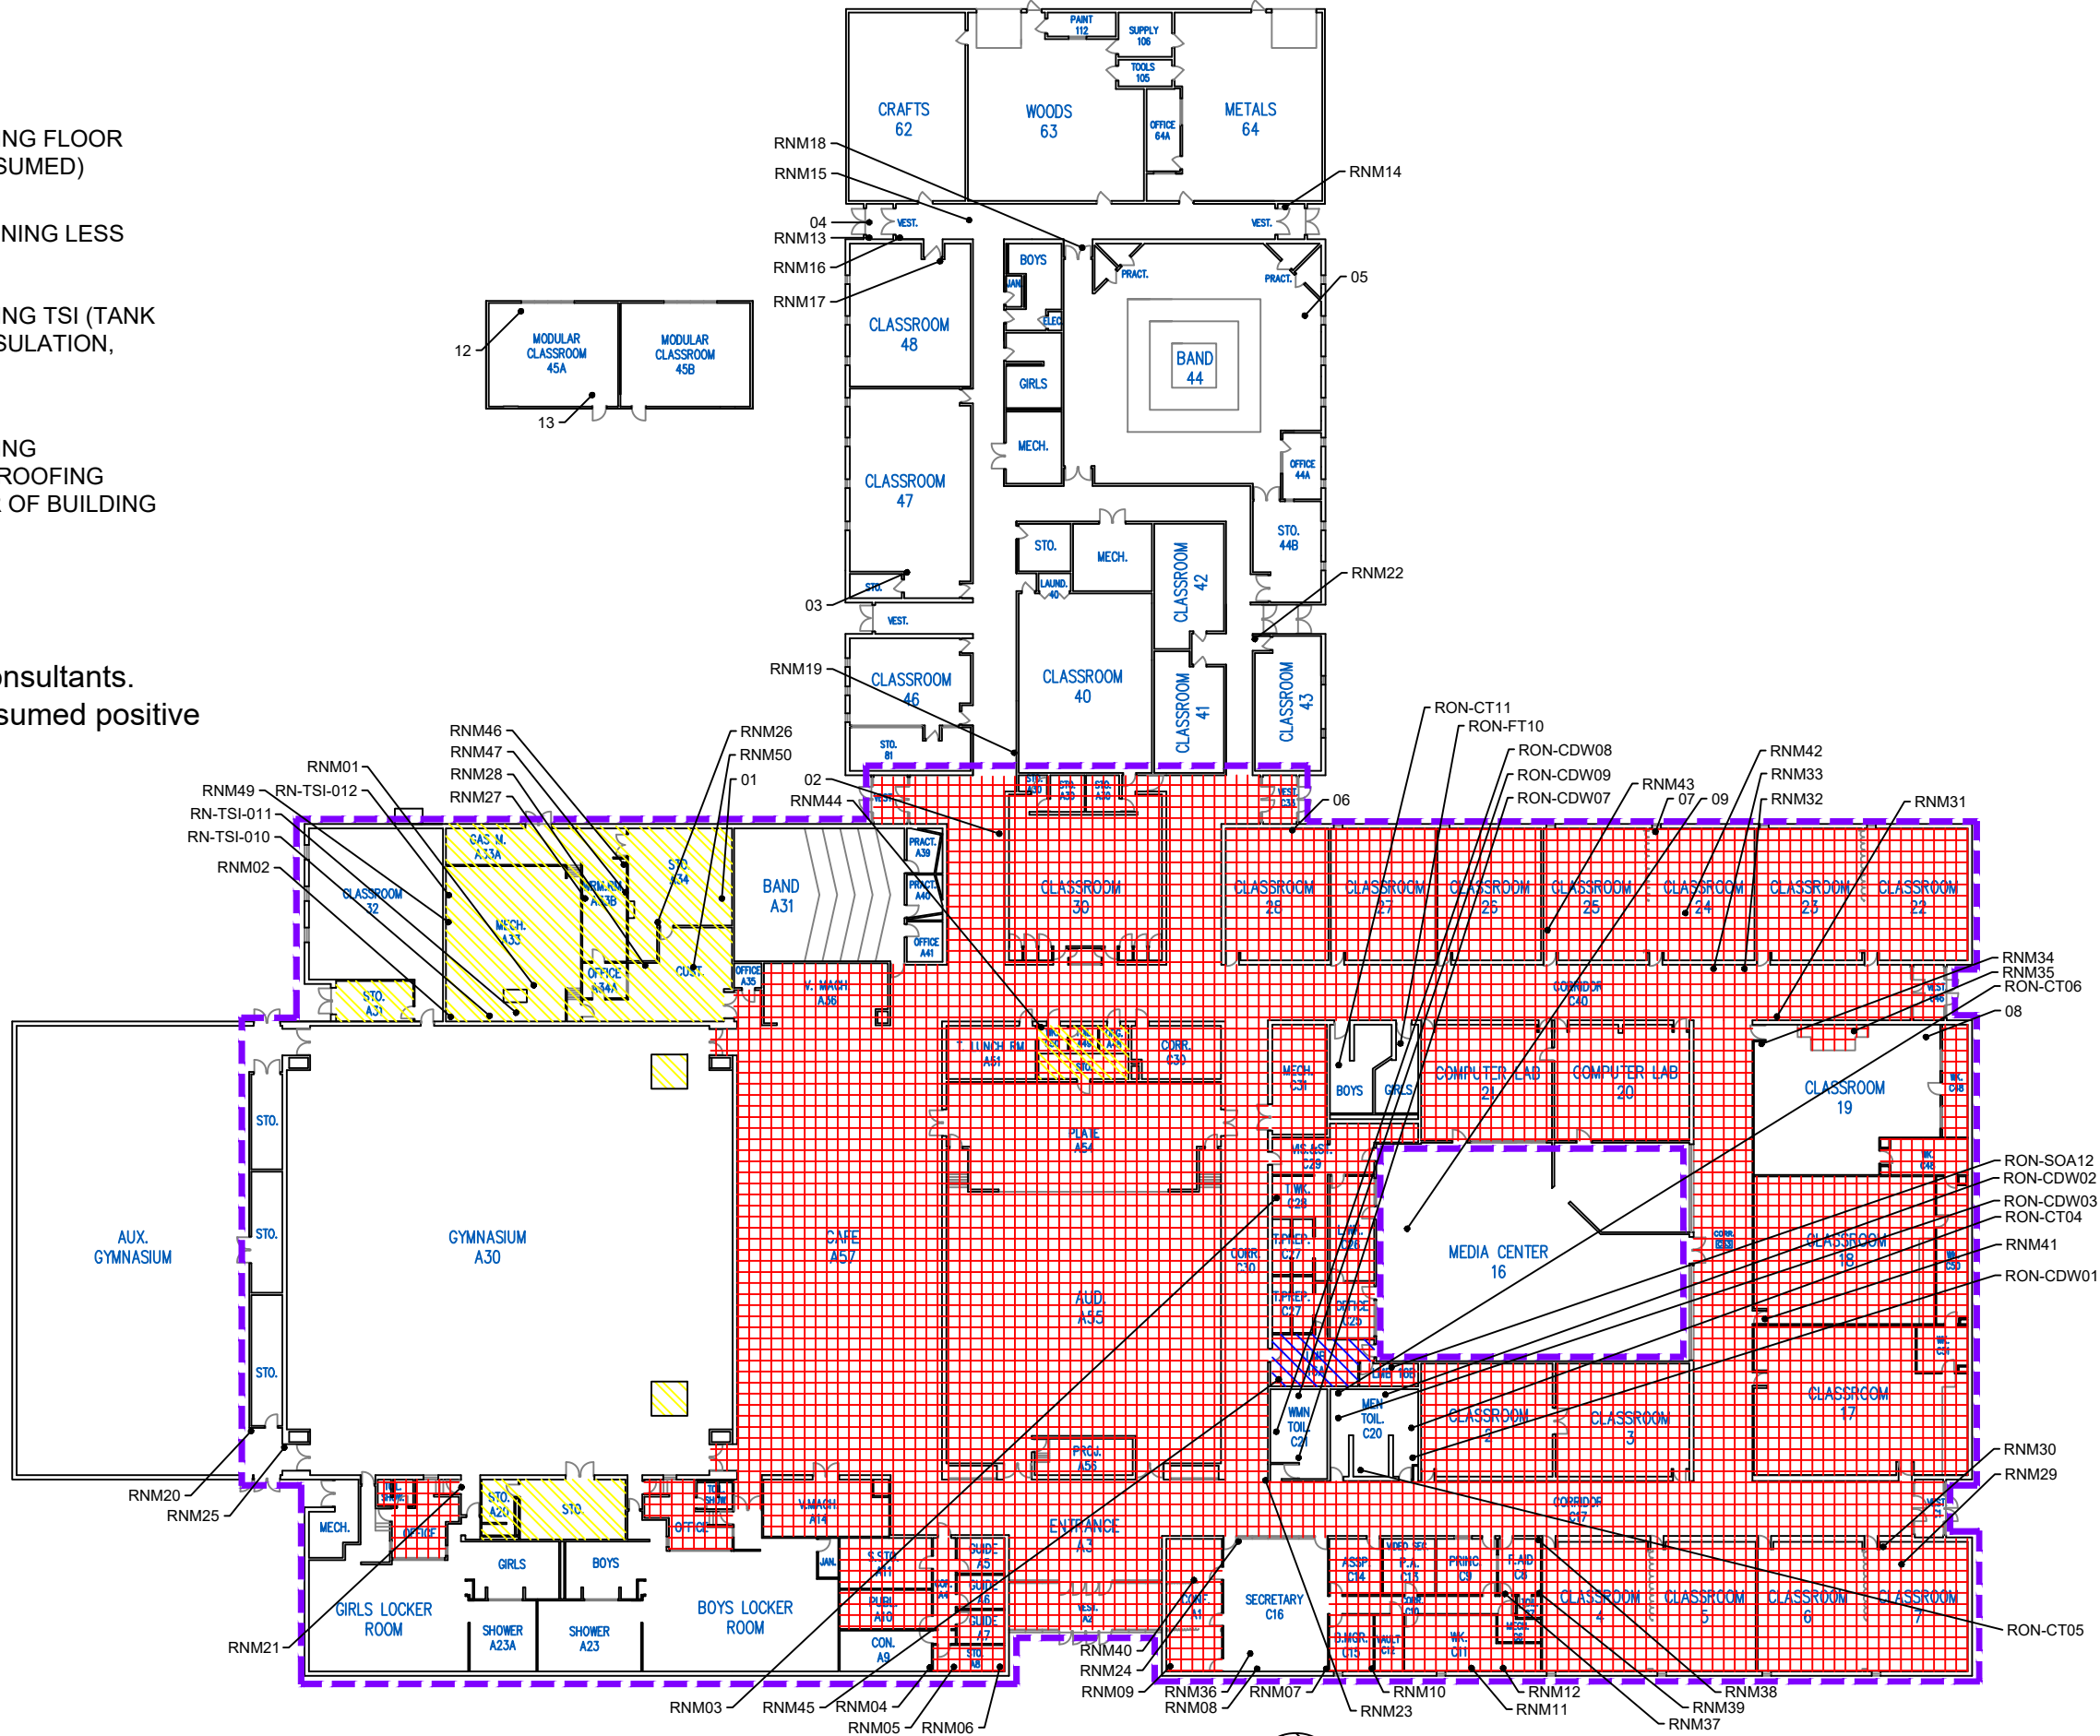
FIRST FLOOR PLAN  
NO SCALE

- ASBESTOS CONTAINING FLOOR TILE (TESTED OR ASSUMED)
- CEILING TILE CONTAINING LESS THAN 1% ASBESTOS
- ASBESTOS CONTAINING TSI (TANK INSULATION, PIPE INSULATION, ETC.)
- ASBESTOS CONTAINING STRUCTURAL FIRE PROOFING AROUND PERIMETER OF BUILDING

NOTE:  
All sampling done by previous consultants.  
CMU filler within the school is assumed positive ACM

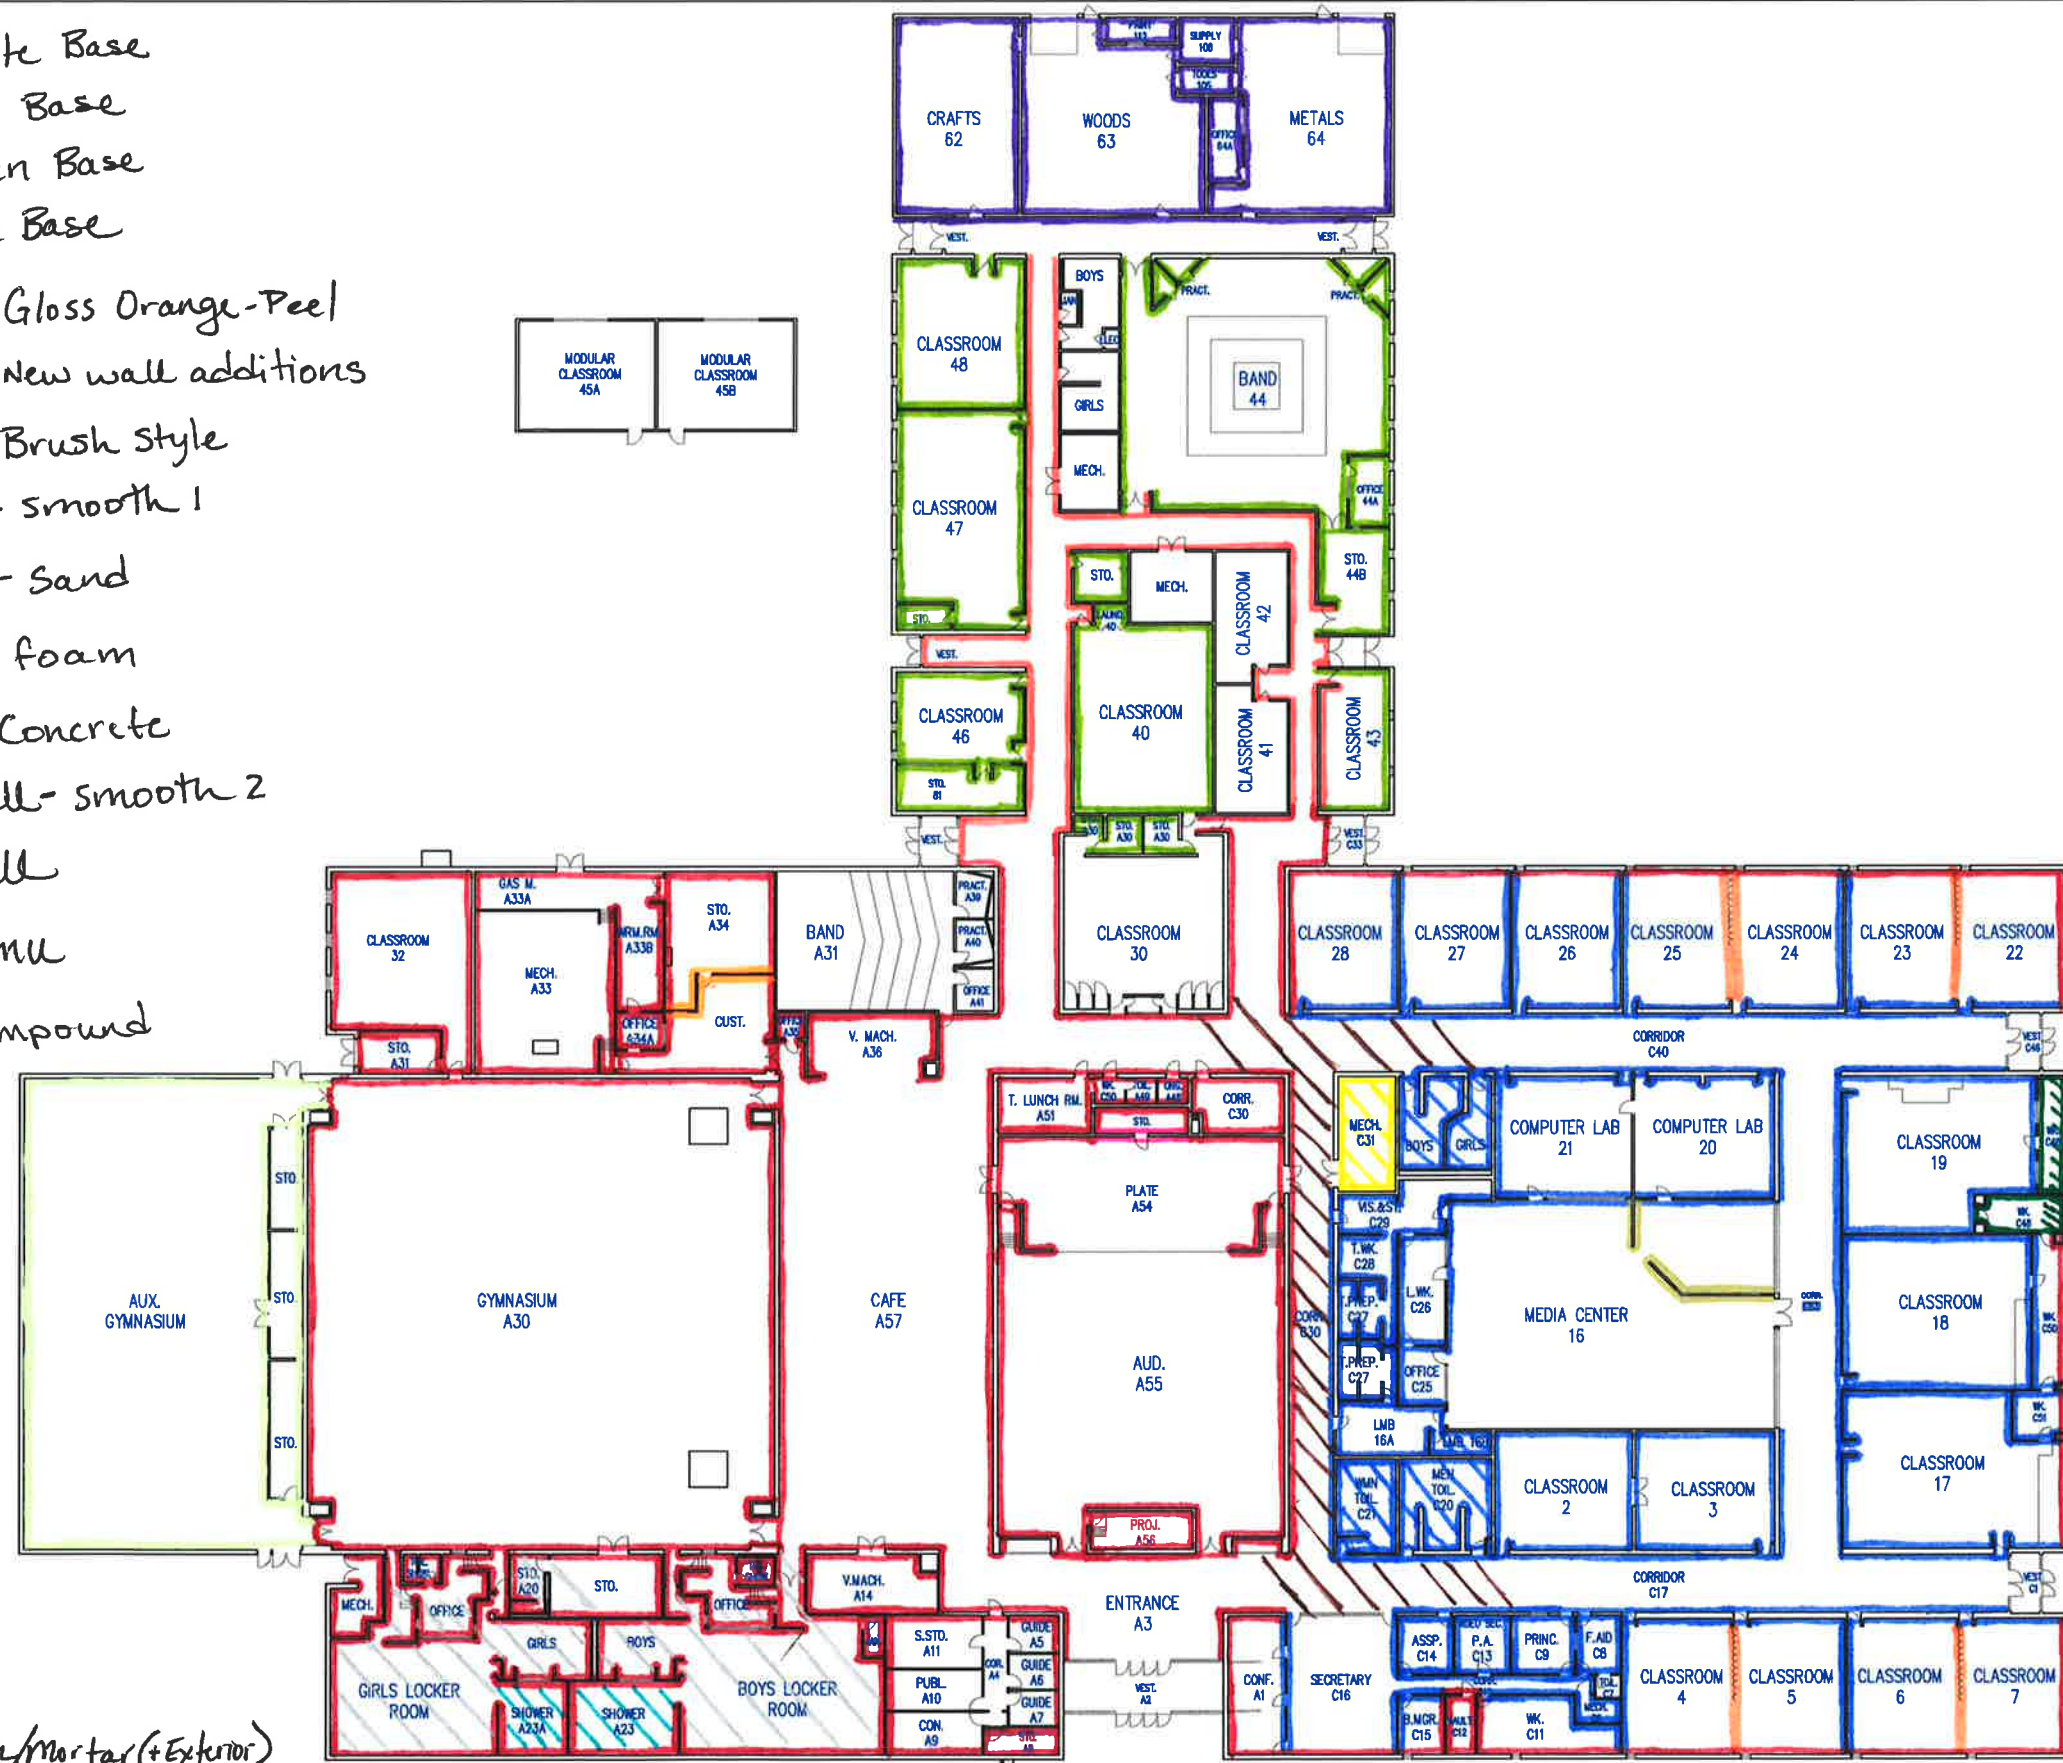
FIRST FLOOR PLAN  
NO SCALE

- CMU Filler - White Base
- CMU Filler - Tan Base
- CMU Filler - Green Base
- CMU Filler - Blue Base
- \* // Textured Drywall - Gloss Orange-Peel
- Textured Drywall - New wall additions
- Textured Drywall - Brush style
- Textured Drywall - smooth 1
- Textured Drywall - Sand
- Rough Coat on foam
- // Heavy Gloss on Concrete
- Textured Drywall - smooth 2
- Textured Drywall
- Painted/Decor CMU
- // Drywall/Joint Compound

- \* Walls not marked are Brick/Mortar (+Exterior)
- \* Any Ceilings Not marked are Drop ceiling tile (All ND)
- \* Ceilings are noted with Hatch

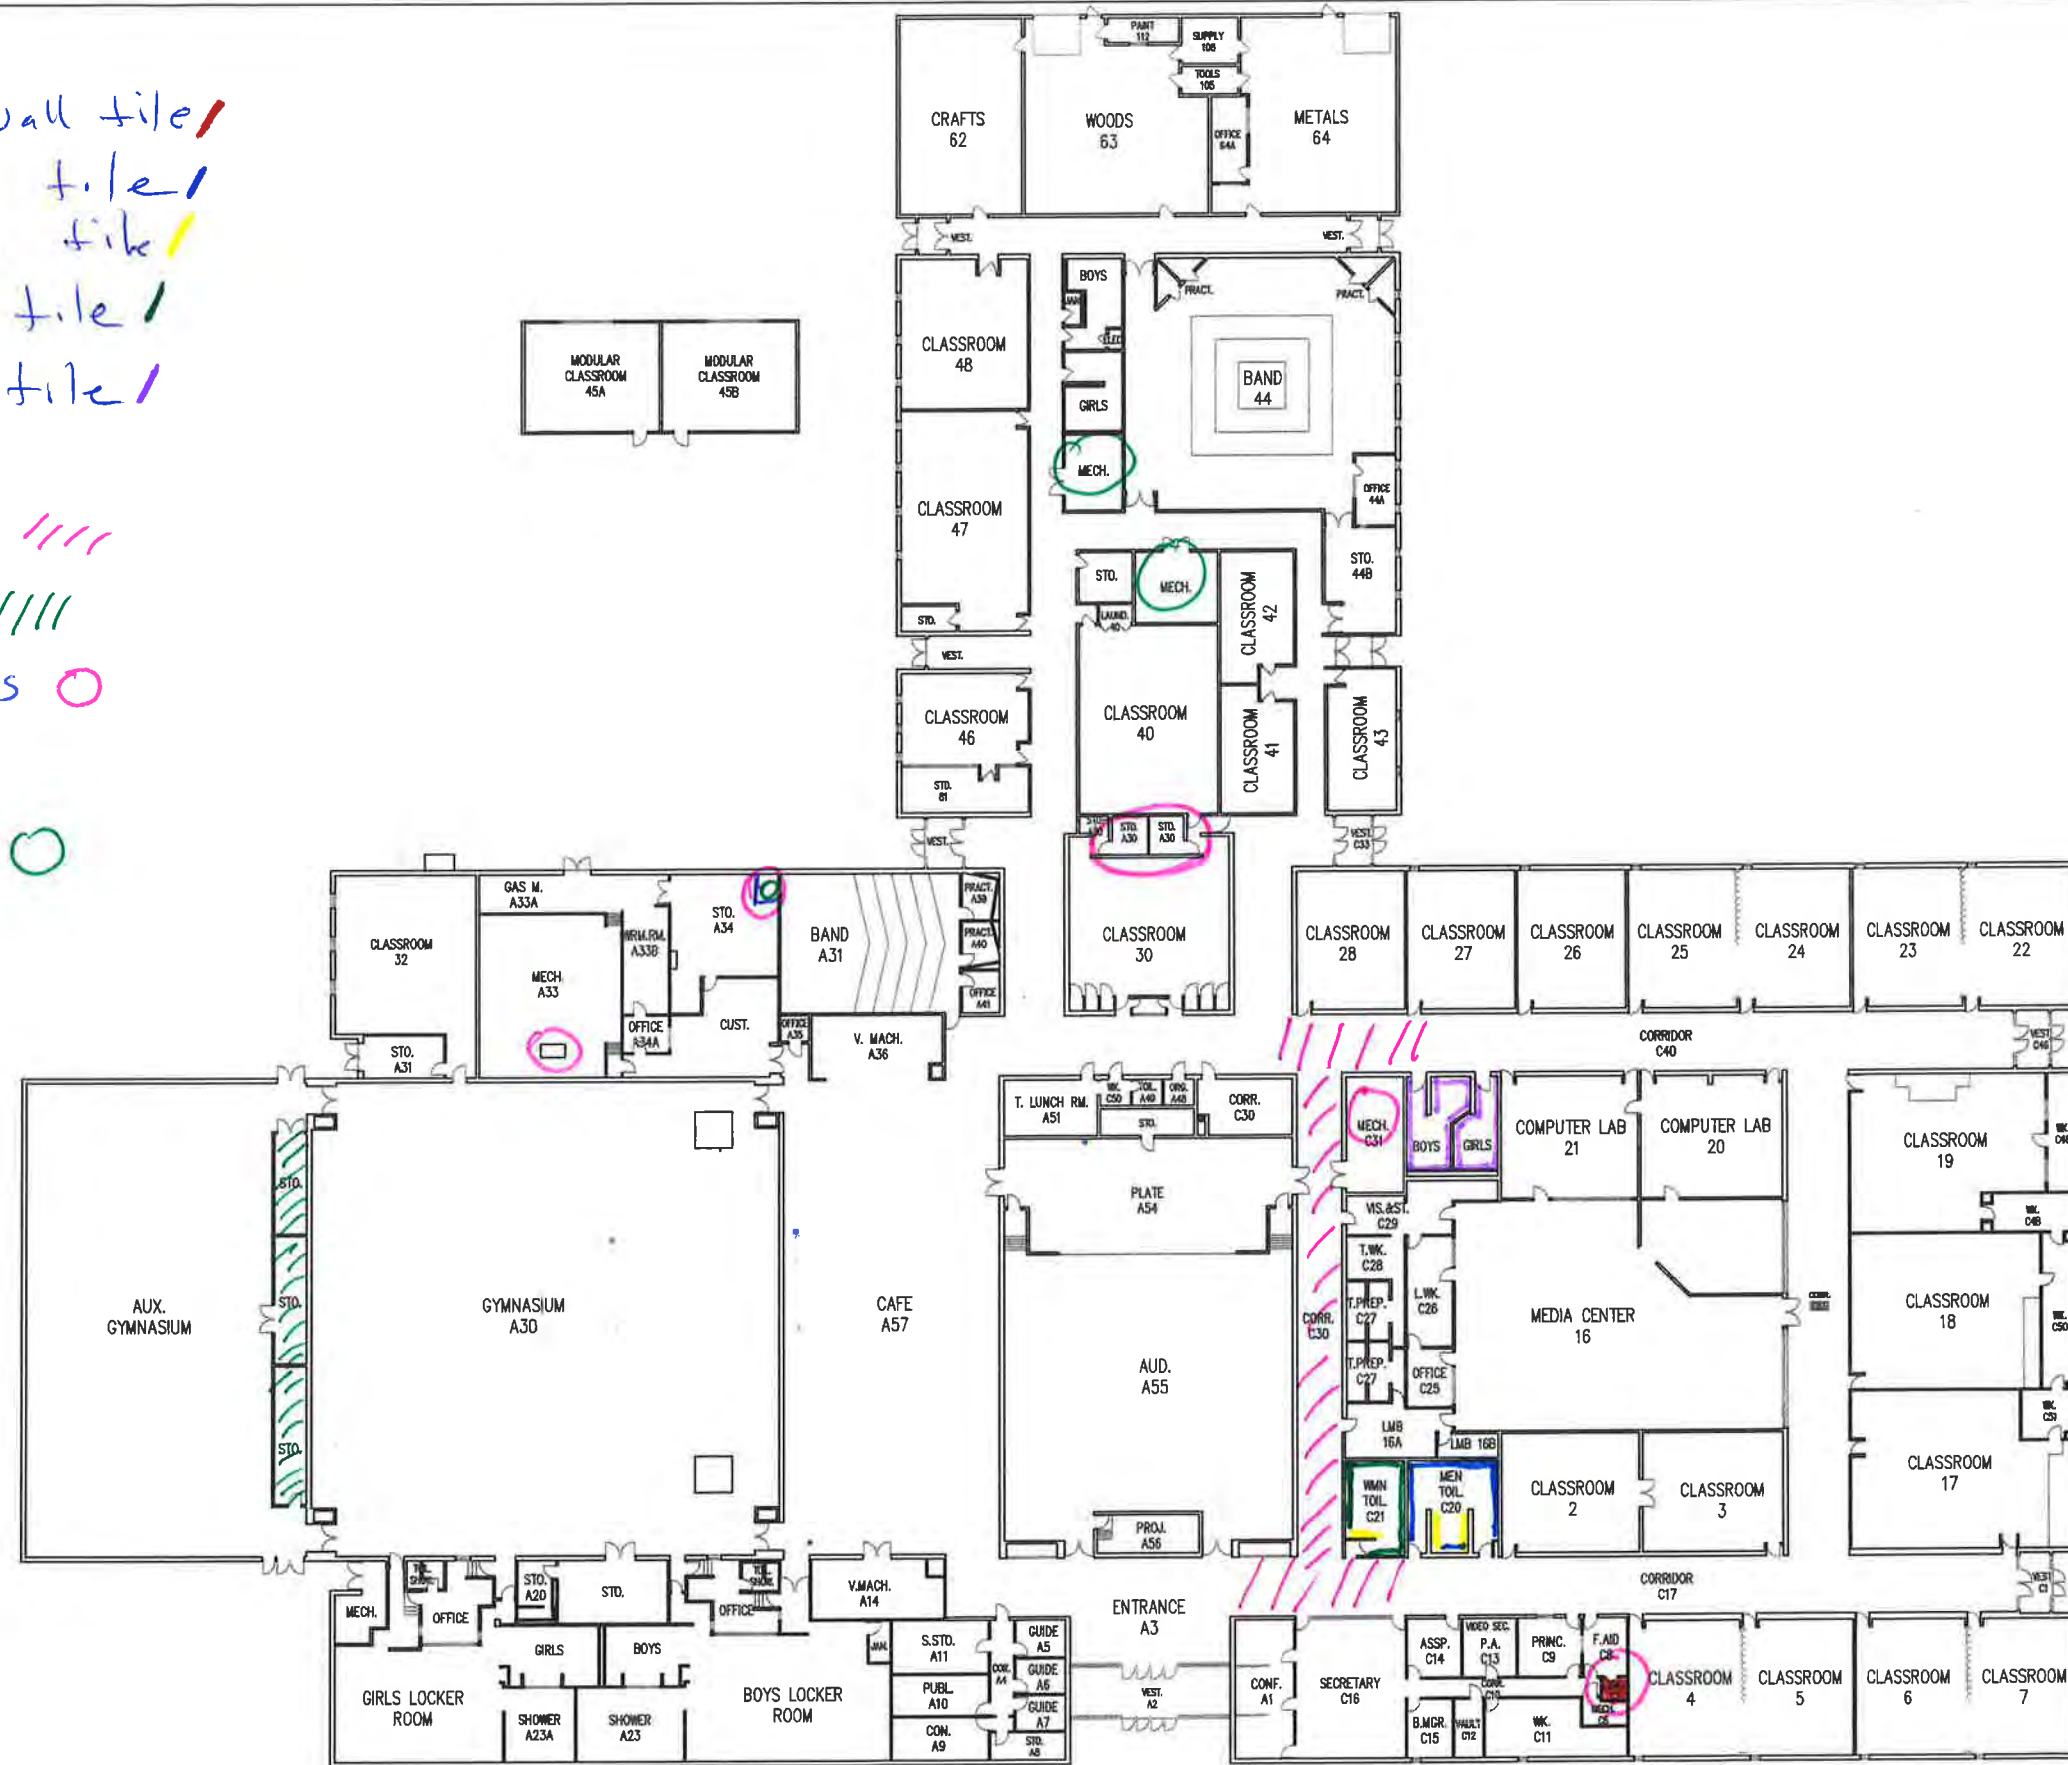
FIRST FLOOR PLAN  
NO SCALE

Vibration Isolators (Fiber) ○

Vibration Isolators (Rubber) ○

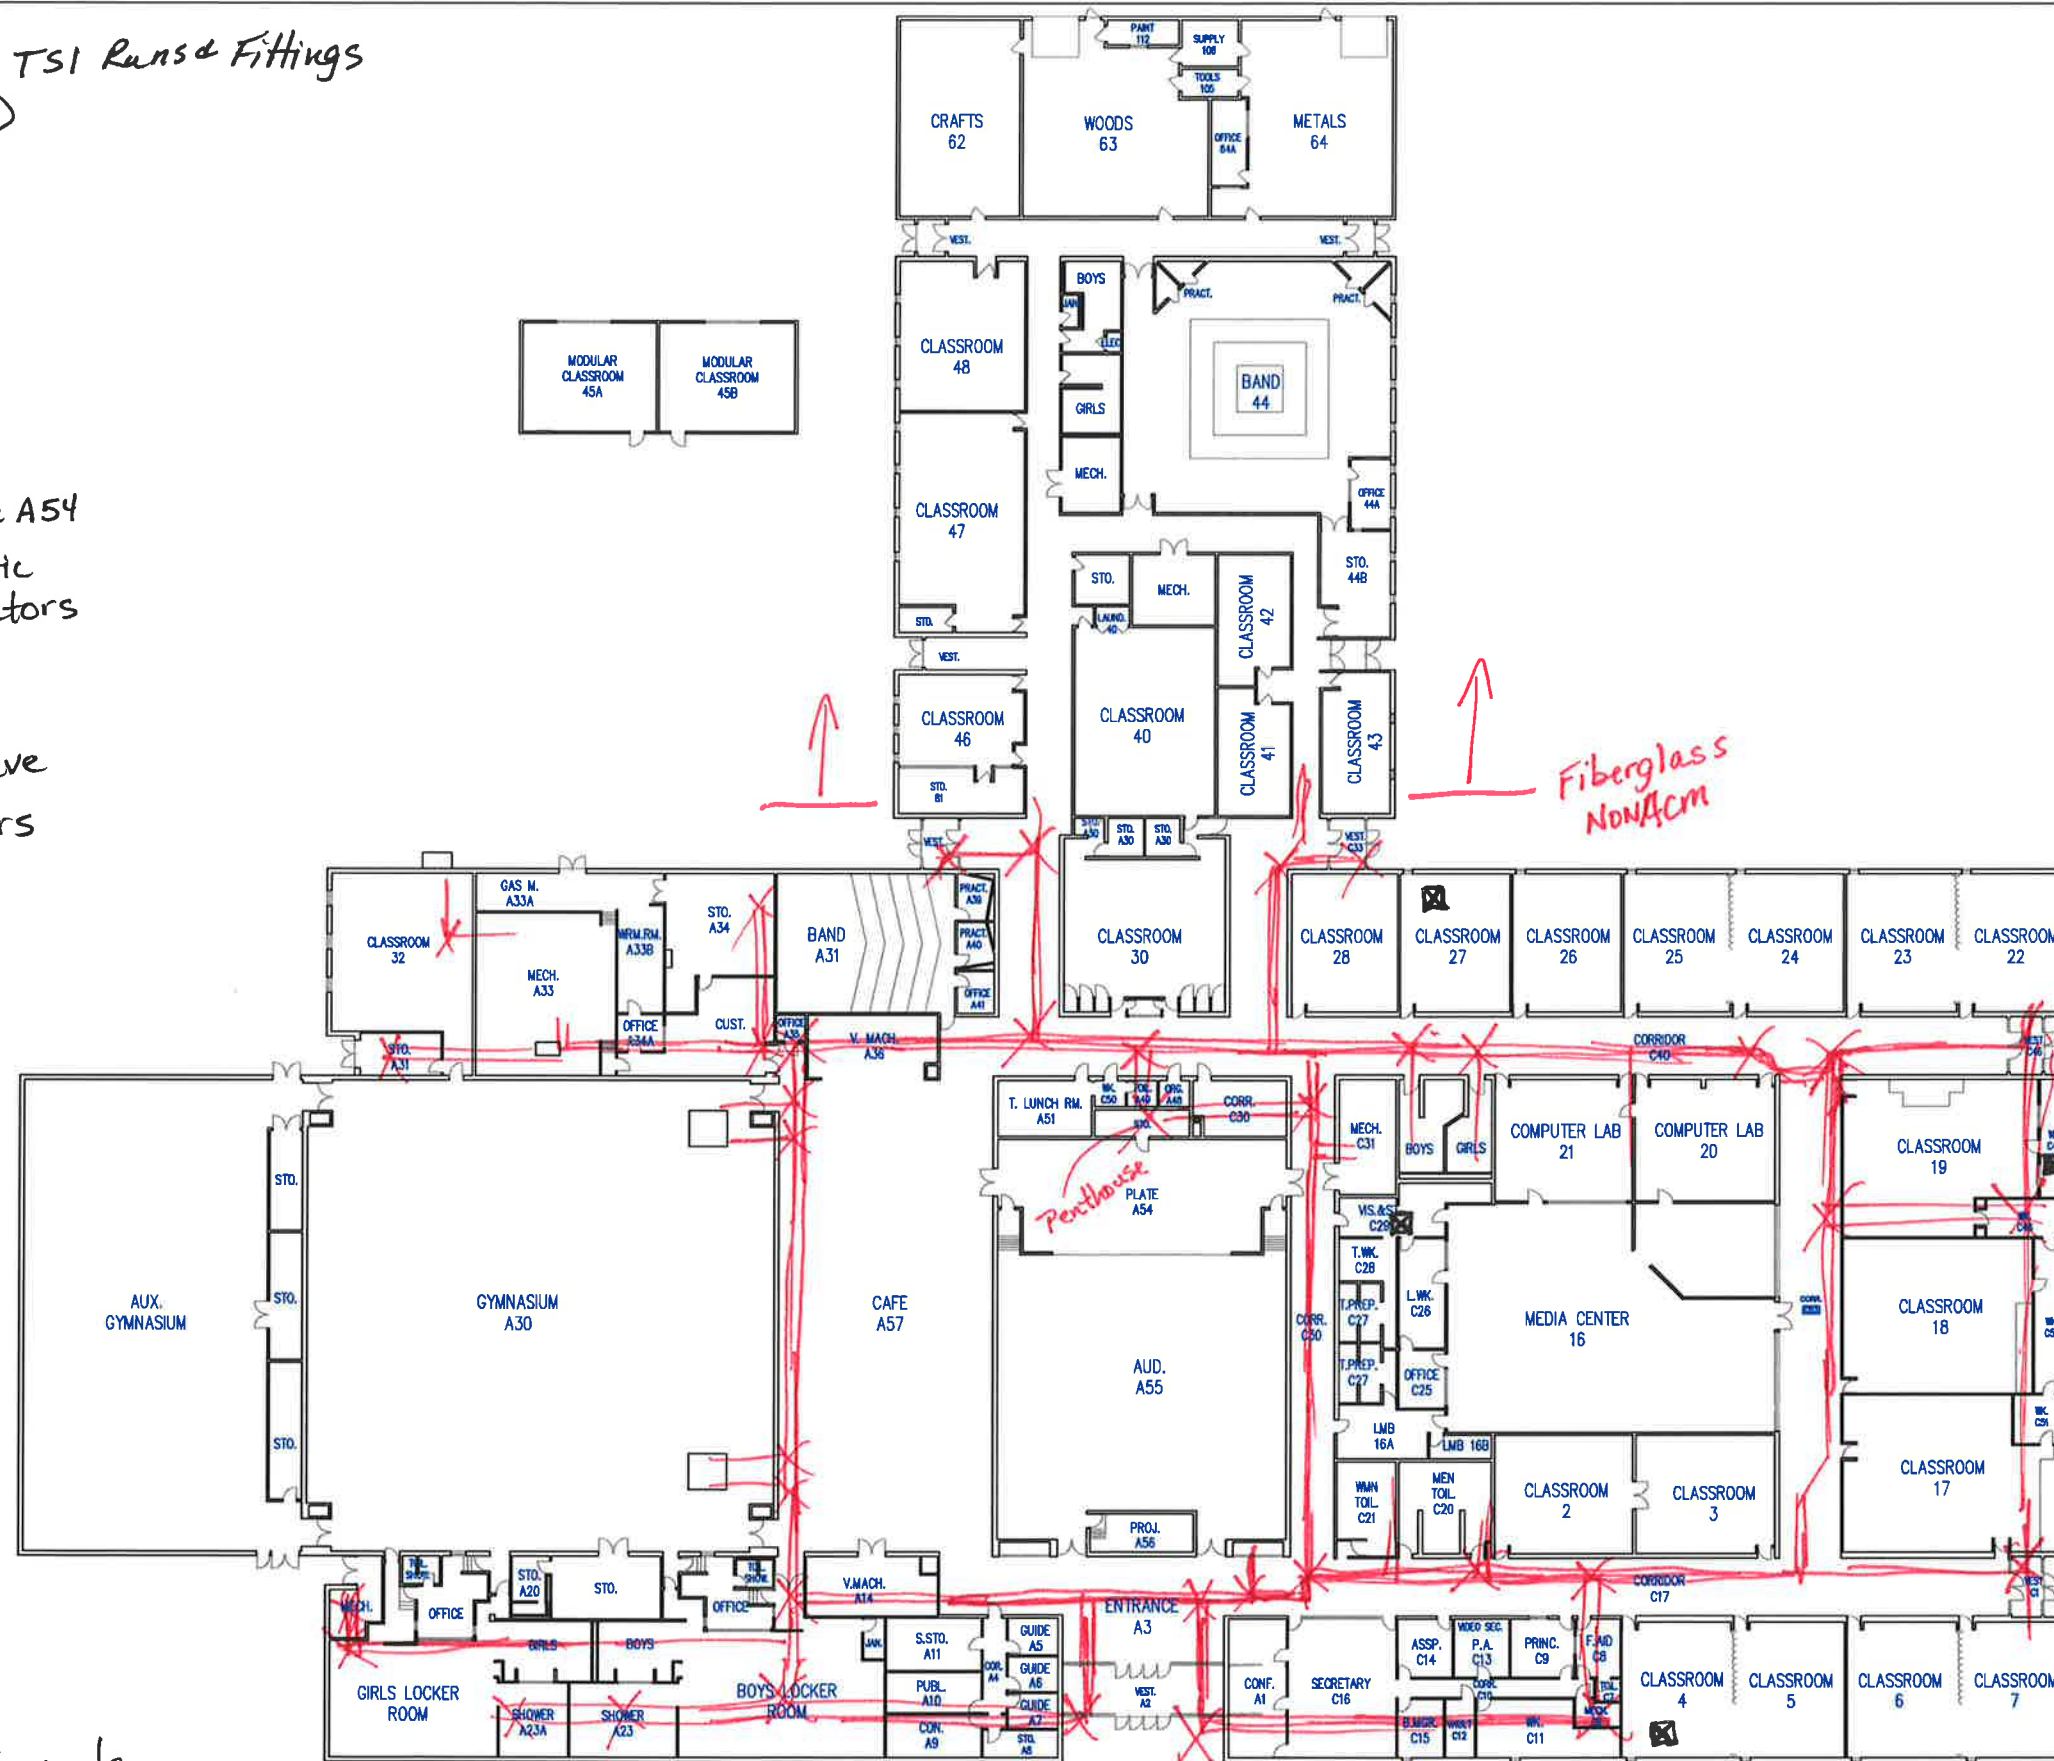
FIRST FLOOR PLAN  
NO SCALE

\*All Mech Rooms have  
- Vibration Isolators  
- TSI Fittings

\*Vibration Isolators in tunnels  
\*TSI Fittings are located in tunnels  
☒ = tunnel Doors

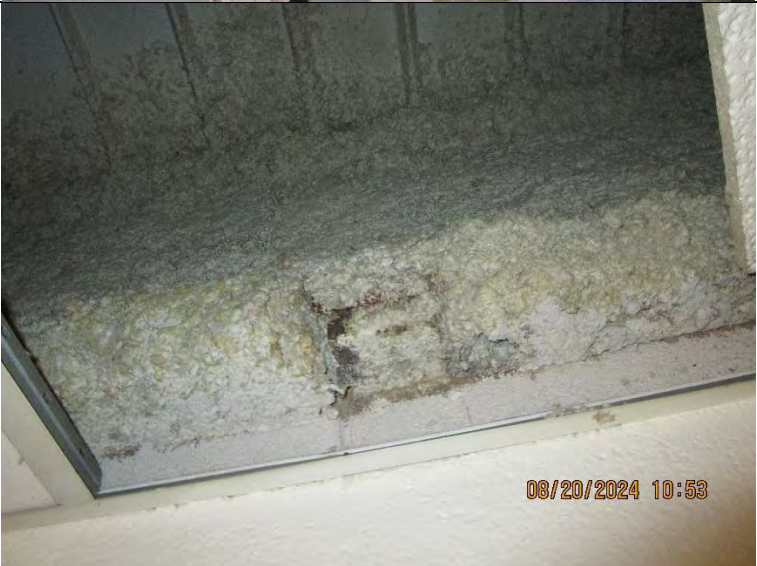
<p><b>Fireproofing Only</b> Beneath Drywall at Ceiling</p> <p>Gym Original Construction</p>

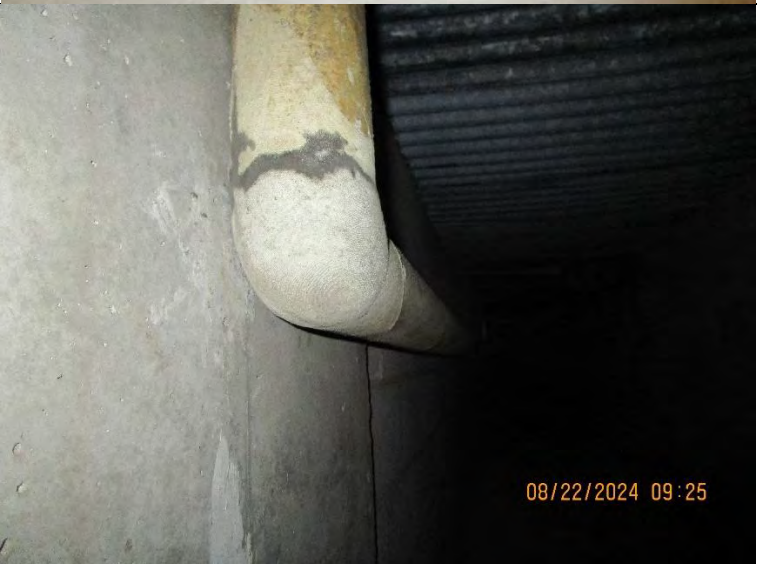
<p><b>Fireproofing</b> Original Construction</p>

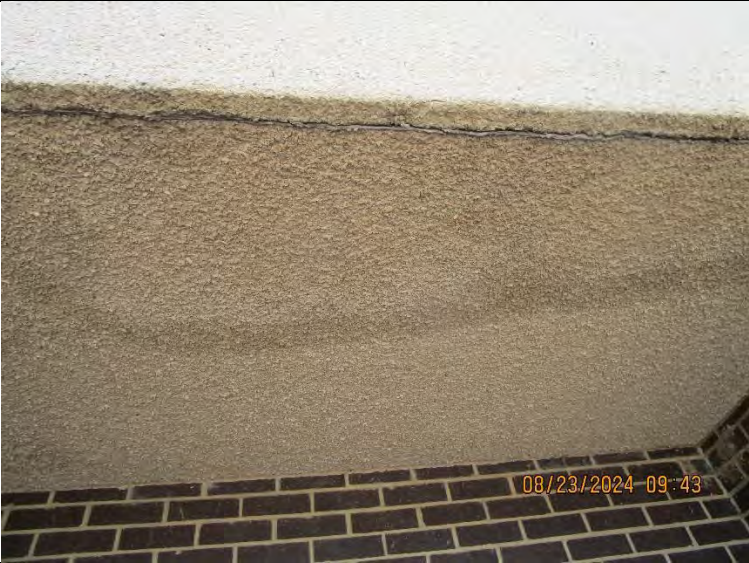
<p><b>Exterior Sealant</b></p> <p>Exterior Windows Original Construction</p>
