## Hastings Middle School Physical Assessment

January 24, 2025

# UPPER ARLINGTON SCHOOLS 2025 FACILITIES ASSESSMENT HASTINGS MIDDLE SCHOOL

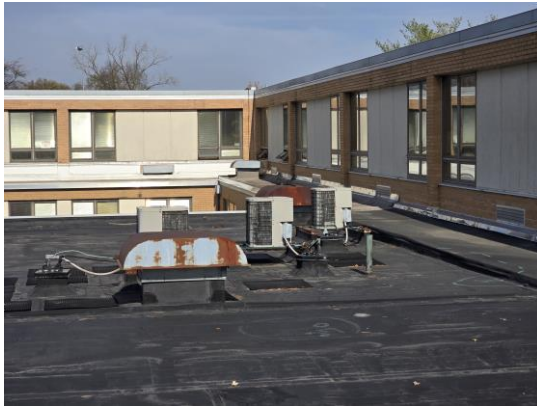
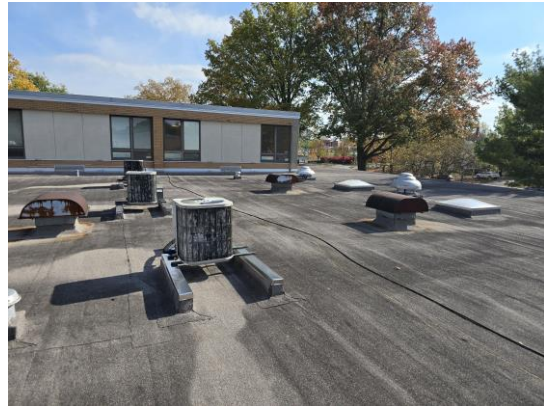
Roof replacement required with proper slope for water drainage

- Full replacement of roof membrane through the building including adding roof insulation to meet current building code and provide proper slope to roof drains.

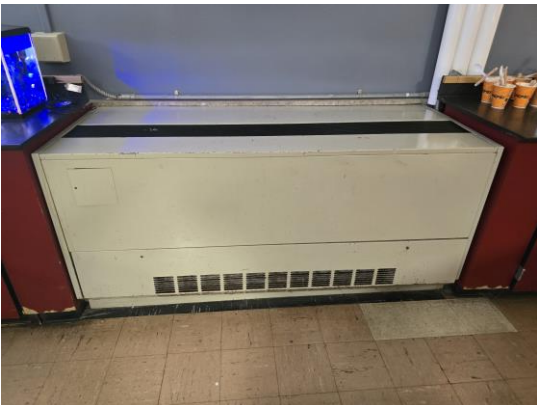
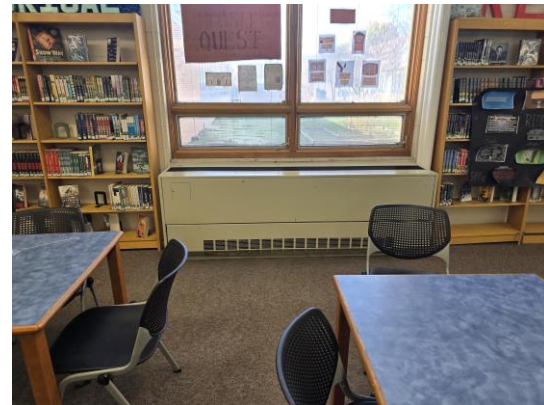
Inefficient unit ventilators need replacement

- Add energy efficient exterior lighting for safety and after-hours use of the site.
- Provide proper railings at the stage steps and side platforms.
- Full replacement of HVAC systems throughout the building.

- Unit vent exterior wall infill will be required with the removal of the unit ventilators.
- Full replacement of electrical systems including fire alarm, lighting, security systems, and building technology throughout the building.

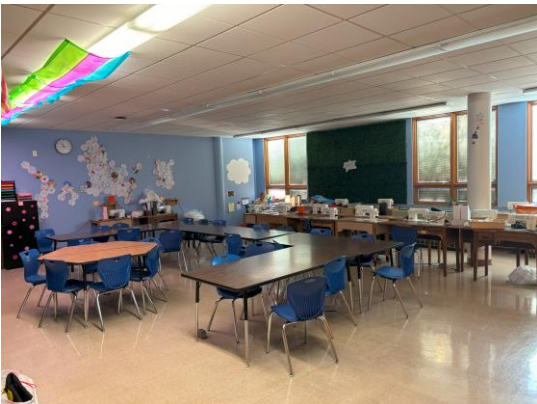
Windows installed in 1997 are at the end of their life requiring repairs & unable to find necessary parts

a. The aluminum clad wood windows were installed in 1997. According to school officials, they are starting to deteriorate and having difficulty finding parts.

- Add overflow roof drains.
- Add eyewash/showers to all science rooms.
- Replace all exterior windows and storefront glazing.
- Level the floor slab in the administration area adjacent to the entry addition.

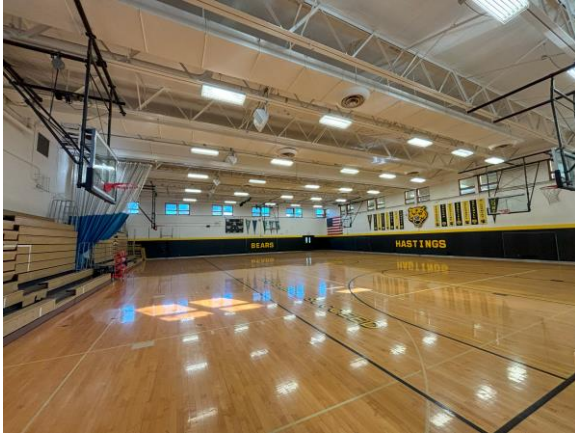
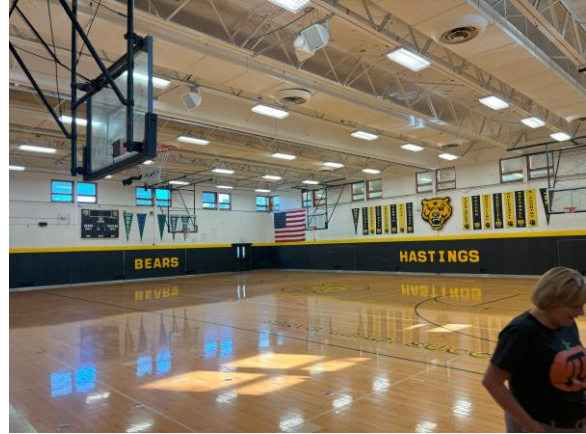
Gymnasium in need of air conditioning

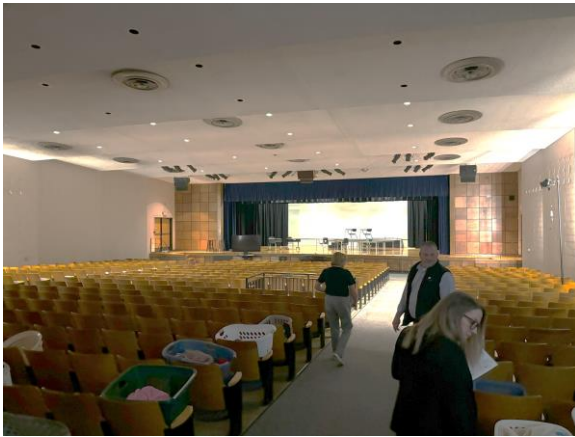
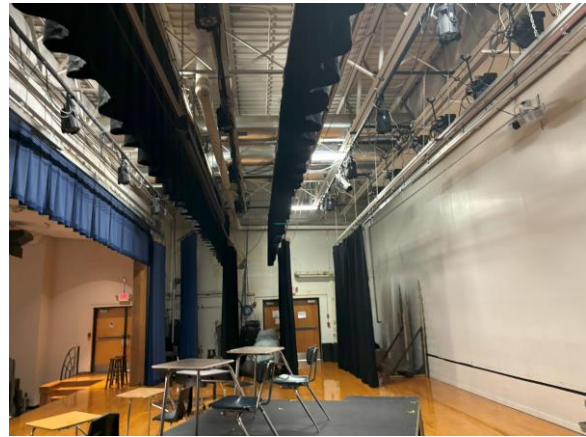
Auditorium upgrades for finishes, seats, railings and platforms
