# Bond Task Force Meeting

Orting School District

Review OSPI Study and Survey Building  
Condition Report

Review Facility Condition Assessment

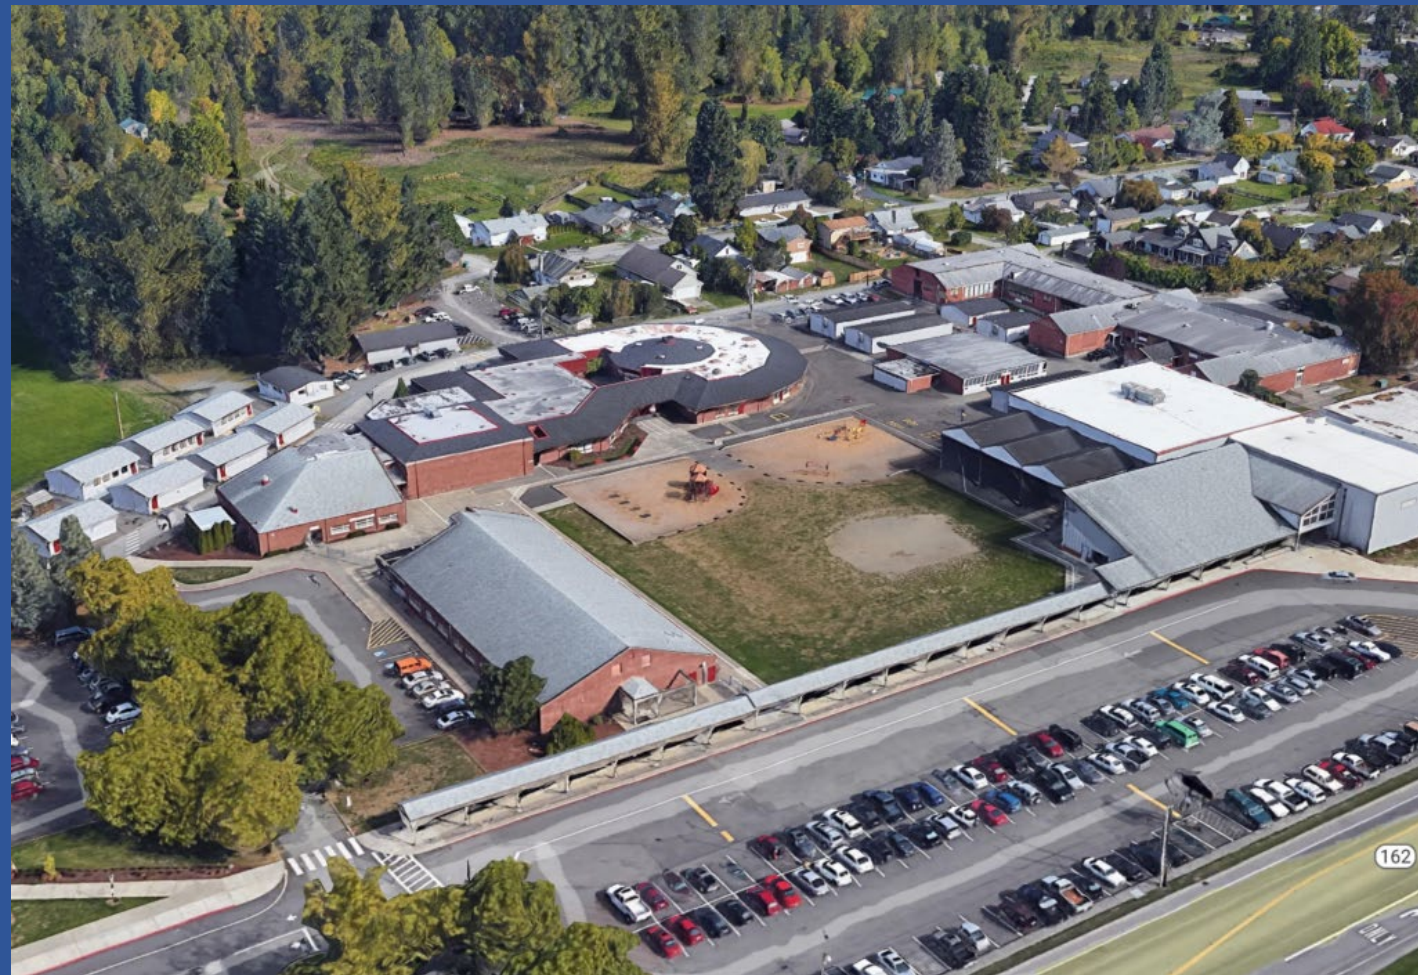
# Orting Elementary School

## Overall **MAIN BUILDING** Score: 59.63%

| CATEGORY | RATING | COMMENTS |
|---|---|---|
| FOUNDATION | 62% (FAIR) | CRACKING |
| SLAB-ON-GRADE | 62% (FAIR) | MINOR CRACKING & SETTLEMENT |
| EXTERIOR VERTICAL ENCLOSURE (WALL) | 62% (FAIR) | SURFACE DAMAGE, POOR INSULATION |
| EXTERIOR HORIZONTAL ENCLOSURE (ROOF) | 62% (FAIR) | SURFACE AGING, WEATHERING |
| INTERIOR CONSTRUCTION | 62% & 30% | DOORS = 30%, OTHER INT. CONST. = 62% |
| INTERIOR FINISHES | 62% & 30% | FLOORING = 30%, OTHER FINISHES=FAIR |
| HVAC | 62% (FAIR) | STUFFY ROOMS, EQUIPMENT OBSOLESCENCE |
| ELECTRICAL | 62% (FAIR) | AGING EQUIPMENT, CAPACITY CHALLENGES, LOW AND UNEVEN LIGHT LEVELS |

- MEP equipment all past its useful life
- Cracking in brick walls, repairs needed
- Single Pane Windows

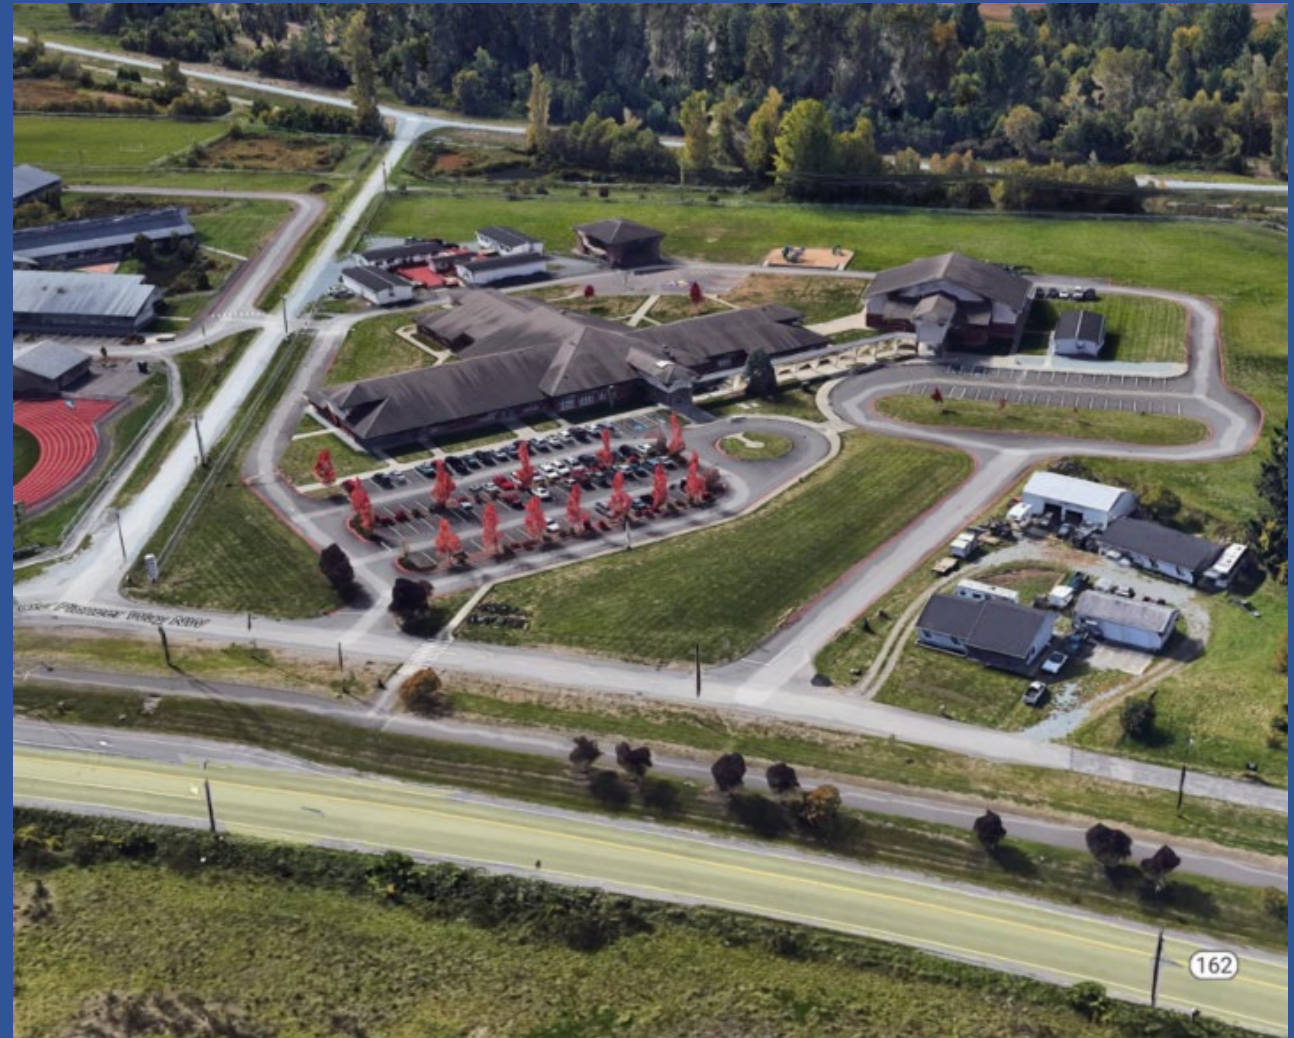
# Ptarmigan Ridge Elementary School

# Overall **MAIN BUILDING** Score: 84.85%

| CATEGORY | RATING | COMMENTS |
|---|---|---|
| EXTERIOR VERTICAL ENCLOSURE (WALL) | 62% (FAIR) | EFFLORESCENCE AND STAINING, POOR WINDOW INSULATION, DOOR HARDWARE WEAR/TEAR |
| INTERIOR FINISHES | 90% & 62% | WALL FINISHES & FLOORING = 62%, OTHER FINISHES=90% |
| HVAC | 90% & 62% | 62%=UNEVEN ROOM COVERAGE, SYSTEM INEFFICIENT, 90%=REMAINDER |
| INTEGRATED AUTOMATION | 62% (FAIR) | EQUIPMENT OBSOLESCENCE |

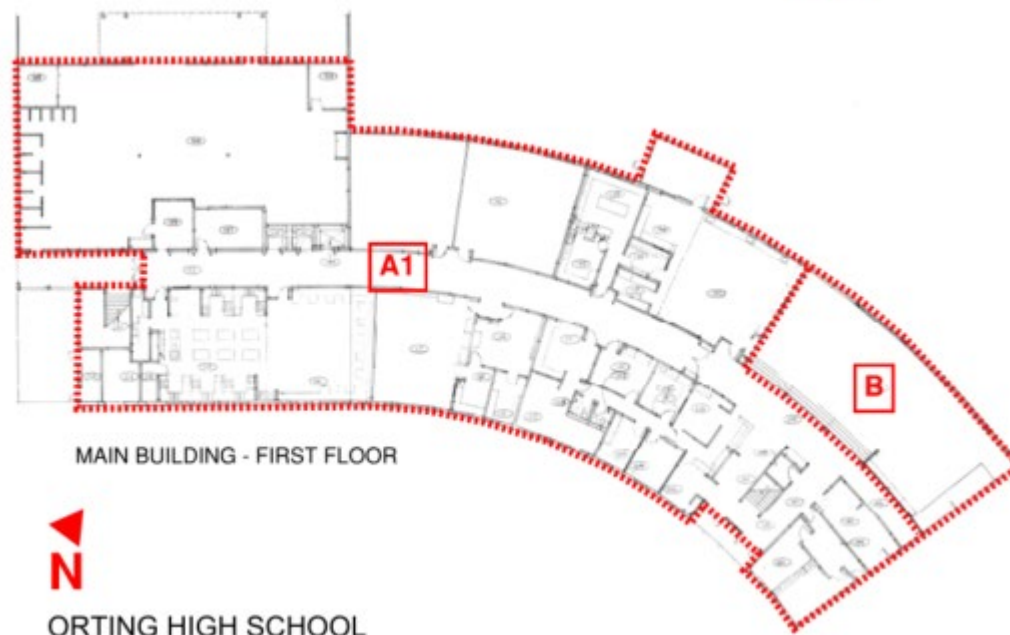
## Overall **MAIN BUILDING** Score: 74.65%

| CATEGORY | RATING | COMMENTS |
|---|---|---|
| SLAB-ON-GRADE | 62% (FAIR) | MINOR CRACKING |
| SUPERSTRUCTURE | 90% & 62% | 62% = STAIRS, 90% = REMAINDER |
| EXTERIOR VERTICAL ENCLOSURE (WALL) | 62% (FAIR) | SURFACE DAMAGE, EXCESSIVE HEAT LOSS, WEAR AND TEAR |
| EXTERIOR HORIZONTAL ENCLOSURE (ROOF) | 62% (FAIR) | SURFACE WEATHERING, GENERAL WEAR AND TEAR, DEFICIENT ROOFING MATERIAL |
| INTERIOR CONSTRUCTION | 62% (FAIR) | WALL/FLOORING/CEILING WEAR AND TEAR, STAINING, DETERIORATION |
| INTERIOR FINISHES | 90% & 62% | CEILINGS = 62%, OTHER FINISHES=90% |
| CONVEYING | 62% (FAIR) | AGING ELEVATOR SYSTEMS |
| HVAC | 90% & 62% | 90% = FUEL & VENTILLATION, 62% = HEATING AND AGING EQUIPMENT |
| ELECTRICAL | 90% & 62% | 62% = AGING LIGHT FIXTURES, 90% = REMAINDER |

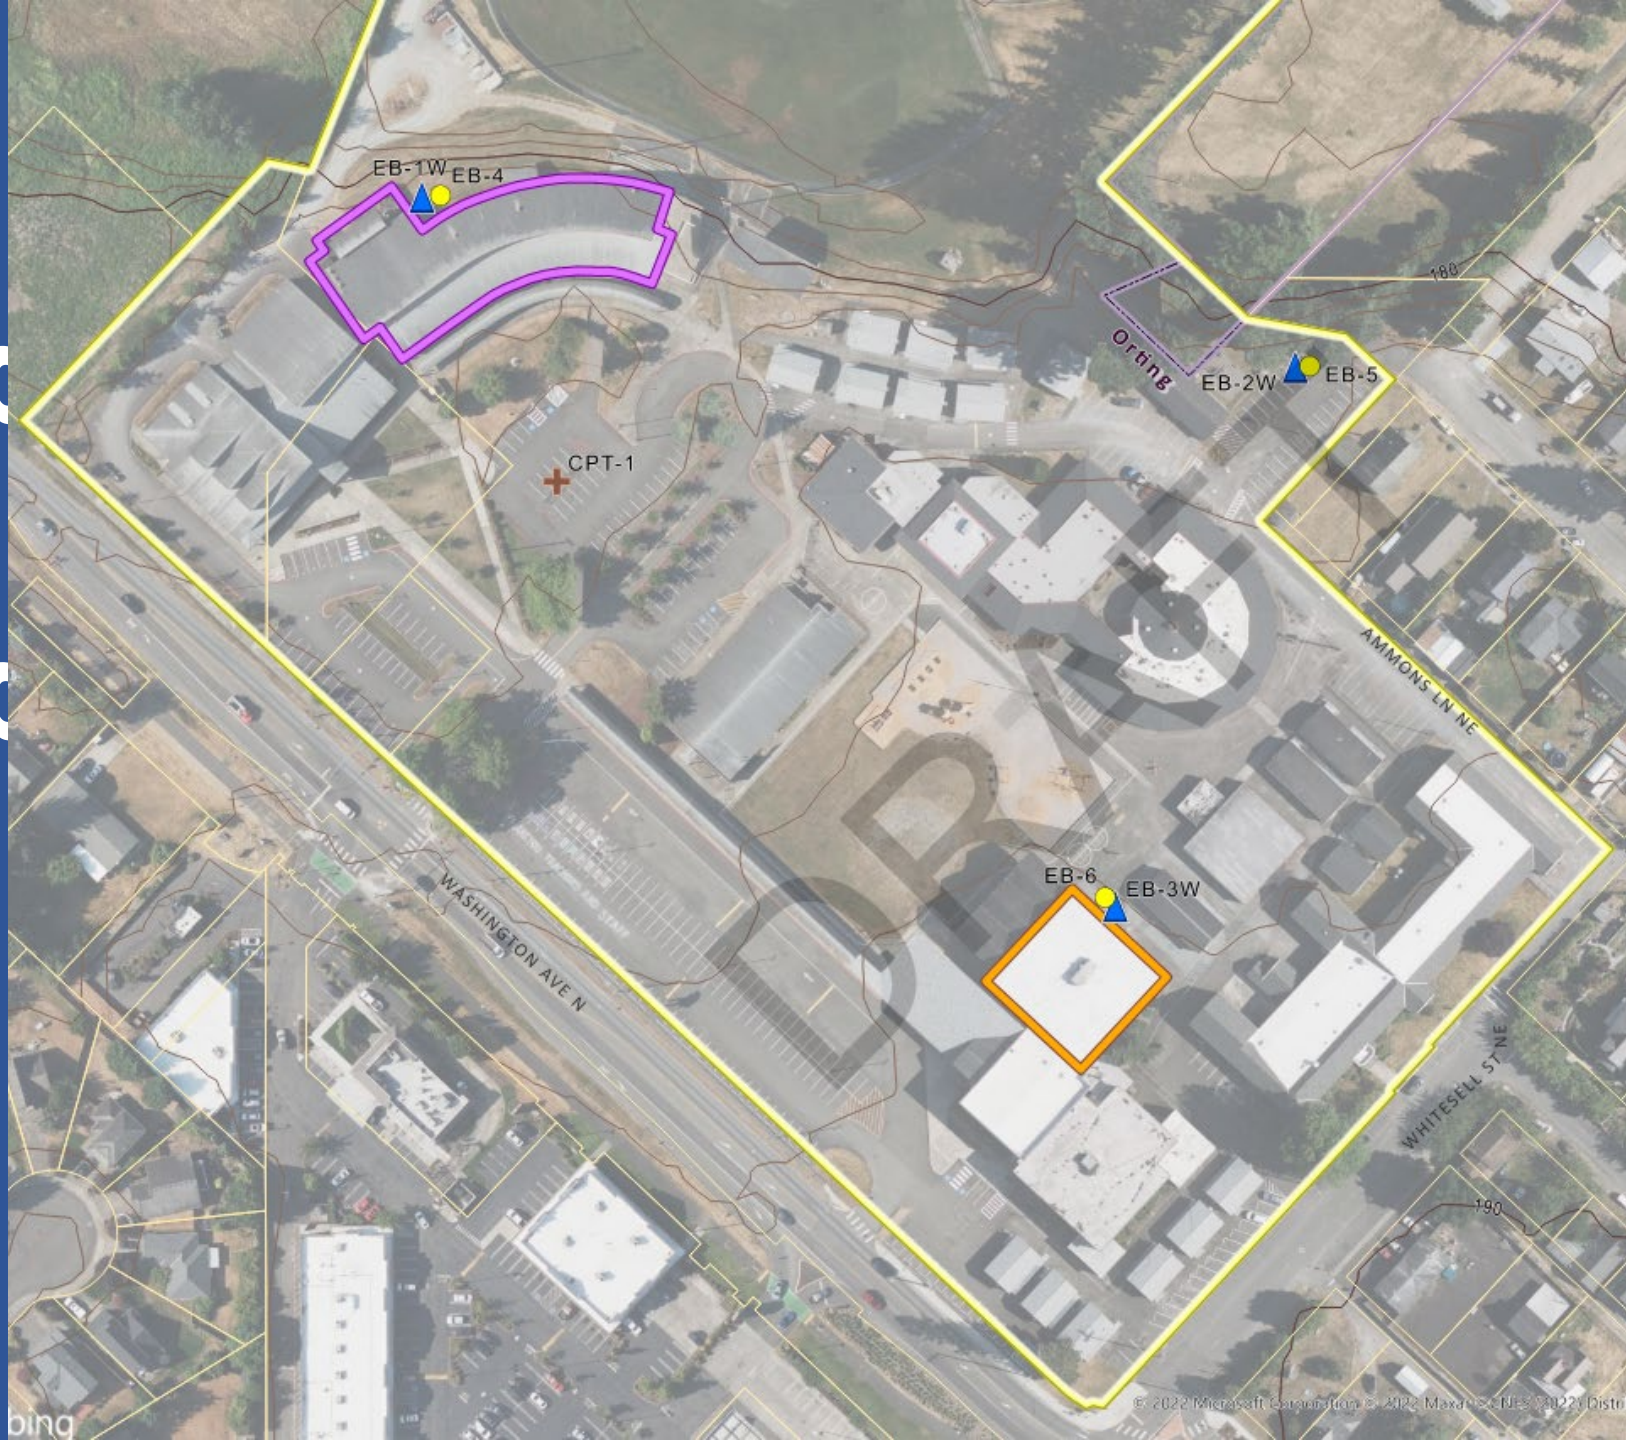
# Orting High

- Parking Area paving repairs needed
- Some wall cracking due to settlement in older buildings
- Some MEP equipment past useful life.
