Re: 49 Union Street, Middleboro, MA - Roof Asbestos Bulk Sampling Report

Enclosed are the analytical results of the suspect asbestos bulk samples collected by Environmental Consulting and Management (ECM) from the roof of the building located at 49 Union Street in Middleborough, MA. The inspection consisted of collecting suspect asbestos containing roofing materials that will be impacted during the upcoming roof replacement project.

### **Site Photographs**

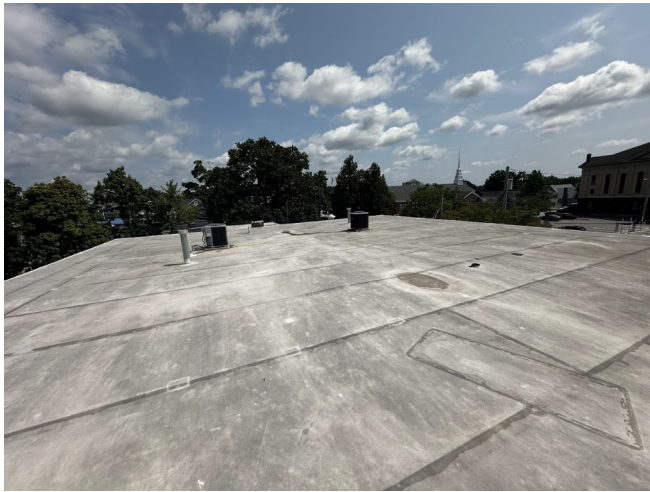
| Sample # | Material | Location | Asbestos % |
|---|---|---|---|
| 04A | Roof Core | South Lower Roof Field | None Detected |
| 04B | Roof Core | Main Roof Field | None Detected |
| 04E | Roof Core | North Lower Roof Field | None Detected |

Roof Field

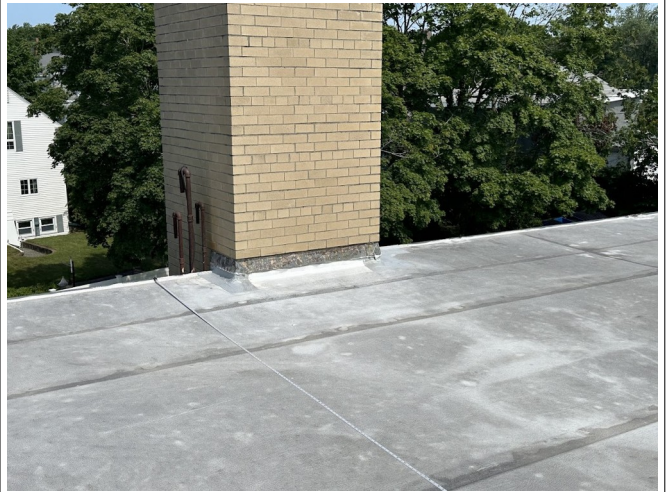
| Sample # | Material | Location | Asbestos % |
|---|---|---|---|
| 1-A-E | Edge Flashing Sealant | Roof Edge | None Detected |

Edge Flashing Sealant

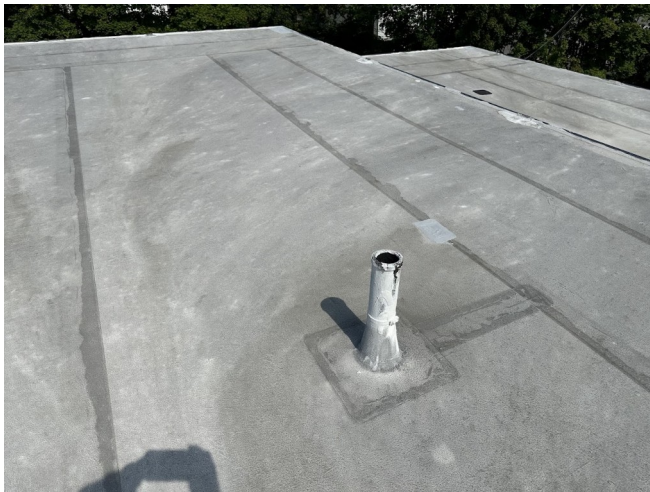
| Sample # | Material | Location | Asbestos % |
|---|---|---|---|
| 2A-C | Pipe Penetration Sealant | Around Vent Pipes | None Detected |

Pipe Penetration Sealant

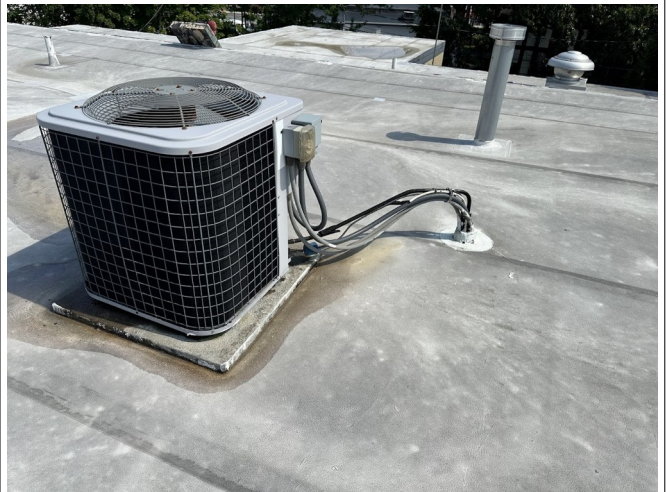
| Sample # | Material | Location | Asbestos % |
|---|---|---|---|
| 05A-C | HVAC Pipe Penetration Sealant | Main Roof Field | None Detected |

HVAC Pipe Penetration Sealant

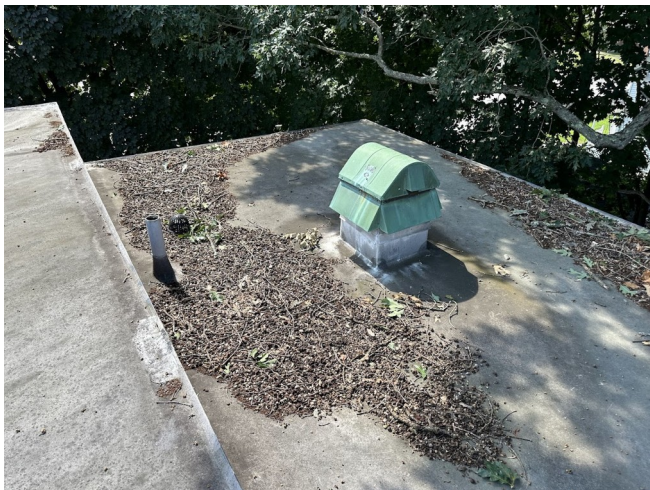
| Sample # | Material | Location | Asbestos % |
|---|---|---|---|
| 03 | Copper Vent Hood Sealant | South Lower Roof | None Detected |

Cooper HVAC Hood Sealant

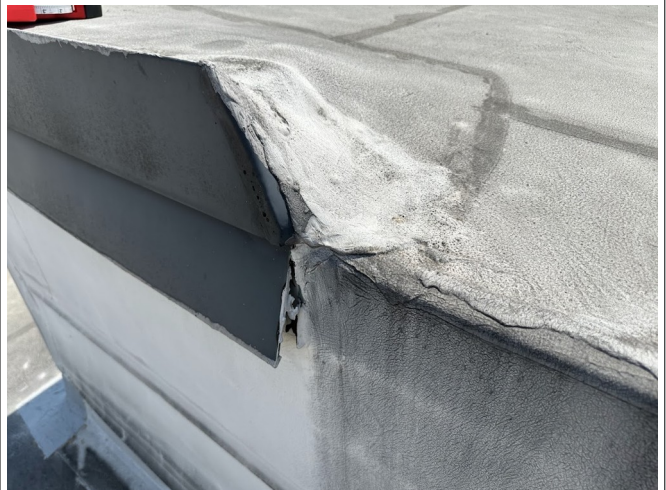
| Sample # | Material | Location | Asbestos % |
|---|---|---|---|
| 06 | Upper Roof Flashing Sealant | Central Upper Roof | None Detected |

Upper Roof Flashing Sealant
