**REPLACEMENT OF QUARRY ROAD BRIDGE
SUFFIELD, CT
ADDENDUM NO. 2
March 31, 2025**

BRIDGE NO.139011

74540 - SUFFIELD
Quarry Road
over
an unnamed stream

Screening Inspection

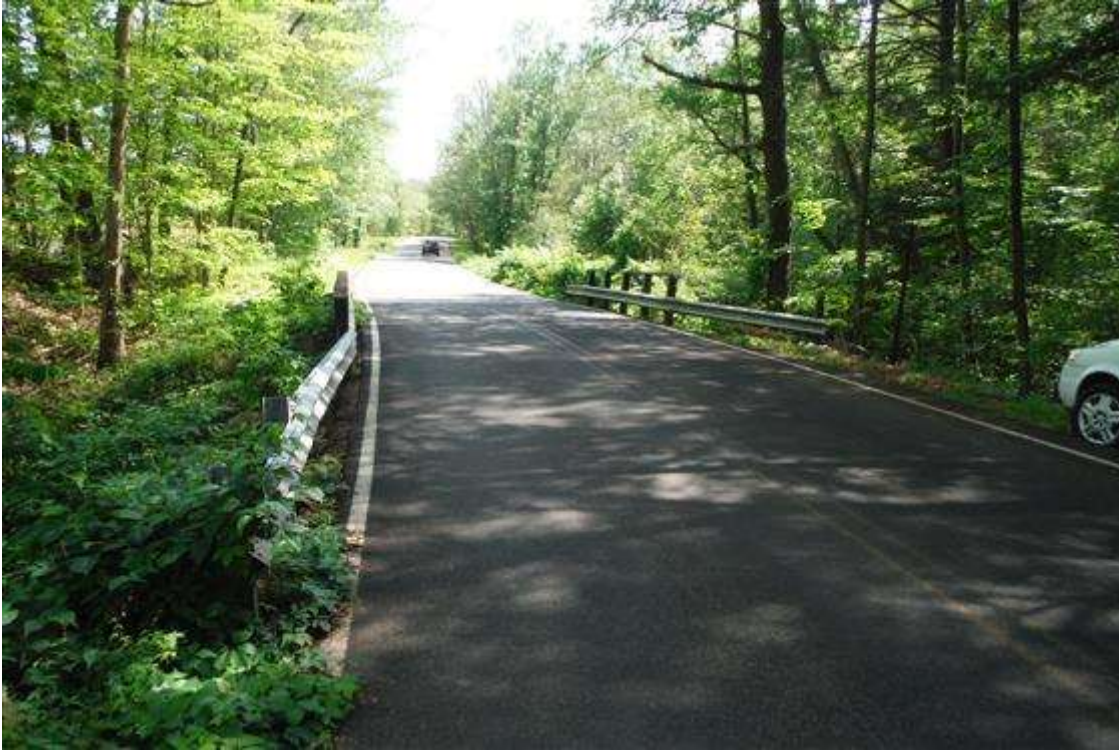
Photo Number: 1

Depression/Settlement	Sat/Better	Bituminous Concrete surface in good condition
Sidewalk	N/A	
Bridge Rail/Fence	Fair/Worse	Rusted bridge rail with section loss. Not connected to bottom flange at outlet. Metal beam rail with no anchors.

Top of Deck
Looking south across bridge

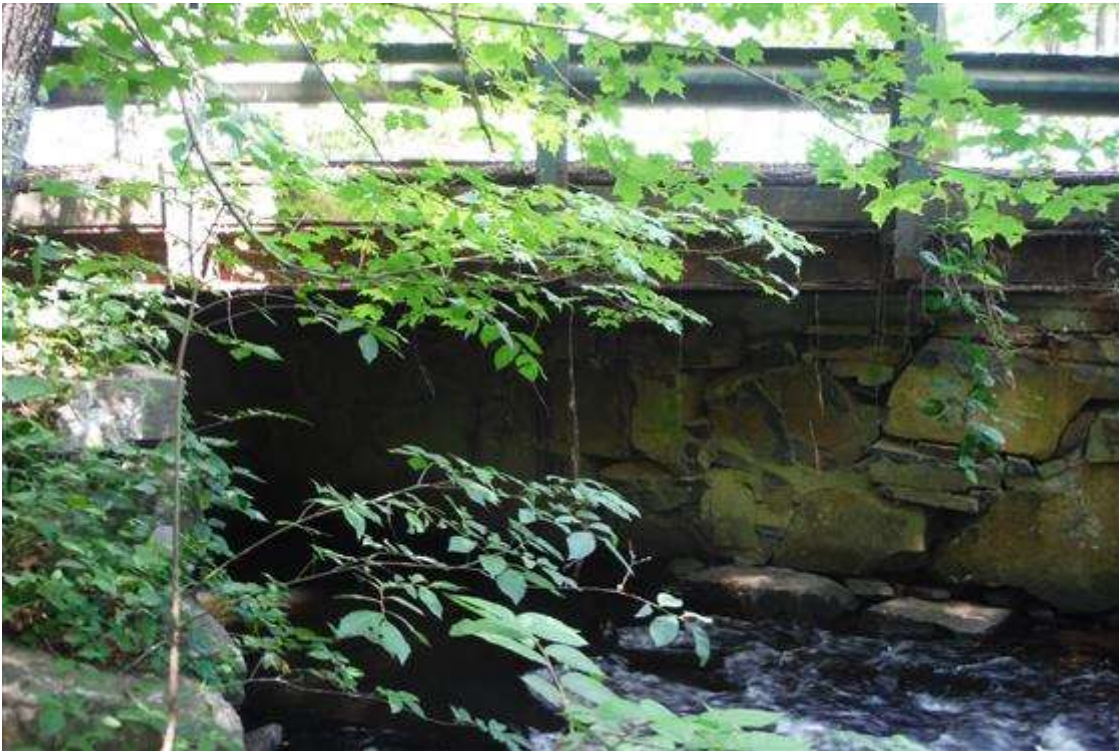
Photo Number: 2

Debris	Sat/Better	Large boulders and rip-rap block flow in downstream channel.
Stream Alignment	Fair/Worse	"S" curvature in channel through bridge area.
Embankment/Erosion	Fair/Worse	Retaining wall on west side of road; south of bridge is failing with loose stones falling into downstream channel.

West Elevation
Looking at outlet

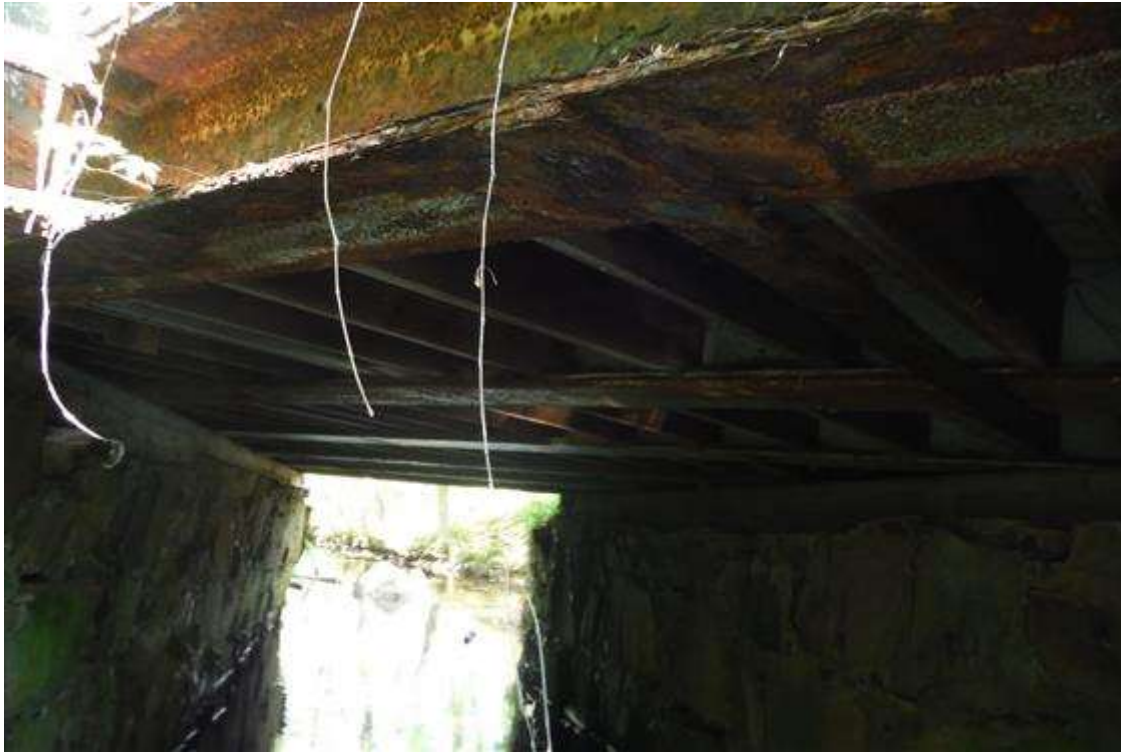
Photo Number: 3

Deck	N/A	Not visible. Wood forms left in place.
Superstructure	Fair/Worse	Heavy lam rust along flanges of west fascia beam.
Substructure	Sat/Better	Loose and missing mortar on masonry abutment walls.

Underside of Bridge
Looking upstream (east) from outlet

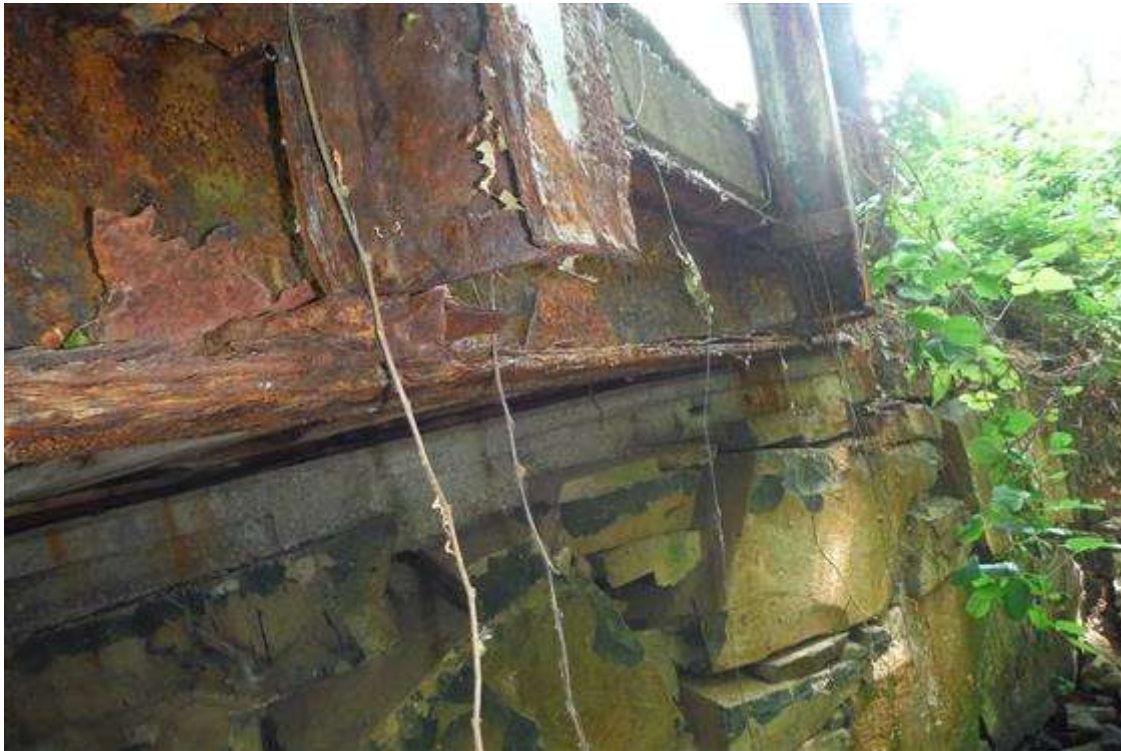
Photo Number: 4

West fascia beam and rail attachment
At outlet

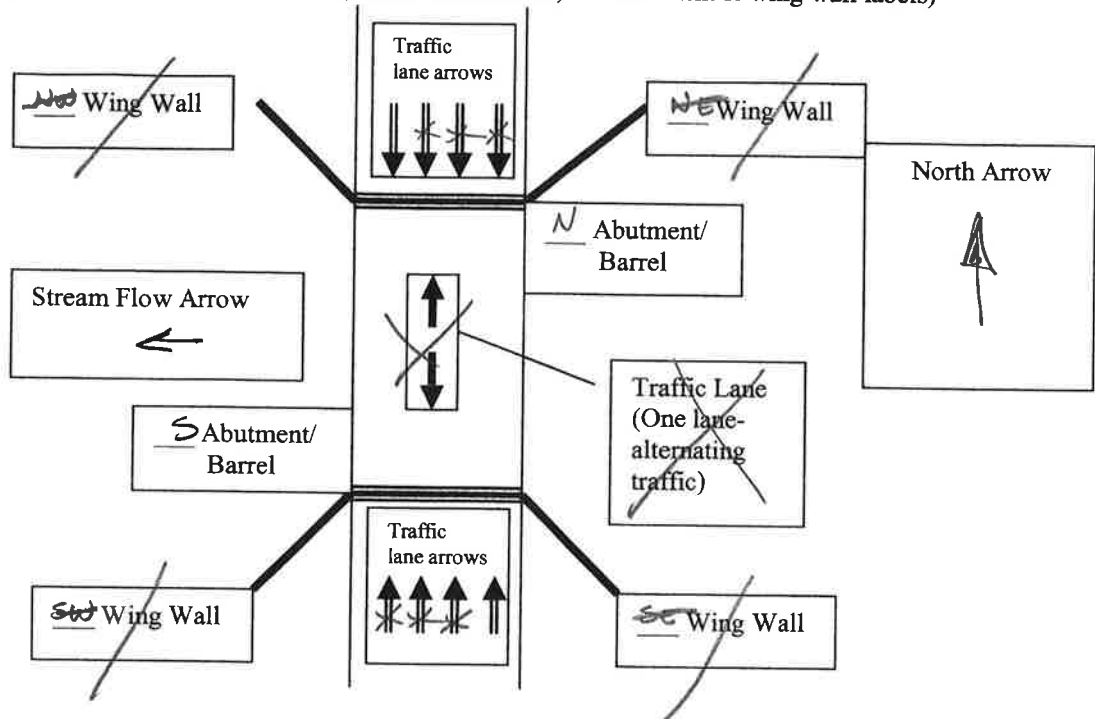
Basic Orientation Sketch:

Topside - Bit. Conc. surface in good condition.
MBR, w/ no anchors or wrap arounds/sharp angles
No sidewalk
Rusted Bridge Rail / section loss @ attachments
not connected to bot. flange

Underside - Bridge @ large skew
Wood forms between beams; deck not visible
Heavy lam rust along top/bottom flanges fascia beam
Loose mortar between masonry abut

Channel - Curvature "S" curve in channel, both sides
Heavy / deep flow, difficult to fully access
Large boulders / riprap block some flow
in downstream channel
Retaining wall failing; loose masonry sw
corner, along roadway

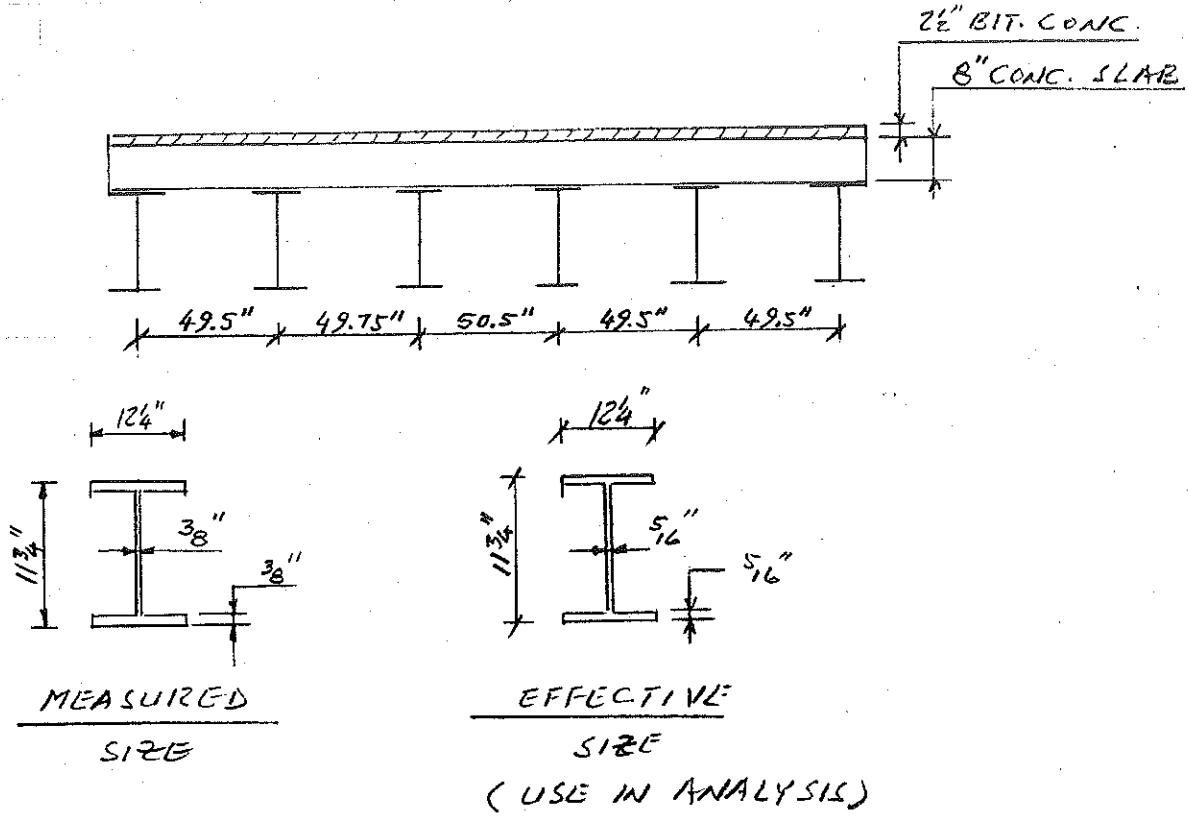
AVERAGE STRINGER SPACING = 49.75" or 4.15'

APPLIED DEAD LOAD PER STRINGER

$$\text{BIT. CONC. W.S.} = 30 \text{ PSF} \times 4.146' = 124 \text{ \#/l}$$

$$\text{CONC. SLAB} = \frac{8"}{12"/11} \times 4.15' \times 150 \text{ PCF} = 415$$

$$3" \times 10" \text{ TIMBER JOIST} = 8 \text{ \#/l} \times 4.15 \text{ \#/l} = 33$$

$$\text{TOTAL } w_{DL} = 572 \text{ \#/l}$$

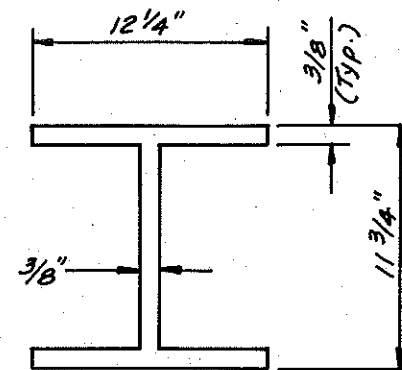
BEAM DETAIL
NOT TO SCALE

TOP FLANGE: 12.2500 x 0.3125
 BOTTOM FLANGE: 12.2500 x 0.3125
 WEB: 11.1250 x 0.3125

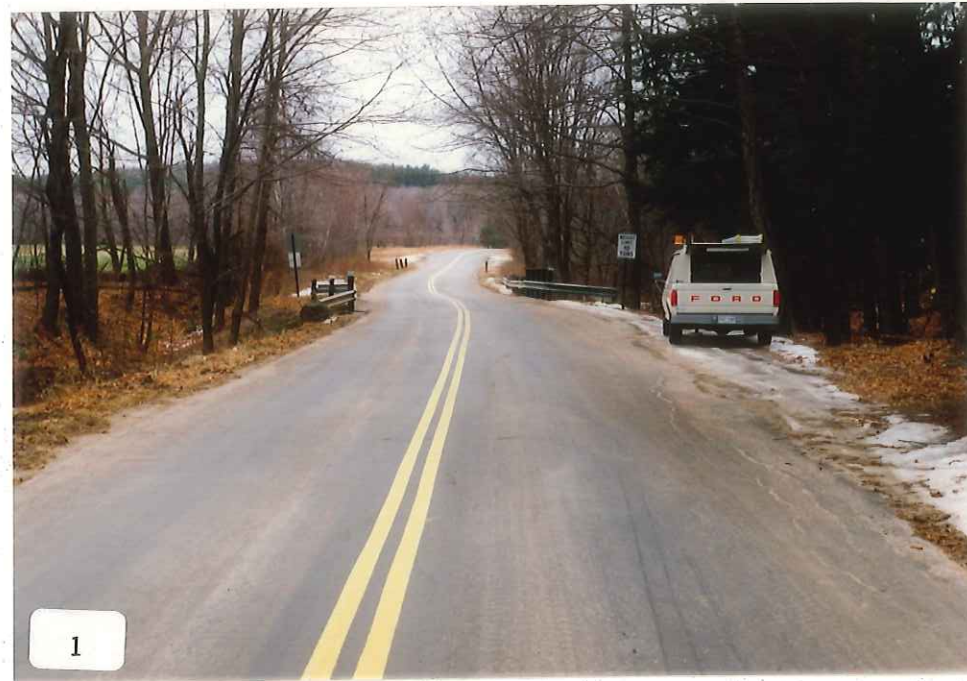
1. Approach (Looking South)
2. Approach (Looking North)
3. East Elevation (Looking Downstream)
4. North End of Stringer at East Fascia
5. West Elevation (Looking Upstream)
6. South End of Stringer at West Fascia
7. View Along North Abutment (Looking Upstream)
8. Concrete Seat on Top of North Abutment
9. Wooden Deck Forms Left in Place
