DeKalb County School District/Elementary Schools

# Dunwoody Elementary

## School Assessment Report

May 19, 2016

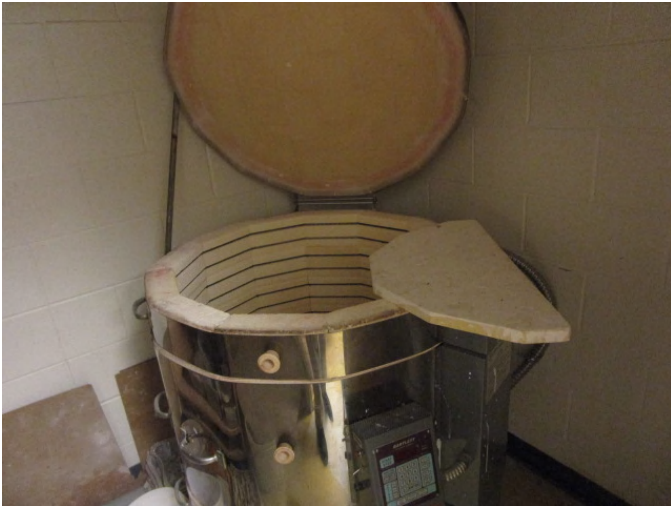
#### System: D3040 - Distribution & Exhaust Systems

**Location:** Storage Room 1218

**Distress:** Needs Remediation

**Notes:** The kiln is located in a storage room with inadequate exhaust. Evaluate appropriateness of the room for this equipment.

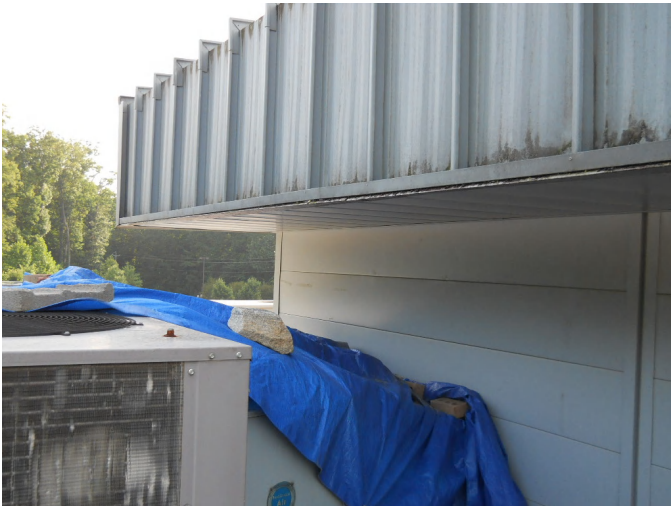
**System: B3010 - Roof Coverings - BUR**

**Location:** Roof Above Room 2120

**Distress:** Needs Remediation

**Notes:** Roof drains into a sloped HVAC duct, running into the wall and into the building. Recommend installation of a gutter system to rectify this problem.

**Correction:** Replace 5" copper box gutters, 16 oz.
