DeKalb County School District/Elementary Schools

# Hambrick Elementary

## School Assessment Report

May 19, 2016

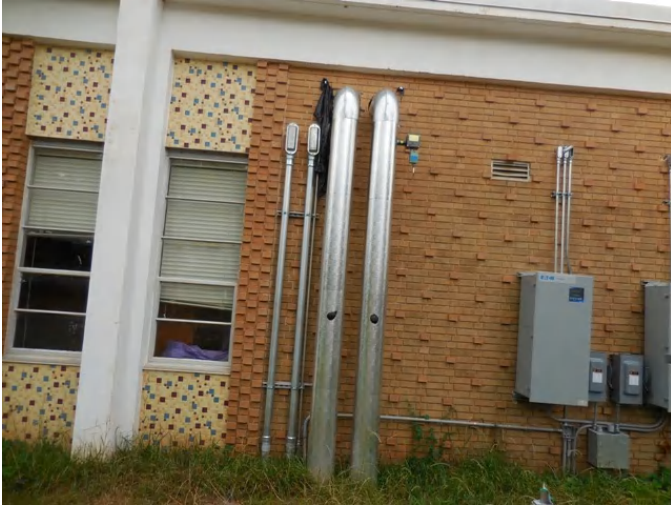
#### System: B2020 - Exterior Windows

**Location:** Throughout Building

**Distress:** Beyond Service Life

**Notes:** The windows are original, not energy efficient, and should be scheduled for replacement.

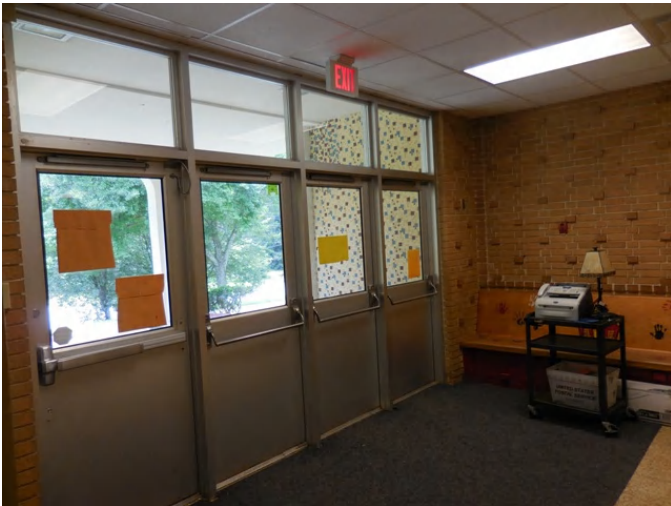
#### System: B2030 - Exterior Doors

**Location:** Throughout Building

**Distress:** Beyond Service Life

**Notes:** The exterior doors are original, not ADA compliant, and should be replaced.

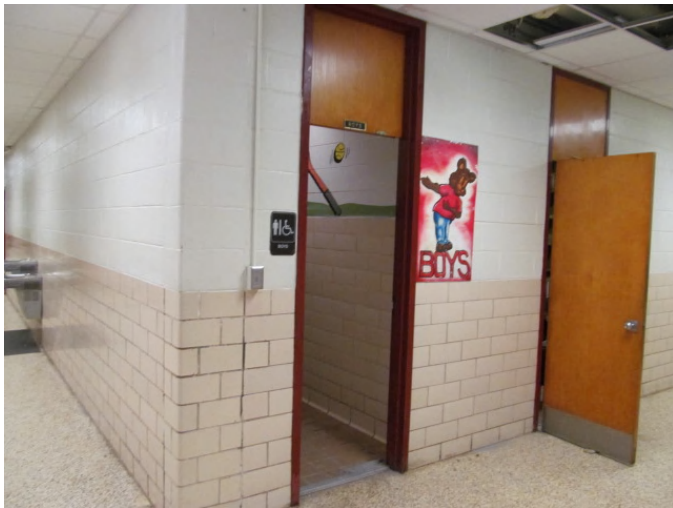
**System: C1010 - Partitions**

**Location:** Throughout Building

**Distress:** Damaged

**Notes:** The CMU/brick partitions are damaged and in need repair or replacement.

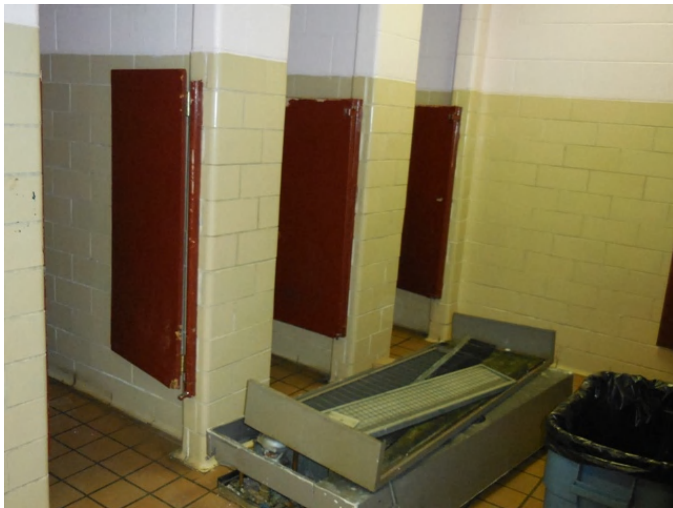
**System: C1030 - Fittings**

**Location:** Throughout Building

**Distress:** Beyond Service Life

**Notes:** Fittings, such as toilet partitions and signage, are beyond their expected service life, damaged, not ADA compliant, and should be replaced.

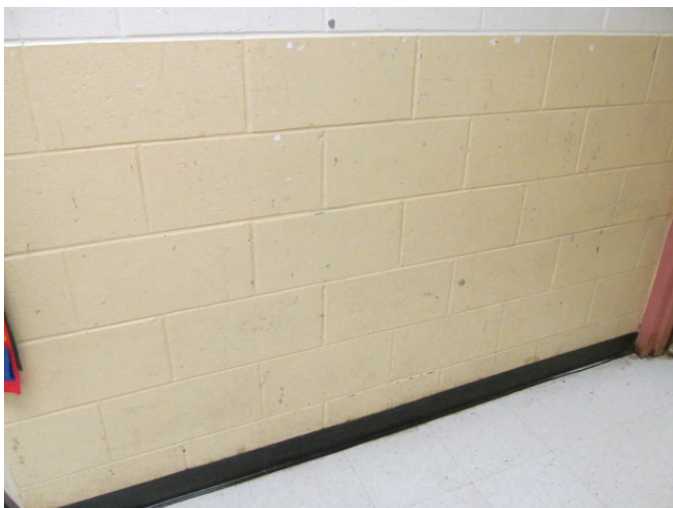
**System: C3010 - Wall Finishes - Paint**

**Location:** Throughout Building

**Distress:** Beyond Service Life

**Notes:** The painted wall finishes are beyond their expected service life and should be replaced.

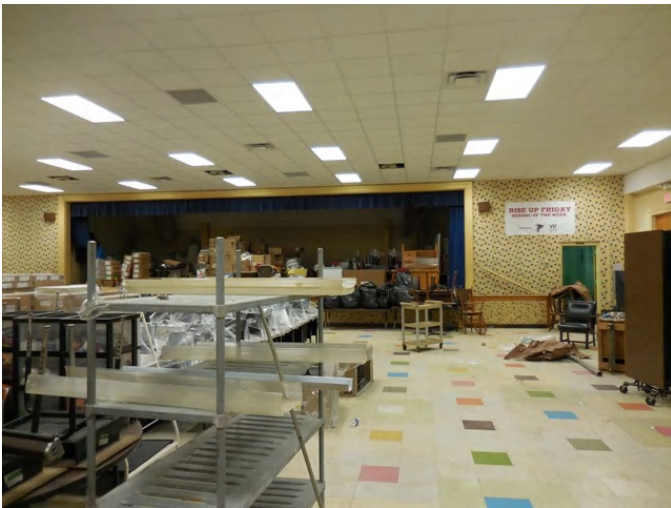
**System: C3020 - Floor Finishes - VCT**

**Location:** Throughout Building

**Distress:** Beyond Service Life

**Notes:** The VCT floor covering is beyond its expected service life and should be replaced.

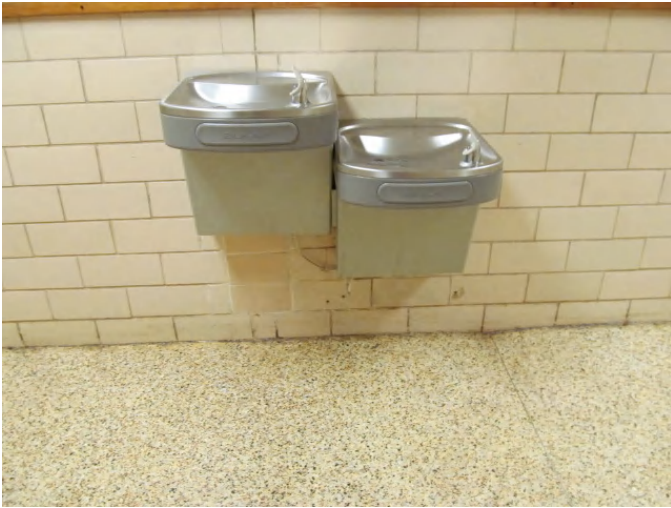
**System: D2010 - Plumbing Fixtures**

**Location:** Hallways

**Distress:** Inadequate

**Correction:** Remove/replace drinking fountain w/recessed ADA compliant drinking fountain

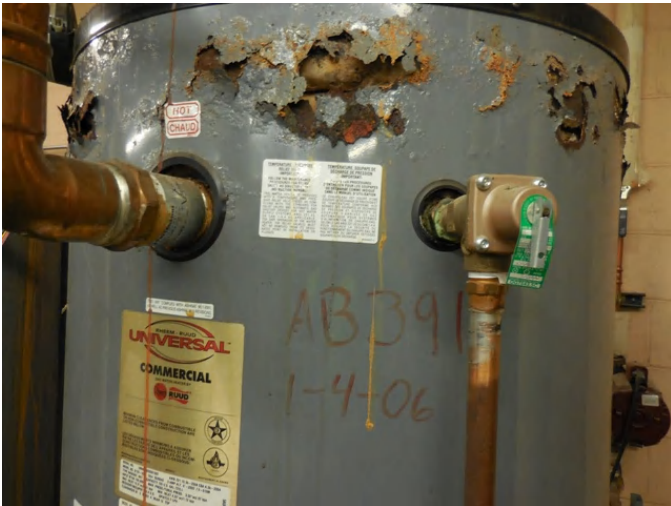
**System: D2020 - Domestic Water Distribution**

**Location:** Throughout Building

**Distress:** Beyond Service Life

**Notes:** The water lines are original and the hot water heaters are severely rusted and need to be replaced. Domestic water distribution system is beyond service life and should be scheduled for replacement. SPLOST project 421-136 to install reduced pressure zone (RPZ) devices on existing domestic and fire water supply lines.

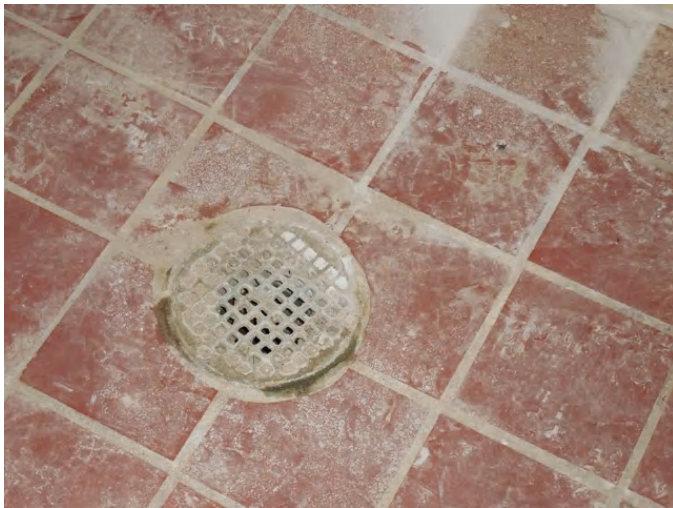
**System: D2030 - Sanitary Waste**

**Location:** Throughout Building

**Distress:** Beyond Service Life

**Notes:** The sanitary waste system is beyond its expected service life and should be scheduled for replacement.

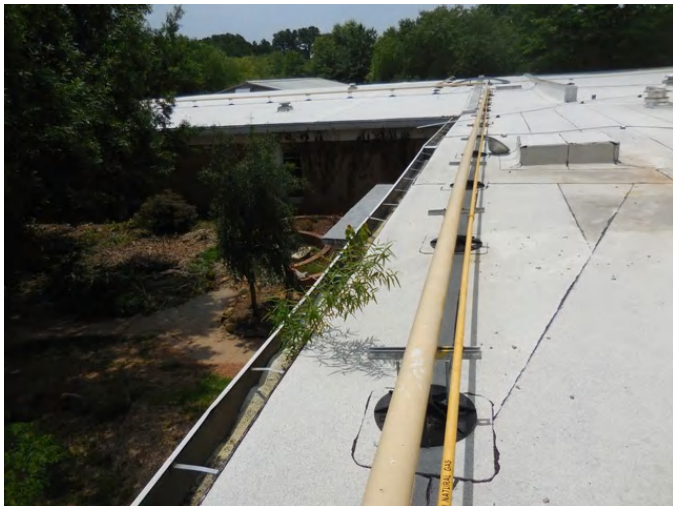
**System: D2090 - Other Plumbing Systems - Natural Gas**

**Location:** Throughout Building and Roof Top

**Distress:** Beyond Service Life

**Notes:** The natural gas system is beyond its expected service life and should be scheduled for replacement.

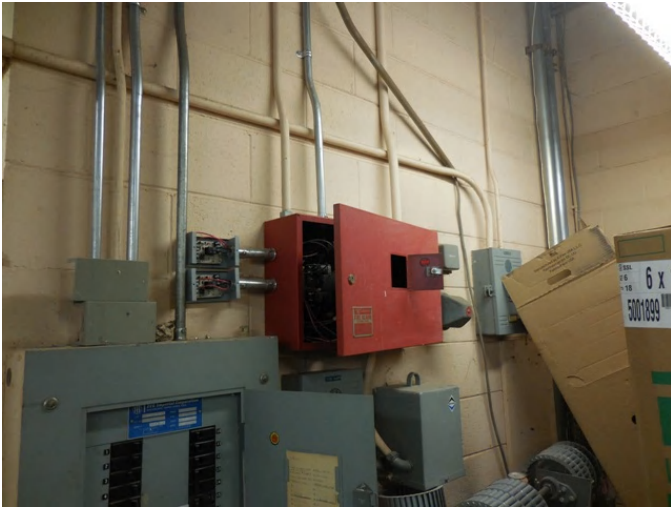
**System: D5030 - Communications and Security - Fire Alarm**

**Location:** Throughout Building

**Distress:** Beyond Service Life

**Notes:** The fire alarm system is beyond its expected service life and should be scheduled for replacement. SPLOST project 111-422 to upgrade communications and security-fire alarm (1971 and 1972 buildings).

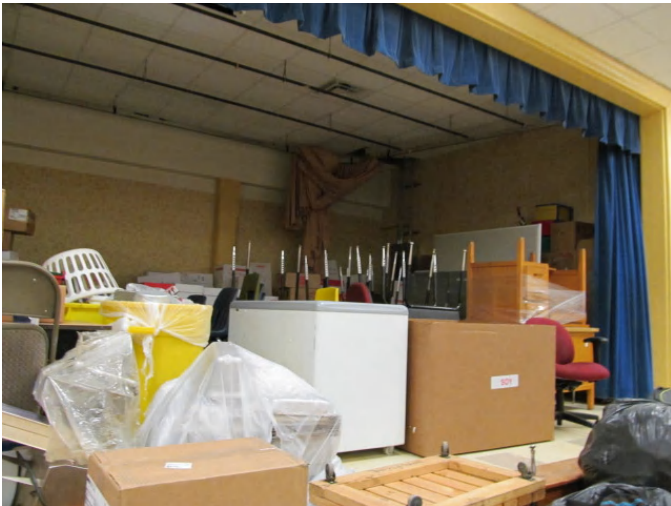
**System: E1020 - Institutional Equipment**

**Location:** Throughout Building

**Distress:** Beyond Service Life

**Notes:** Institutional equipment, such as theater and stage equipment, library equipment and audio-visual equipment, is beyond its expected service life and should be scheduled for replacement.

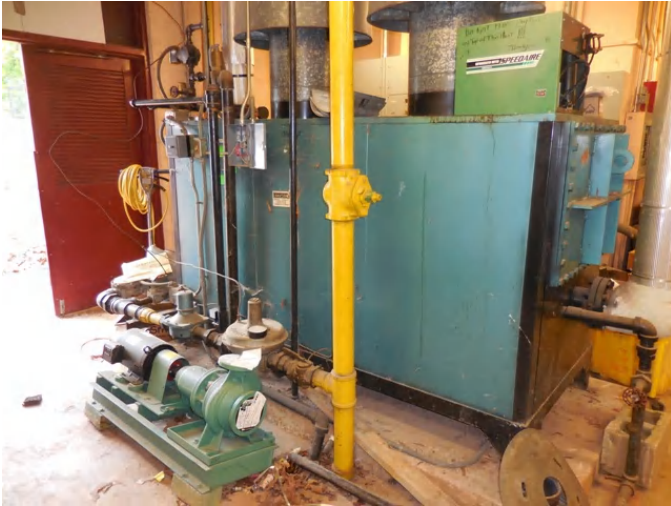
**System: D3020 - Heat Generating Systems**

**Location:** Mechanical Room

**Distress:** Beyond Service Life

**Notes:** The boiler is original and still functional, but beyond its expected service life, not code compliant, and should be scheduled for replacement.

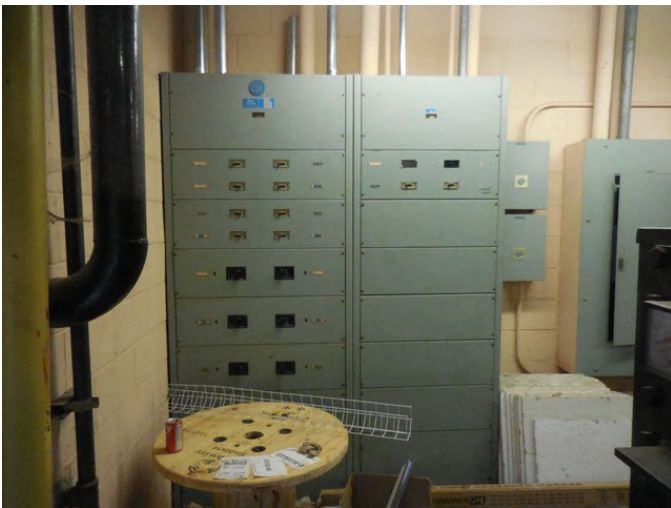
**System: D5010 - Electrical Service/Distribution**

**Location:** Main Switch Room/Throughout Building

**Distress:** Beyond Service Life

**Notes:** The majority of the electric service/distribution system is original. A couple of panel boards have been updated to support the equipment, but the overall system is beyond its expected service life and should be scheduled for replacement.

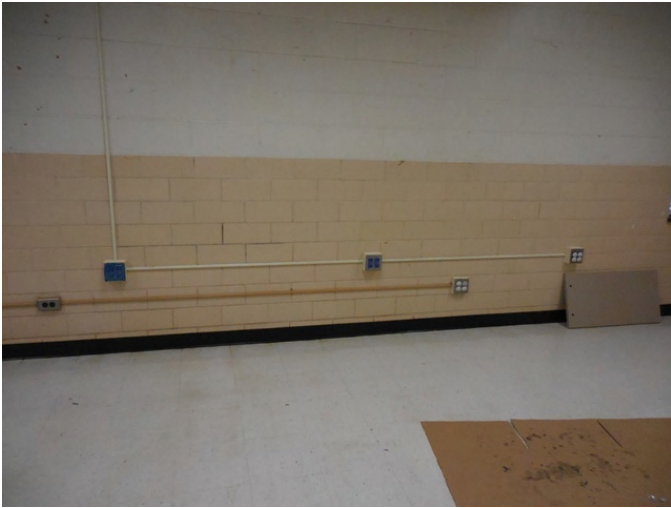
### **System: D5020 - Branch Wiring**

**Location:** Throughout Building

**Distress:** Beyond Service Life

**Notes:** The majority of the branch wiring system is original. With the installation of new equipment, some wiring has been updated. The overall system is beyond its expected service life and should be scheduled for replacement.

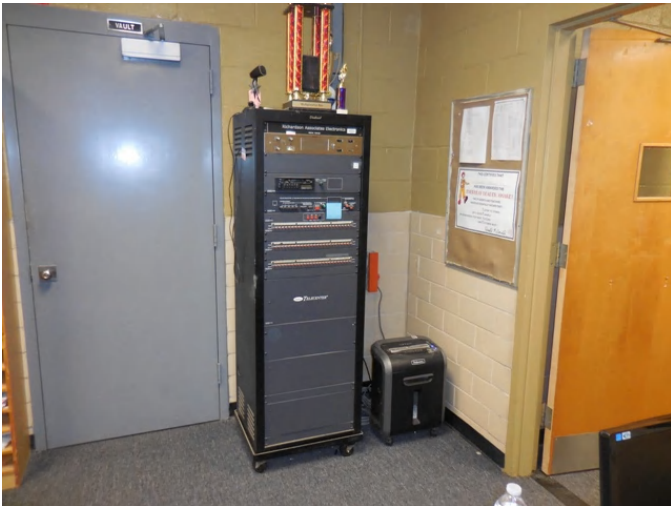
### **System: D5030 - Communications and Security - Clock & PA Systems**

**Location:** Throughout Building

**Distress:** Beyond Service Life

**Notes:** Clock and PA systems are beyond their expected service life and should be scheduled for replacement.

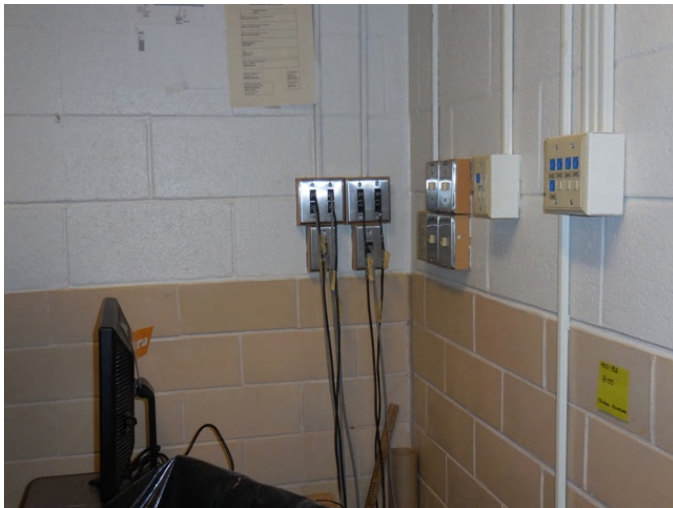
**System: D5030 - Communications and Security - Telephone & Data**

**Location:** Throughout Building

**Distress:** Beyond Service Life

**Notes:** Telephone and data systems are beyond their expected service life and should be scheduled for replacement.

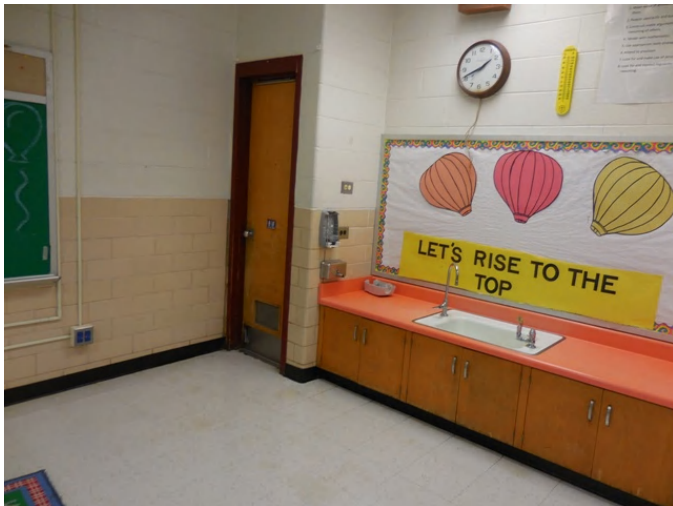
**System: E2010 - Fixed Furnishings**

**Location:** Throughout Building

**Distress:** Beyond Service Life

**Notes:** Fixed furnishings are beyond their expected service life and should be scheduled for replacement.

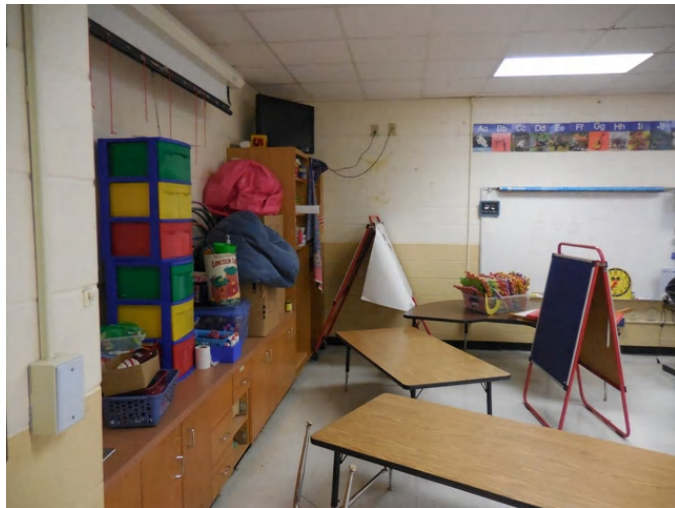
#### **System: C3010 - Wall Finishes - Paint**

**Location:** Throughout Building

**Distress:** Beyond Service Life

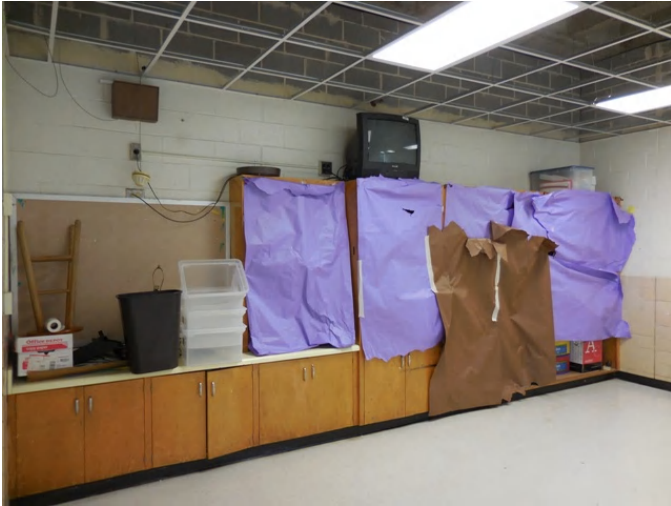
**System: D5030 - Communications and Security - Clock & PA Systems**

**Location:** Throughout Building

**Distress:** Beyond Service Life

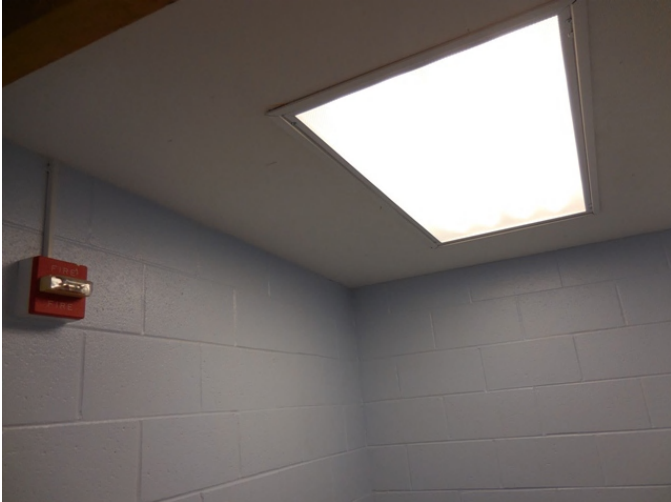
**System: D5030 - Communications and Security - Fire Alarm**

**Location:** Throughout Building

**Distress:** Beyond Service Life

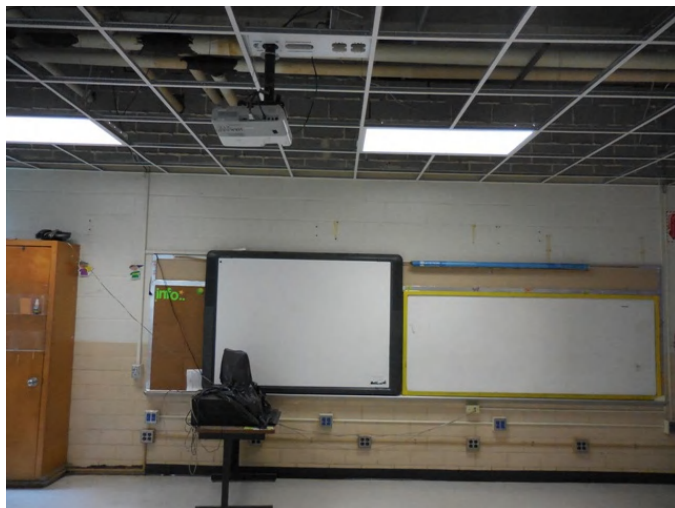
**System: D5030 - Communications and Security - Telephone & Data**

**Location:** Throughout Building

**Distress:** Beyond Service Life

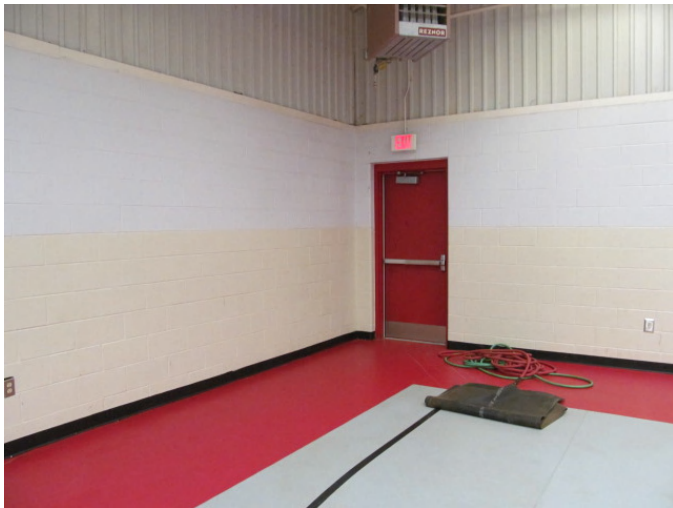
#### System: C3010 - Wall Finishes - Paint

**Location:** Throughout Building

**Distress:** Beyond Service Life

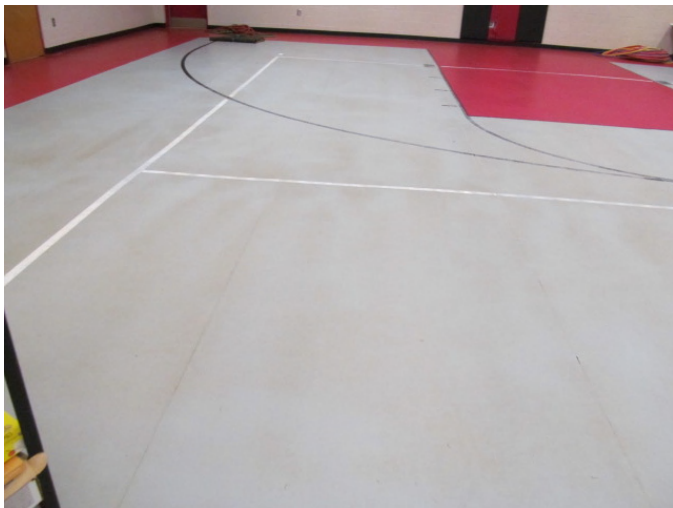
#### System: C3020 - Floor Finishes - Neoprene

**Location:** Basketball Court

**Distress:** Beyond Service Life

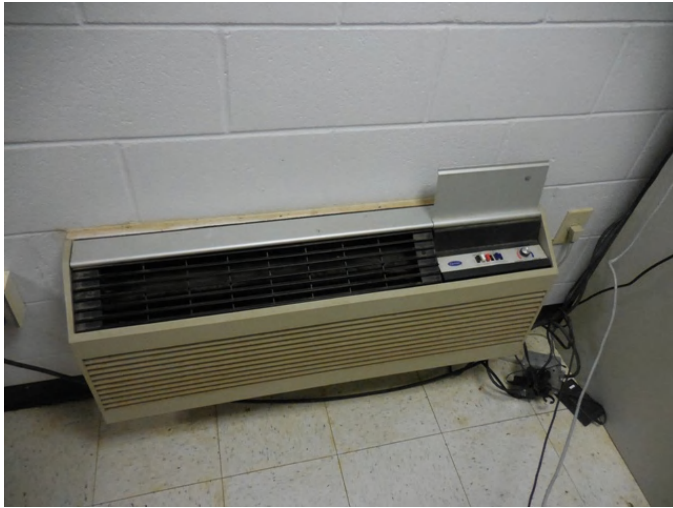
**System: D3050 - Terminal & Package Units**

**Location:** Throughout Building

**Distress:** Inadequate

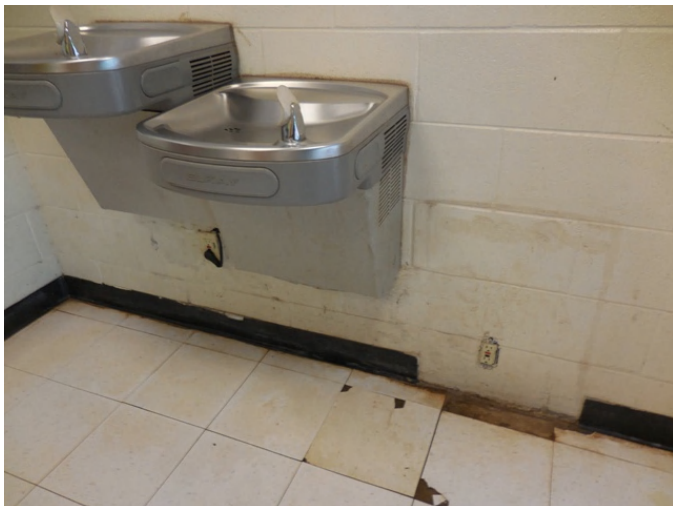
**System: C3020 - Floor Finishes - VCT**

**Location:** Entrance Area and Offices

**Distress:** Beyond Service Life

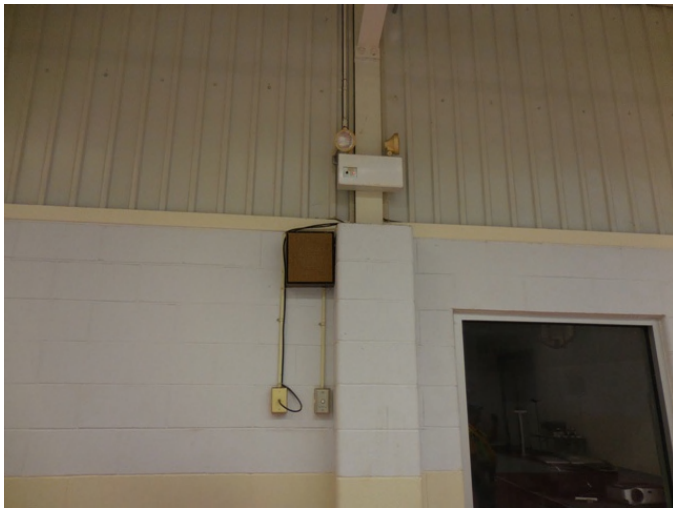
**System: D5030 - Communications and Security - Security & CCTV**

**Location:** Throughout Building

**Distress:** Beyond Service Life

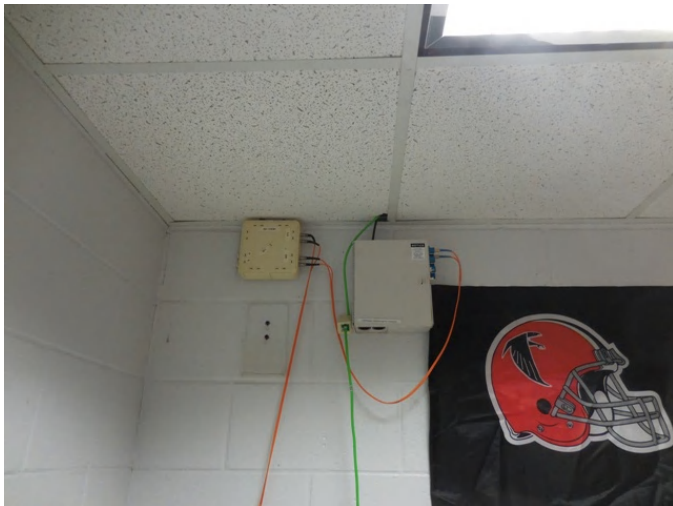
**System: D5030 - Communications and Security - Telephone & Data**

**Location:** Office Area

**Distress:** Beyond Service Life

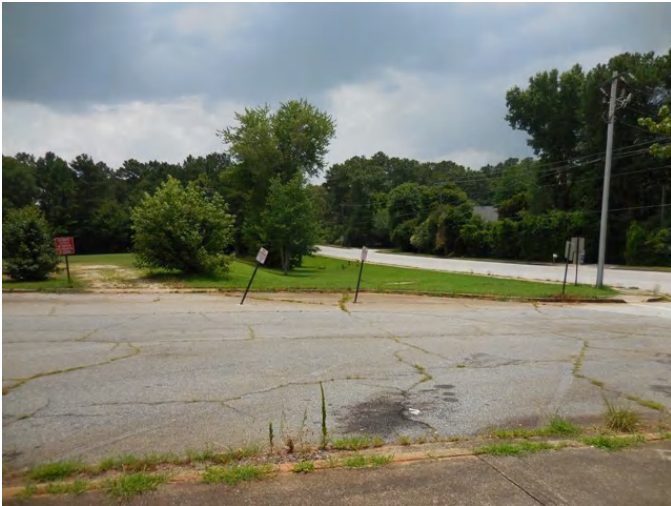
#### **System: G2020 - Parking Lots**

**Location:** Site

**Distress:** Beyond Service Life

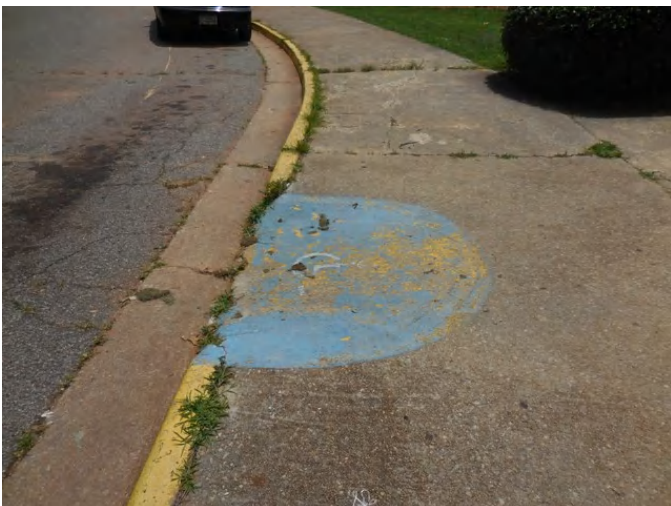
#### **System: G2030 - Pedestrian Paving**

**Location:** Site

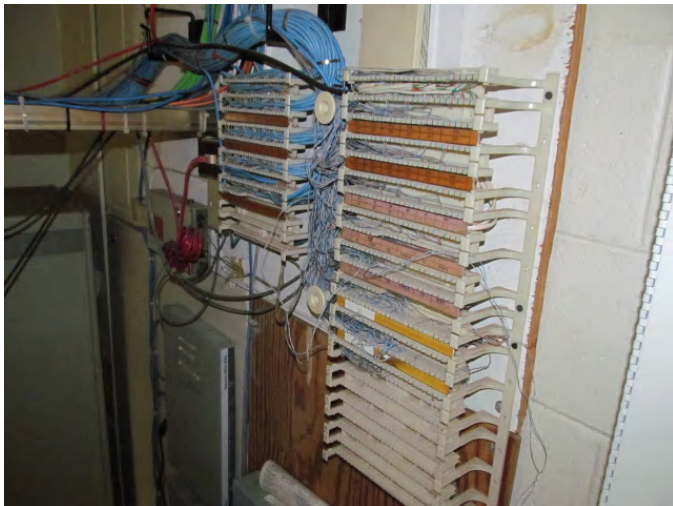
**System: G4030 - Site Communications & Security**

**Location:** Site  
**Distress:** Beyond Service Life  
**Category:** Deferred Maintenance  
**Priority:** 3 Priority  
**Correction:** Renew System  
**Qty:** 72,384.00  
**Unit of Measure:** S.F.  
**Estimate:** \$53,347.01  
**Assessor Name:** Eduardo Lopez  
**Date Created:** 06/30/2015

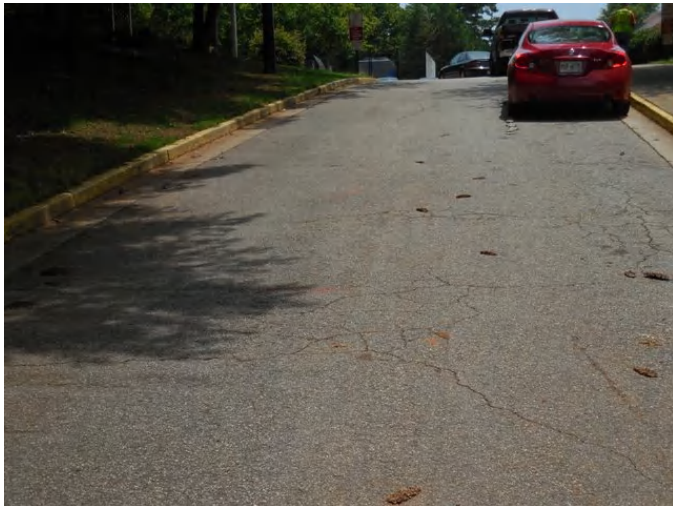
**System: G2010 - Roadways**

**Location:** Site

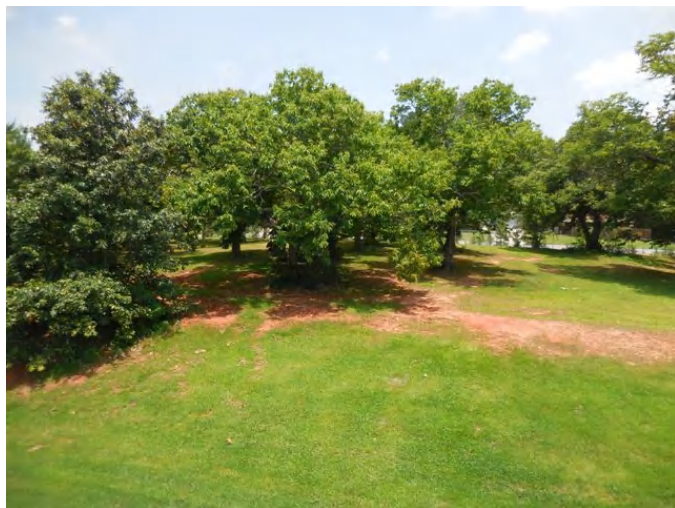
**System: G2050 - Landscaping**

**Location:** Site
