DeKalb County School District/Elementary Schools

# Hightower Elementary

## School Assessment Report

May 19, 2016

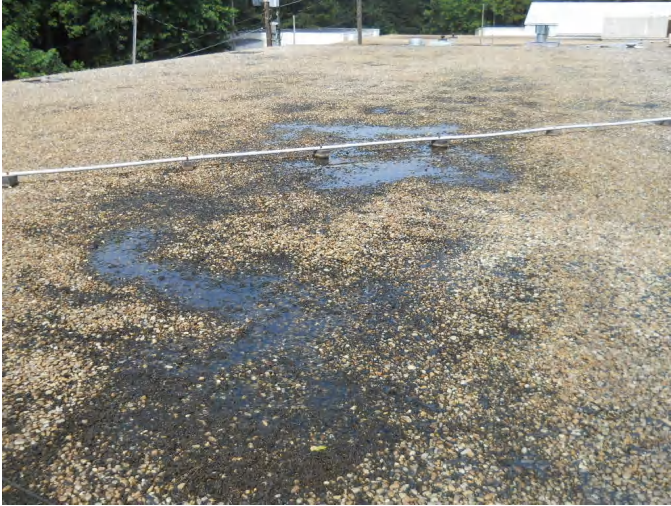
#### **System: B3010 - Roof Coverings - BUR**

**Location:** Roof

**Distress:** Damaged

**Notes:** The roof covering is leaking. Add alternate SPLOST project 313-422 to evaluate and repair the 2008 roof replacement over the 58, 60, 66 and 68 buildings due to leaks.

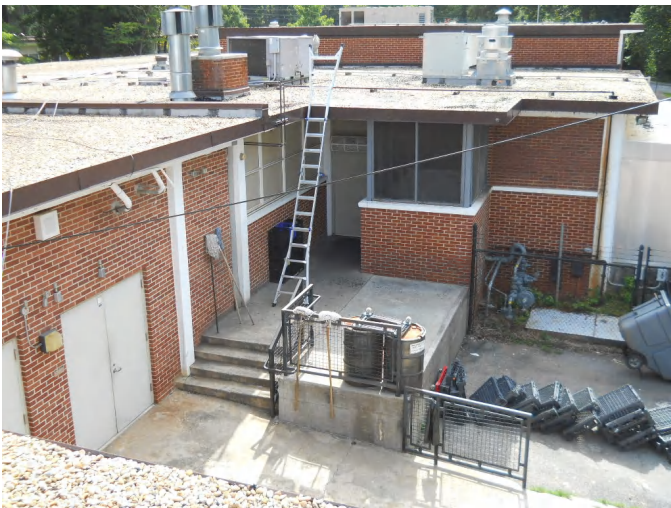
#### **System: B3020 - Roof Openings**

**Location:** Roof

**Distress:** Missing

**Notes:** There is no safe roof access for maintenance personnel. Recommend installation of an OSHA-compliant roof hatch/ladder system for safe access. SPLOST project 313-422 to install roof hatch and ladder as appropriate.

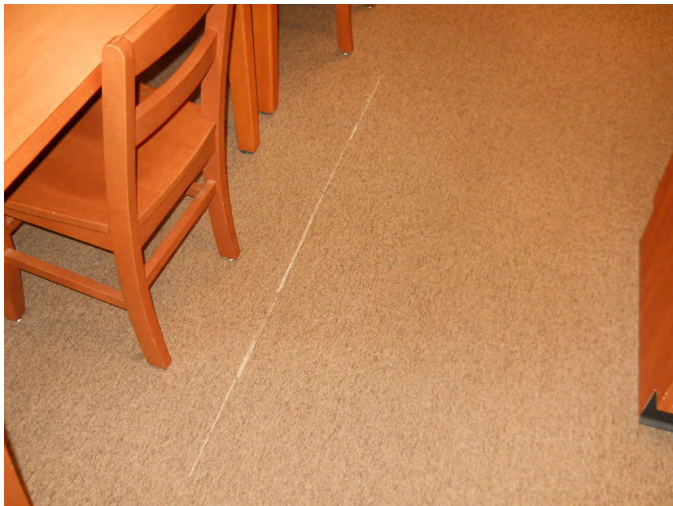
**System: C3020 - Floor Finishes - Carpet**

**Location:** Media Center, Offices

**Distress:** Beyond Service Life

**Notes:** The carpet is beyond its expected service life and should be replaced.

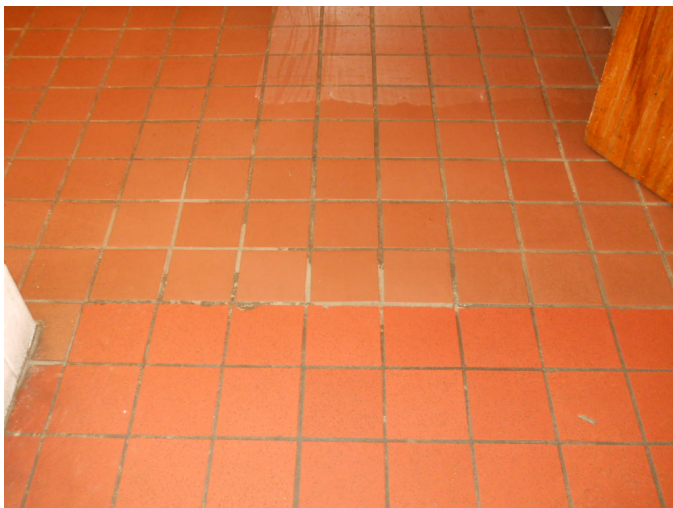
**System: C3020 - Floor Finishes - Ceramic & Quarry Tile**

**Location:** Kitchen

**Distress:** Damaged

**Notes:** The tile floor covering is worn and patched, and should be replaced.

**Correction:** Replace quarry tile floor

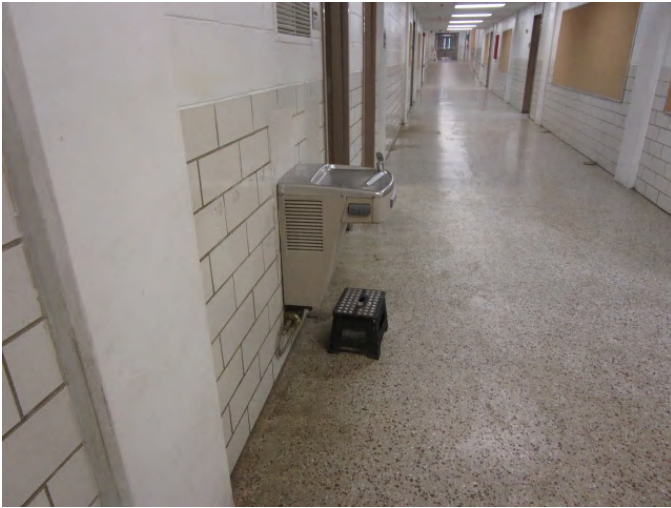
**System: D2010 - Plumbing Fixtures**

**Location:** Hallways

**Distress:** Needs Remediation

**Correction:** Remove/replace drinking fountain w/recessed ADA compliant drinking fountain

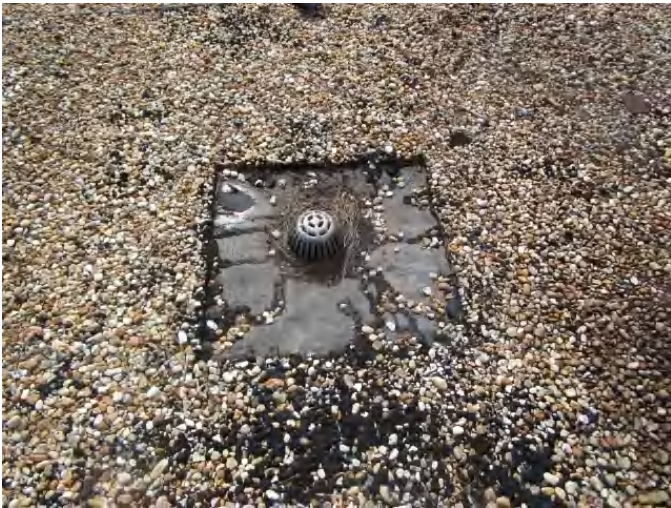
**System: D2040 - Rain Water Drainage**

**Location:** Throughout Building

**Distress:** Beyond Service Life

**Notes:** The rainwater drainage system is beyond its expected service life and should be scheduled for replacement. SPLOST project 313-422 to replace the cast iron water drainage system

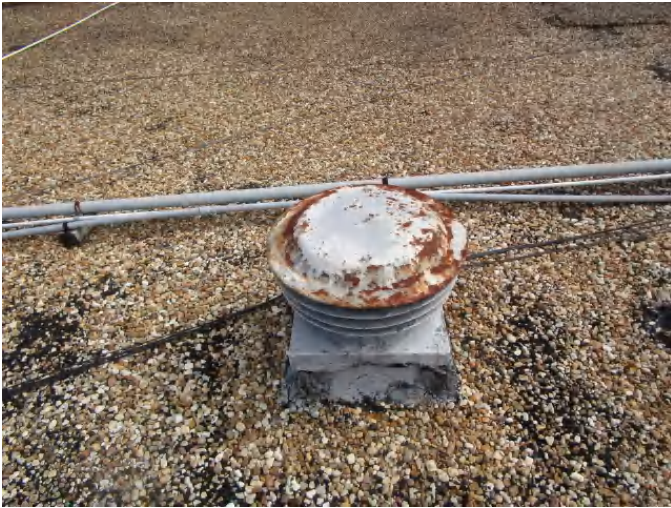
**System: D3040 - Distribution & Exhaust Systems**

**Location:** Throughout Building  
**Distress:** Beyond Service Life  
**Category:** Deferred Maintenance / Energy  
**Priority:** 3 Priority  
**Correction:** Renew System  
**Qty:** 48,735.00  
**Unit of Measure:** S.F.  
**Estimate:** \$295,383.00  
**Assessor Name:** Sam Mandela  
**Date Created:** 07/17/2015

**Notes:** The distribution and exhaust systems are beyond their expected service life and should be scheduled for replacement.

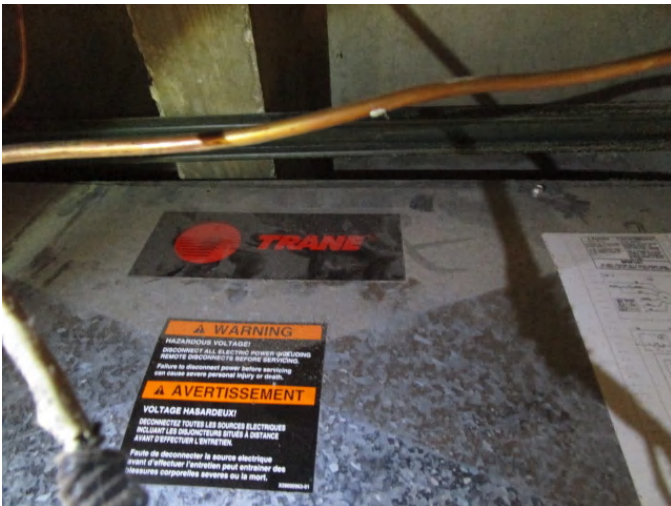
**System: D3050 - Terminal & Package Units**

**Location:** Throughout Building  
**Distress:** Beyond Service Life  
**Category:** Deferred Maintenance / Energy  
**Priority:** 3 Priority  
**Correction:** Renew System  
**Qty:** 48,735.00  
**Unit of Measure:** S.F.  
**Estimate:** \$992,829.00  
**Assessor Name:** Ben Nixon  
**Date Created:** 07/16/2015

**Notes:** The terminal and package units are beyond their expected service life and should be scheduled for replacement.

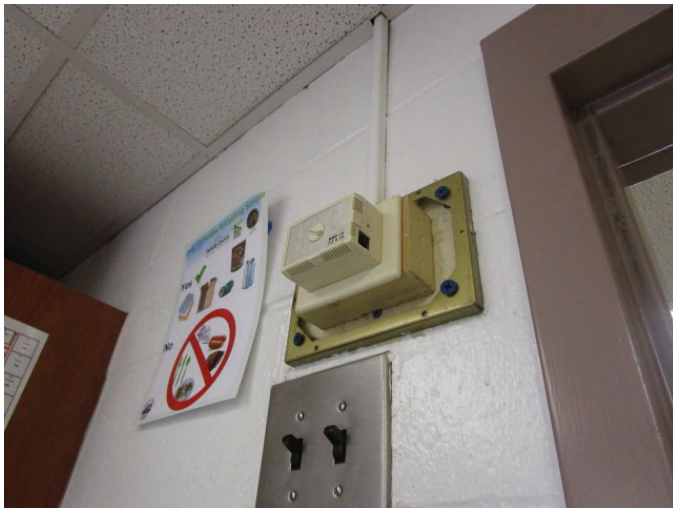
**System: D3060 - Controls & Instrumentation**

**Location:** Throughout Building  
**Distress:** Beyond Service Life  
**Category:** Deferred Maintenance / Energy  
**Priority:** 3 Priority  
**Correction:** Renew System  
**Qty:** 48,735.00  
**Unit of Measure:** S.F.  
**Estimate:** \$192,991.00  
**Assessor Name:** Sam Mandola  
**Date Created:** 07/17/2015

**Notes:** The controls and instrumentation system is beyond its expected service life and should be scheduled for replacement.

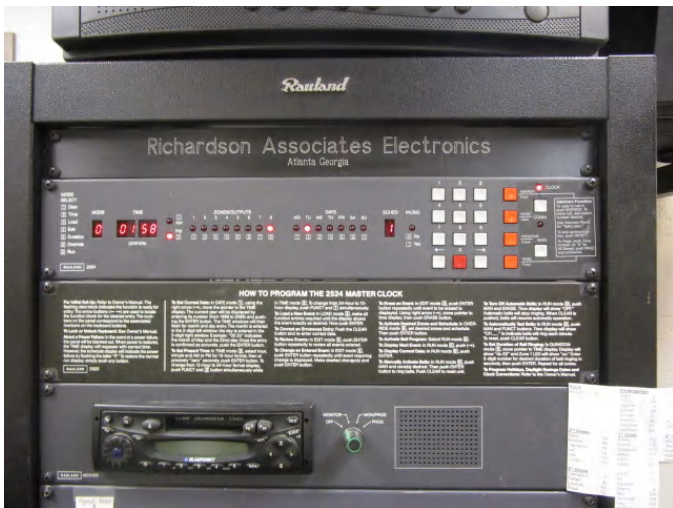
**System: D5030 - Communications and Security - Clock & PA Systems**

**Location:** Throughout Building  
**Distress:** Beyond Service Life  
**Category:** Deferred Maintenance  
**Priority:** 3 Priority  
**Correction:** Renew System  
**Qty:** 48,735.00  
**Unit of Measure:** S.F.  
**Estimate:** \$300,208.00  
**Assessor Name:** Ben Nixon  
**Date Created:** 04/11/2015

**Notes:** Clock and PA systems are beyond their expected service life and should be scheduled for replacement.

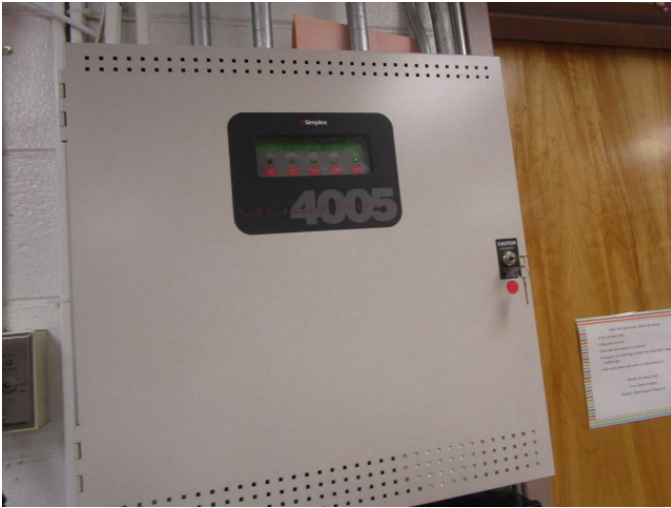
**System: D5030 - Communications and Security - Fire Alarm**

**Location:** Throughout Building  
**Distress:** Beyond Service Life  
**Category:** Deferred Maintenance  
**Priority:** 3 Priority  
**Correction:** Renew System  
**Qty:** 48,735.00  
**Unit of Measure:** S.F.  
**Estimate:** \$65,938.00  
**Assessor Name:** Ben Nixon  
**Date Created:** 04/11/2015

**Notes:** The fire alarm system is beyond its expected service life and should be scheduled for replacement.

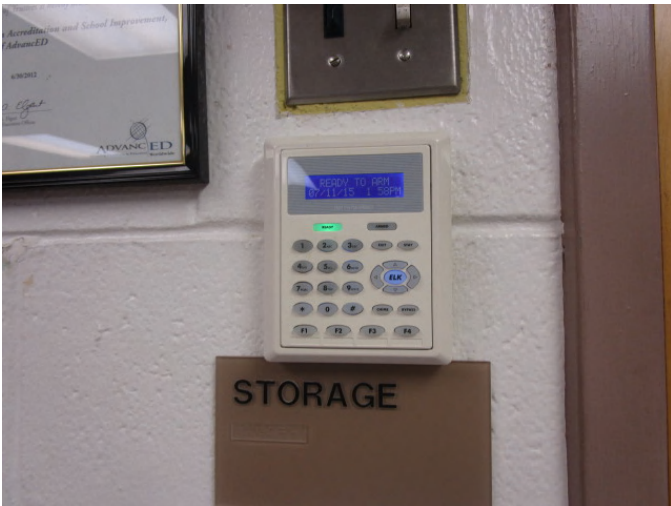
**System: D5030 - Communications and Security - Security & CCTV**

**Location:** Throughout Building  
**Distress:** Beyond Service Life  
**Category:** Deferred Maintenance  
**Priority:** 3 Priority  
**Correction:** Renew System  
**Qty:** 48,735.00  
**Unit of Measure:** S.F.  
**Estimate:** \$32,701.00  
**Assessor Name:** Ben Nixon  
**Date Created:** 04/11/2015

**Notes:** The security and CCTV systems are beyond their expected service life and should be scheduled for replacement.

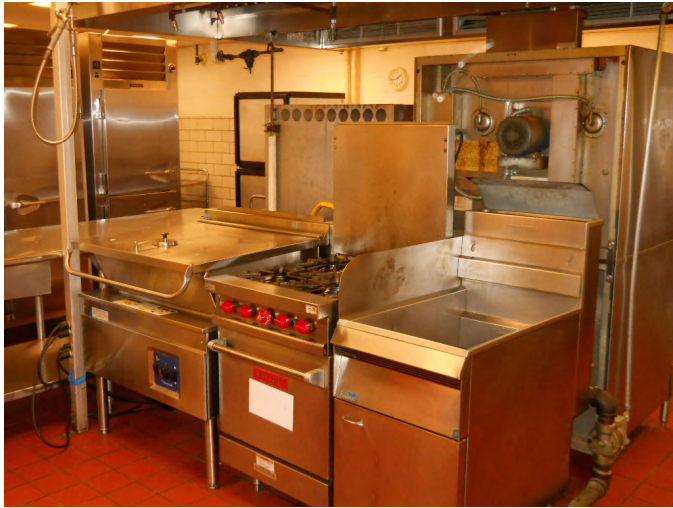
**System: E1090 - Other Equipment - Kitchen**

**Location:** Kitchen

**Distress:** Beyond Service Life

**Notes:** Kitchen equipment is beyond its expected service life and should be scheduled for replacement.

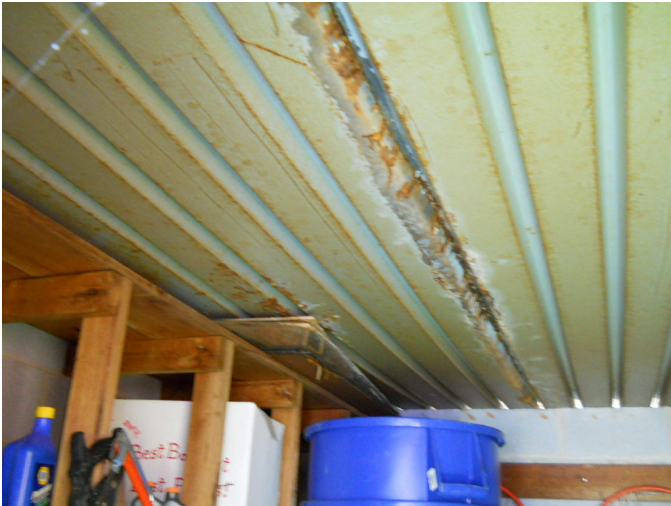
#### System: B1020 - Roof Construction

**Location:** Roof

**Distress:** Damaged

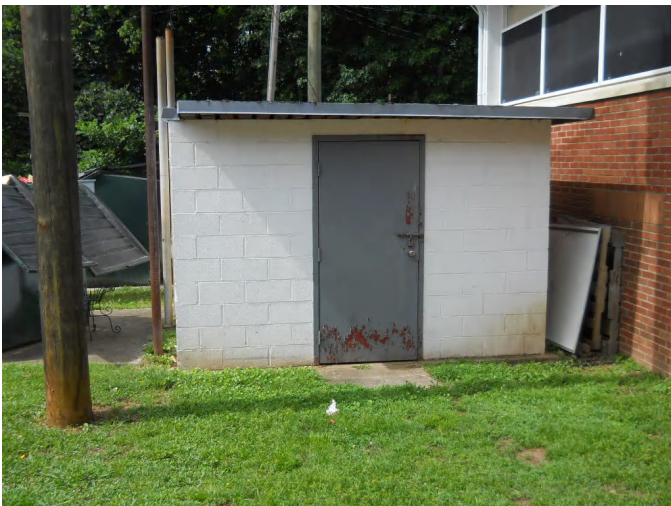
#### System: B3010 - Roof Coverings

**Location:** Roof

**Distress:** Beyond Service Life

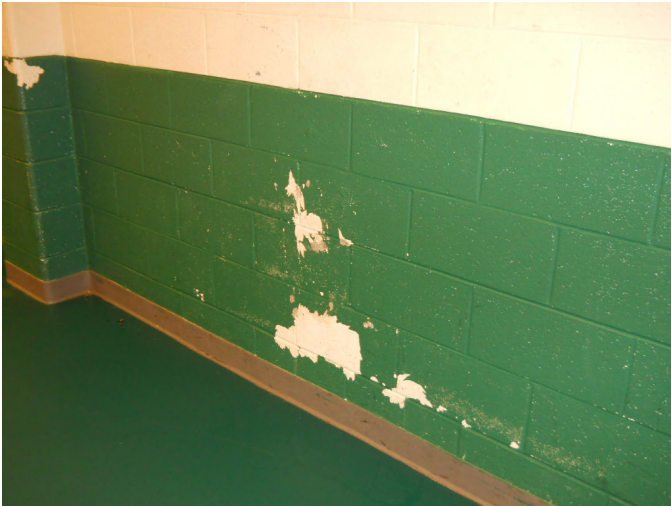
#### **System: C3010 - Wall Finishes - Paint**

**Location:** Throughout Building

**Distress:** Beyond Service Life

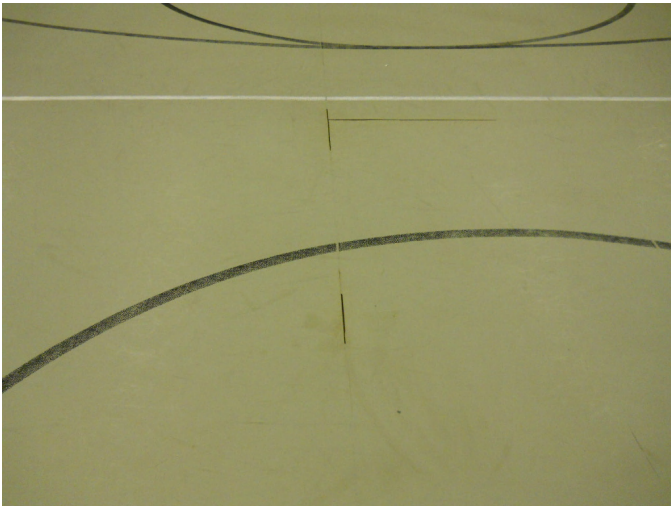
#### **System: C3020 - Floor Finishes - Neoprene**

**Location:** Basketball Court

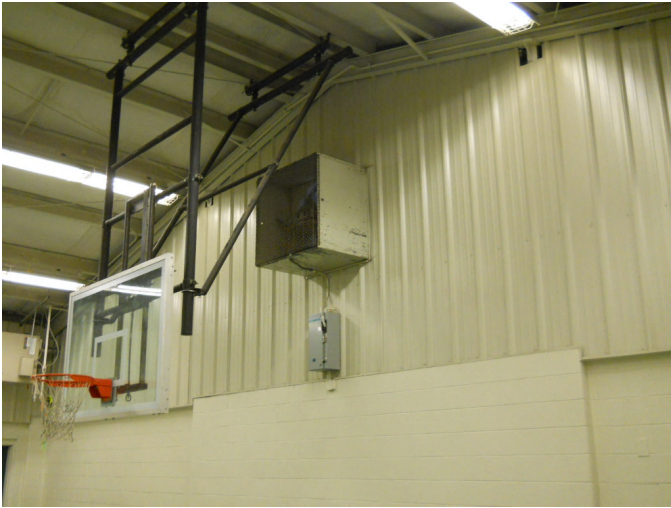
**System: D3050 - Terminal & Package Units**

**Location:** Throughout Building

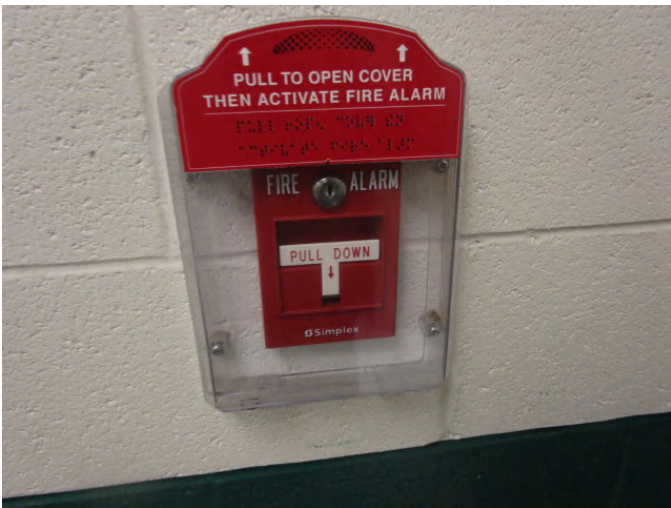
**System: D5030 - Communications and Security - Fire Alarm**

**Location:** Throughout Building

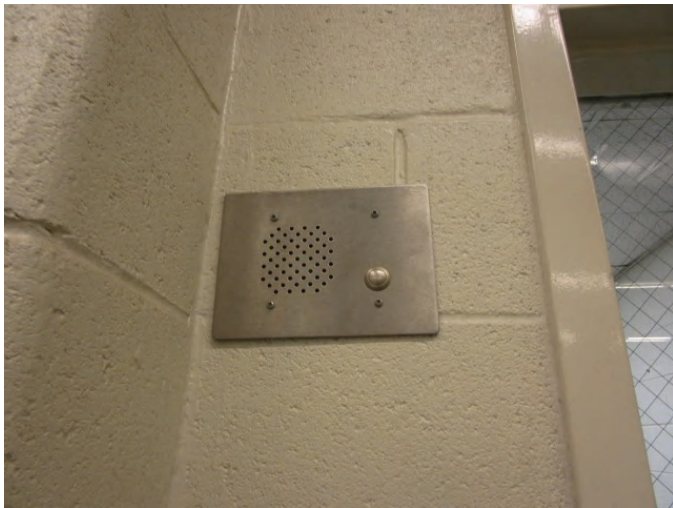
**System: D5030 - Communications and Security - Public Address & Clock System**

**Location:** Throughout Building

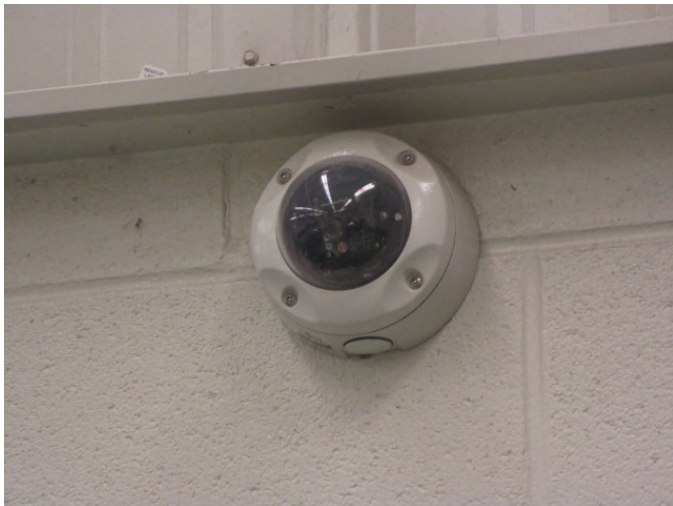
**System: D5030 - Communications and Security - Security & CCTV**

**Location:** Throughout Building

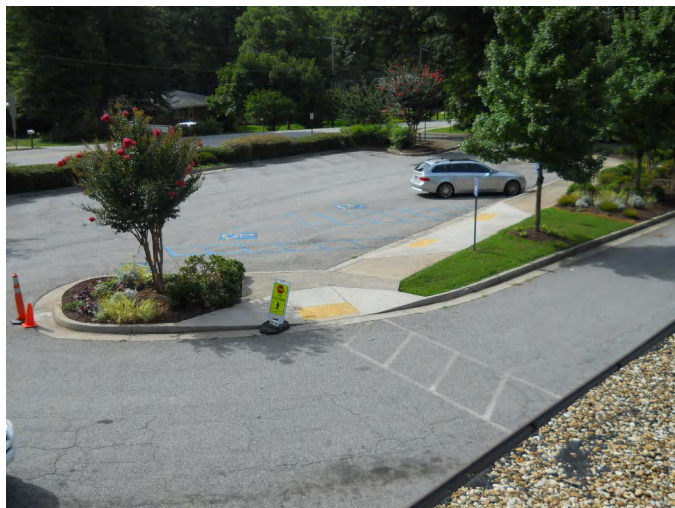
#### System: G2010 - Roadways

**Location:** Site

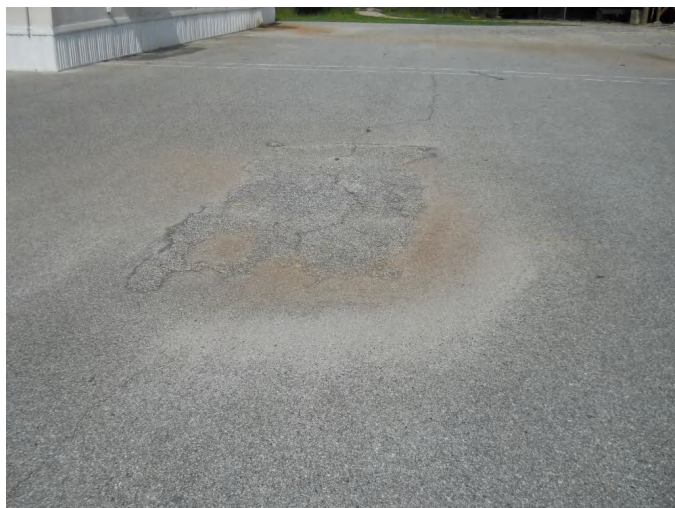
#### System: G2020 - Parking Lots

**Location:** Site

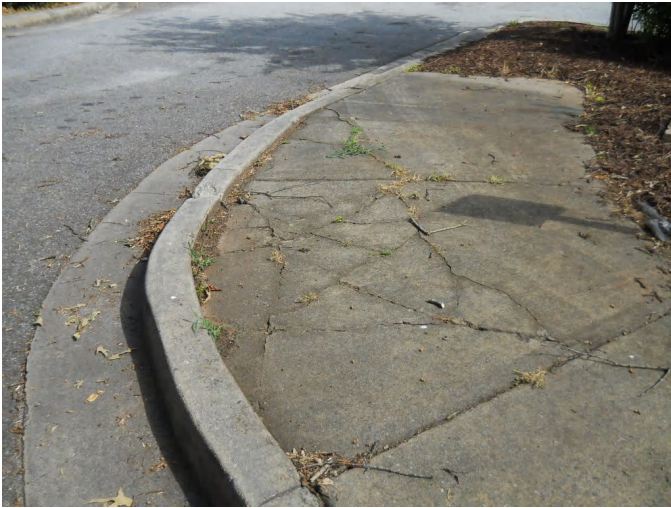
**System: G2030 - Pedestrian Paving**

**Location:** Site  
**Distress:** Beyond Service Life  
**Category:** Deferred Maintenance  
**Priority:** 3 Priority  
**Correction:** Renew System  
**Qty:** 54,363.00  
**Unit of Measure:** S.F.  
**Estimate:** \$89,698.95  
**Assessor Name:** Eduardo Lopez  
**Date Created:** 07/14/2015

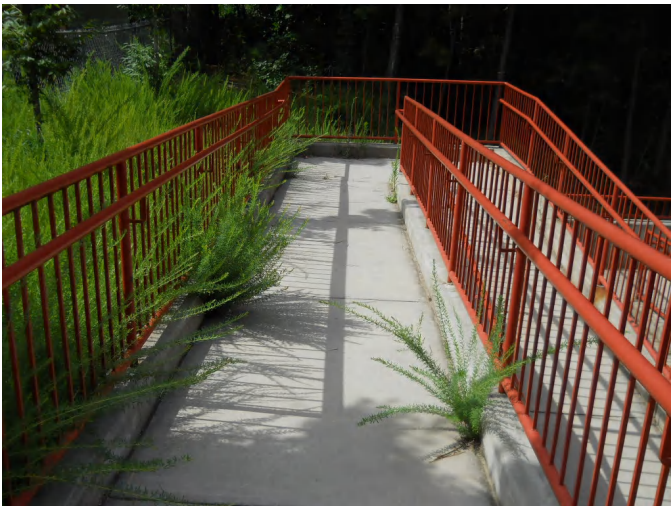
**System: G2050 - Landscaping**

**Location:** Site  
**Distress:** Beyond Service Life  
**Category:** Deferred Maintenance  
**Priority:** 3 Priority  
**Correction:** Renew System  
**Qty:** 54,363.00  
**Unit of Measure:** S.F.  
**Estimate:** \$86,708.99  
**Assessor Name:** Eduardo Lopez  
**Date Created:** 07/14/2015

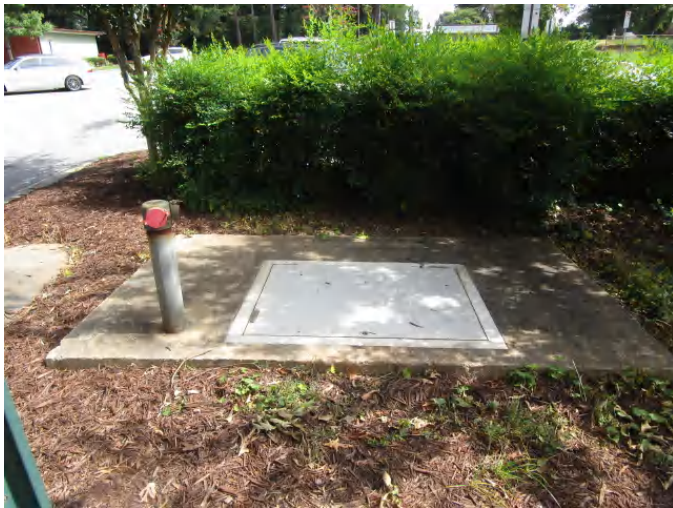
### **System: G3010 - Water Supply**

**Location:** Site

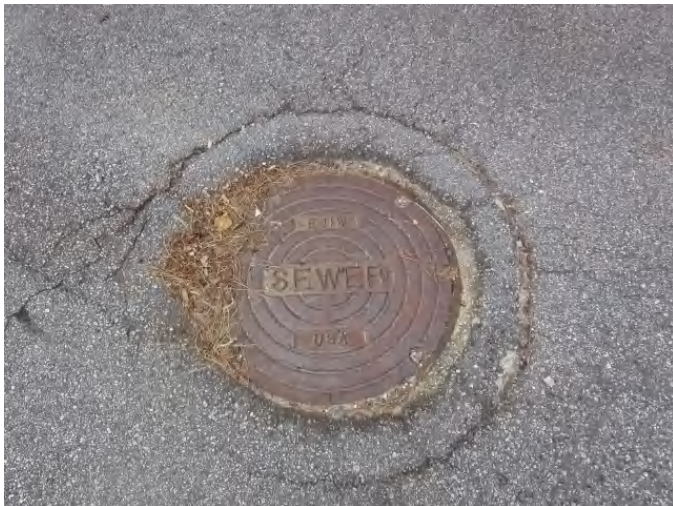
### **System: G3020 - Sanitary Sewer**

**Location:** Site

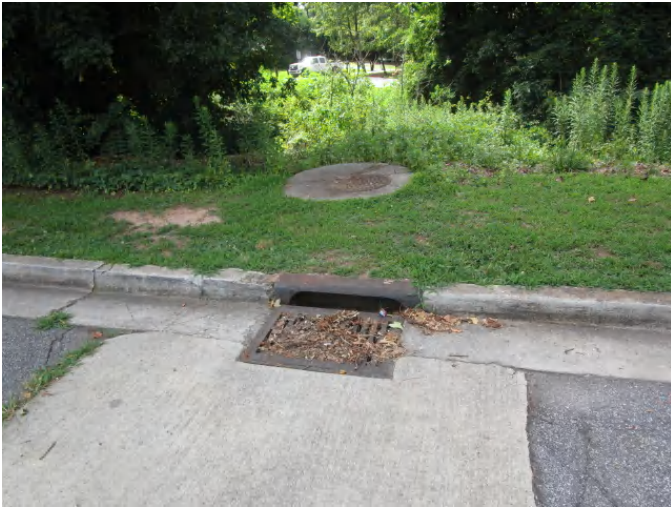
**System: G3030 - Storm Sewer**

**Location:** Site  
**Distress:** Beyond Service Life  
**Category:** Deferred Maintenance  
**Priority:** 3 Priority  
**Correction:** Renew System  
**Qty:** 54,363.00  
**Unit of Measure:** S.F.  
**Estimate:** \$212,287.52  
**Assessor Name:** Sam Mandola  
**Date Created:** 07/14/2015

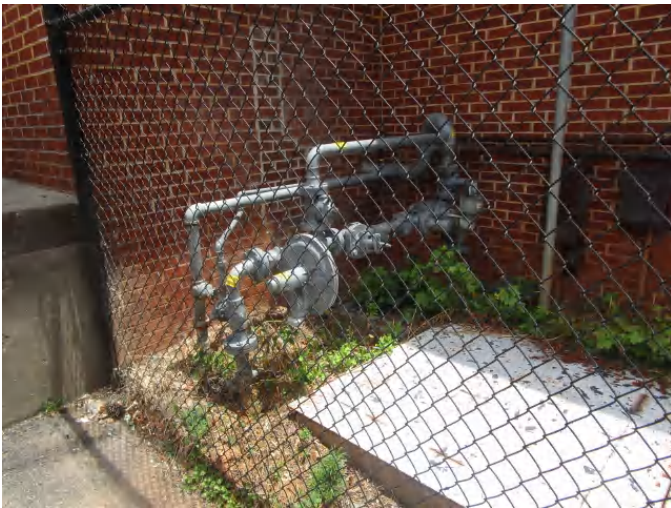
**System: G3060 - Fuel Distribution**

**Location:** Site  
**Distress:** Beyond Service Life  
**Category:** Deferred Maintenance  
**Priority:** 3 Priority  
**Correction:** Renew System  
**Qty:** 54,363.00  
**Unit of Measure:** S.F.  
**Estimate:** \$46,643.45  
**Assessor Name:** Eduardo Lopez  
**Date Created:** 07/14/2015

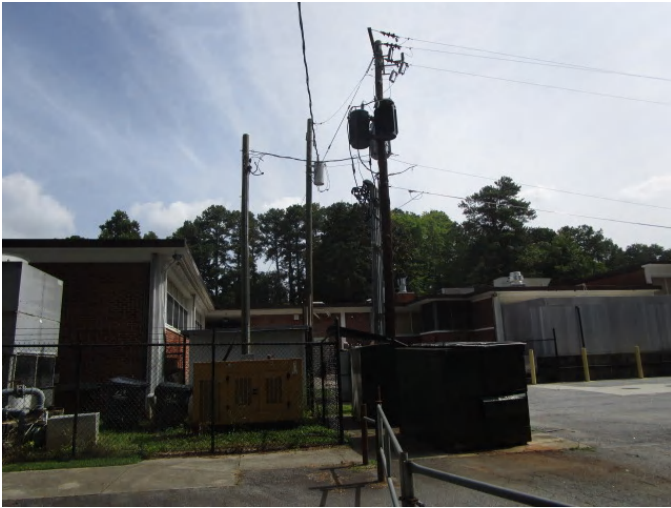
**System: G4010 - Electrical Distribution**

**Location:** Site

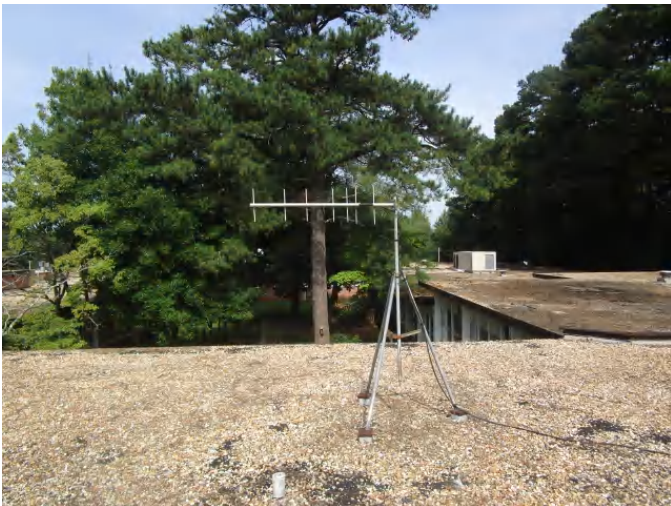
**System: G4030 - Site Communications & Security**

**Location:** Site
