DeKalb County School District/Elementary Schools

# Ronald E. McNair Discovery Learning Academy

## School Assessment Report

May 20, 2016

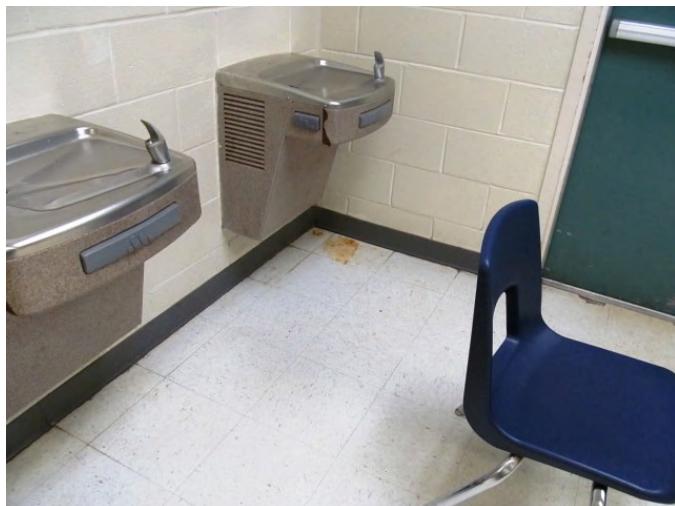
**System: C3020 - Floor Finishes - VCT**

**Location:** Throughout Building

**Distress:** Beyond Service Life

**Notes:** The VCT flooring is aged, cracked and worn, and should be replaced.
