**DeKalb County School District/Elementary Schools**

# **Oak View Elementary**

## **School Assessment Report**

**May 20, 2016**

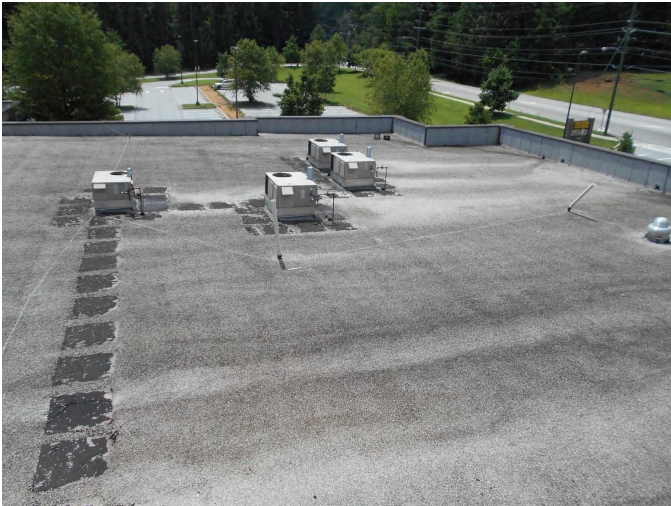
#### **System: B3010 - Roof Coverings - BUR**

**Location:** Roof

**Distress:** Needs Remediation

**Notes:** Numerous roof leaks were reported and observed during the assessment. Recommend repairs to the roof covering system.

**Correction:** Minor BUR membrane repairs, 2% of roof area

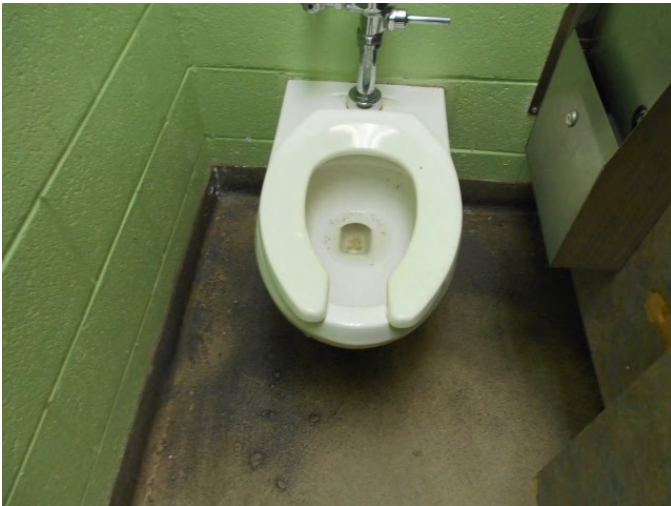
#### **System: C3020 - Floor Finishes - Epoxy**

**Location:** Restrooms and Kitchen

**Distress:** Beyond Service Life

**Notes:** The flooring surface in the student restrooms and kitchen is inadequate to maintain sanitary conditions. Recommend installation of a durable epoxy or ceramic floor tile finish.

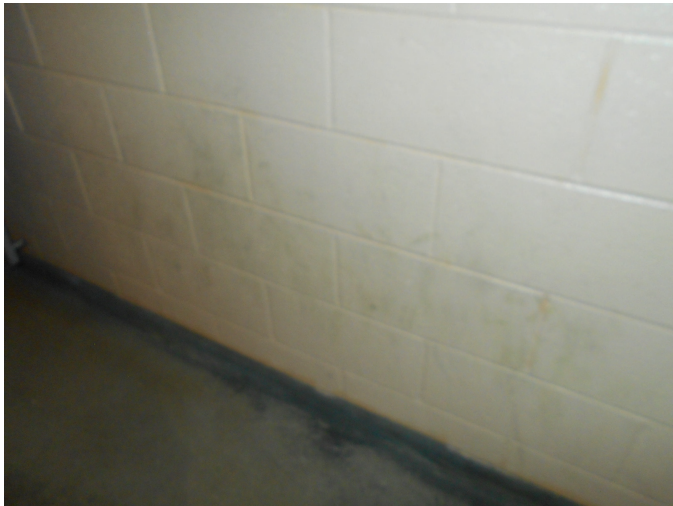
**System: C3010 - Wall Finishes - Paint**

**Location:** Throughout Building

**Distress:** Beyond Service Life

**Notes:** The painted wall finishes are beyond their expected service life, damaged and dirty, and should be replaced.

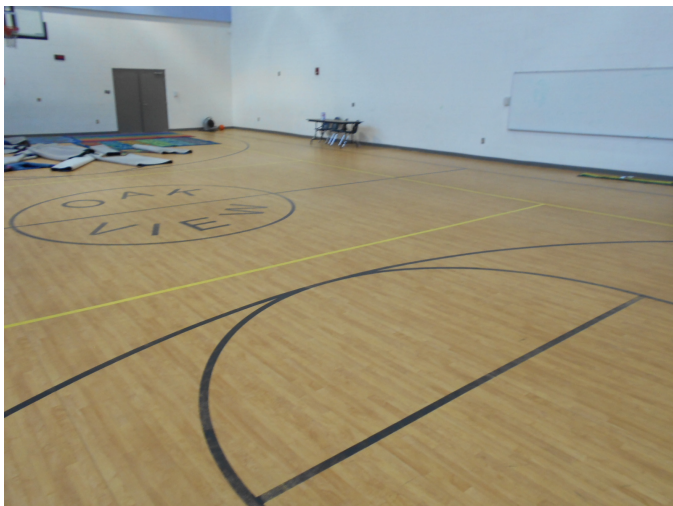
**System: C3020 - Floor Finishes - Athletic Flooring**

**Location:** Gym

**Distress:** Beyond Service Life

**Notes:** The athletic floor covering is beyond its expected service life, worn and delaminating, and should be replaced.

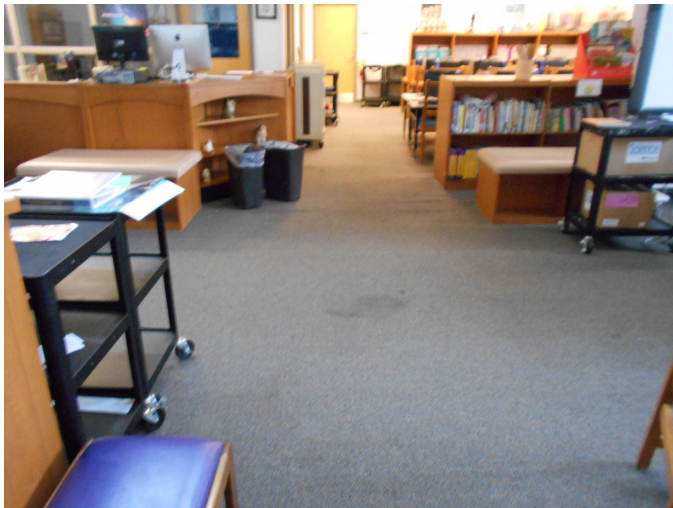
**System: C3020 - Floor Finishes - Carpet**

**Location:** Media Center, Offices

**Distress:** Beyond Service Life

**Notes:** The carpet is beyond its expected service life, worn and dirty, and should be replaced.

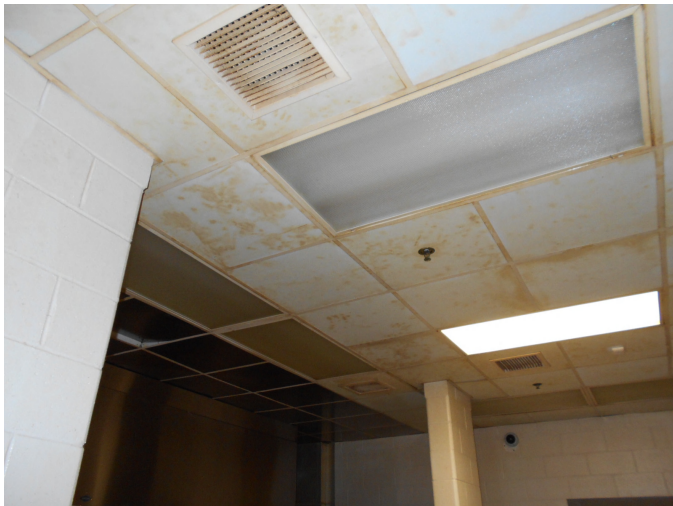
**System: C3030 - Ceiling Finishes**

**Location:** Kitchen

**Distress:** Needs Remediation

**Notes:** The acoustical ceiling system in the kitchen is dirty, damaged, and should be replaced.

**Correction:** Replace acoustic tile ceiling, fire-rated

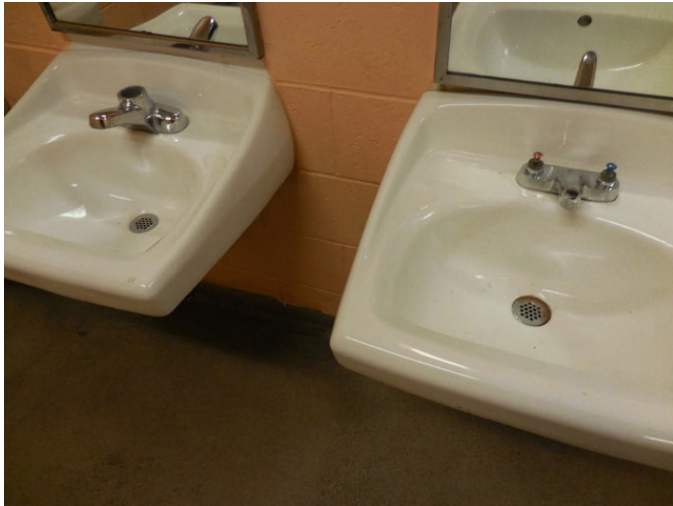
**System: D2010 - Plumbing Fixtures**

**Location:** Throughout Building

**Distress:** Damaged

**Notes:** Plumbing fixtures throughout the building have issues. Toilets and sinks stained and loose and broken, and not ADA compliant, and should be scheduled for replacement.

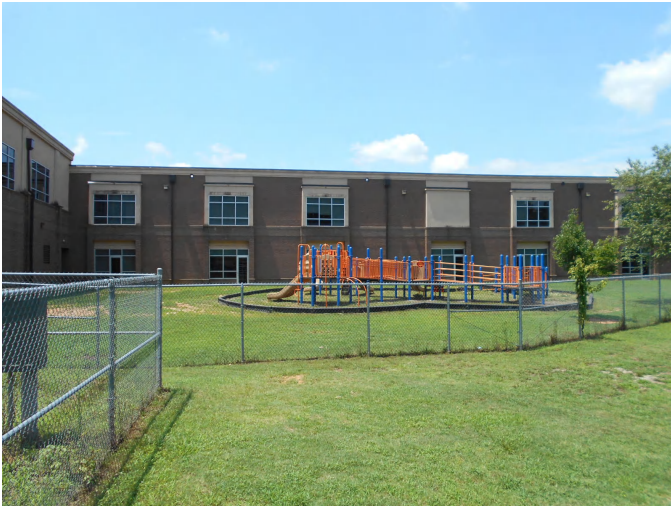
#### **System: G4030 - Site Communications & Security**

**Location:** Site

**Distress:** Beyond Service Life

**Notes:** Site communications and security systems are beyond their expected service life, inadequate, and should be replaced/upgraded to provide improved coverage.
