DeKalb County School District/Elementary Schools

# Oakcliff Elementary

## School Assessment Report

May 20, 2016

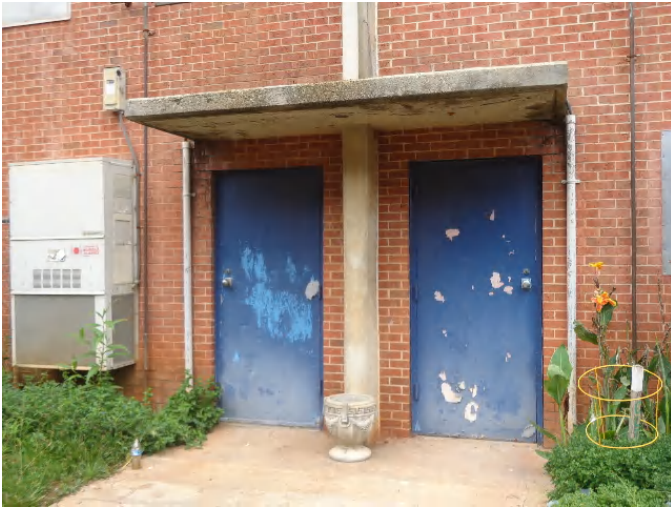
#### **System: B2030 - Exterior Doors**

**Location:** Throughout Building

**Distress:** Beyond Service Life

**Notes:** The original exterior doors are aged, rusted and should be replaced. Basement emergency exit doors are missing panic hardware and should be provided. Emergency exit doors at electrical room are not equipped with fire exit hardware.

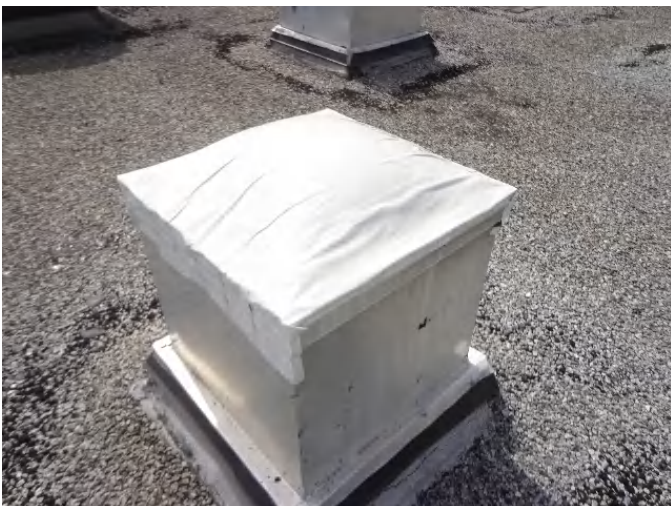
#### **System: B3020 - Roof Openings**

**Location:** Roof

**Distress:** Beyond Service Life

**Notes:** The small acrylic domes are damaged, broken and patched, and leak, causing damage to the interior. Included in SPLOST IV scope.

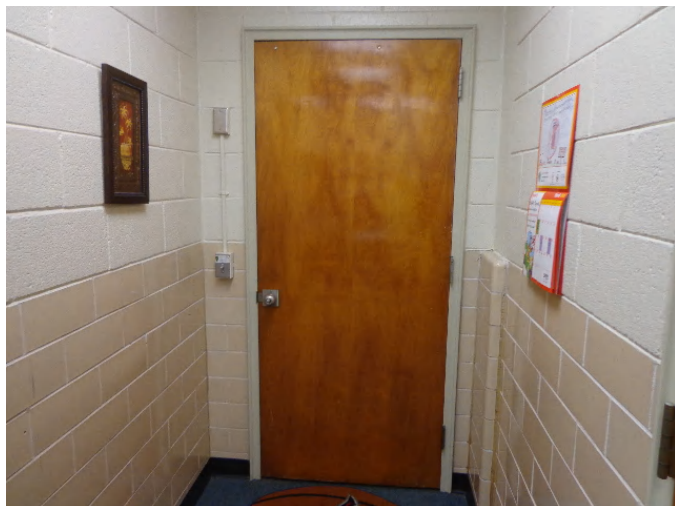
**System: C1020 - Interior Doors**

**Location:** Throughout Building

**Distress:** Beyond Service Life

**Notes:** The interior doors are aged, failing, not ADA or building code compliant, and should be replaced.

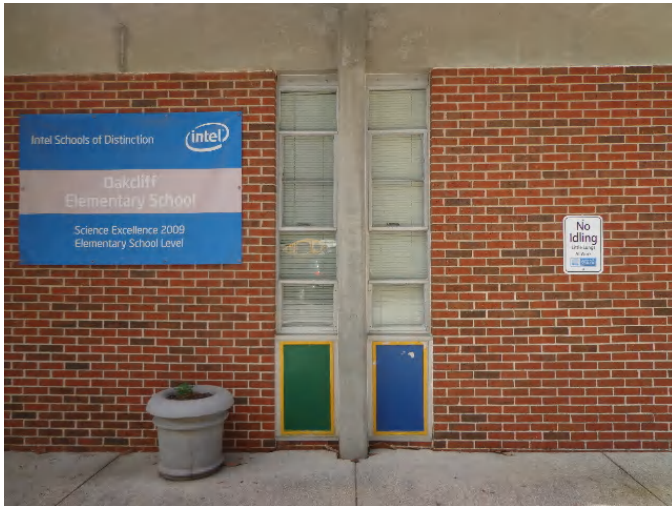
**System: B2020 - Exterior Windows**

**Location:** Throughout Building

**Distress:** Beyond Service Life

**Notes:** The aluminum frame, operable, single pane windows are aged, not energy efficient, and should be replaced.

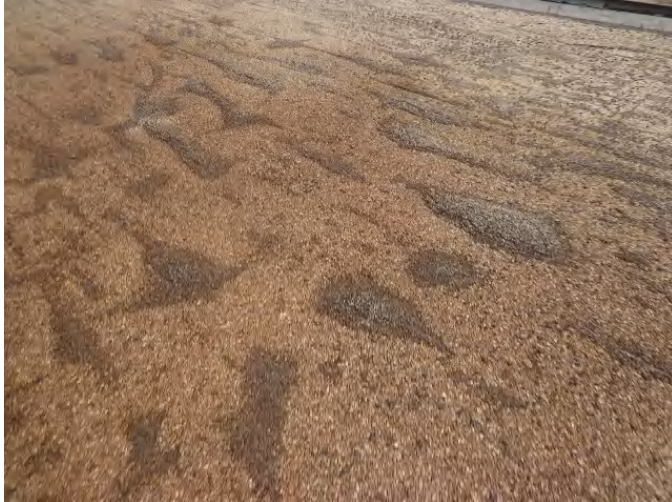
**System: B3010 - Roof Coverings - BUR**

**Location:** Roof

**Distress:** Beyond Service Life

**Notes:** Built-up roof covering is in deteriorating condition, with cracks, severe blisters, loss of surface, patches, ponding and reported water leaks throughout the building, and should be replaced. SPLOST project 423-422 to replace the roof on the 64, 66 and 70 buildings.

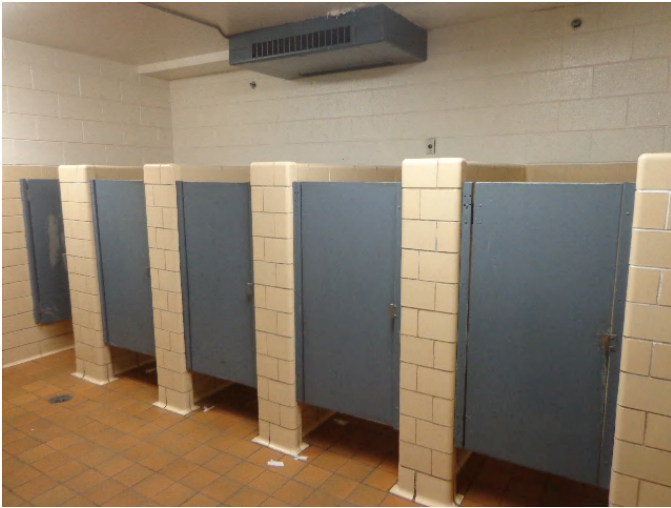
**System: C1030 - Fittings**

**Location:** Throughout Building

**Distress:** Beyond Service Life

**Notes:** Fittings, such as toilet partitions, handrails and room signage, are beyond their expected life and should be replaced to improve ADA accessibility and comply with building code.

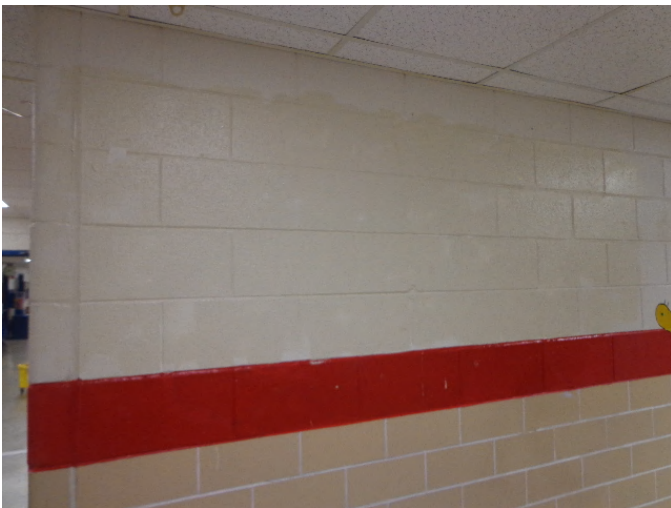
**System: C3010 - Wall Finishes - Paint**

**Location:** Throughout Building

**Distress:** Beyond Service Life

**Notes:** The painted wall finishes are beyond their expected service life, scuffed and stained, and should be replaced.

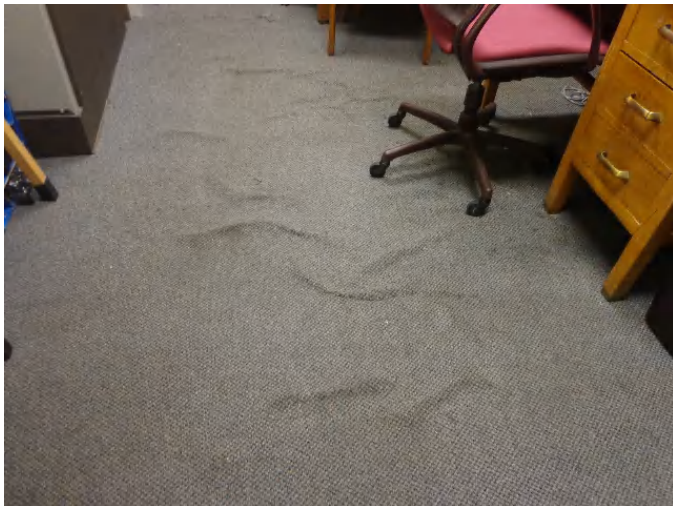
**System: C3020 - Floor Finishes - Carpet**

**Location:** Throughout Building

**Distress:** Beyond Service Life

**Notes:** The carpet is aged, stained and frayed, and should be replaced.

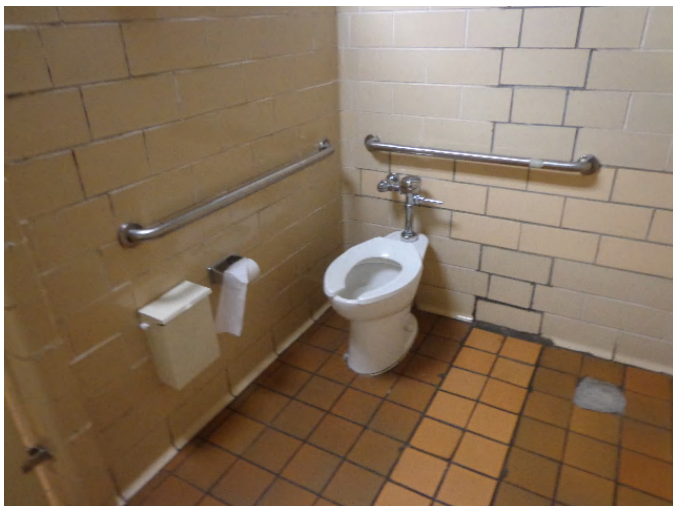
**System: C3020 - Floor Finishes - Ceramic & Quarry Tile**

**Location:** Kitchen and Restrooms

**Distress:** Beyond Service Life

**Notes:** The tile floor covering is beyond its expected service life, cracked, patched and worn, and should be replaced.

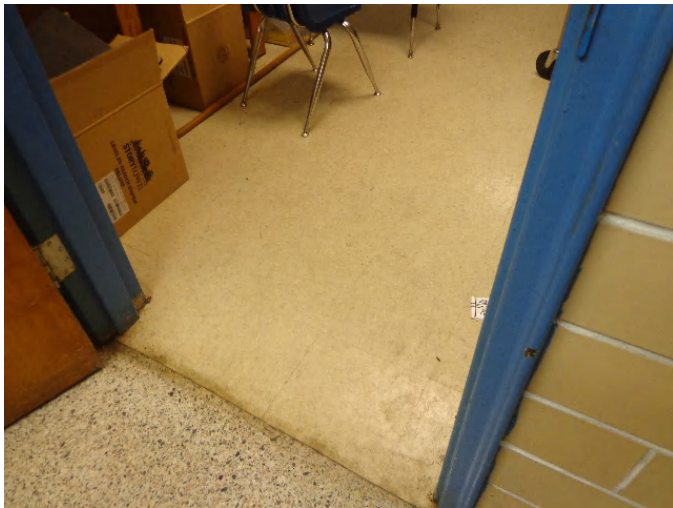
**System: C3020 - Floor Finishes - VCT**

**Location:** Throughout Building

**Distress:** Beyond Service Life

**Notes:** The VCT flooring is aged, stained and worn, and should be replaced.

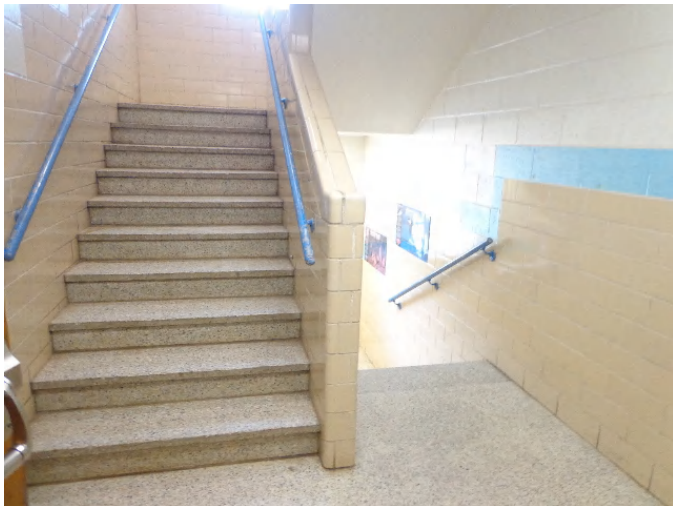
**System: D1010 - Elevators and Lifts**

**Location:** Throughout Building

**Distress:** Missing

**Notes:** Different mid-levels, including the basement, are not accessible and it is recommended to be provide an elevator to improve ADA accessibility.

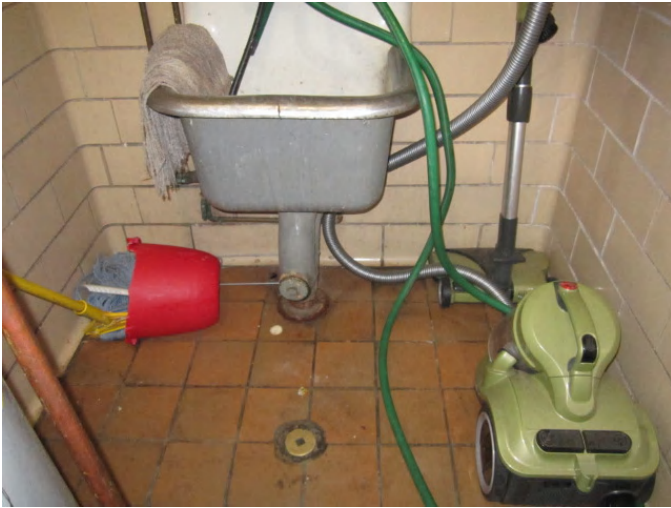
**System: D2010 - Plumbing Fixtures**

**Location:** Throughout Building

**Distress:** Beyond Service Life

**Notes:** The plumbing fixtures are beyond their expected service life and should be scheduled for replacement. Restrooms are missing at the different levels and should be added/upgraded to improve ADA accessibility.

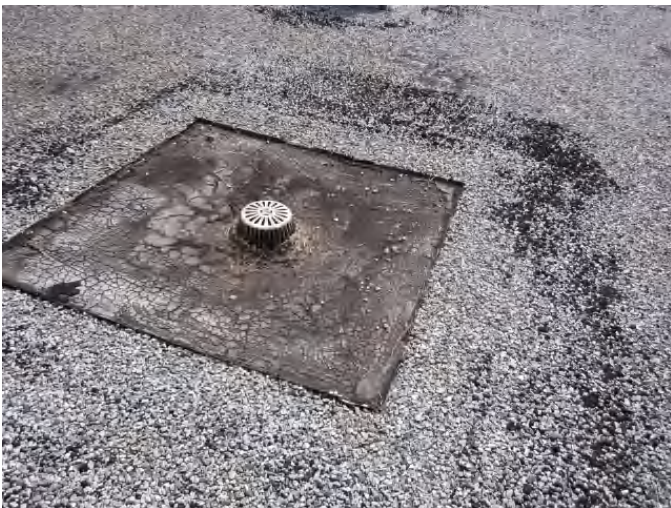
**System: D2040 - Rain Water Drainage**

**Location:** Throughout Building

**Distress:** Beyond Service Life

**Notes:** The rainwater drainage system is beyond its expected service life and should be scheduled for replacement.

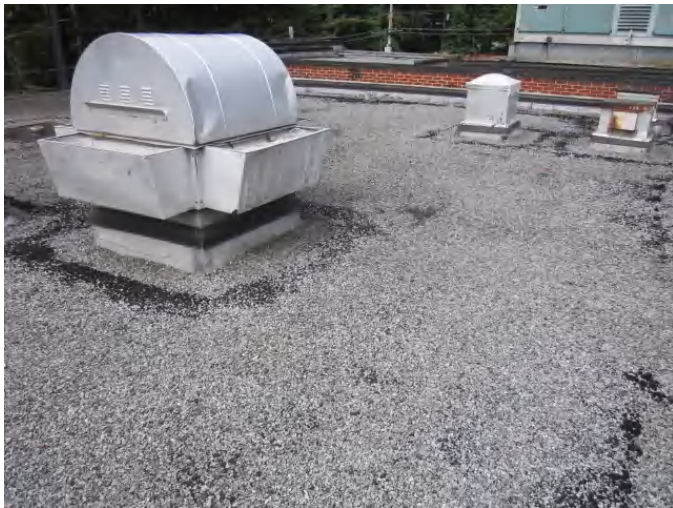
**System: D3040 - Distribution & Exhaust Systems**

**Location:** Throughout Building

**Distress:** Beyond Service Life

**Notes:** The distribution and exhaust systems are beyond their expected service life, inadequate, not working in some restrooms, and should be scheduled for replacement. SPLOST project 423-422 to replace the building exhaust systems.

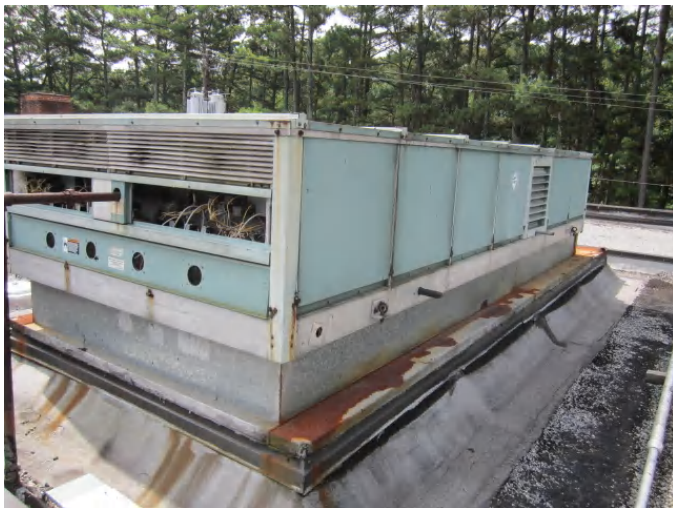
**System: D3050 - Terminal & Package Units**

**Location:** Throughout Building

**Distress:** Beyond Service Life

**Notes:** The terminal and package units are beyond their expected service life, inadequate, and should be scheduled for replacement.

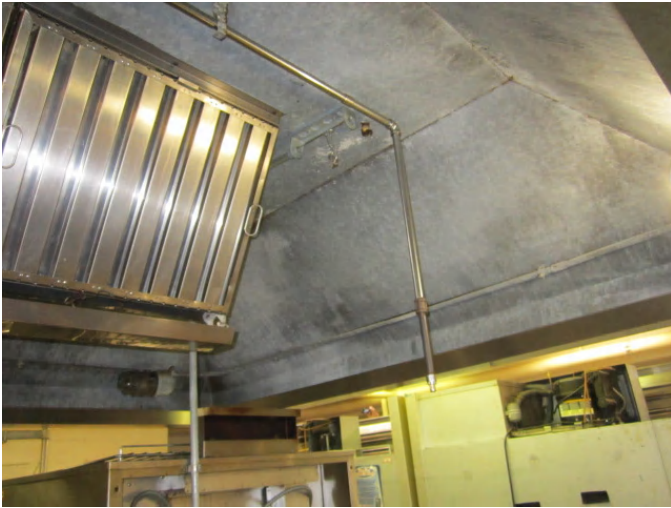
**System: D3090 - Other HVAC Systems/Equip - Kitchen Hood**

**Location:** Kitchen  
**Distress:** Beyond Service Life  
**Category:** Deferred Maintenance  
**Priority:** 3 Priority  
**Correction:** Renew System  
**Qty:** 66,750.00  
**Unit of Measure:** S.F.  
**Estimate:** \$90,313.00  
**Assessor Name:** Eduardo Lopez  
**Date Created:** 04/11/2015

**Notes:** The kitchen hood system is beyond its expected service life, aged, and should be scheduled for replacement.

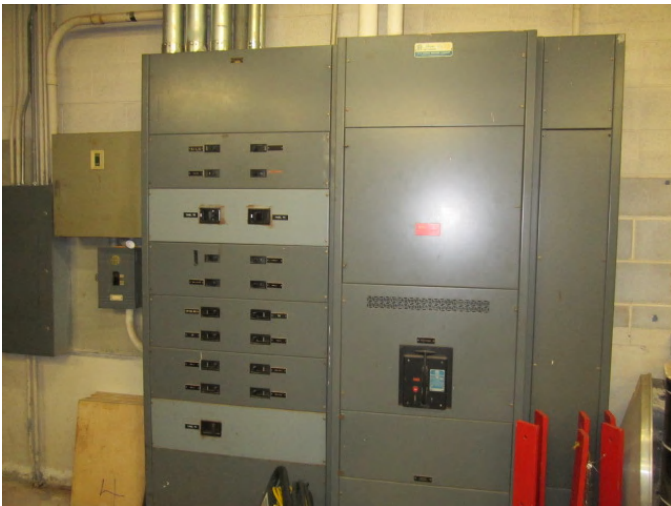
**System: D5010 - Electrical Service/Distribution**

**Location:** Main Switch Room/Throughout Building  
**Distress:** Beyond Service Life  
**Category:** Deferred Maintenance  
**Priority:** 3 Priority  
**Correction:** Renew System  
**Qty:** 66,750.00  
**Unit of Measure:** S.F.  
**Estimate:** \$132,899.00  
**Assessor Name:** Eduardo Lopez  
**Date Created:** 07/08/2015

**Notes:** The electrical service/distribution system is beyond its expected service life, aged, and should be scheduled for replacement.

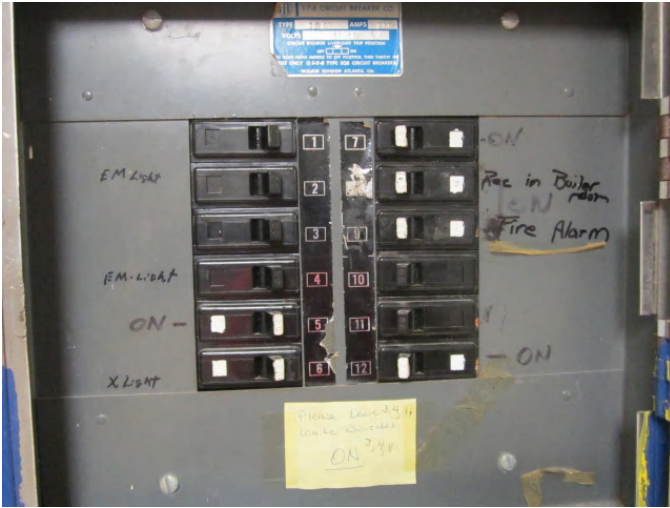
### **System: D5020 - Branch Wiring**

**Location:** Throughout Building

**Distress:** Beyond Service Life

**Notes:** The branch wiring system is beyond its expected service life, not building code compliant, and should be scheduled for replacement. electrical outlets are not GFI in wet areas.

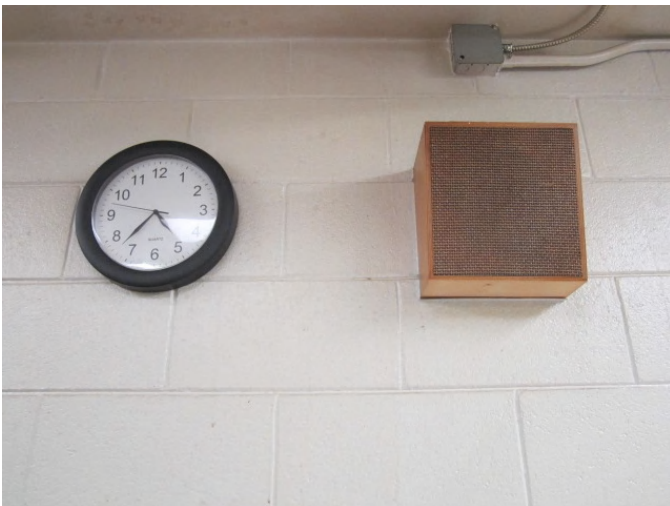
### **System: D5030 - Communications and Security - Clock & PA Systems**

**Location:** Throughout Building

**Distress:** Beyond Service Life

**Notes:** Clock and PA systems are beyond their expected service life, aged, and should be scheduled for replacement.

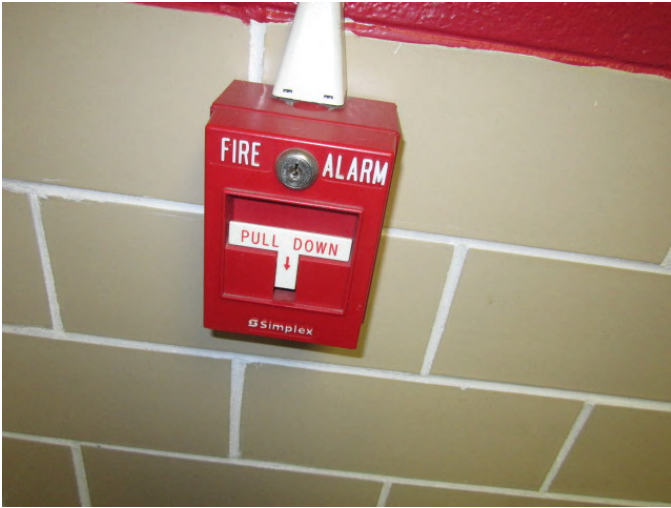
**System: D5030 - Communications and Security - Fire Alarm**

**Location:** Throughout Building

**Distress:** Beyond Service Life

**Notes:** The fire alarm system is beyond its expected service life, not building code compliant, and should be scheduled for replacement. Visible alarms (strobes) are not installed in restrooms.

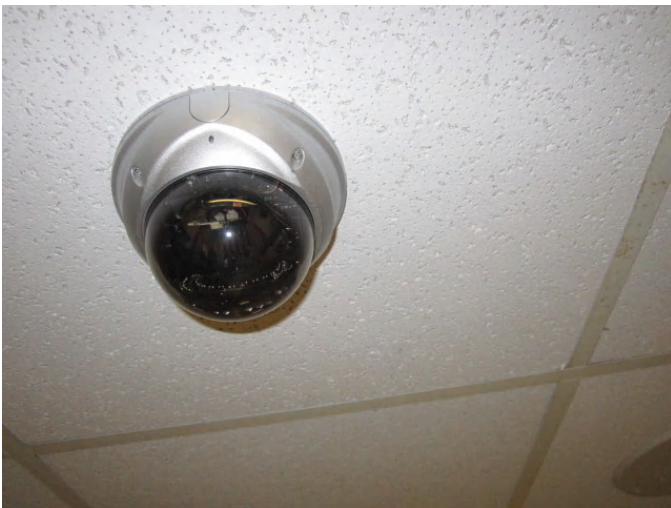
**System: D5030 - Communications and Security - Security & CCTV**

**Location:** Throughout Building

**Distress:** Beyond Service Life

**Notes:** The security and CCTV systems are beyond their expected service life, aged, and should be scheduled for replacement.

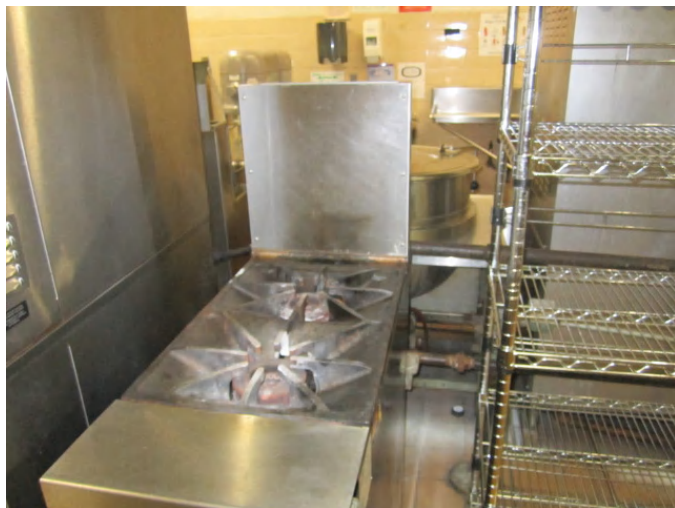
**System: E1090 - Other Equipment (Kitchen Equipment)**

**Location:** Kitchen

**Distress:** Beyond Service Life

**Notes:** Kitchen equipment is beyond its expected service life and should be scheduled for replacement.

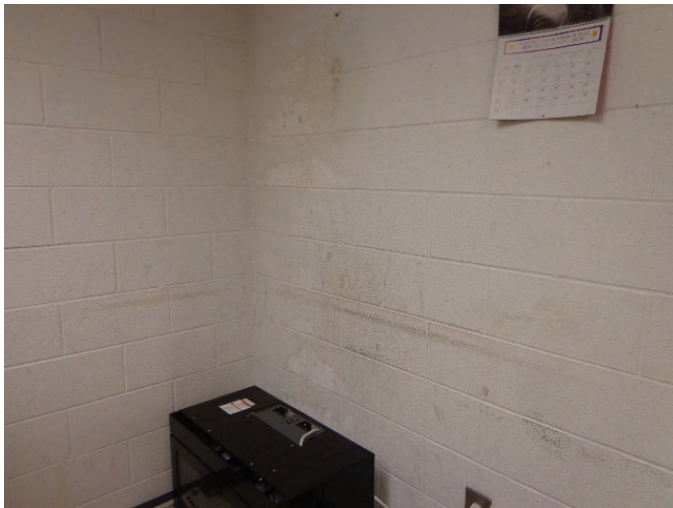
#### **System: C3010 - Wall Finishes - Paint**

**Location:** Throughout Building

**Distress:** Beyond Service Life

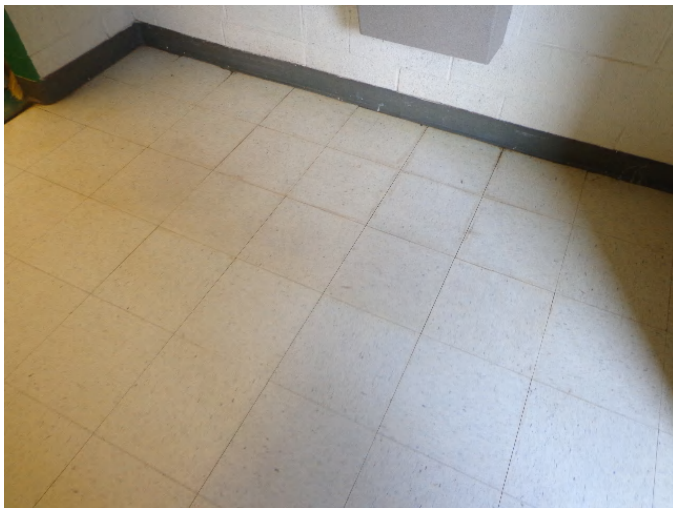
#### **System: C3020 - Floor Finishes - VCT**

**Location:** Entrance Area and Offices

**Distress:** Beyond Service Life

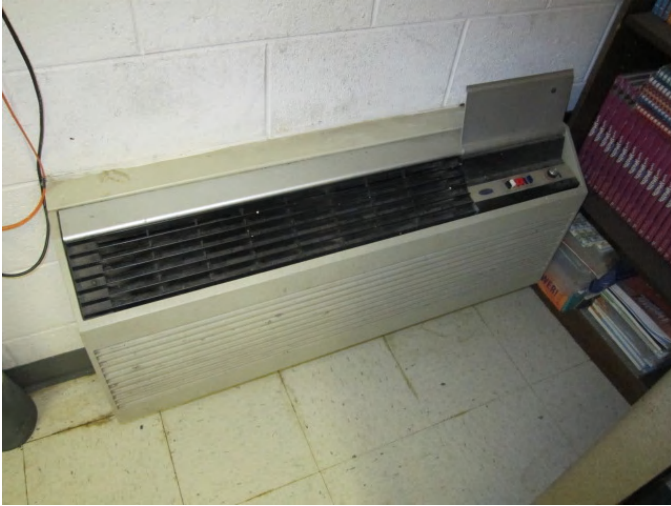
**System: D3050 - Terminal & Package Units**

**Location:** Throughout Building

**Distress:** Inadequate

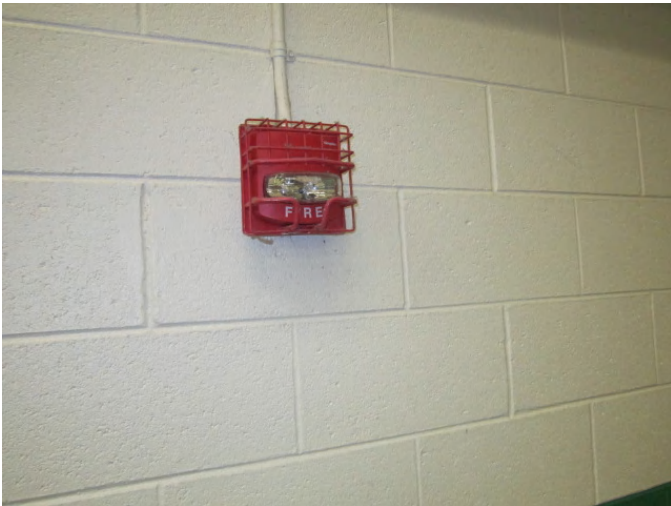
**System: D5030 - Communications and Security - Fire Alarm**

**Location:** Throughout Building

**Distress:** Beyond Service Life

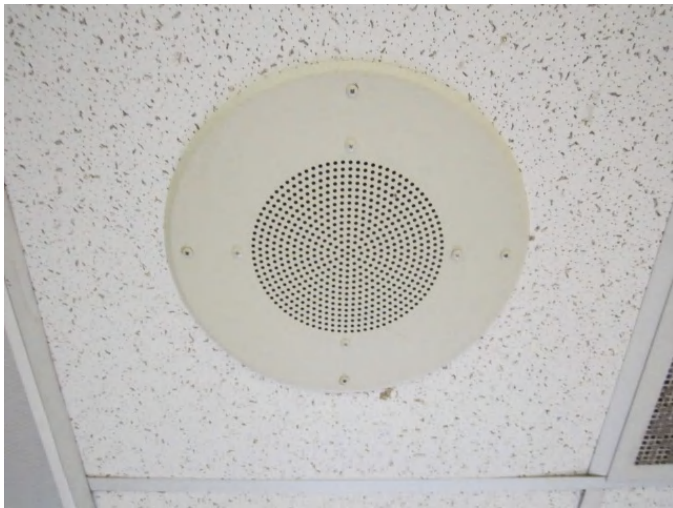
**System: D5030 - Communications and Security - Public Address & Clock System**

**Location:** Throughout Building

**Distress:** Beyond Service Life

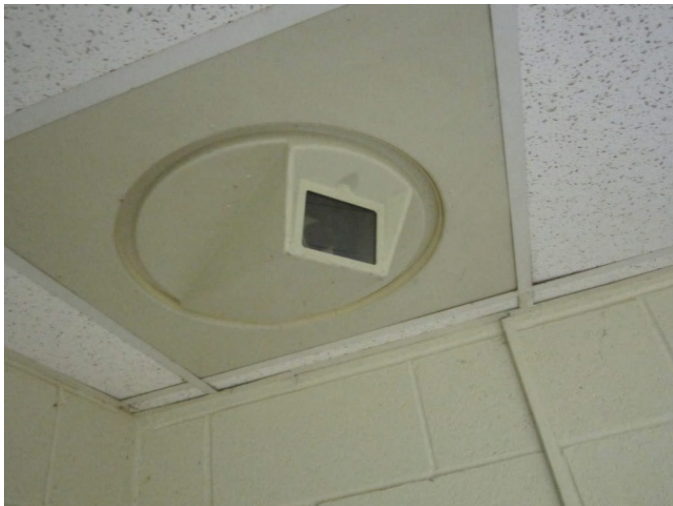
**System: D5030 - Communications and Security - Security & CCTV**

**Location:** Throughout Building

**Distress:** Beyond Service Life

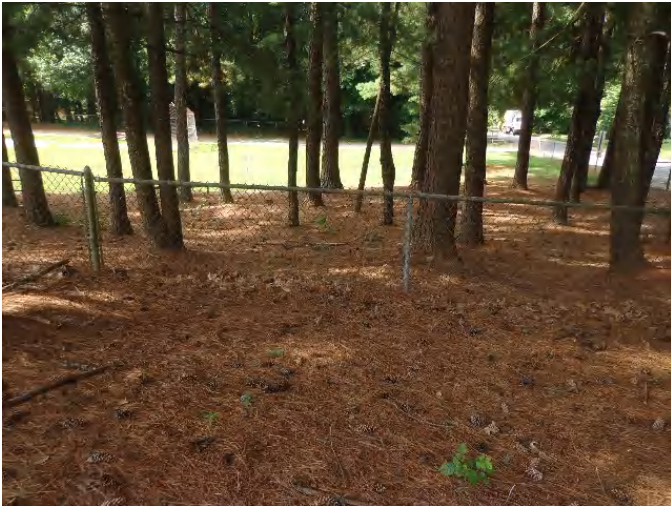
#### **System: G2040 - Fencing & Guardrails**

**Location:** Site

**Distress:** Beyond Service Life

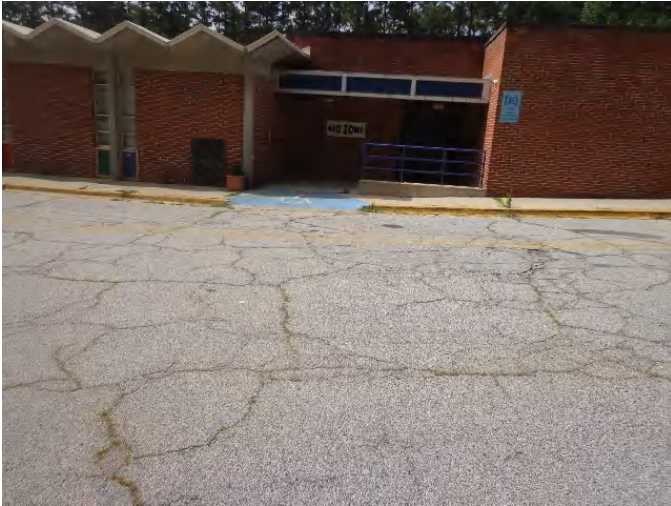
**System: G2010 - Roadways**

**Location:** Site

**Distress:** Beyond Service Life

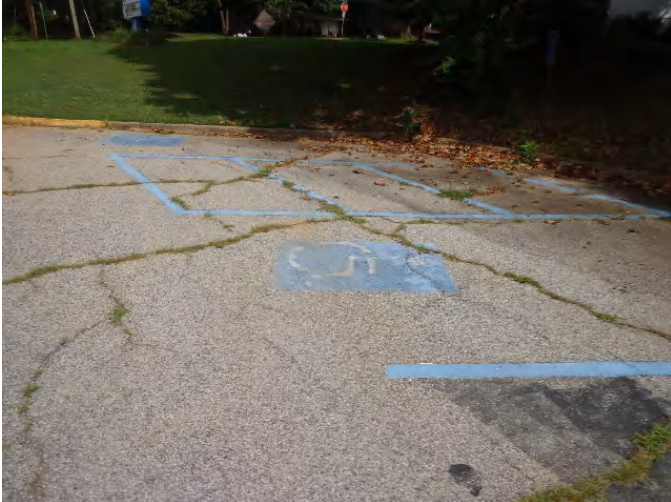
**System: G2020 - Parking Lots**

**Location:** Site

**Distress:** Beyond Service Life

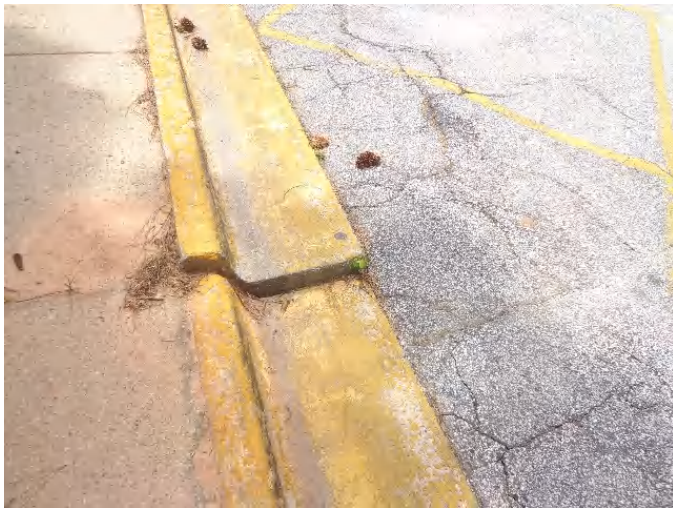
**System: G2030 - Pedestrian Paving**

**Location:** Site

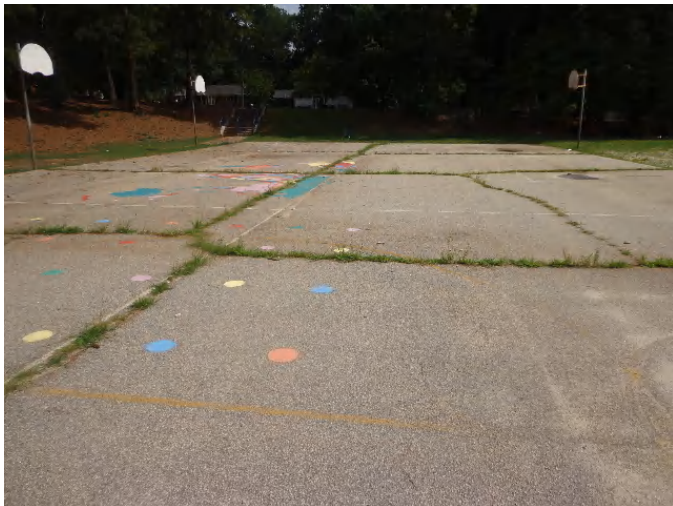
**System: G2040 - Hard Surface Play Area**

**Location:** Site

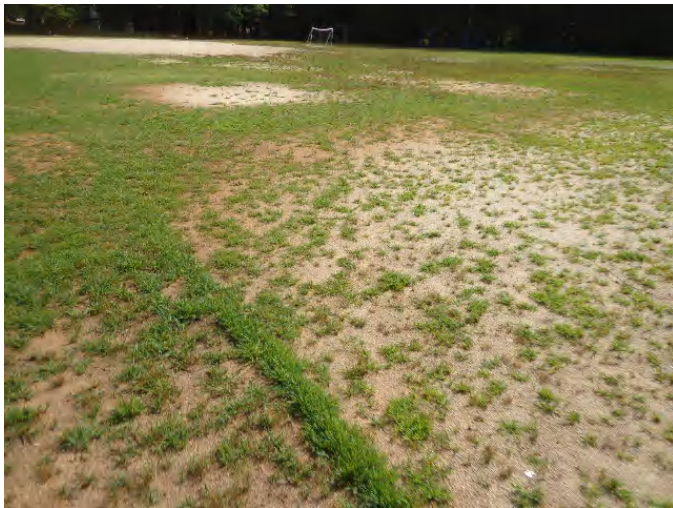
**System: G2040 - Playing Field**

**Location:** Site

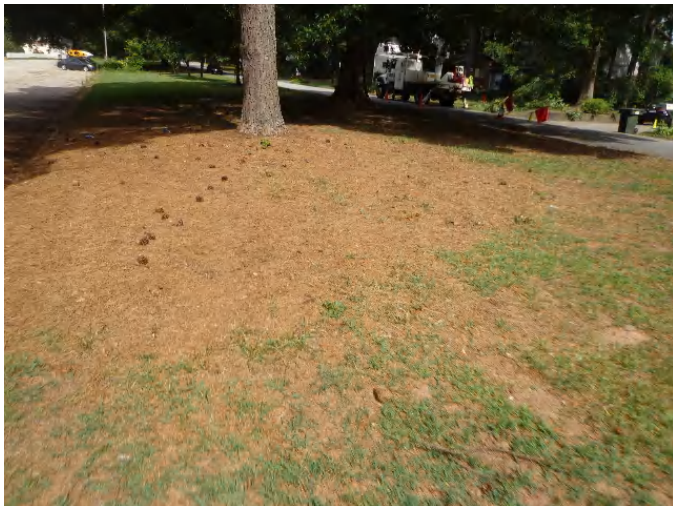
**System: G2050 - Landscaping**

**Location:** Site

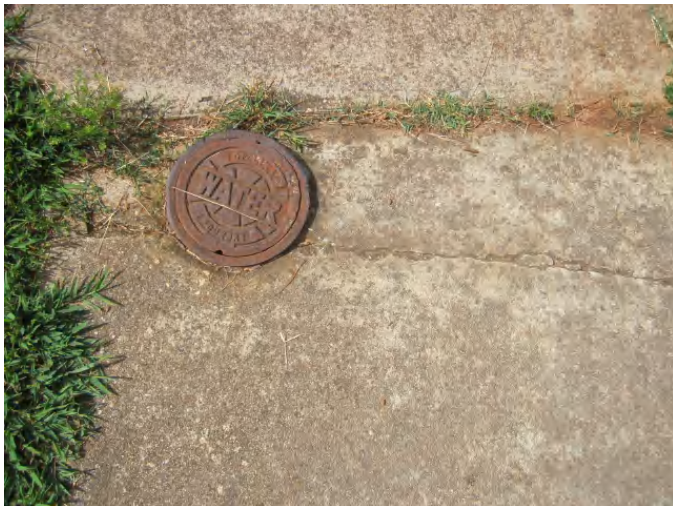
**System: G3010 - Water Supply**

**Location:** Site  
**Distress:** Beyond Service Life  
**Category:** Deferred Maintenance  
**Priority:** 3 Priority  
**Correction:** Renew System  
**Qty:** 72,228.00  
**Unit of Measure:** S.F.  
**Estimate:** \$145,395.00  
**Assessor Name:** Eduardo Lopez  
**Date Created:** 07/08/2015

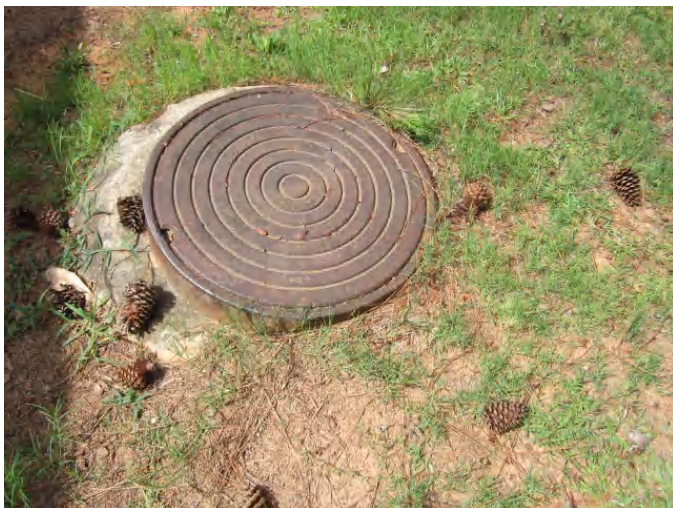
**System: G3020 - Sanitary Sewer**

**Location:** Site  
**Distress:** Beyond Service Life  
**Category:** Deferred Maintenance  
**Priority:** 3 Priority  
**Correction:** Renew System  
**Qty:** 72,228.00  
**Unit of Measure:** S.F.  
**Estimate:** \$91,368.00  
**Assessor Name:** Eduardo Lopez  
**Date Created:** 07/08/2015

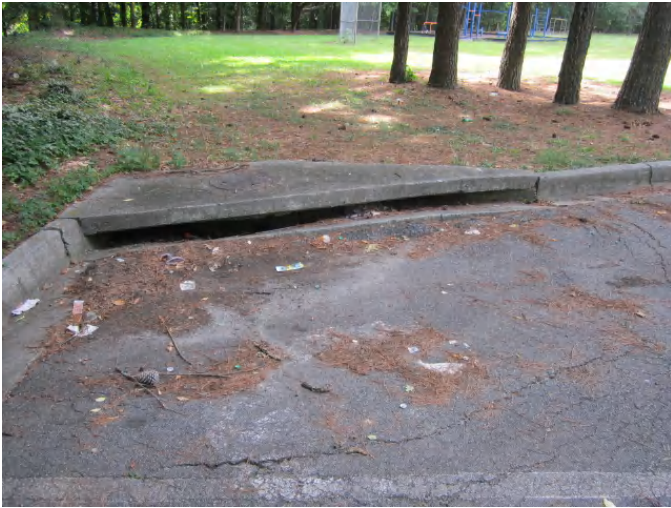
**System: G3030 - Storm Sewer**

**Location:** Site  
**Distress:** Beyond Service Life  
**Category:** Deferred Maintenance  
**Priority:** 3 Priority  
**Correction:** Renew System  
**Qty:** 72,228.00  
**Unit of Measure:** S.F.  
**Estimate:** \$282,050.00  
**Assessor Name:** Eduardo Lopez  
**Date Created:** 07/08/2015

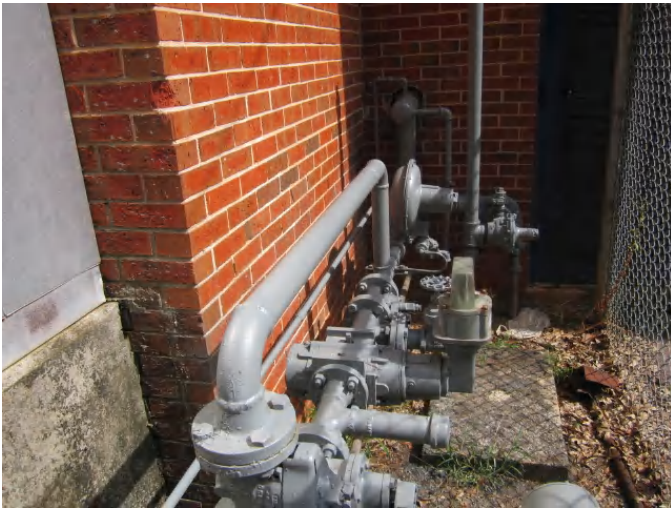
**System: G3060 - Fuel Distribution**

**Location:** Site  
**Distress:** Beyond Service Life  
**Category:** Deferred Maintenance  
**Priority:** 3 Priority  
**Correction:** Renew System  
**Qty:** 72,228.00  
**Unit of Measure:** S.F.  
**Estimate:** \$61,972.00  
**Assessor Name:** Eduardo Lopez  
**Date Created:** 07/08/2015

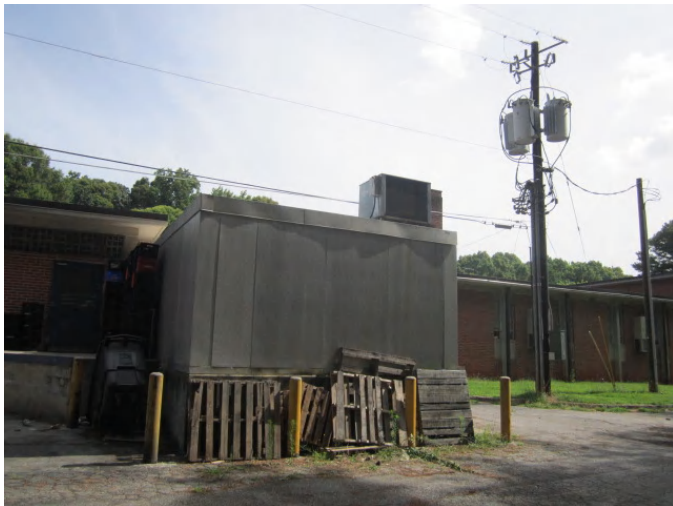
**System: G4010 - Electrical Distribution**

**Location:** Site  
**Distress:** Beyond Service Life  
**Category:** Deferred Maintenance  
**Priority:** 3 Priority  
**Correction:** Renew System  
**Qty:** 72,228.00  
**Unit of Measure:** S.F.  
**Estimate:** \$147,778.00  
**Assessor Name:** Eduardo Lopez  
**Date Created:** 07/08/2015

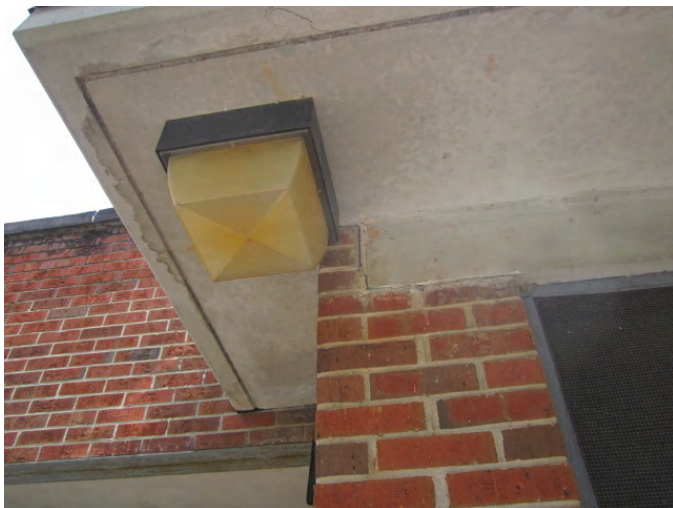
**System: G4020 - Site Lighting**

**Location:** Site  
**Distress:** Beyond Service Life  
**Category:** Deferred Maintenance  
**Priority:** 3 Priority  
**Correction:** Renew System  
**Qty:** 72,228.00  
**Unit of Measure:** S.F.  
**Estimate:** \$91,368.00  
**Assessor Name:** Eduardo Lopez  
**Date Created:** 07/08/2015

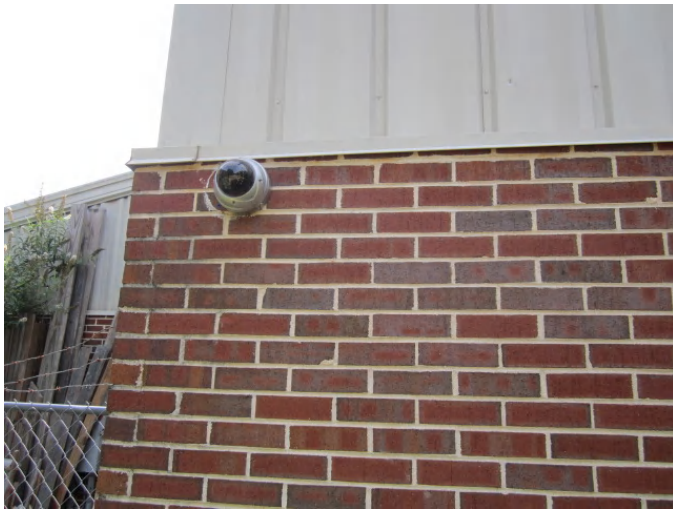
**System: G4030 - Site Communications & Security**

**Location:** Site
