DeKalb County School District/Elementary Schools

# Princeton Elementary

## School Assessment Report

May 20, 2016

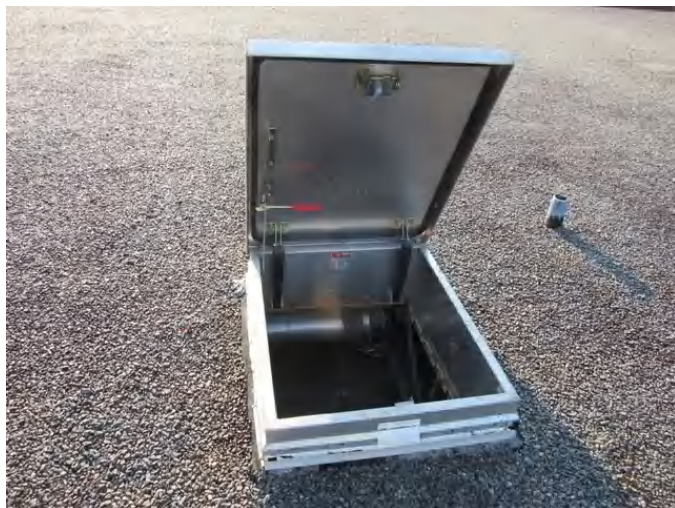
#### System: B3020 - Roof Openings

**Location:** Roof

**Distress:** Inadequate

**Notes:** Roof hatch does not comply with OSHA standards; roof opening protection and proper extension of fixed ladder to platform is not provided.

**Correction:** Replace roof hatch and structure single unit

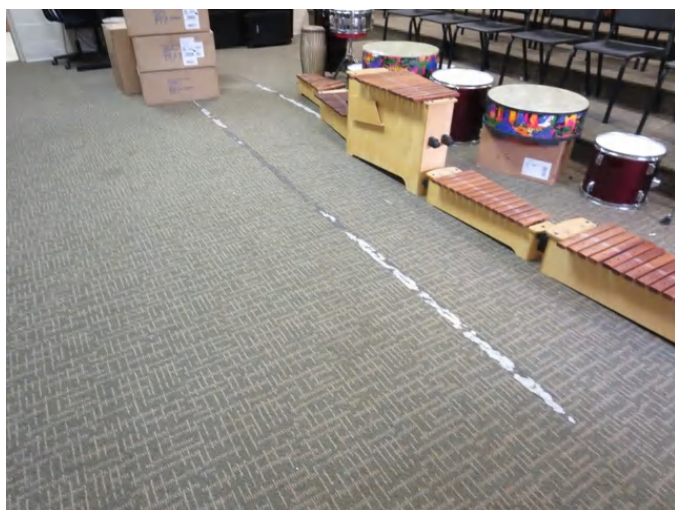
#### System: C3020 - Floor Finishes - Carpet

**Location:** Classroom, Media Center, and Offices

**Distress:** Beyond Service Life

**Notes:** The carpet in the music room is stained, showing signs of failure, and should be replaced.
