**DeKalb County School District/Elementary Schools**

# **Rockbridge Elementary**

## **School Assessment Report**

**May 20, 2016**

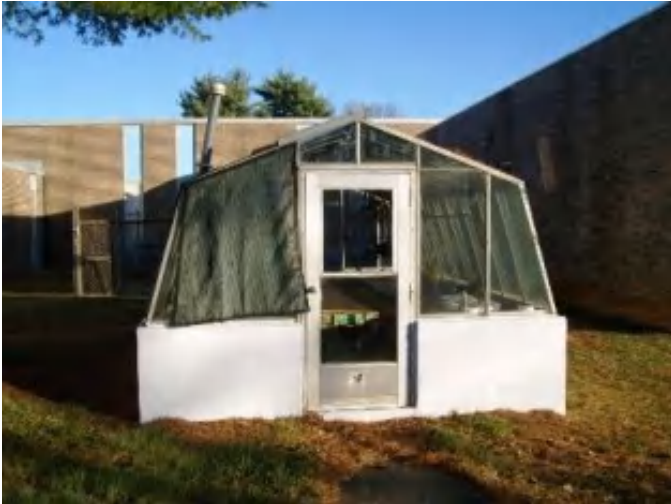
#### **System: G1020 - Site Demolitions and Relocations**

**Location:** Entire Building

**Distress:** Beyond Service Life

**Notes:** The greenhouse is scheduled for demolition. This deficiency is for demolition and removal of the building. SPLOST project 508 -422 to replace school.

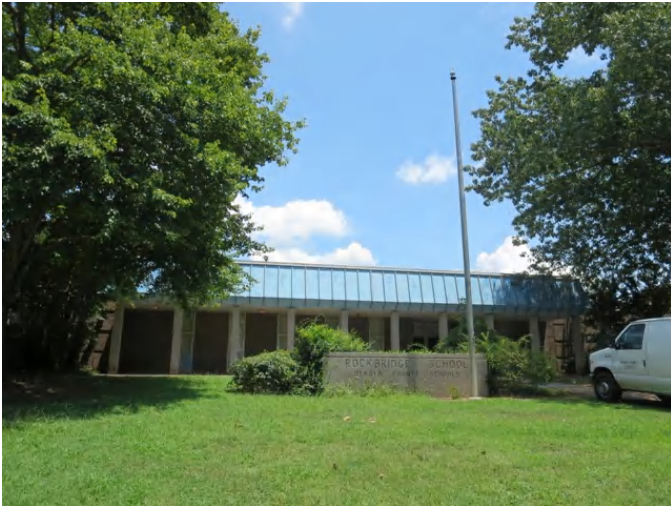
#### System: G1020 - Site Demolitions and Relocations

**Location:** Entire Building

**Distress:** Beyond Service Life

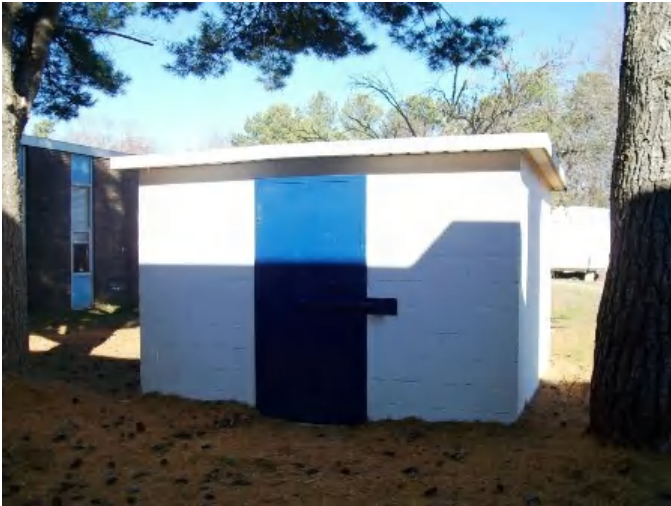
#### **System: G1020 - Site Demolitions and Relocations**

**Location:** Entire Building

**Distress:** Beyond Service Life

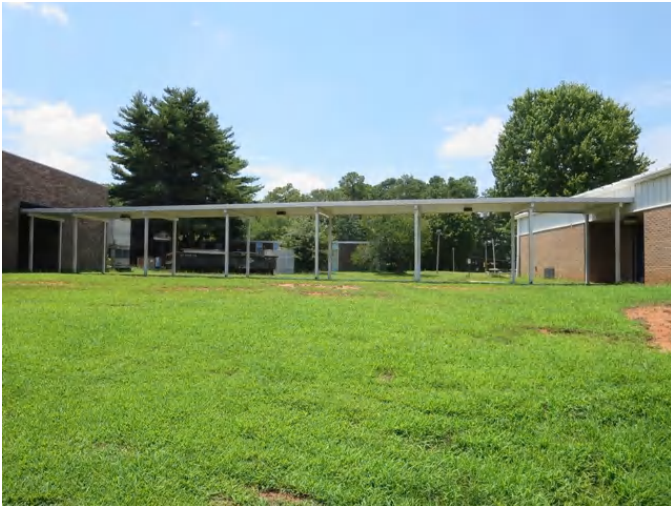
#### **System: G1020 - Site Demolitions and Relocations**

**Location:** Entire Building

**Distress:** Beyond Service Life

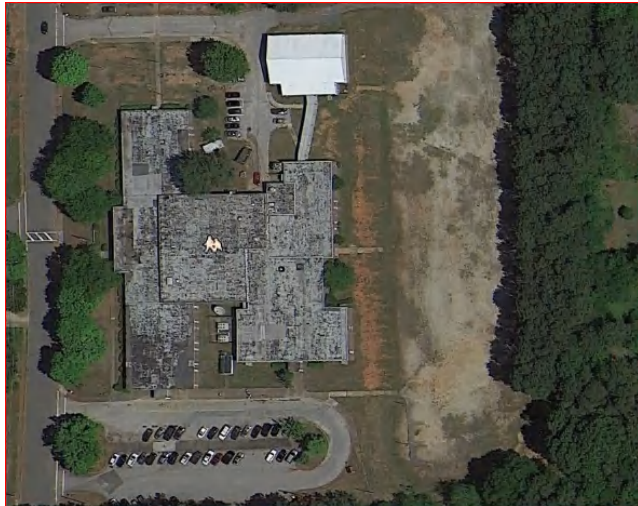
#### System: G1020 - Site Demolitions and Relocations

**Location:** Entire Site

**Distress:** Beyond Service Life
