DeKalb County School District/Elementary Schools

# Stone Mill Elementary

## School Assessment Report

May 20, 2016

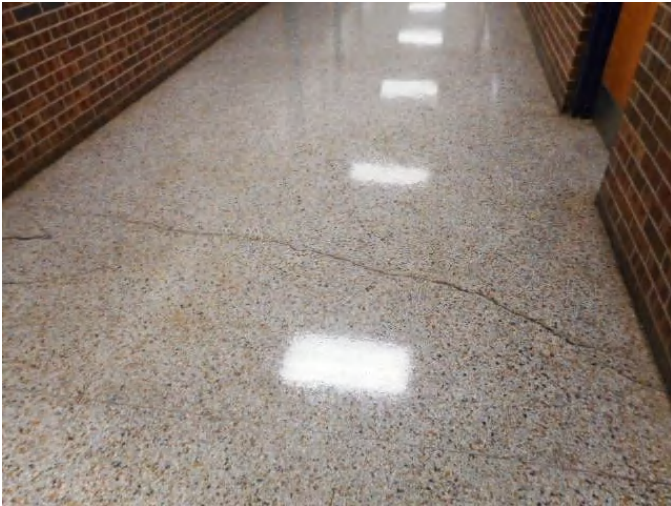
#### **System: A1010 - Standard Foundations**

**Location:** Hallway

**Distress:** Damaged

**Notes:** There are visible cracks on the floor and an engineering study should be conducted to determine the cause. Pricing does not include mitigation measures.

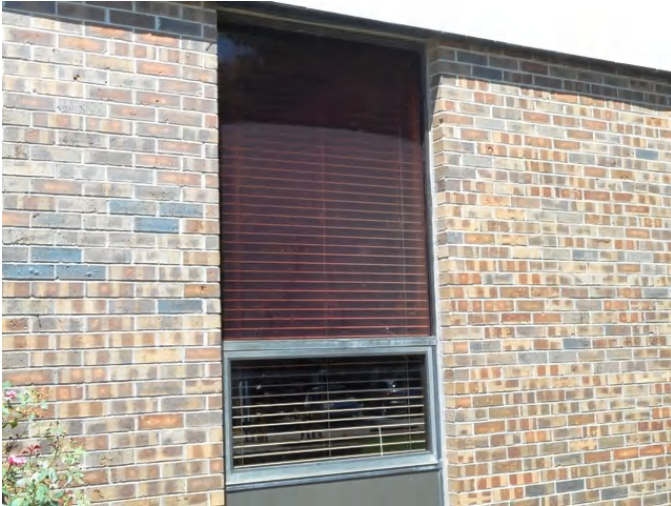
**System: B2020 - Exterior Windows**

**Location:** Throughout Building

**Distress:** Beyond Service Life

**Notes:** The aluminum frame, operable, single pane windows are aged, damaged, not energy efficient, and should be replaced.

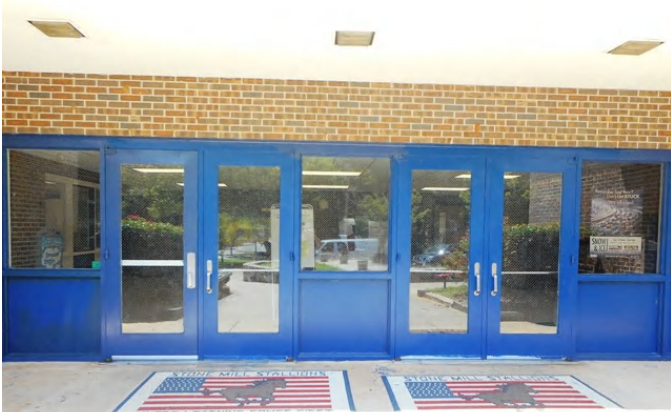
**System: B2030 - Exterior Doors**

**Location:** Throughout Building

**Distress:** Beyond Service Life

**Notes:** The original metal exterior doors are aged, rusted, not easy to operate, and should be replaced.

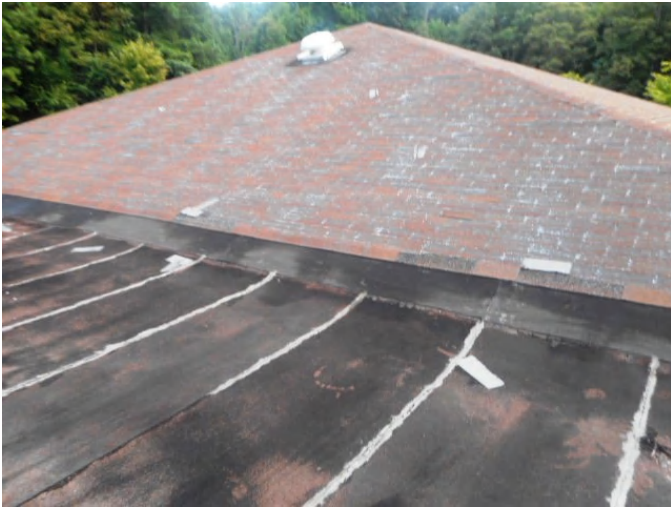
**System: B3010 - Roof Coverings - Asphalt Shingles**

**Location:** Roof

**Distress:** Beyond Service Life

**Notes:** The asphalt shingle roofing is aged, damaged, and should be replaced. SPLOST project 130-422 to replace the asphalt single-ply roofing (1975 building).

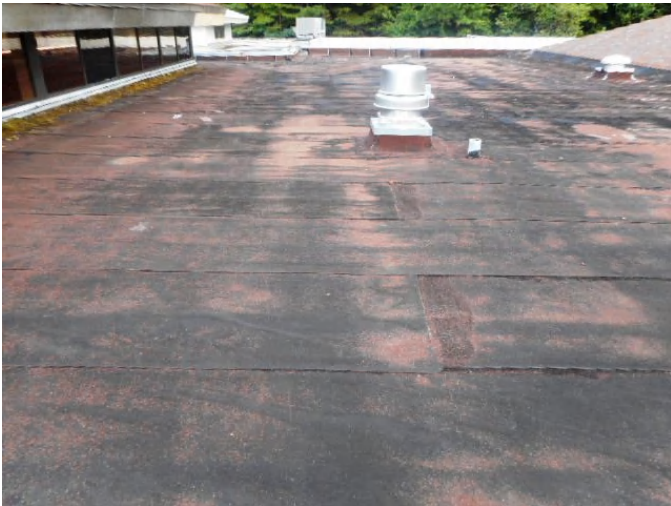
**System: B3010 - Roof Coverings - BUR**

**Location:** Roof

**Distress:** Beyond Service Life

**Notes:** Built-up roof covering is in deteriorating condition, with cracks, bubbling, patches and reported water leaks. SPLOST project 130-422 to replace the roof on the 75 building.

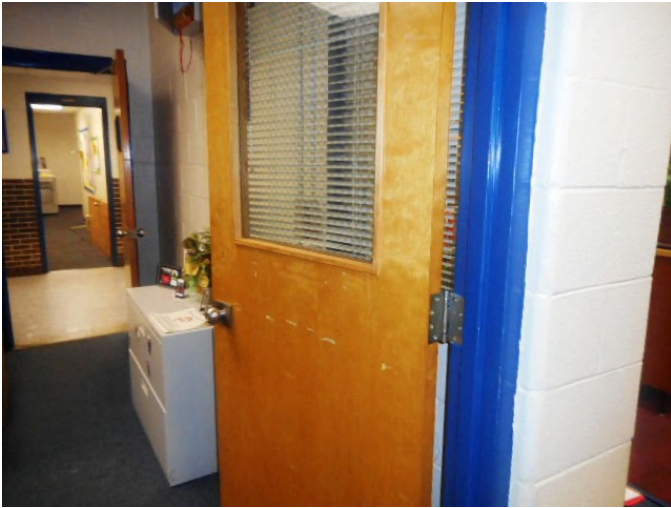
**System: C1020 - Interior Doors**

**Location:** Throughout Building

**Distress:** Beyond Service Life

**Notes:** The interior doors are aged, failing, not ADA or building code compliant, and should be replaced.

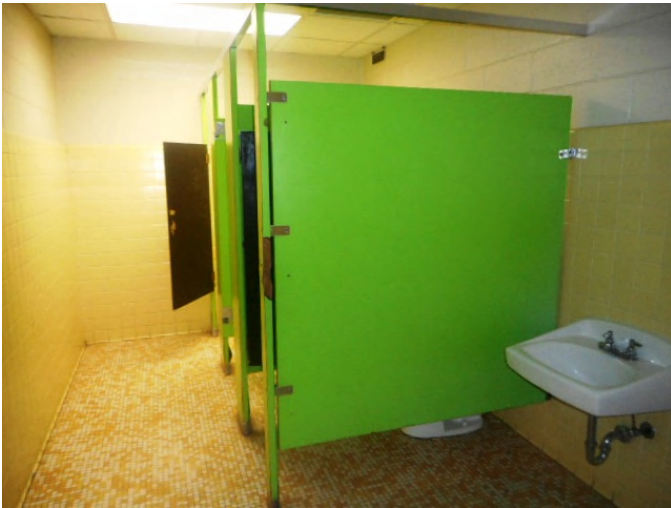
**System: C1030 - Fittings**

**Location:** Throughout Building

**Distress:** Beyond Service Life

**Notes:** Fittings, such as toilet partitions, handrails and signage, are beyond their expected service life, not ADA compliant, and should be replaced. SPLOST project 130-422 to include hall restroom ADA renovations.

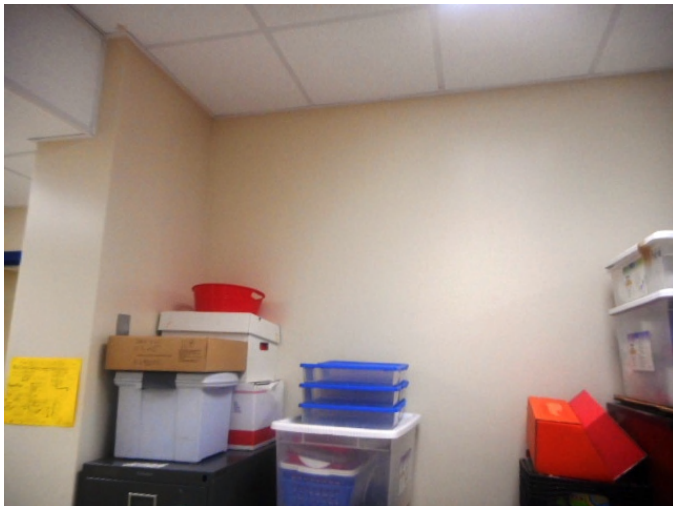
**System: C3010 - Wall Finishes - Paint**

**Location:** Throughout Building

**Distress:** Beyond Service Life

**Notes:** The painted wall finishes are beyond their expected service life and should be replaced.

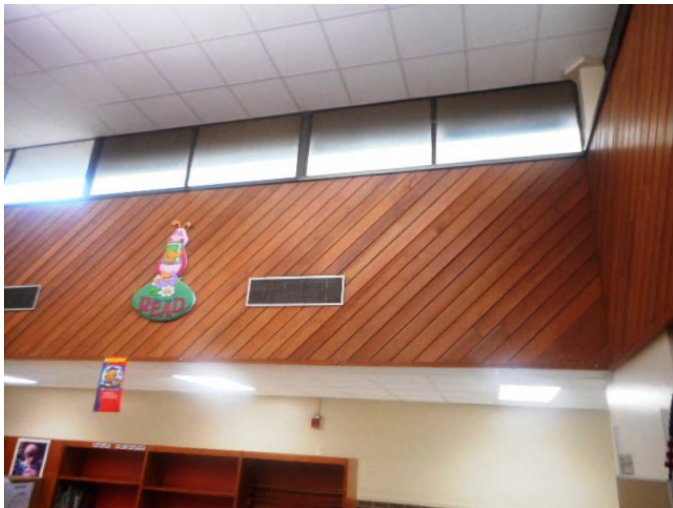
**System: C3010 - Wall Finishes - Wall Coverings**

**Location:** Throughout Building

**Distress:** Beyond Service Life

**Notes:** The wood panel wall coverings are beyond their expected service life and should be replaced.

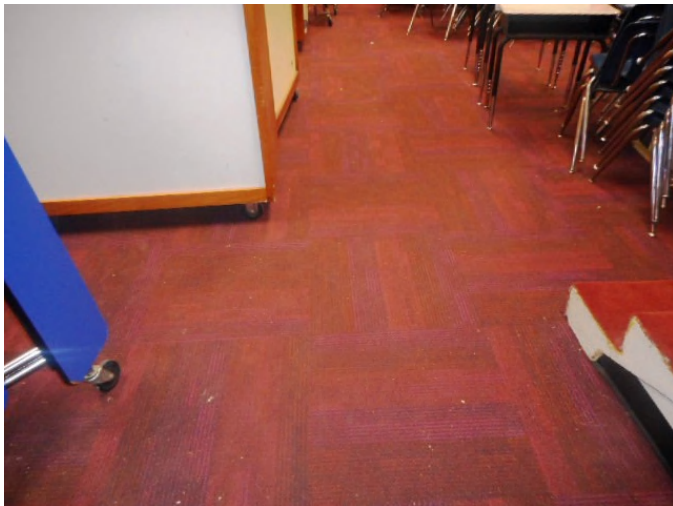
**System: C3020 - Floor Finishes - Carpet**

**Location:** Throughout Building

**Distress:** Beyond Service Life

**Notes:** The carpet is aged and stained, and should be replaced.

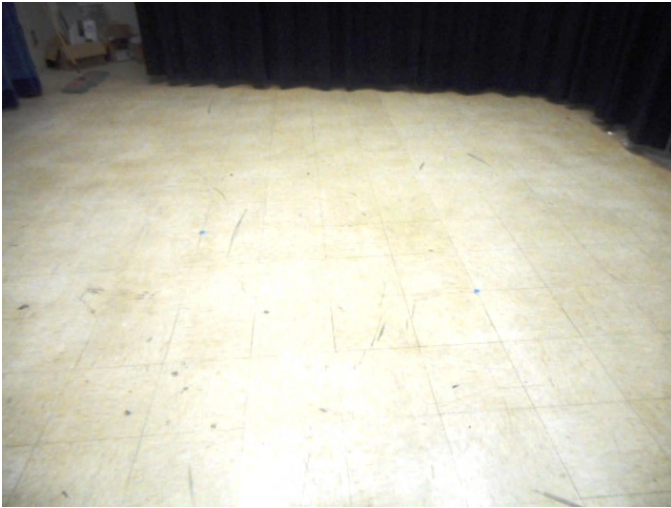
### **System: C3020 - Floor Finishes - VCT**

**Location:** Throughout Building

**Distress:** Beyond Service Life

**Notes:** The VCT flooring is aged and worn, and should be replaced.

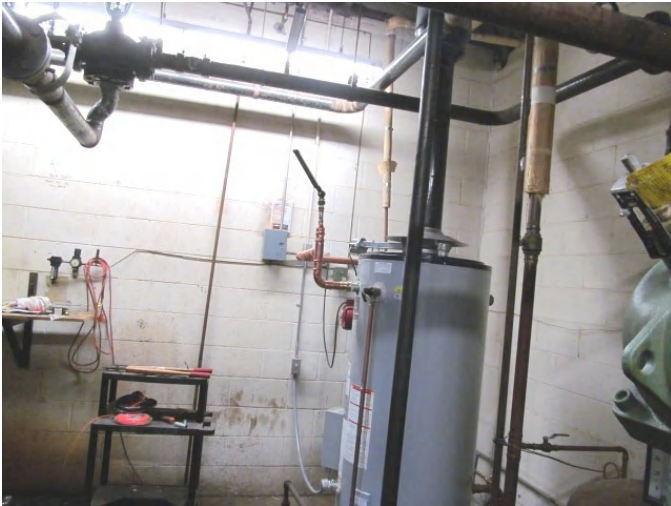
### **System: D2020 - Domestic Water Distribution**

**Location:** Throughout Building

**Distress:** Beyond Service Life

**Notes:** The domestic water distribution system is beyond its expected service life and should be scheduled for replacement. SPLOST project 421-140 to install reduced pressure zone (RPZ) devices on existing domestic and fire water supply lines.

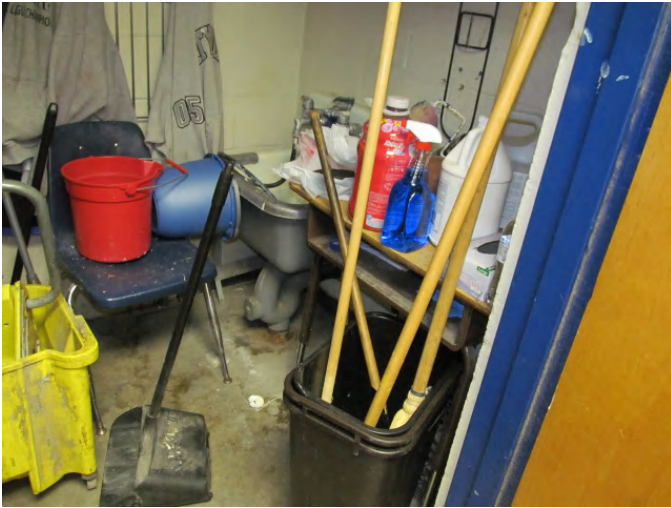
**System: D2030 - Sanitary Waste**

**Location:** Throughout Building

**Distress:** Beyond Service Life

**Notes:** The sanitary waste system is beyond its expected service life and should be scheduled for replacement. SPLOST project 421-140 to install a new 3,000-gallon grease trap.

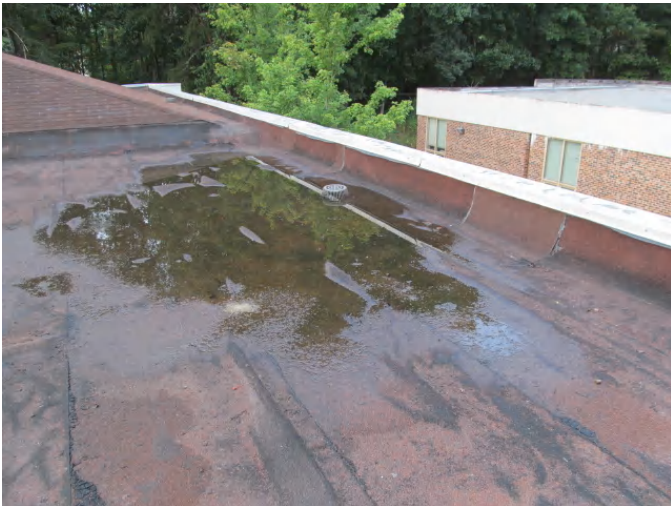
**System: D2040 - Rain Water Drainage**

**Location:** Throughout Building

**Distress:** Beyond Service Life

**Notes:** The rain water drainage system is beyond its expected service life, damaged, inadequate, and should be replaced in conjunction with the roof covering. SPLOST project 130-422 to replace the roof drainage system (1975 building).

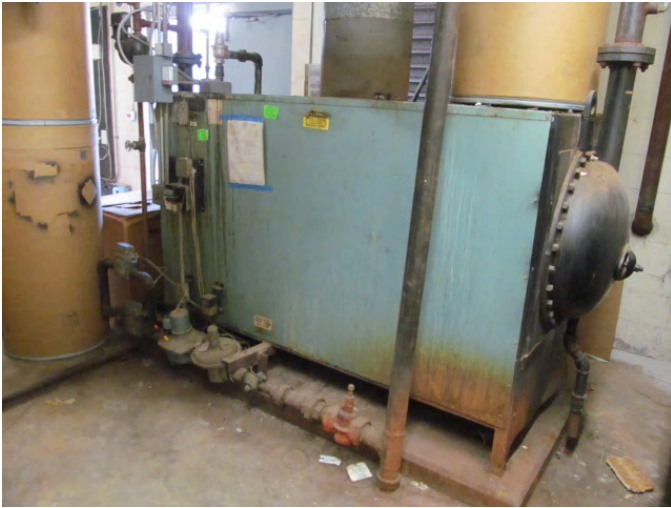
**System: D3020 - Heat Generating Systems**

**Location:** Mechanical Room

**Distress:** Beyond Service Life

**Notes:** The heat generating system is beyond its expected service life and should be scheduled for replacement.

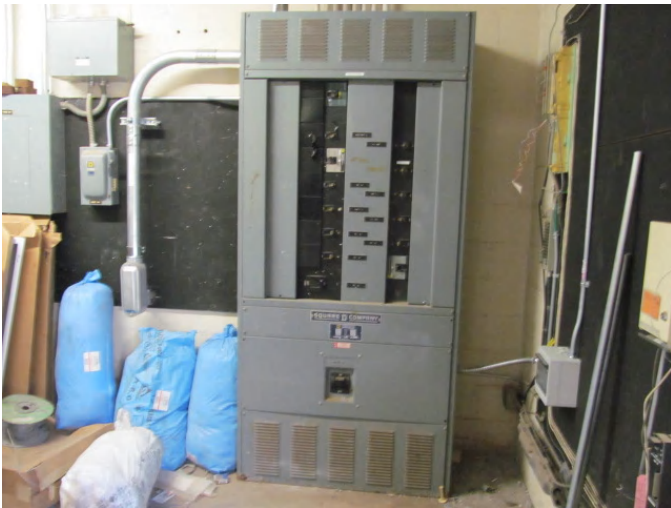
**System: D5010 - Electrical Service/Distribution**

**Location:** Main Switch Room/Throughout Building

**Distress:** Beyond Service Life

**Notes:** The original switchgear and distribution system is beyond its expected service life and should be replaced.

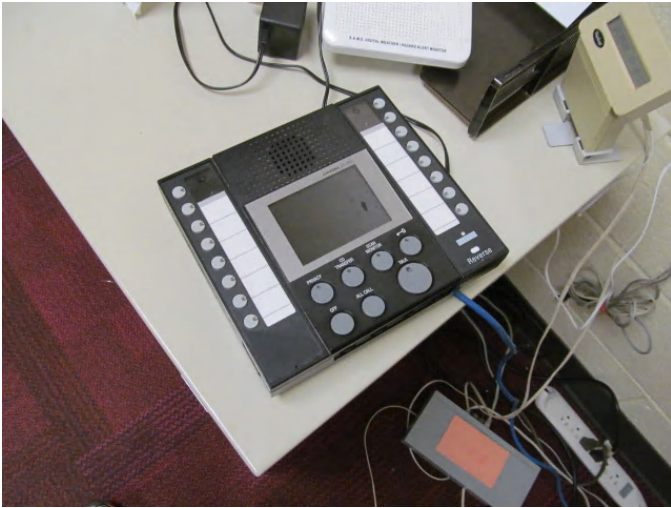
**System: D5030 - Communications and Security - Clock & PA Systems**

**Location:** Throughout Building

**Distress:** Beyond Service Life

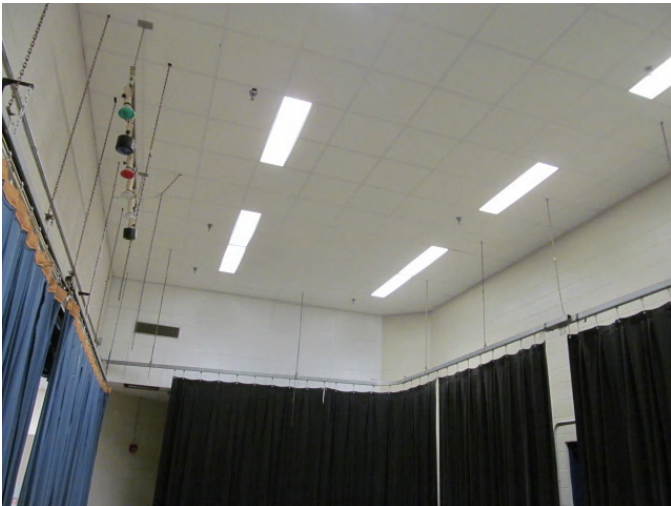
**System: F1020 - Institutional Equipment**

**Location:** Throughout Building

**Distress:** Beyond Service Life

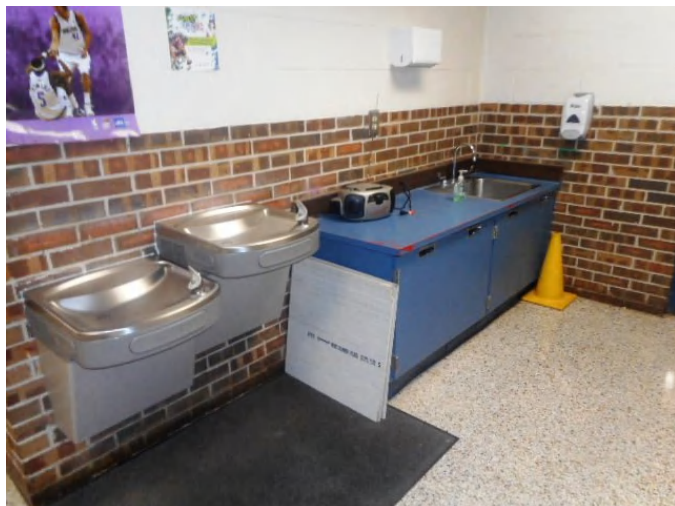
**System: E2010 - Fixed Furnishings**

**Location:** Throughout Building

**Distress:** Beyond Service Life

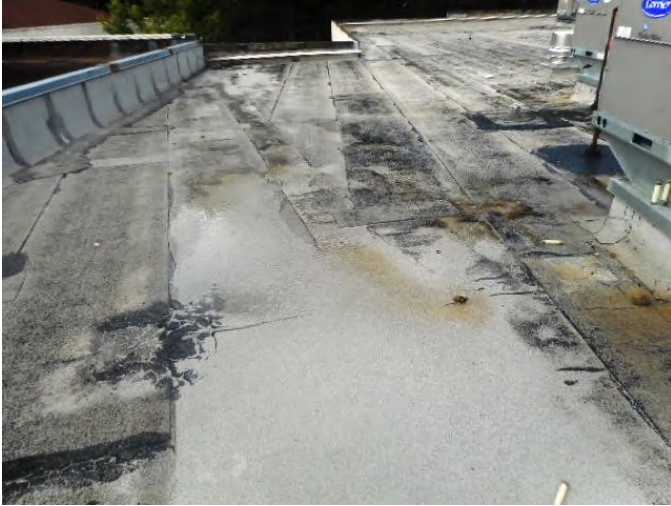
#### **System: B3010 - Roof Coverings - BUR**

**Location:** Roof

**Distress:** Beyond Service Life

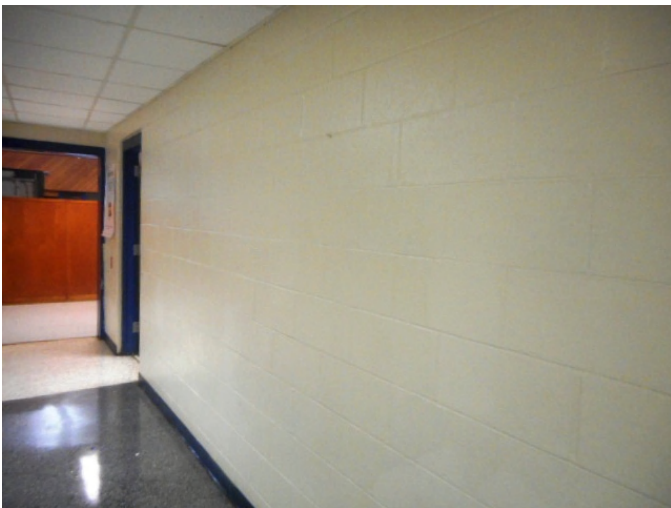
#### **System: C3010 - Wall Finishes - Paint**

**Location:** Throughout Building

**Distress:** Beyond Service Life

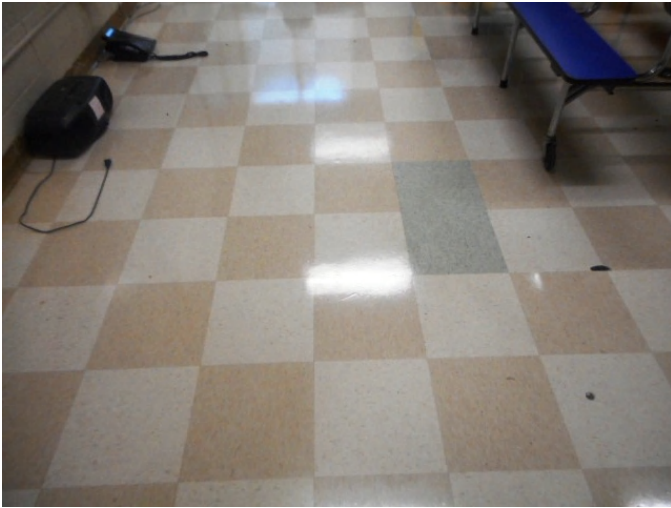
**System: C3020 - Floor Finishes - VCT**

**Location:** Throughout Building

**Distress:** Beyond Service Life

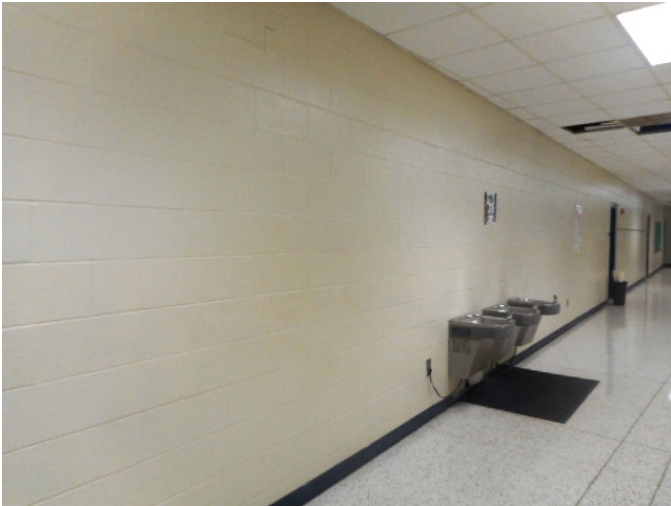
**System: D2010 - Plumbing Fixtures**

**Location:** Hallway

**Distress:** Needs Remediation

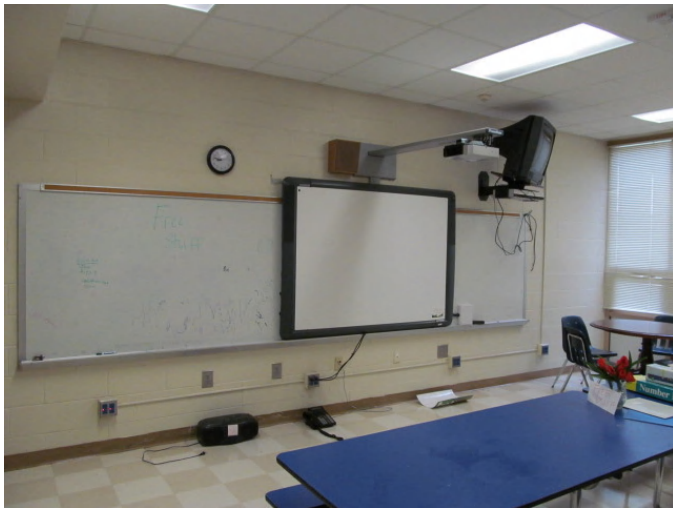
**System: D5030 - Communications and Security - Clock & PA Systems**

**Location:** Throughout Building

**Distress:** Beyond Service Life

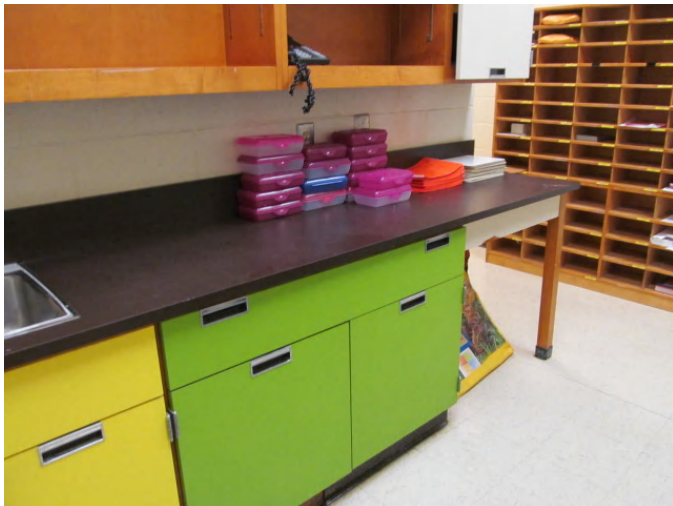
**System: E2010 - Fixed Furnishings**

**Location:** Throughout Building

**Distress:** Beyond Service Life

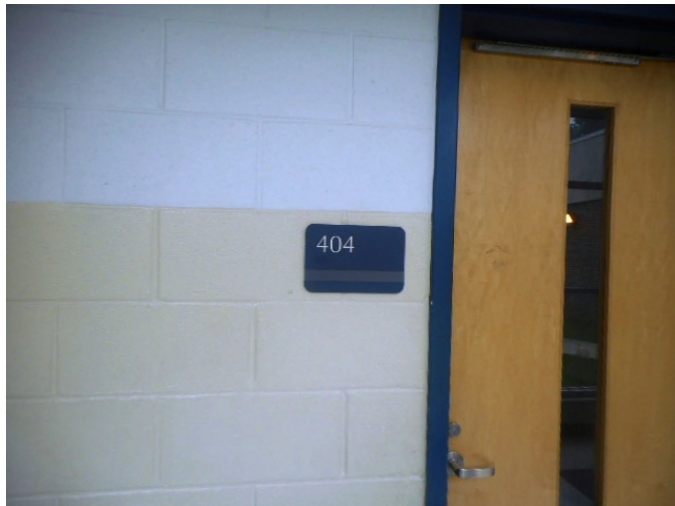
#### **System: C3010 - Wall Finishes - Paint**

**Location:** Throughout Building

**Distress:** Beyond Service Life

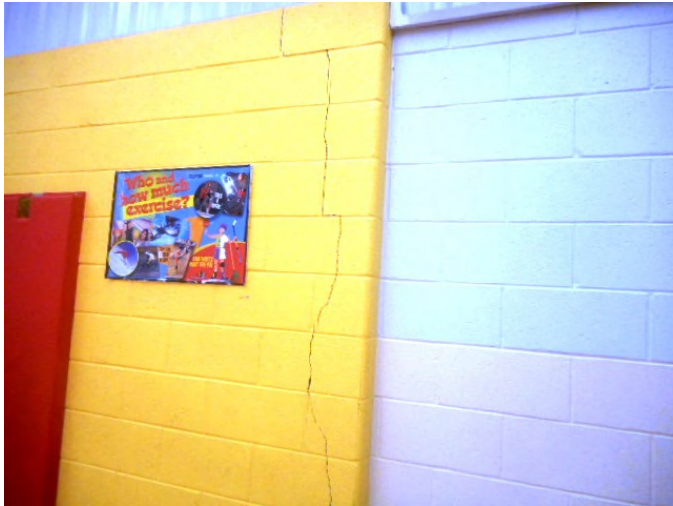
#### **System: B2010 - Exterior Walls**

**Location:** Exterior Wall

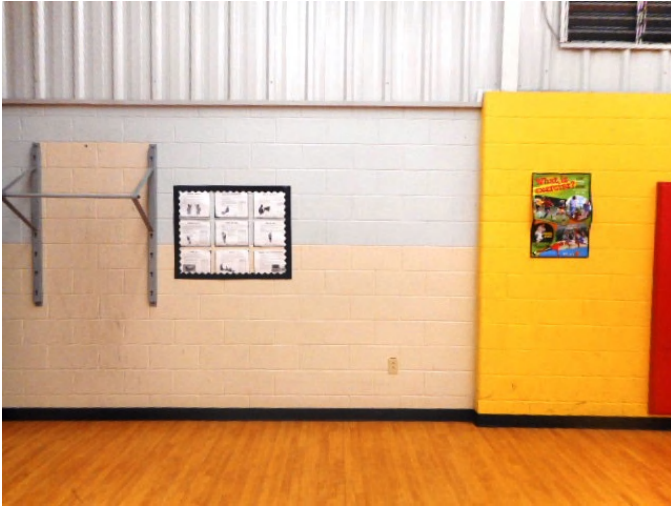
**System: C3010 - Wall Finishes - Paint**

**Location:** Throughout Building

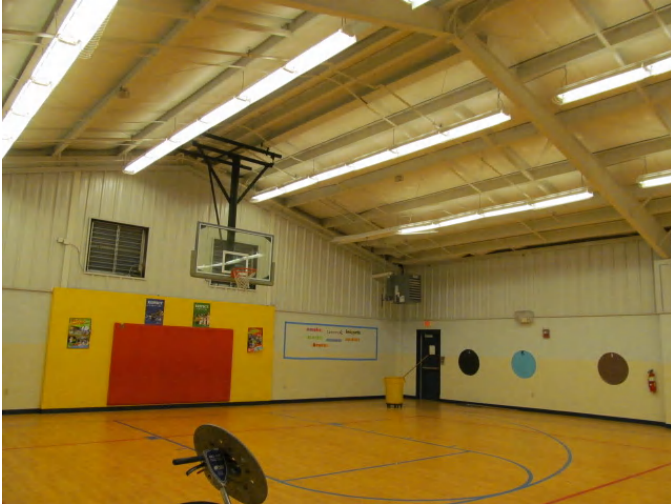
**System: D3050 - Terminal & Package Units**

**Location:** Throughout Building

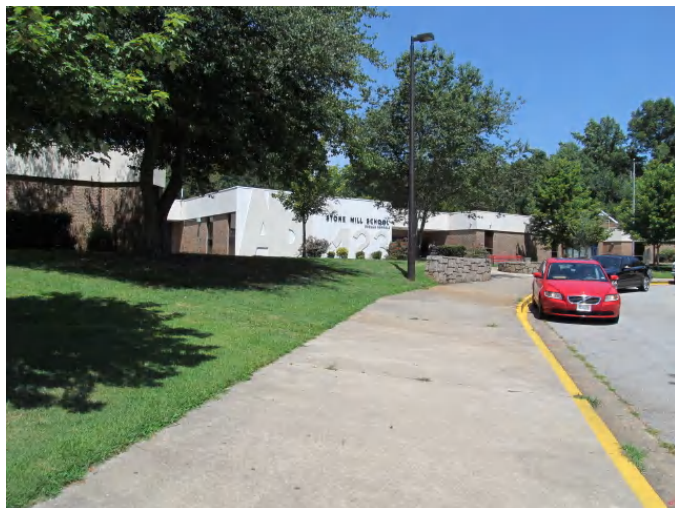
#### **System: G4020 - Site Lighting**

**Location:** Site

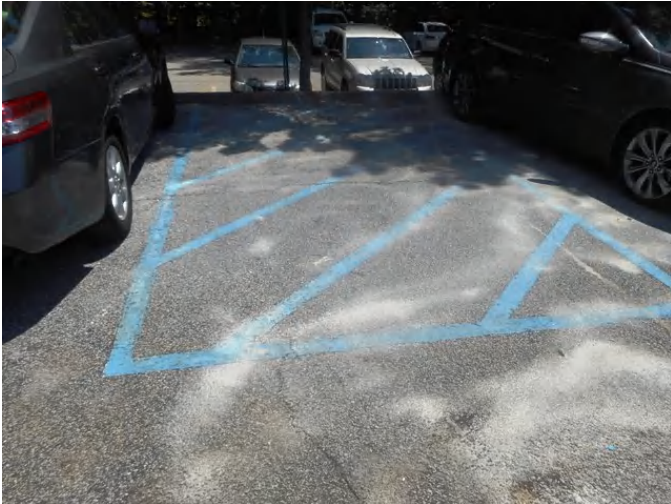
**System: G2010 - Roadways**

**Location:** Parking Lot

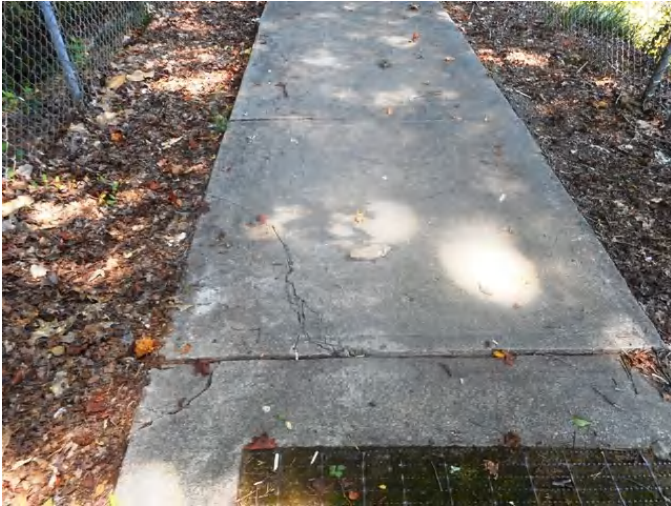
**System: G2030 - Pedestrian Paving**

**Location:** Site

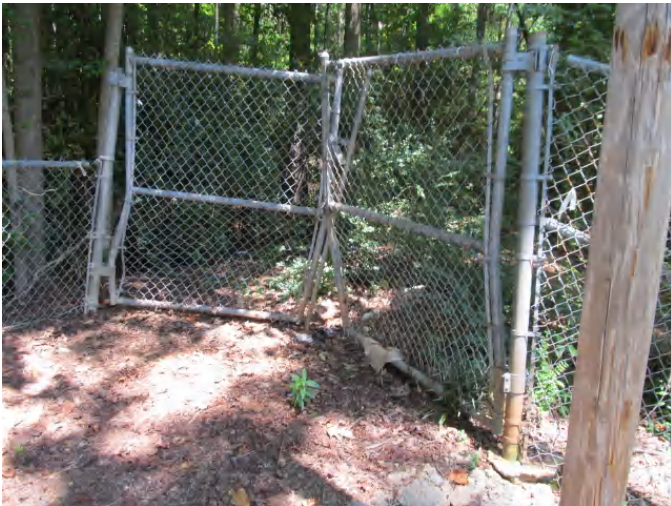
**System: G2040 - Fencing & Guardrails**

**Location:** Site

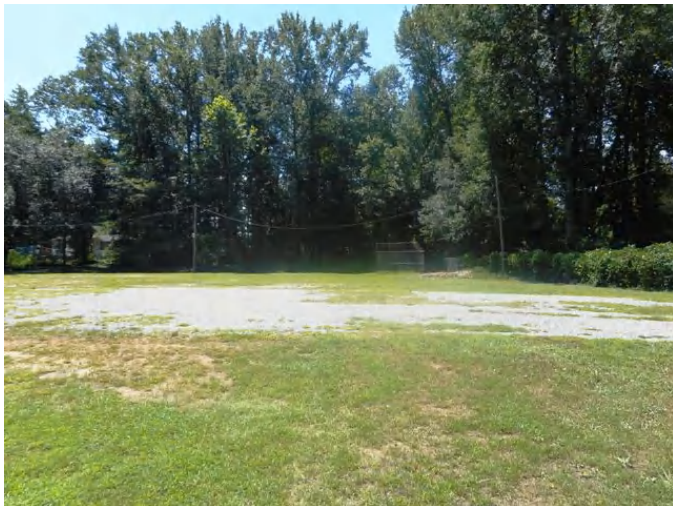
### **System: G2040 - Playing Field**

**Location:** Site

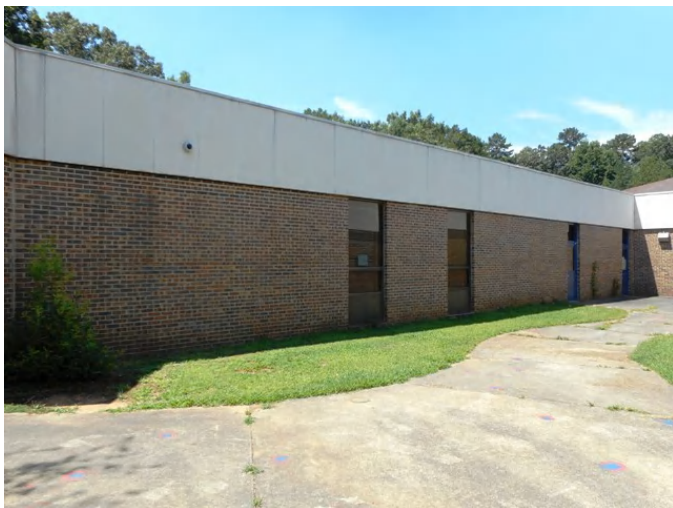
### **System: G4030 - Site Communications & Security**

**Location:** Site

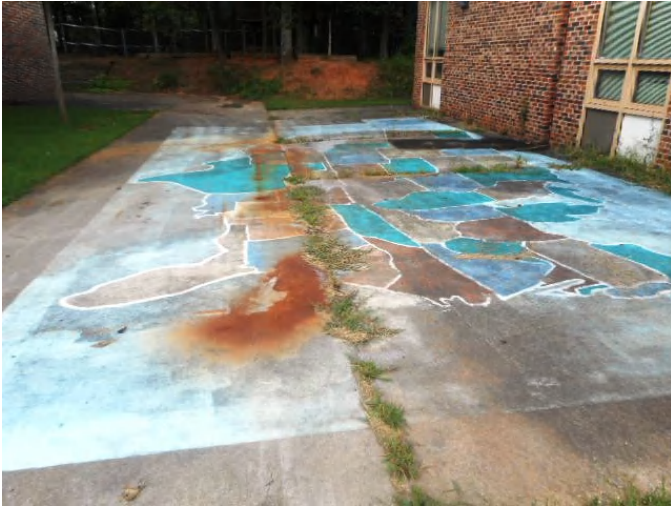
**System: G2040 - Hard Surface Play Area**

**Location:** Site
