**DeKalb County School District/Middle Schools**

# **Stone Mountain Middle**

## **School Assessment Report**

**May 20, 2016**

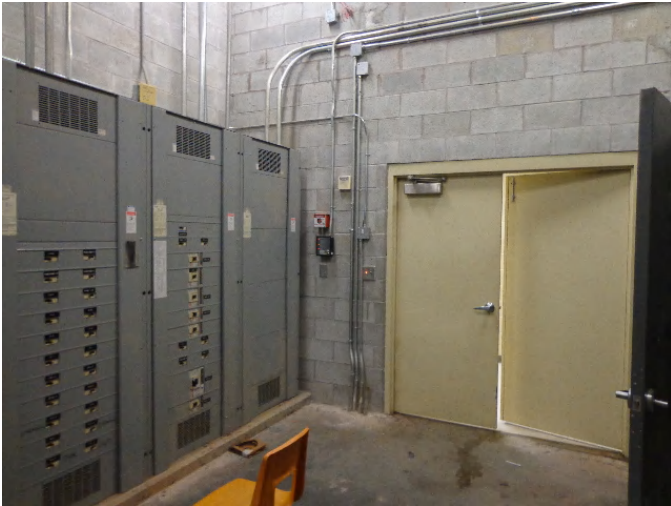
#### System: B2030 - Exterior Doors

**Location:** Stage Exit and Electrical Room

**Distress:** Missing

**Notes:** Emergency exit doors are missing a panic hardware device and should be provided per code.

**Correction:** Replace door panic device

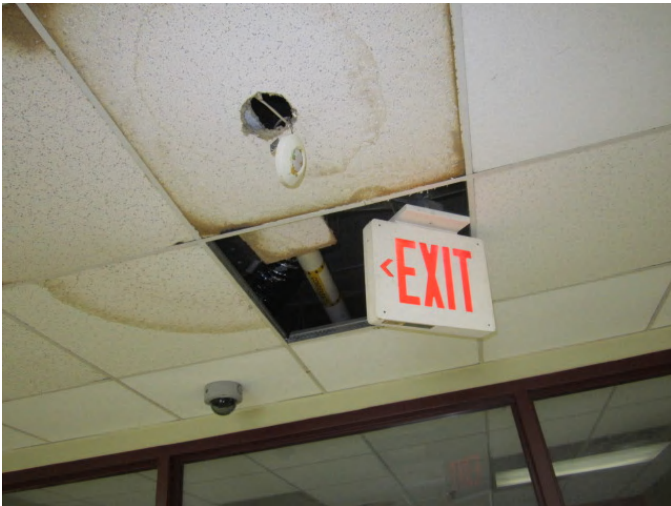
#### System: D3040 - Distribution Systems & Exhaust Systems

**Location:** Throughout Building

**Distress:** Needs Remediation

**Notes:** An engineering study required for multiple locations where there is water (appears condensation) from return air connection side of above ceiling fan coil units in corridors. All locations have water dripping from same location on fan coil unit and have damaged large areas of lay-in ceiling. Fan coils served by chilled water from cooling tower and heating hot water from boiler.

**Correction:** Engineering study for inadequate A/C cooling.

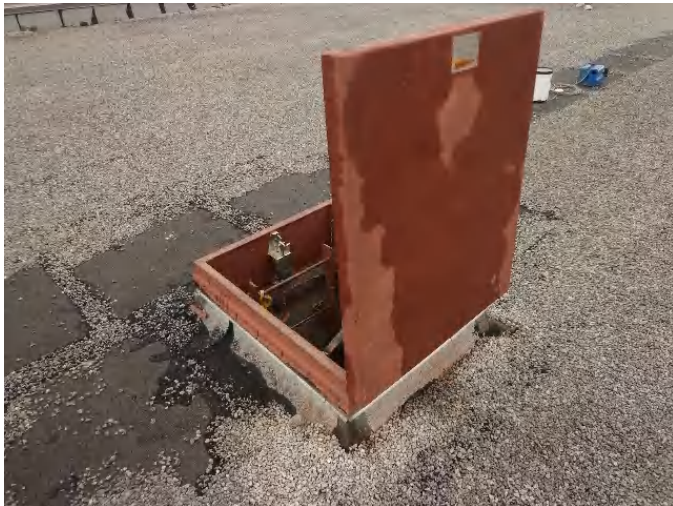
**System: B3020 - Roof Openings**

**Location:** Roof

**Distress:** Inadequate

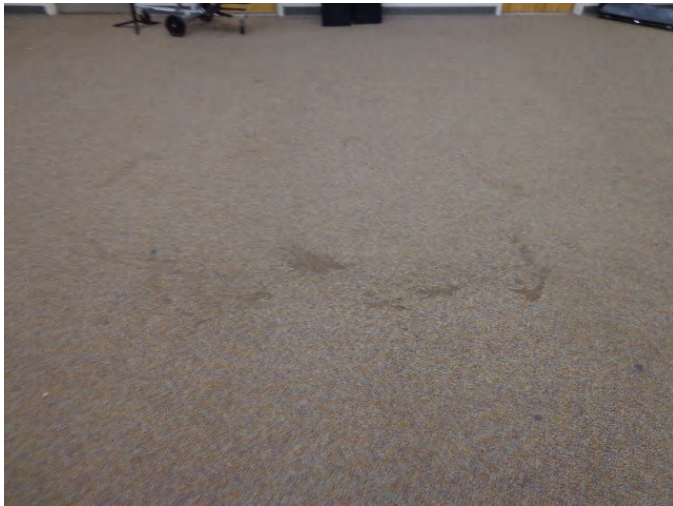
**System: C3020 - Floor Finishes - Carpet**

**Location:** Offices, Media Center, and Music/Band Room

**Distress:** Beyond Service Life

**Notes:** The carpet is stained in different locations, showing signs of early failure, and should be replaced.

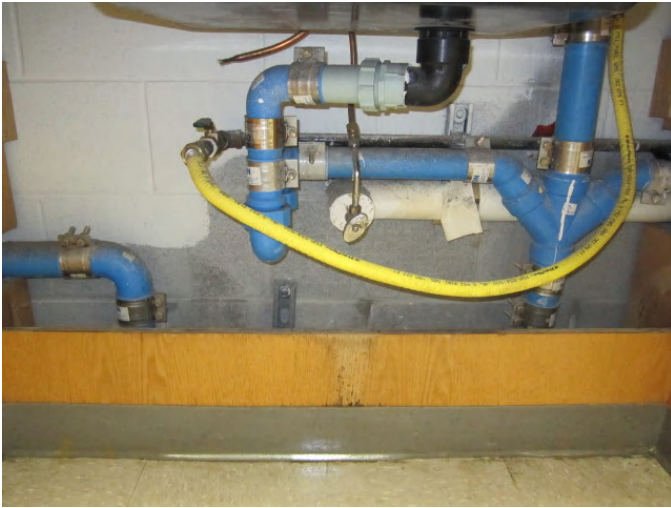
**System: D2090 - Other Plumbing Systems - Natural Gas**

**Location:** Science Classrooms

**Distress:** Inadequate

**Notes:** Lab emergency shutoffs for natural gas are inaccessible or inadequate (locked or in another room) and should be moved to the hallway exit in each room. SPLOST IV project 332-422 is scheduled to provide this work, along with related ADA and fire life safety upgrades.

**Correction:** Replace pipe and fittings, industrial gas

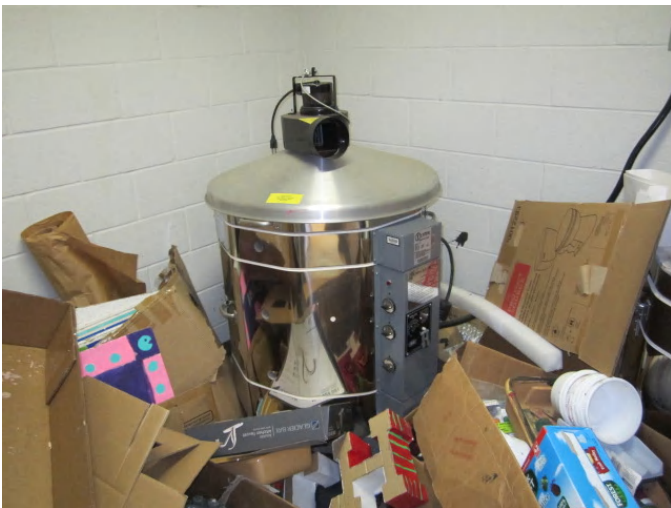
**System: D3040 - Distribution Systems & Exhaust Systems**

**Location:** 604A Art Lab

**Distress:** Inadequate

**Notes:** Kiln exhaust system is inadequate and has insufficient outside air available. Replace with code compliant system with run time delay.

**Correction:** Replace unit ventilator, 2000 CFM, heat/cool coils

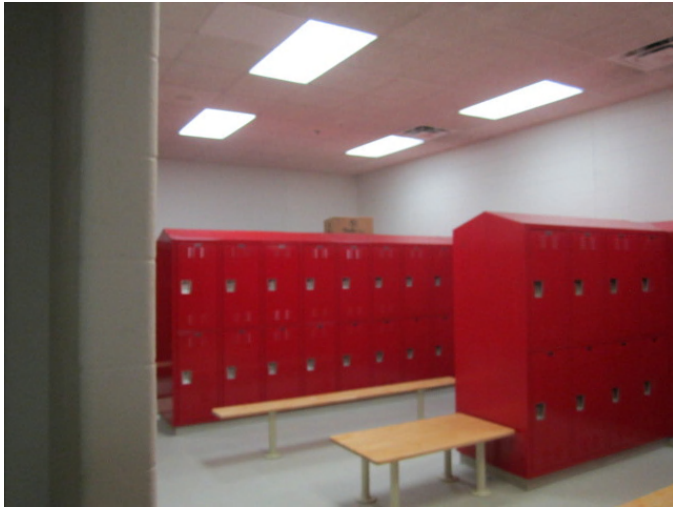
**System: D3040 - Distribution Systems & Exhaust Systems**

**Location:** Boys and Girls Locker Rooms

**Distress:** Inadequate

**Notes:** Ventilation and exhaust is inadequate in boys and girls locker rooms and should be replaced.

**Correction:** Replace roof mounted exhaust fan, 8500 CFM exhaust fan

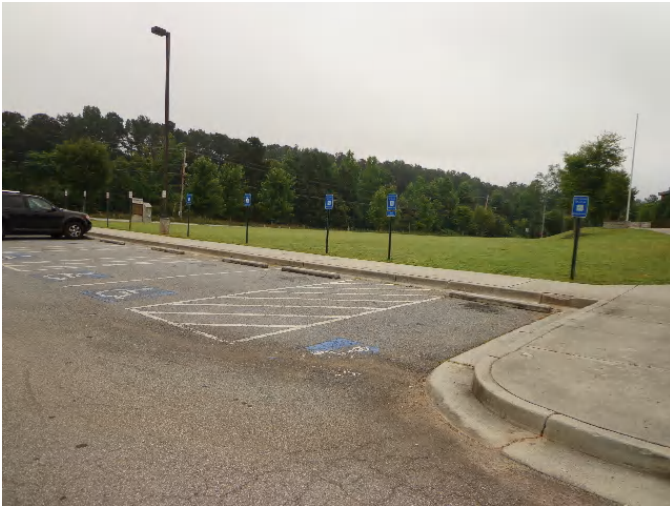
#### System: G2010 - Roadways

**Location:** Front ADA Parking

**Distress:** Inadequate

**Notes:** The accessible route from the front ADA parking spaces to the sidewalk passes behind parked vehicles, on the roadway, and it is preferable that the accessible route does not pass behind parked vehicles. Provide a curb ramp per ADA standards for each access aisle serving the ADA parking spaces.

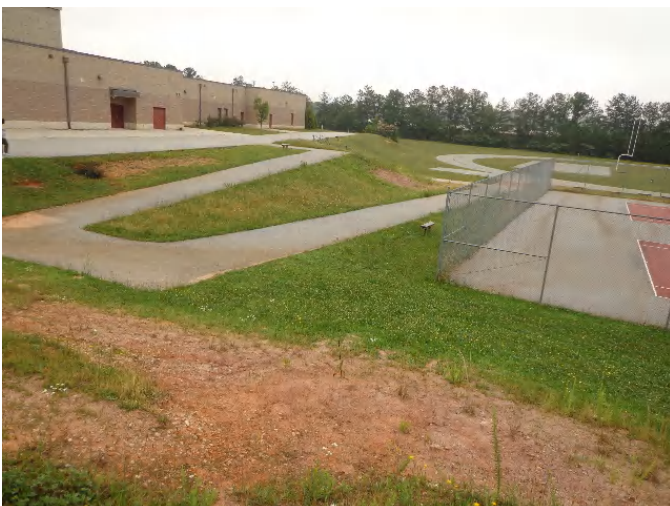
#### System: G2030 - Pedestrian Paving

**Location:** Playing Field

**Distress:** Inadequate

**Correction:** Remove/replace ramp w/ADA compliant ramp w/railing
