A G E N D A
Riverside Unified School District
Operations Division

Operations/Board Subcommittee Meeting
Conference Room 3 A/B
3380 14th Street, Riverside, California
August 6, 2013 – 1:00 p.m. to 4:30 p.m.

**Security Audit of Facilities
Operations Division
Arlington High School
May 2, 2013**

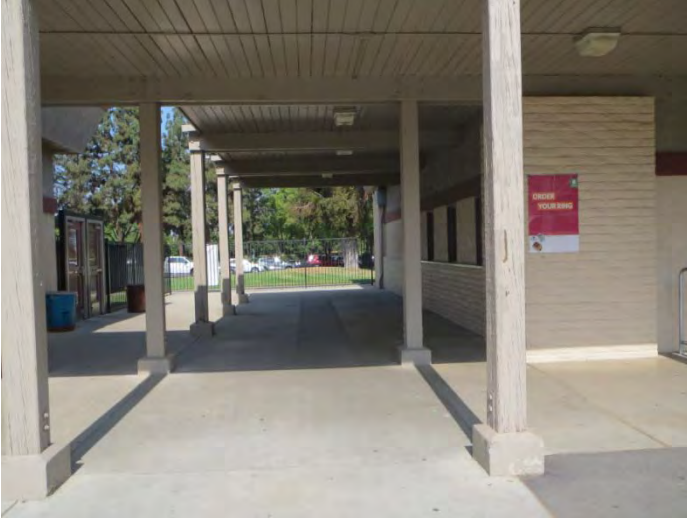
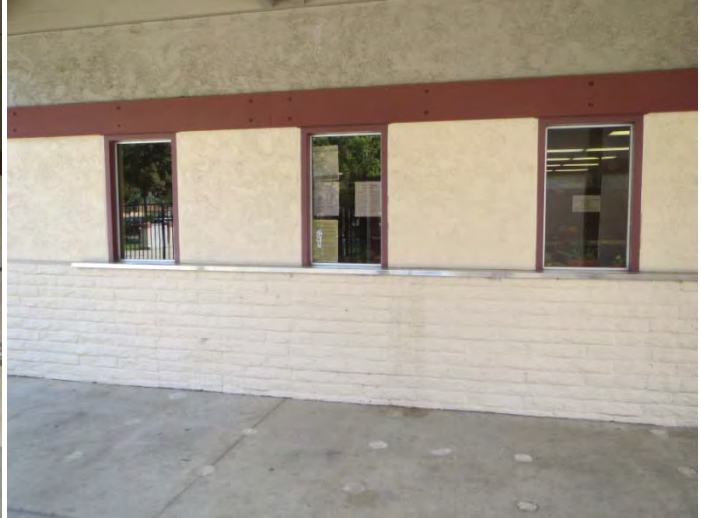
Photos 1 and 2: Exterior of Attendance Office

The office is accessible from the parking lot. There is a campus supervisor stationed at the office to check visitors in and direct them to their destination. Currently everyone is routed through the office, with many of them needing to go to the attendance office. Many visitors bypass the attendance office however. Ideally, visitors could enter either the attendance office or the main administration office, but could not proceed into the rest of the campus without checking into either.

A door would need to be added to the attendance office, and the exterior fencing modified to make this occur. Due to the block construction of the attendance office building, this is going to be more complicated than some modifications at other sites.

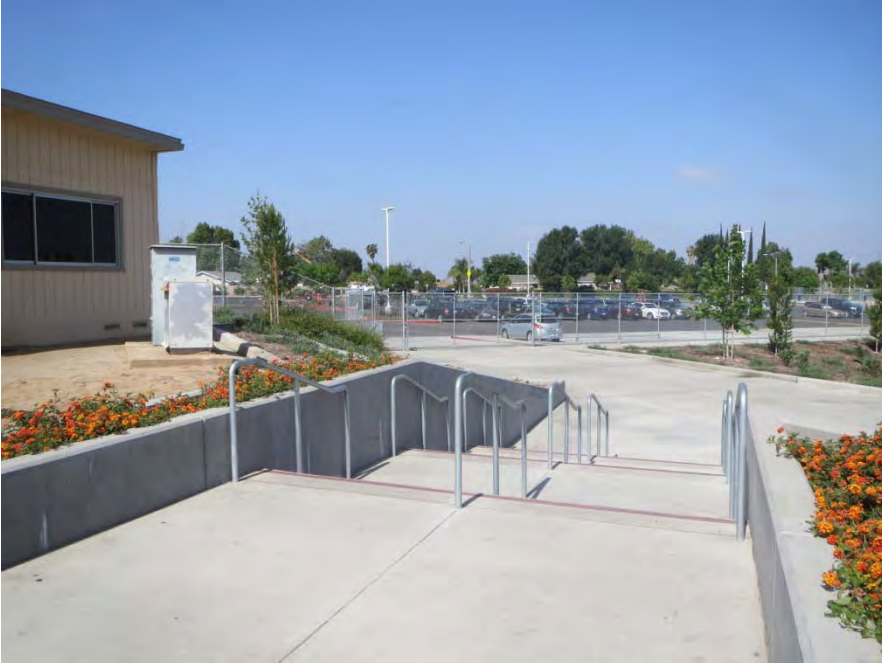
Photo 4: Access from fields

At the athletic fields, the site is secure during the day, but fencing will need to be added to keep the remainder of the campus secure during off hours from people using the athletic facilities.

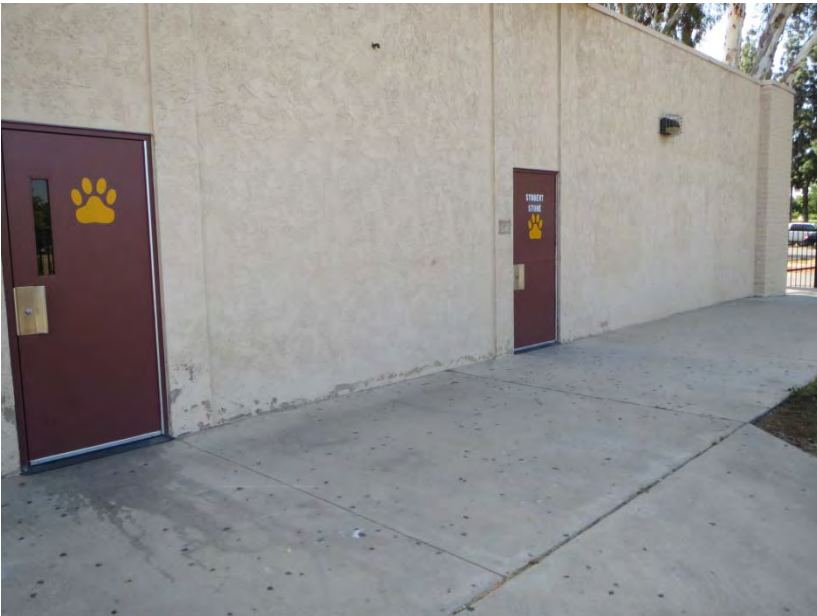
Photo 5: Exterior of Student Store

The student store is located out of view from the rest of the campus. Though the area is fenced, due to the isolated area, it would benefit from a surveillance camera.

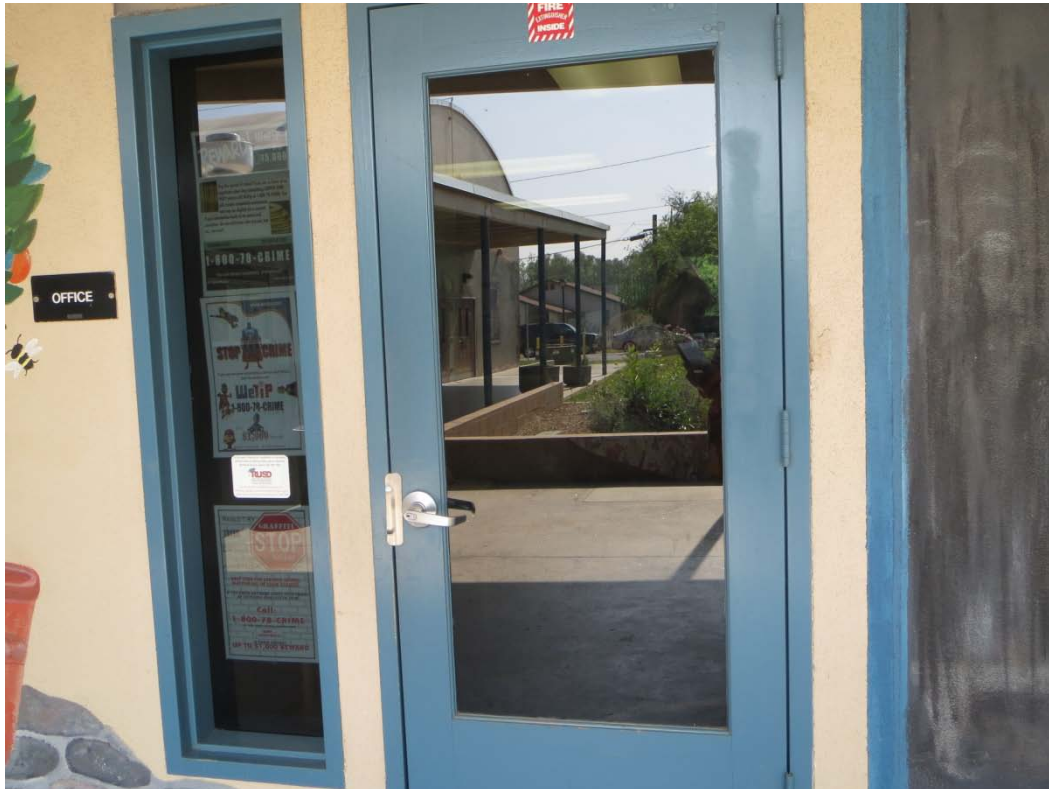
Photo 1:
Entrance to Main
Office from
Outside

The office at Bryant is highly visible, however the main gate into the campus remains unsecured, and students have to exit the main gate in order to access the office. The door is all glass. The office door can only be locked from the outside, and can be broken into by breaking the glass and opening the door handle from the inside.

There are two doors into the office, and the office in the workroom could be fenced in and a dedicated access created into the campus. A second entrance in the front fence will need to be created so that there can be a free flow of students at the start of school and dismissal, and during public events.

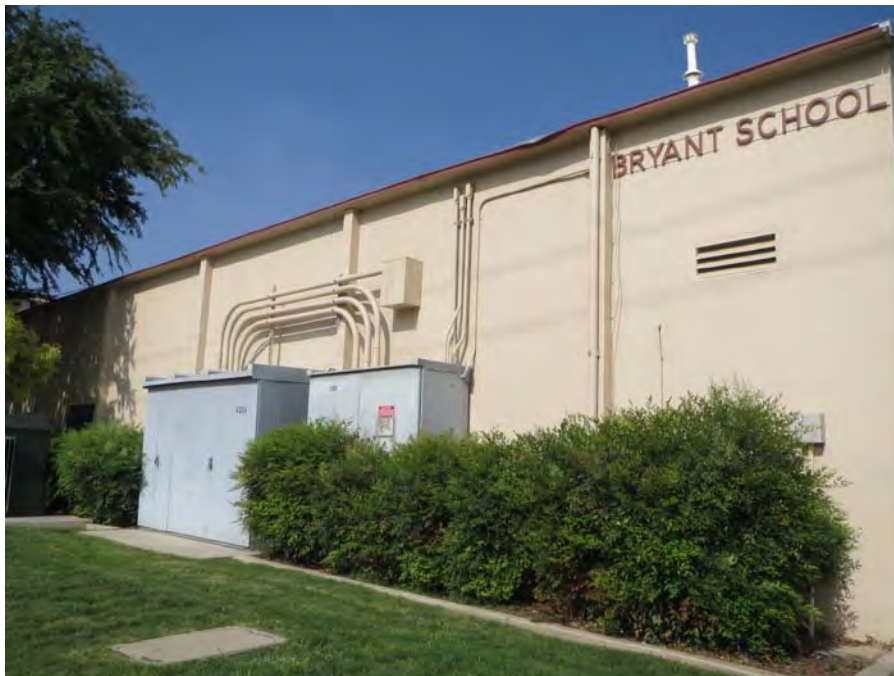
Photo 5: Possible Roof entry
from MPR on Cedar Street

There are locations where roofs can be accessed, however it has not been an issue to date.

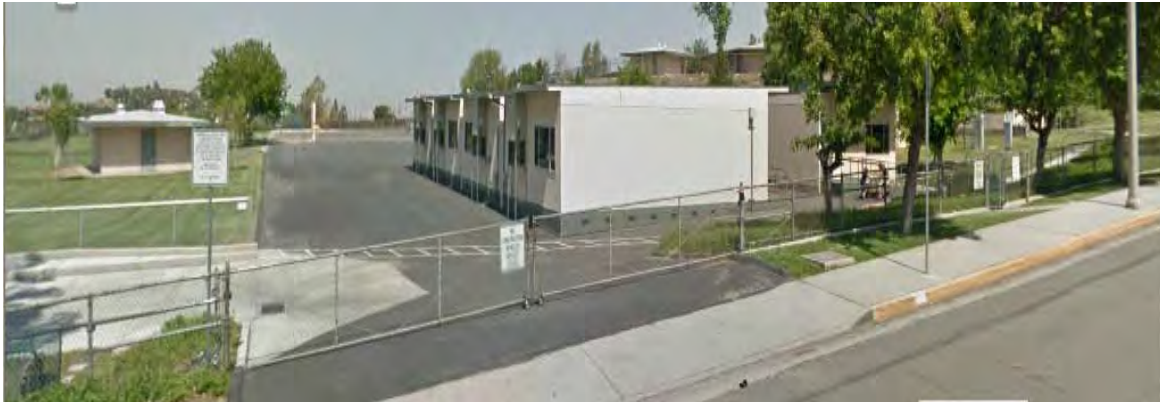
Photo 2: Lower campus from Shaker Drive

The front of the site has a short fence which does not adequately secure the site. The fence height needs to be increased to the standard 6 feet from the access ramp to the lower parking lot, and then between the lower parking lot and the play field. The gate to the fire lane can be moved back to the inside edge of the lower parking lot. Since the route from the lower parking lot to the ramp is an accessible path of travel, a gate with an means of access for those with mobility issues will be necessary. When the short fence is replaced, the trees overhanging the fence will need to have any close branches trimmed to discourage people from using the trees to climb the fence.

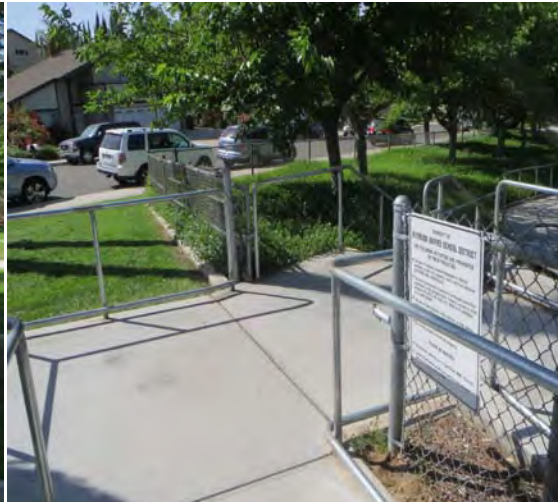
Photo 5: Location of proposed gate with accessible lock.

Picnic tables in the lunch area should be secured to deter moving the tables to climb on the roof. This can be done by the M&O department.

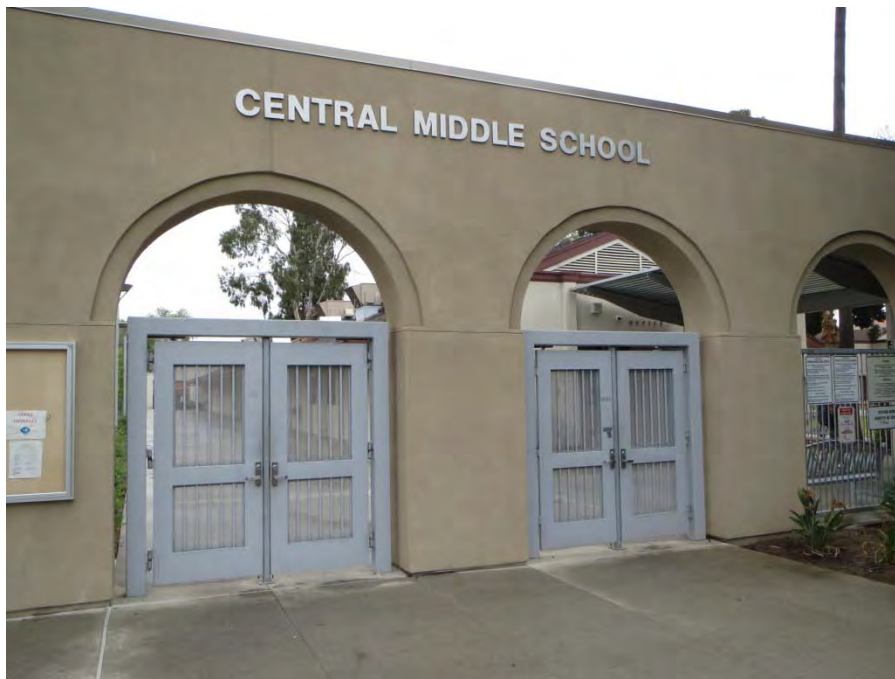
Photo 1: Existing entry gates

The office at Central Middle School is somewhat difficult to locate and is easily bypassed by visitors on campus. A six foot gate is needed to close off the hallway to the 100 wing. A 30' ornamental iron fence with two gates is needed between the administration building and the fence by the MPR to close the walkway down to the 400 wing. Because the path of travel is effected, the project will need to go through DSA for approval.

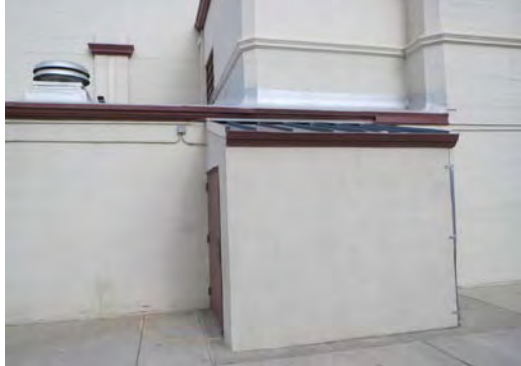
Photo 4: Elevator equipment room

The equipment room for the elevator adjacent to the gym has a very low roof, and can be accessed fairly easily.

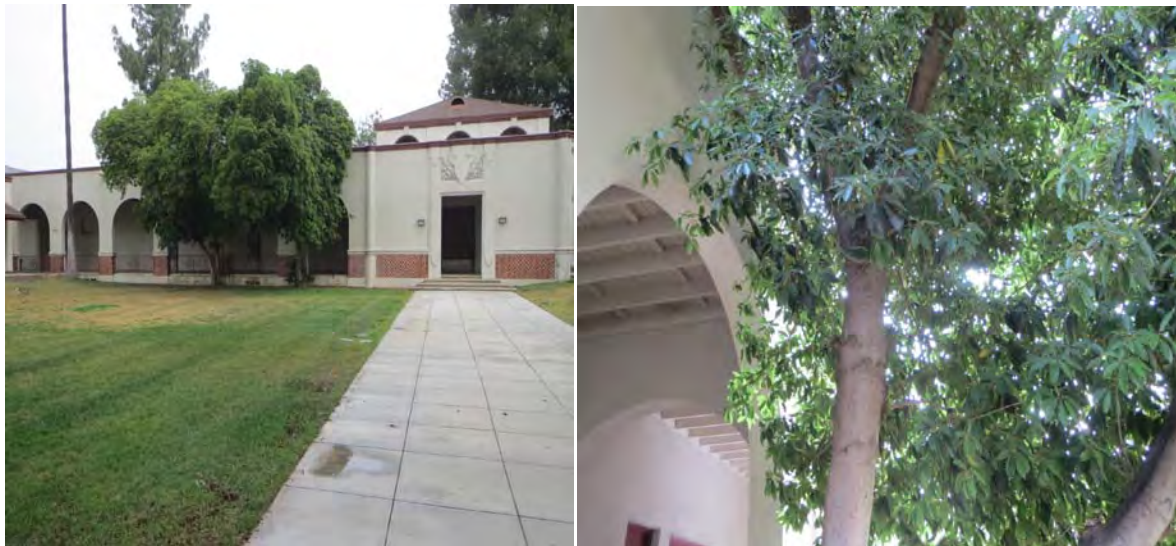
Photos 5 and 6: Tree outside courtyard side of 300 wing

There is a large tree in the courtyard that people climb to access the roof. Due to the size of the tree and the limbs that would need to be trimmed, an arborist will most likely be needed.

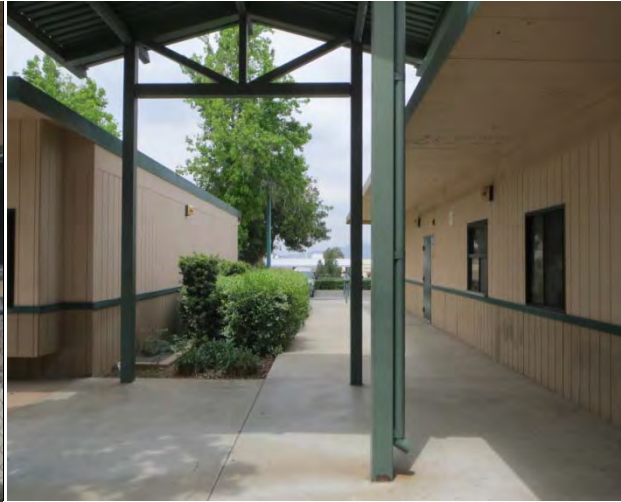
Photo 5

Due to the topography of the site, path of travel issues will need to be addressed. There are access upgrades required elsewhere on campus, particularly in the restrooms. These requirements will likely be triggered by the extent of the other upgrades. Parking lots are out of compliance with current code as well and will need to be modified.

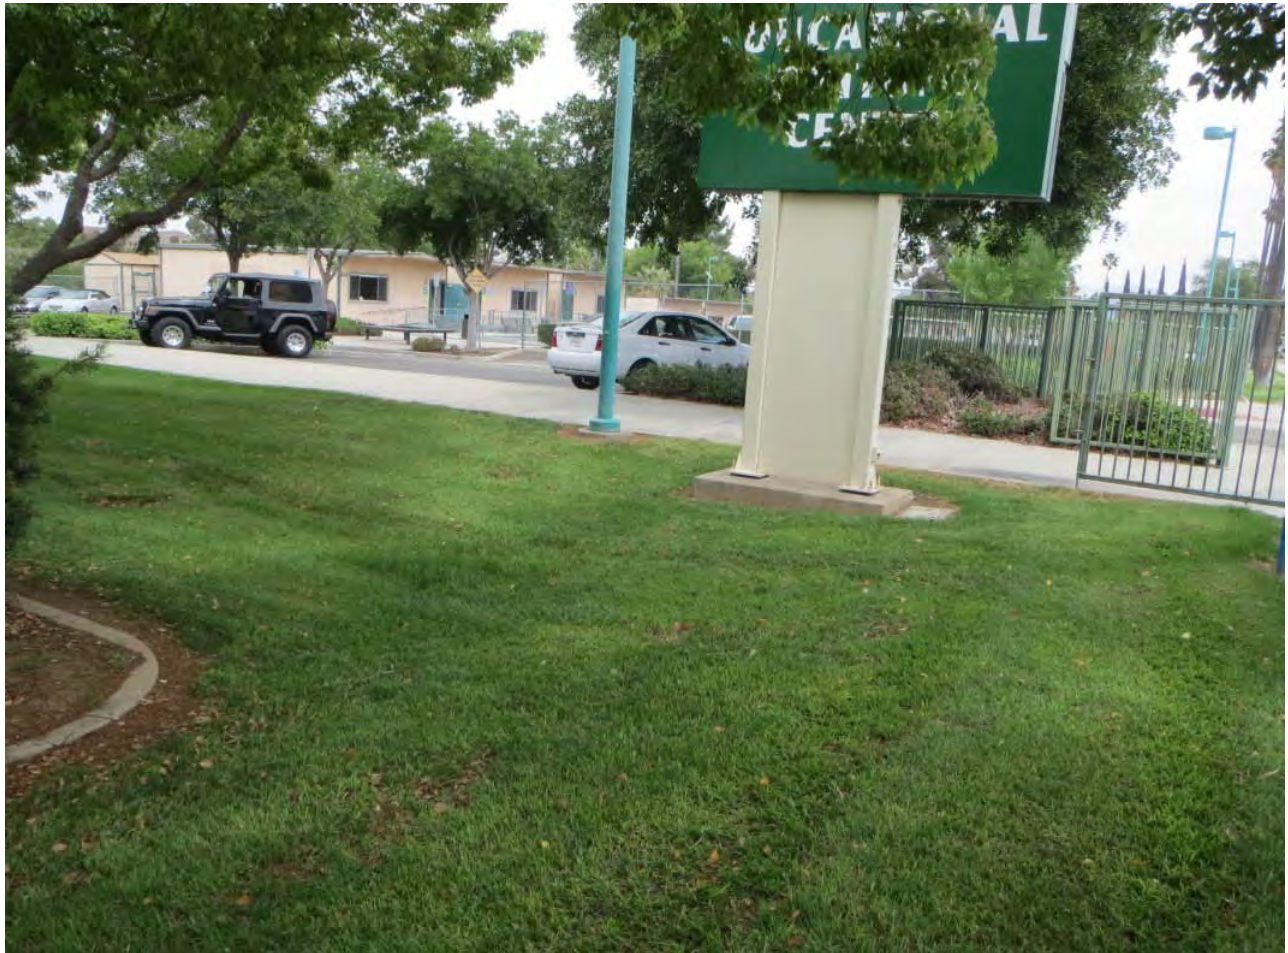
Photo 8

To monitor the access of the campus by motor vehicles during school hours, the administration requests parking lot changes to link both parking lots to a single access point that could then be monitored by a campus supervisor.

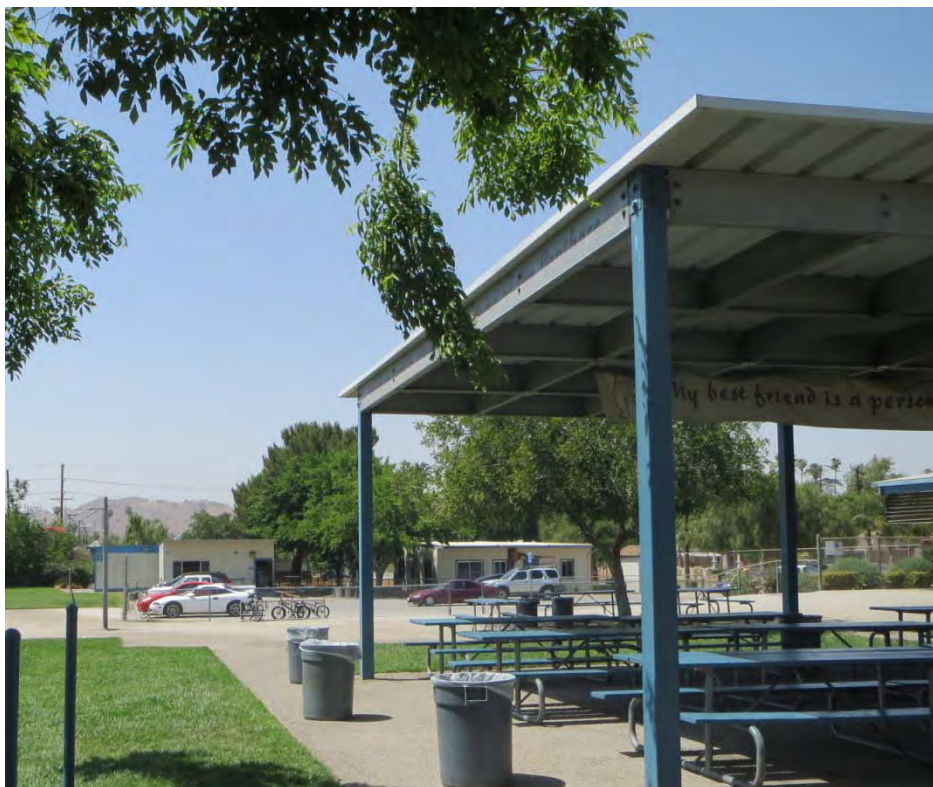
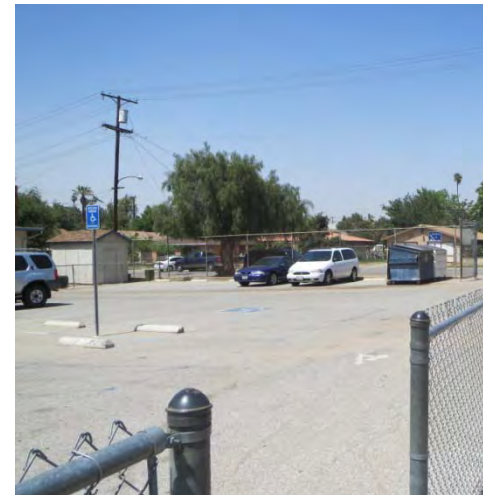
Photos 1 and 2: Student lot separated from campus by 3' chain link fence

The student parking lot off of 13th street is surrounded primarily by a 3 foot fence. The location where a gate should be is open with no gate. There is a portable classroom used by the COPE program on the opposite side of the parking lot from the Lincoln school. These recommendations assume that the COPE portable can remain unfenced and separate from the rest of the site since it is a self contained program.

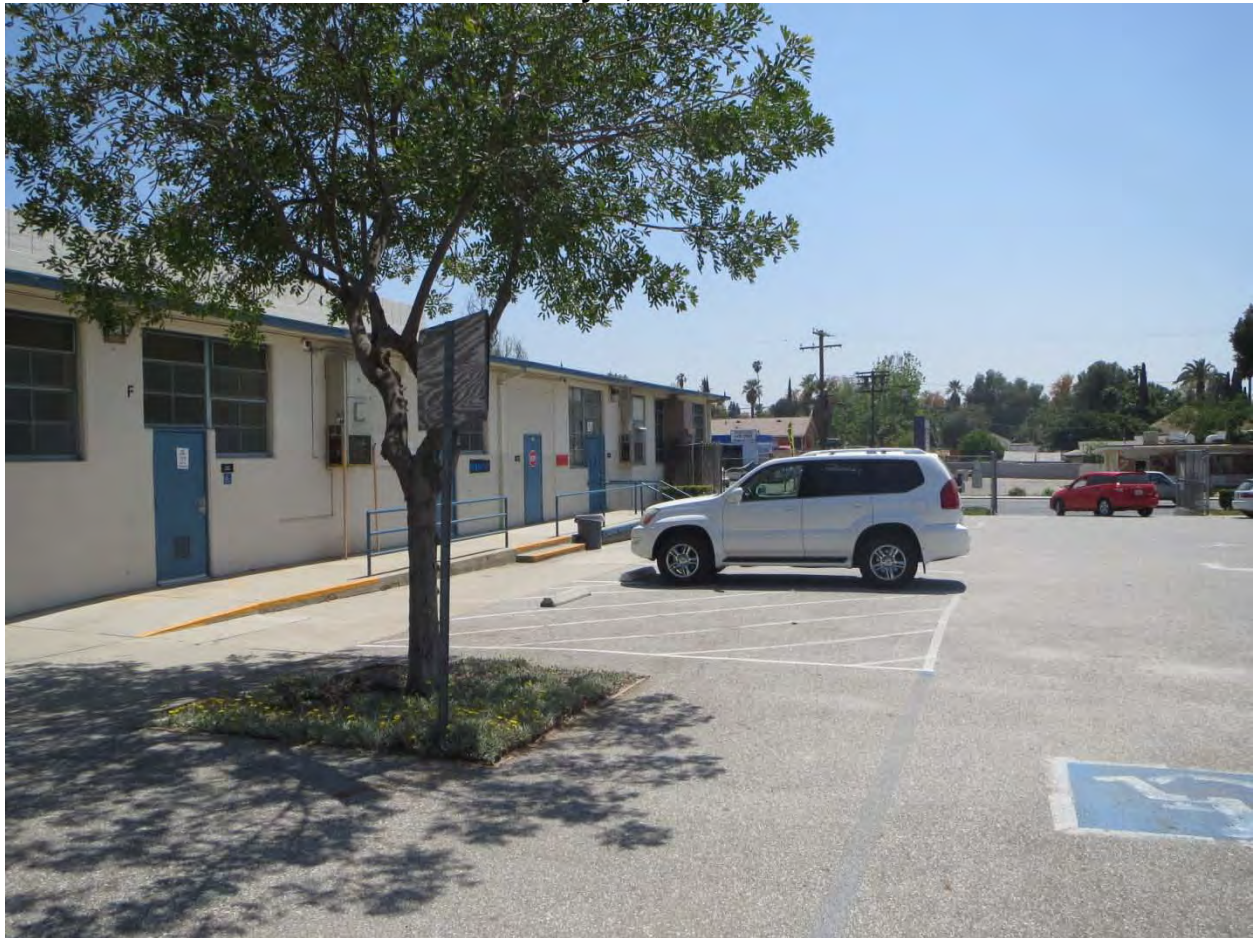
Photo 3: Staff parking lot open to 14th Street and directly accessible to classrooms

The staff and visitor parking is accessed from 14th Street. The parking lot is not separated from the classrooms or the athletic fields. The parking lot should be fenced from the rest of the campus. Staff could access the campus via gates that would be closed at the start of school.

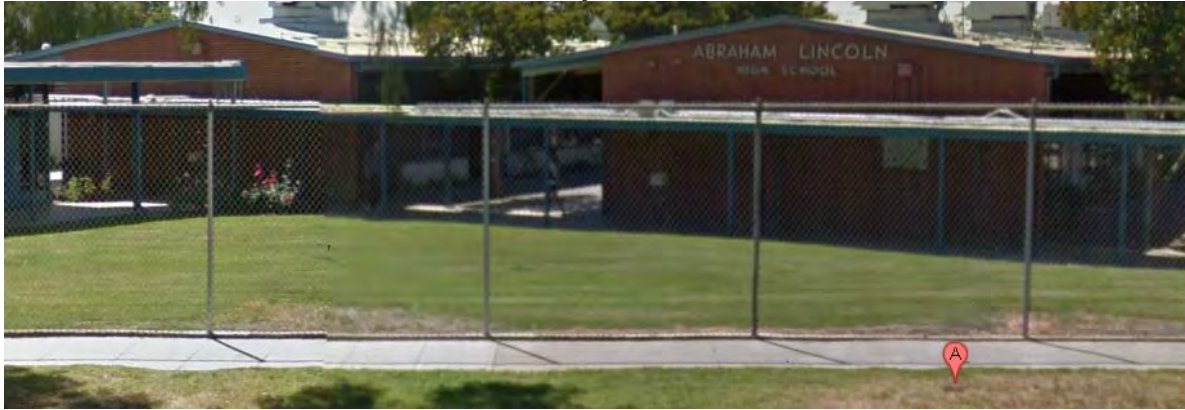
Photo 4: Potential visitor parking lot

The administration office is remote from either of the existing parking lots, and it would not be possible to create a fencing option that would direct visitors directly to the office without them accessing the rest of campus.. There is a large grass area directly in front of the administration office. A portion of the grass area could be converted to a visitor parking lot. The site reports they receive 5-10 visitors a day. A small parking lot with 10 spaces should be more than sufficient to accommodate an average of the daily visitors, most of whom stay only a short time on campus. There is a rear entrance to the administration building where visitors could be directed after checking in, and could also serve as a student entrance.

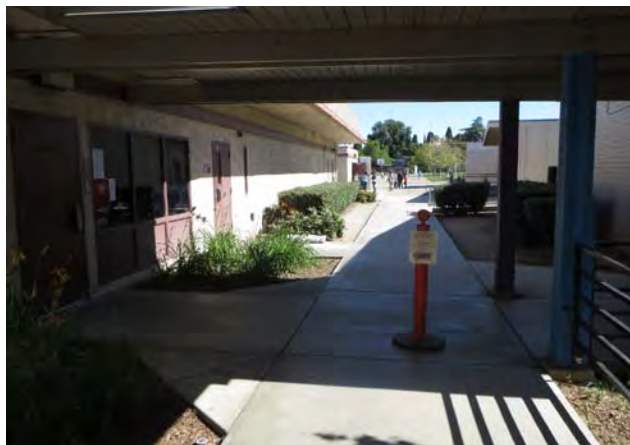
Photo 1

Although visitor's are encouraged to check into the office via signage, there is no fencing compelling them to do so, and the office is easily bypassed and free entry given to the rest of the site.

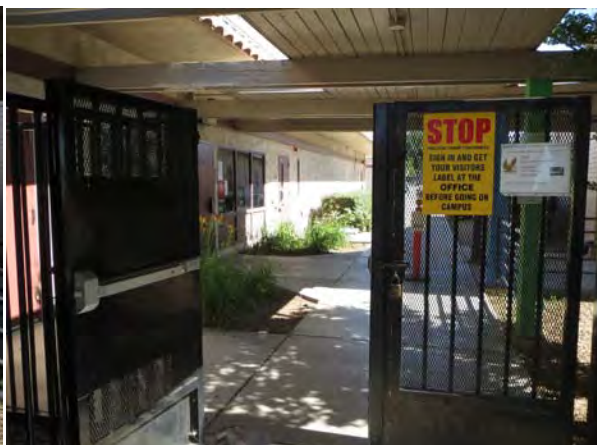
Photo 2

There has been a fence installed along the front of the campus to separate the classrooms in the front from entry from the street, however the gates are left unlocked to provide access from the parking lot since this is the only accessible entry from the lot. Leaving the gate unlocked defeats the purpose of the gate in the first place.

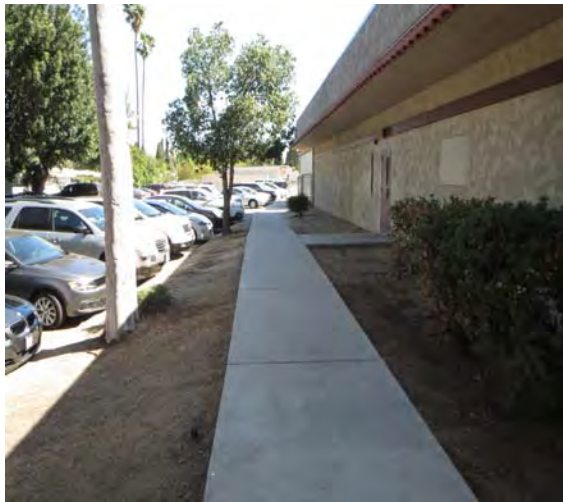
Photo 5

Classroom No. 22's only outside access is directly into the parking lot. The only other door is an interior door that leads into another classroom. Fencing needs to be added to separate the classroom from the parking lot and allow students access to the campus without traveling outside the fence lines.

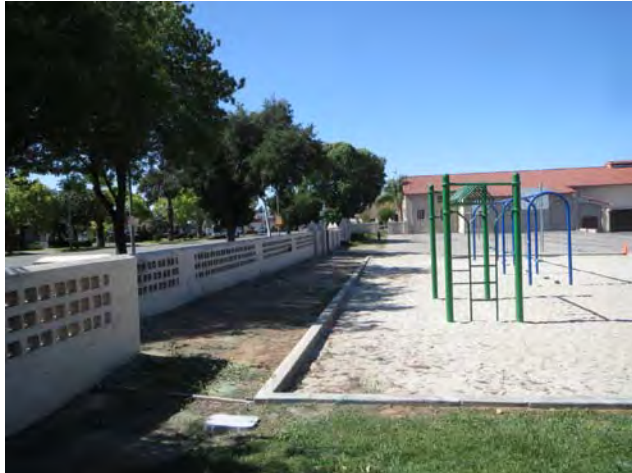
Photo 7

Magnolia has a historical fence separating the playground from Magnolia Avenue. Unfortunately, the fence is only 3-4 feet tall, and also has footholds that would make even that low fence even easier to climb. Students aren't allowed to use much of the playfield area due to its proximity to Magnolia Avenue. A standard 6' fence should be installed on the interior of the historic fence to secure the playground area from unauthorized access. The fence would need to be 450' in length with gates that mirror the gate locations of the historic wall.

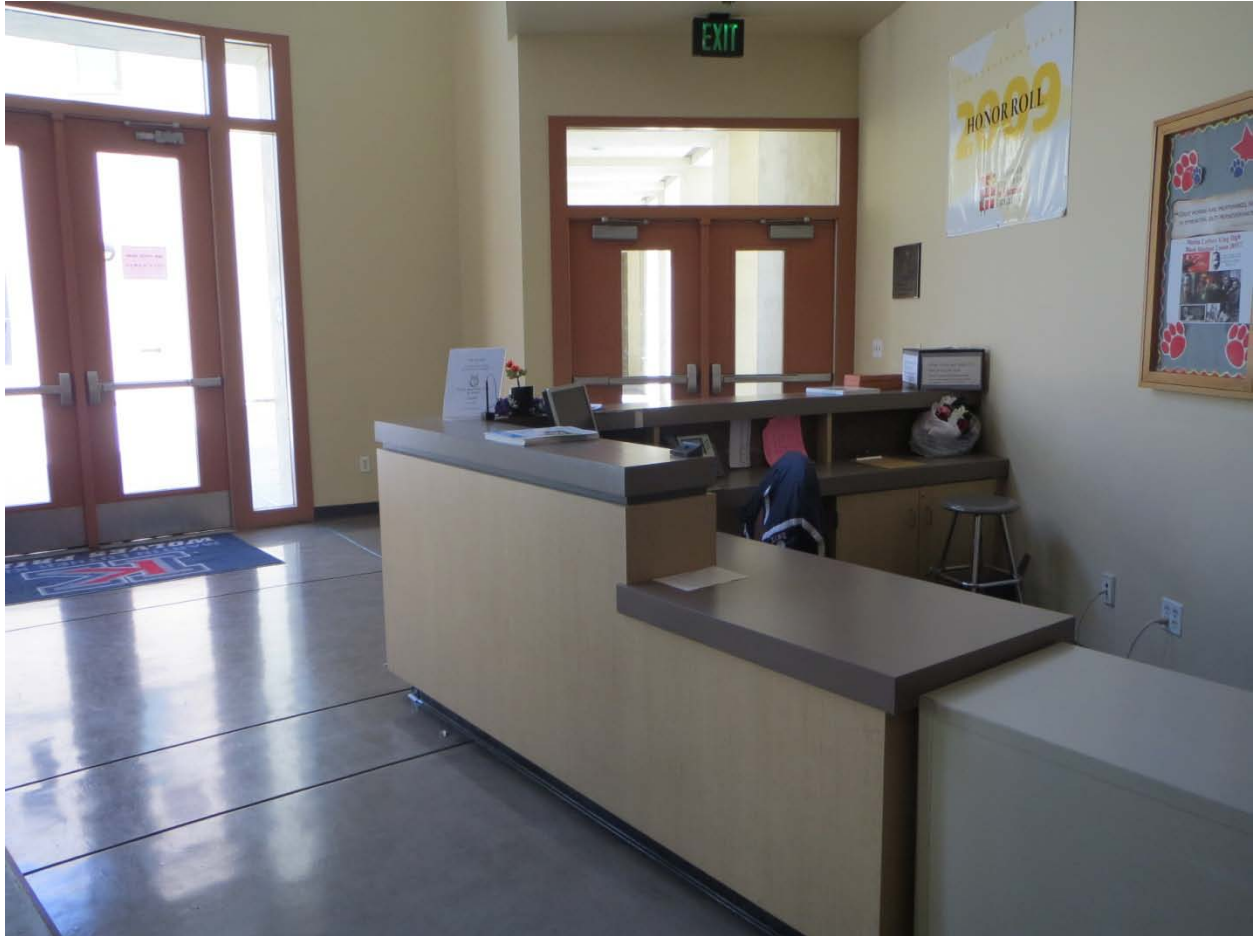
Photo 1

The administration entry needs to be manned at all times by a campus supervisor to ensure that visitors sign in to the campus. Since the administration offices are on the second floor, this has to be a separate duty. If the campus supervisor was located outside the main building, although in the weather, they would be able to make additional observations of the parking lot and gates leading into the sites.

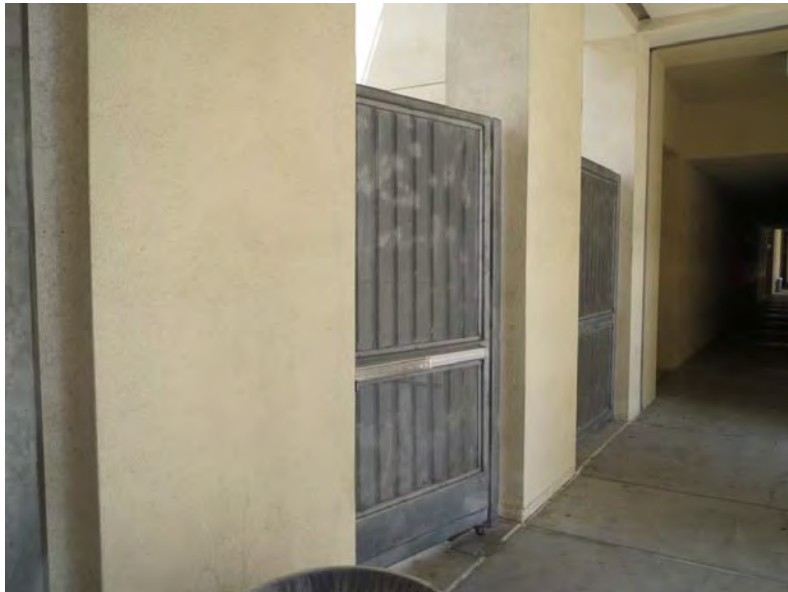
Photo 2

The large gates located primarily in the front of the school, but also elsewhere on the campus have automatic closers that do not function properly. Although they have been adjusted, the closers no longer maintain the adjustment need to be replaced. Since all of the gates are not needed for emergency egress, gates can be locked during the day to prevent added wear, and to ensure that gates are not left open. Students can be more readily monitored through the unlocked gates.

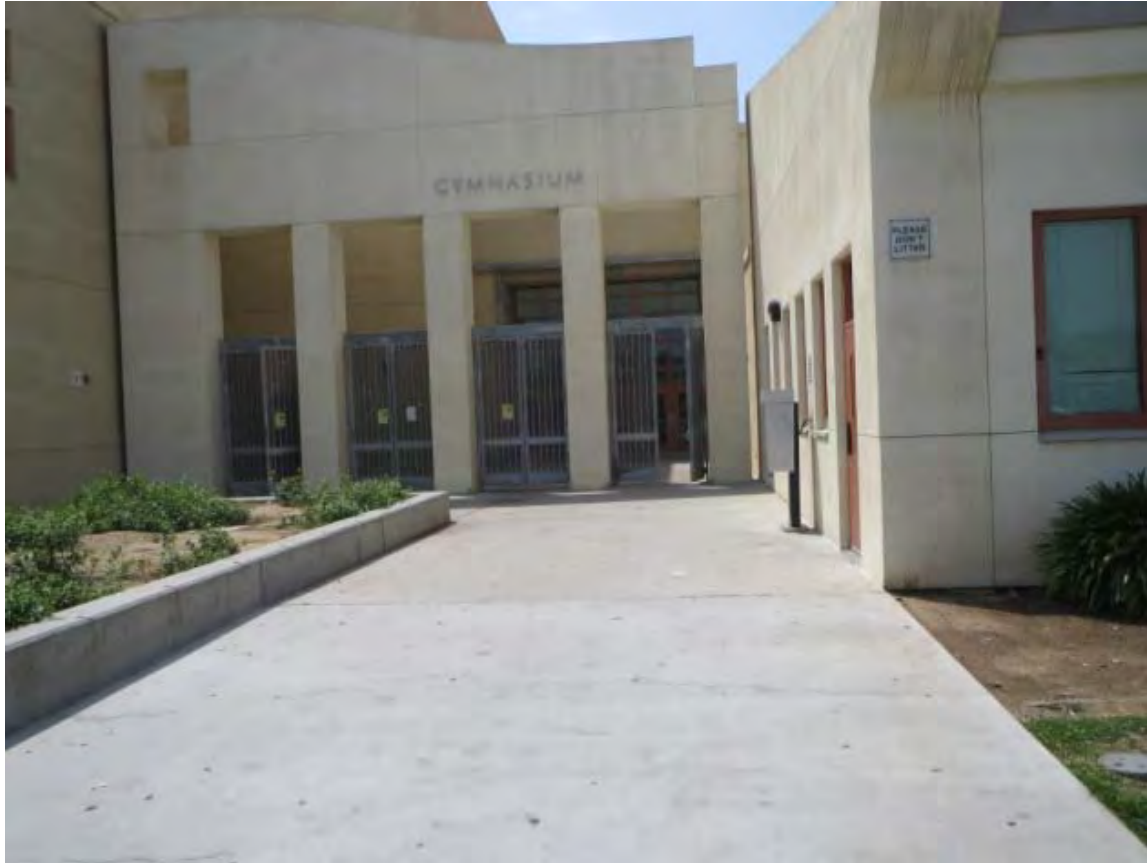
Photo 7

There are portables near the athletic fields that would be impossible to include within the building perimeter fence, however if the rear parking lot were secured, this would not be an issue. Classroom D101 has one door that opens onto the exterior of the campus. The site has solved this issue procedurally.

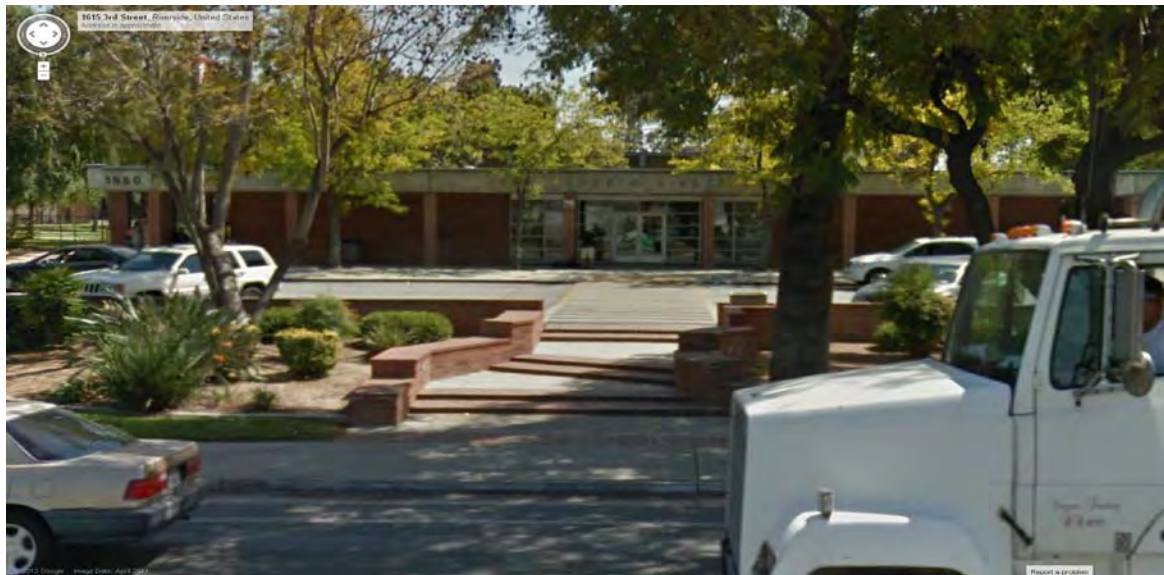
Photo No. 1

The John W. North High School office is clearly labeled.

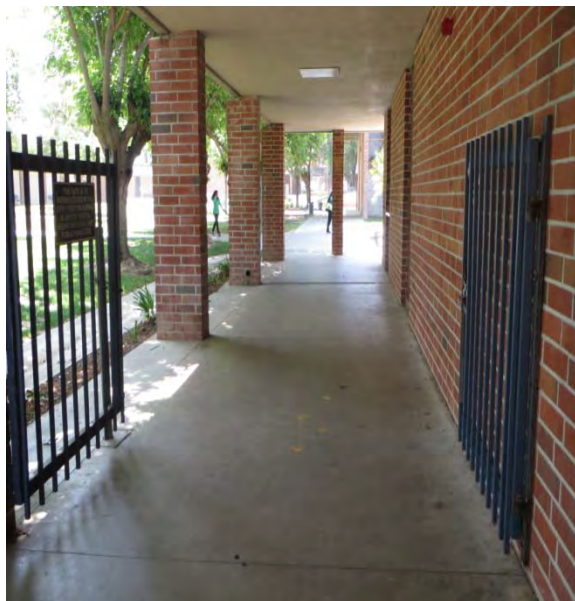
Photo No. 2

The site has a campus supervisor stationed at the gate east of the office to check visitors into the site. The gate west of the office was locked on the day of the visit. Since both gates are used for evacuation routes, the gates need to remain unlocked during school hours. Both gates should be equipped with panic hardware.

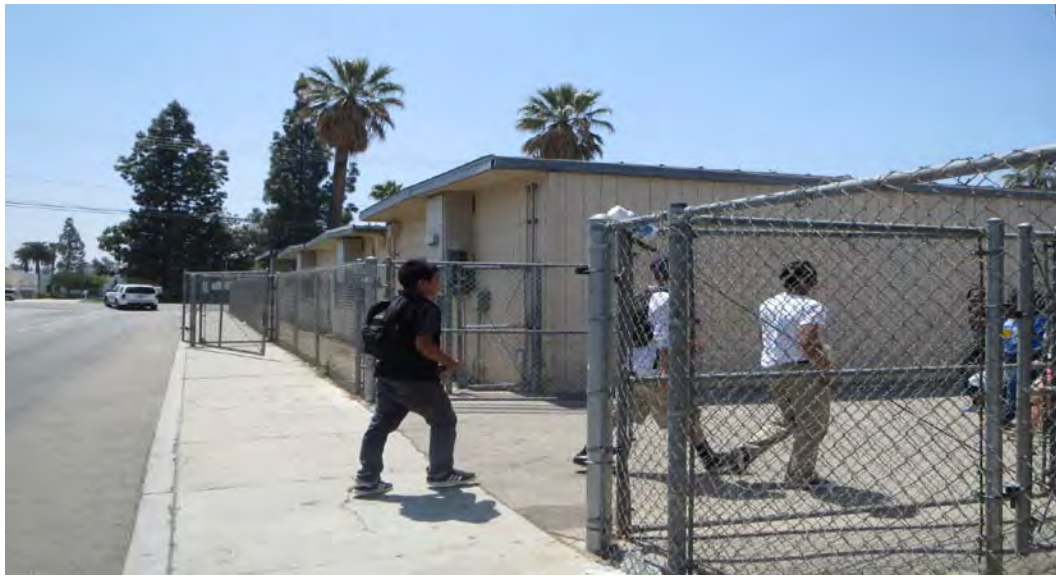
Photo No. 4

The old agriculture area is accessed primarily by the Maintenance and Operations Division. M and O should take care to secure the gate to the area to keep students from entering the area.

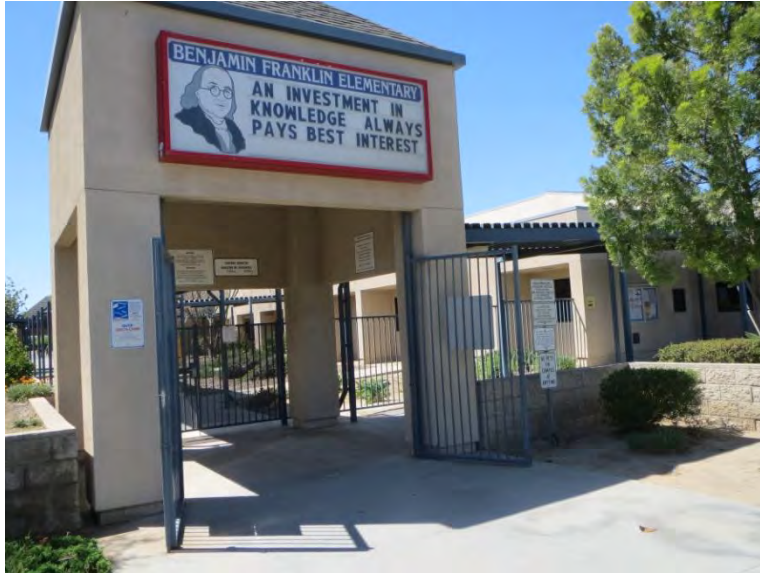
Photo 1: Redundant front gate that doesn't prevent entry

The entrance to the office is well-defined and encourages people to check in to the office. The first gate under the archway seems to be redundant and does not prevent entry into the site.

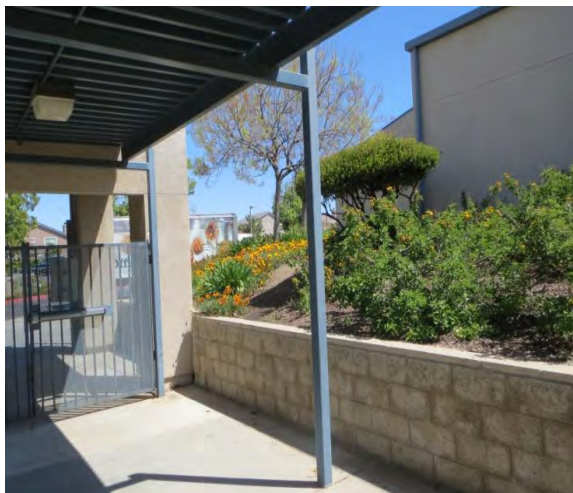
The planter to the immediate east of the main entrance does not have a fence separating the exterior of the school from the interior. Anyone entering the planter can simply walk onto the interior of the campus. Twenty (20) feet of ornamental iron fence will need to be added in this location.

Photo 2: Planter east of main entrance from campus interior

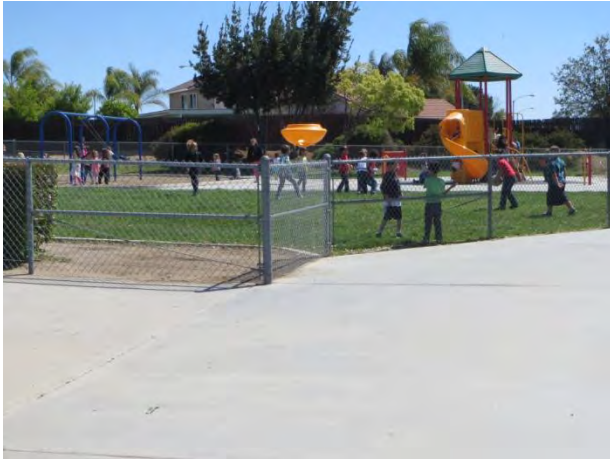
Photo 3: 4' kindergarten fence

The fence surrounding the kindergarten area is only about four feet tall. Approximately 324 feet of 6 foot tall chain link fencing will need to replace two sides of the fence. Access to the third side can be limited by tying the fence line into the property line with an additional 10 feet of fencing. The gate to the kindergarten area should also be secured except at the start of school and at dismissal. The short gate can be relocated to the east side of the kindergarten yard to allow access for landscaping maintenance.

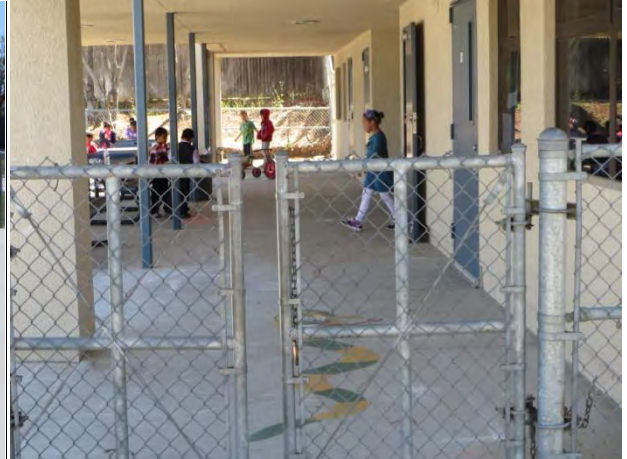
Photo 4: Short kindergarten gate

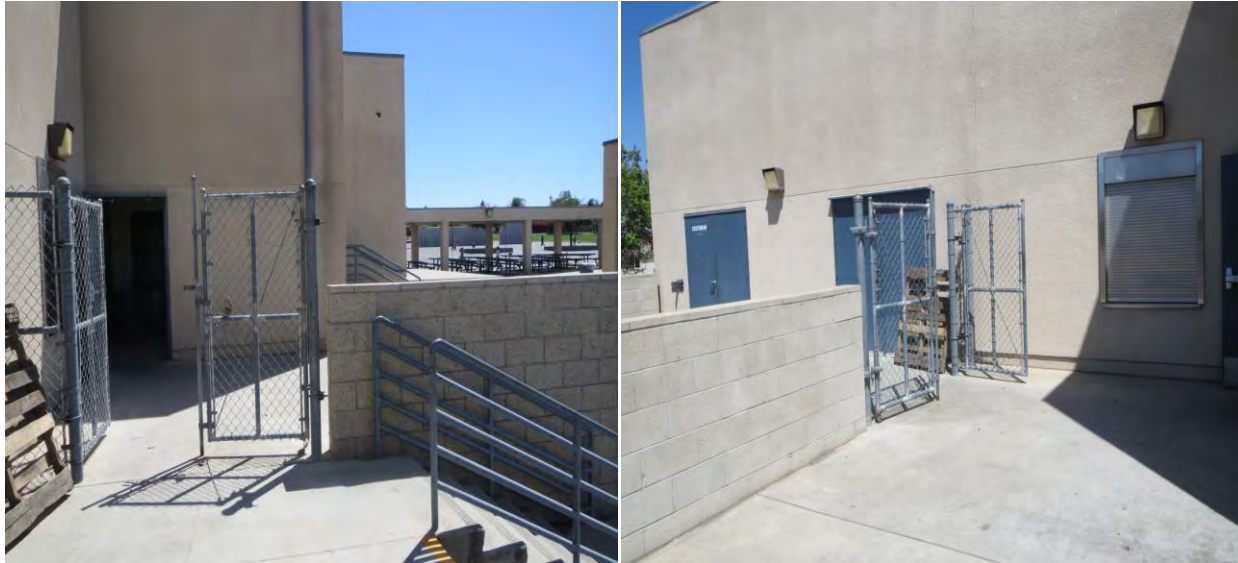
Photo 6 and 7: Stairway leading from driveway to lunch court area, and gate leading from delivery area

Fencing by the delivery dock is short. A stairway leading from the driveway up to the delivery platform makes it very easy to climb over the fence into the lunch court area. The gate leading from the delivery area to the lunch area is left unlocked since the custodian to access a storage room and trash bins, particularly during lunch. I would recommend that a drive gate be installed further down the driveway to enclose the area from outside access during school hours. This would require 30.5 feet of 6' high chain link fencing, including a drive gate.

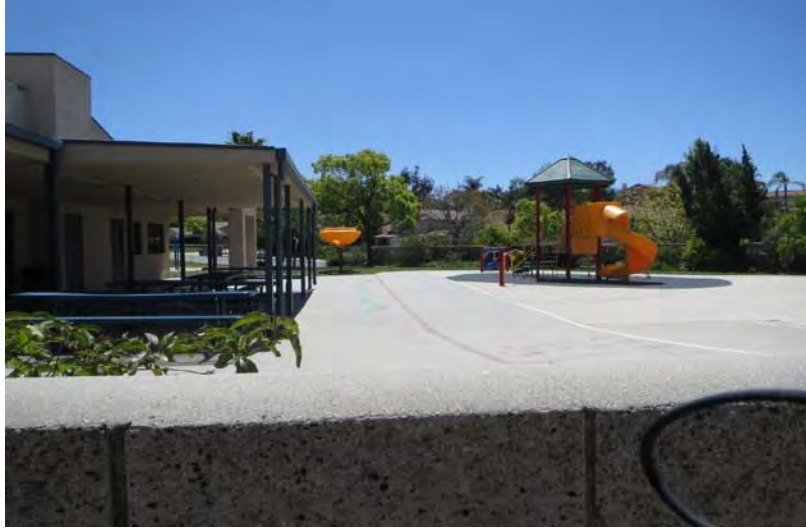
The fence surrounding the kindergarten area is short in some areas. Some parts of the fencing will need to be replaced. Photo3

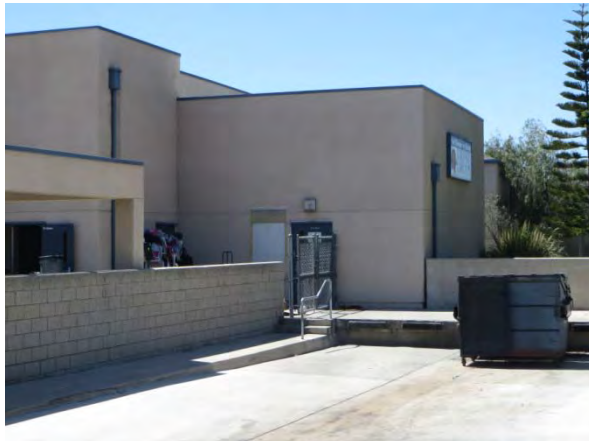
Photo 4

Fencing by the delivery dock is short. A stairway leading from the driveway up to the delivery platform makes it very easy to climb over the fence into the lunch court area. The fencing will need to be augmented in this area probably by installing a taller fence adjacent to or on top of the existing stucco fence.

Fencing adjacent to loading dock

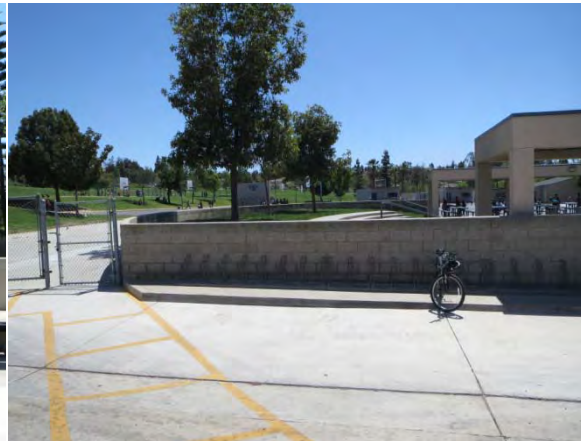
Photo 5

Low fence by lunch court

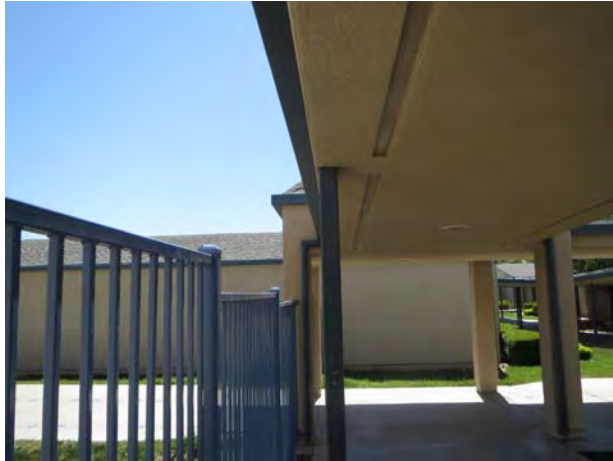
At the entrance to the school, the front fence intersect is the covered walkway providing an easy means to climb onto the walkway roof. Once someone is on top of the covered walkway, they have access to most of the roofs on the campus.

Fence provides access to covered walkway. The walkway accesses most buildings on site. Photo 6

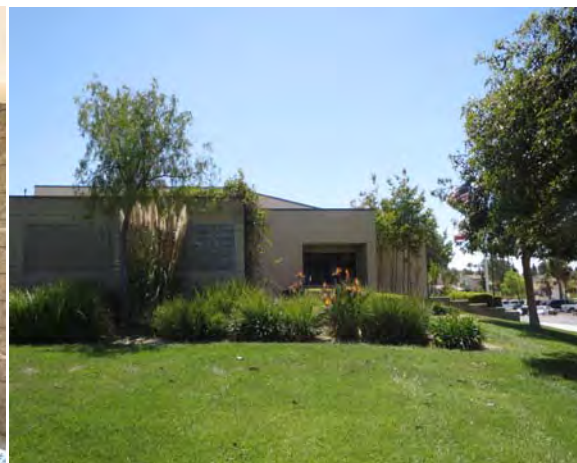
Photo 8

Although the means of access is not immediately obvious, there has been considerable history of people accessing the roof over the office area. Most likely it is accessed by climbing the wall of the teacher's lounge patio area.

Interior and exterior of teachers' lounge patio

These locations would be well suited to pilot the installation anti-climbing spikes as a deterrent to people accessing the roof since we have a history of people climbing onto the roof at this site, and these locations are not legitimately accessed by outside visitors. Warning signs will need to be installed warning of the anti-climbing spikes.
