Report of Limited Subsurface Exploration **Butler High School Athletic Field & Track**

Matthews, Mecklenburg County, North Carolina

ECS Project No. 08:13994-A

January 9, 2025

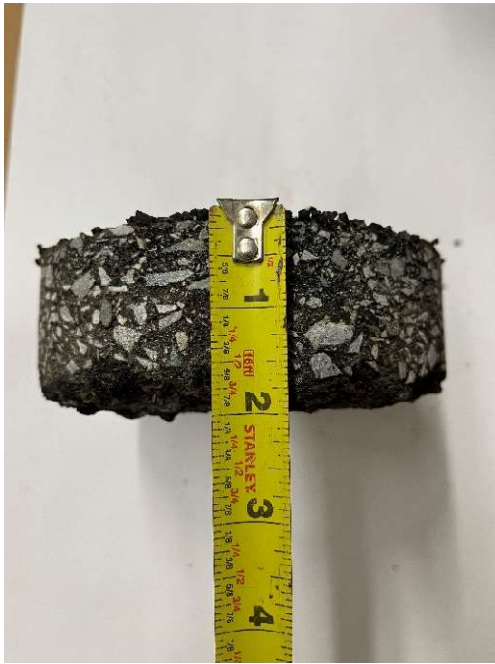
Pavement Core C - 04

Rubber Surface Coat: 1/8 inch
Asphalt Thickness: 1 5/8 inches
Aggregate Base Course Thickness: 4 inches

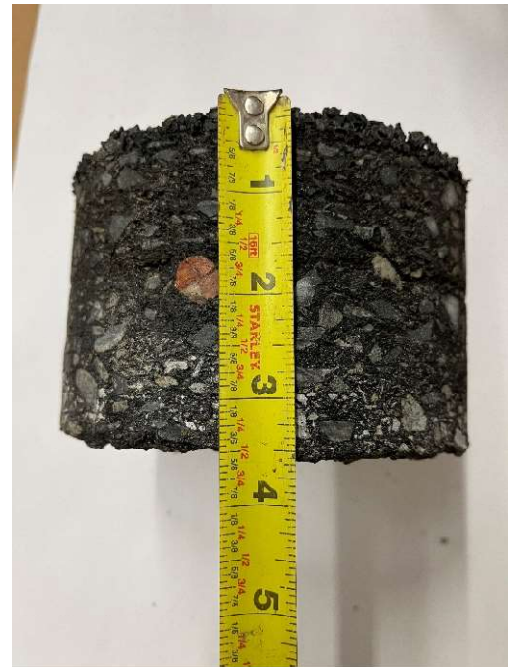
Pavement Core C - 05

Rubber Surface Coat: 3/8 inch
Asphalt Thickness: 3 1/8 inches
Aggregate Base Course Thickness: 4 inches

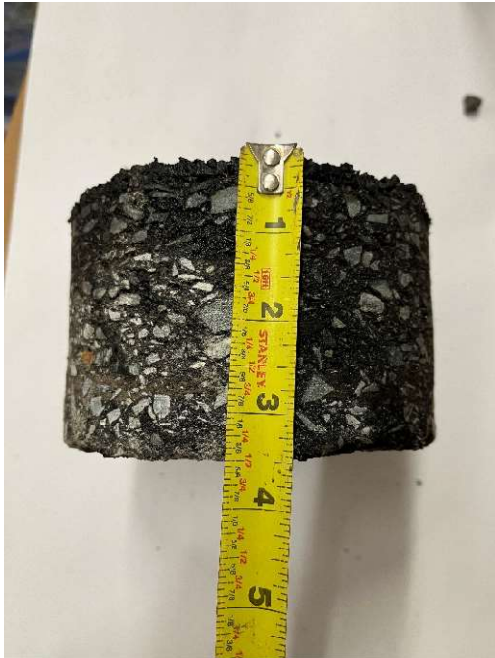
Pavement Core C-06

Rubber Surface Coat: 3/8 inch
Asphalt Thickness: 3 1/8 inches
Aggregate Base Course Thickness: 4 inches

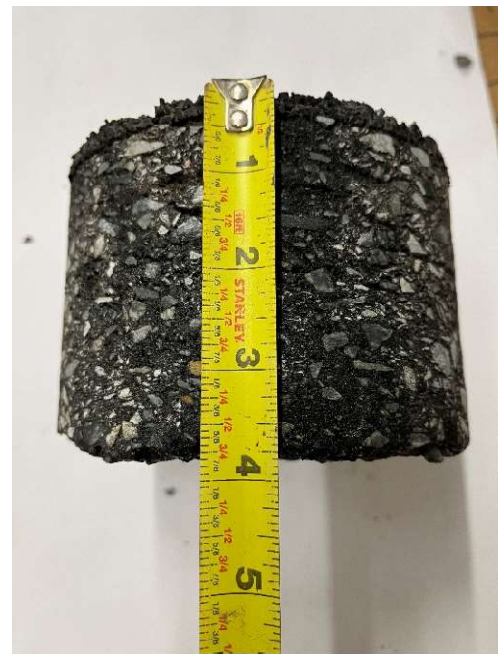
Pavement Core C-07

Rubber Surface Coat: 3/8 inch
Asphalt Thickness: 3 3/4 inches
Aggregate Base Course Thickness: 5 inches
