To: David Wong, City of San Bruno, CA
From: Alta Planning + Design
Date: July 2022
Re: Capuchino High Walk Audit and Recommendations DRAFT Memo

**Safe Routes to Schools Improvement Plan
Capuchino High School**

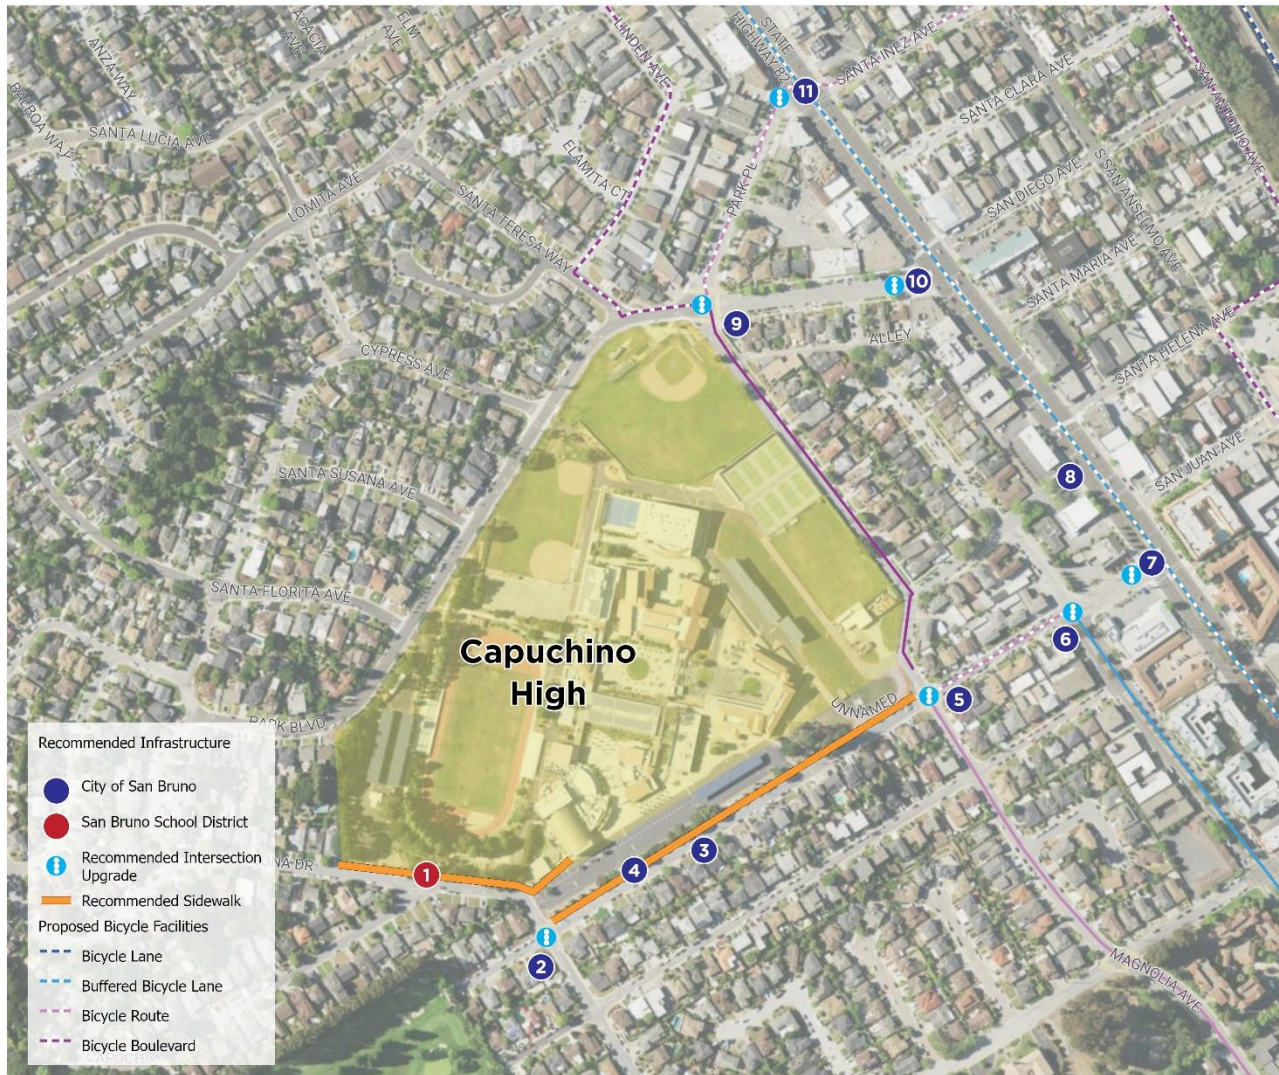
- 1. Finding:** *Barcelona Dr lacks a sidewalk on its northern side, on school property (just south of the football field). The lack of sidewalk leading into the school parking lot off Barcelona Dr forces students to walk in the driveway to pass through the yellow gate. Due to congestion at Barcelona Dr/Millwood Dr, impatient drivers were also seen speeding into the parking lot, using the same drive student were forced to use to enter school grounds while walking.*

- 2. Finding:** *The intersection of Barcelona Dr/Millwood Dr contains extra space at the corners that can be repurposed for additional pedestrian protection and comfort. It is also missing a crosswalk on the southern side of the intersection. All corners lack curb ramps.*

- 3. **Finding:** *The steepness of Millwood Dr, in both directions, leads to perceived driver speeding (based on feedback from stakeholders during the walk audit).*
Recommendation: Install “speed feedback” along the corridor between Barcelona Dr and Magnolia Ave.
 Implementing agency: City.

- 4. **Finding:** *With the rolled curbs along Millwood Dr, drivers park partially on the sidewalk, blocking them for people walking. This is especially prevalent between Barcelona Dr and Magnolia Ave.*
Recommendation: On the north side of Millwood, on school property, widen sidewalks and install vertical 6” curb instead of the existing rollover style. This may require use of school property (depending on where the right-of-way line is). Implementing agency: City.

- 5. **Finding:** *The intersection of Magnolia Ave/Millwood Dr contains extra space at the corners that can be repurposed for additional pedestrian protection and comfort. The curb ramps at Magnolia/Millwood lack tactile warning pads.*
Recommendation: Install paint and post curb extensions and tactile warning pads. Implementing agency: City.

- 6. **Finding:** *The intersection of Broadway/Millwood Dr is extremely large due to the excess width of Millwood Dr to the east, and the presence of a median on Broadway to the south. The intersection contains excess space at the corners and lacks crosswalks on all legs. While stop signs exist on Millwood Dr, they are absent from Broadway.*
Recommendations: Implementing agency: City.
 - a. Complete a stop warrant study to consider the addition of stop signs on Broadway.
 - b. Install 4 paint and post curb extensions to reduce the pedestrian crossing distance.
 - c. Install high visibility crosswalks on all sides of the intersection.

- 7. **Finding:** *The intersection of Millwood Dr/El Camino Real contains excess space at the corners. The crosswalks along El Camino Real at this intersection are faded.*
Recommendations: Implementing agency: City.
 - a. Install two paint and post curb extensions to narrow the opening onto Millwood Dr.
 - b. Install a high-visibility crosswalk at the western approach on Millwood Dr.

- 8. **Finding:** *The intersection of Capuchino Dr/El Camino Real contains excess space at the corners. The crosswalks along El Camino Real at this intersection are faded.*
Recommendation: Implementing agency: City.
 - a. Install two paint and post curb extensions to narrow the opening onto Capuchino Dr.
 - b. Install a high-visibility crosswalk at the western approach across Capuchino Dr.

9. Finding: *The intersection of Park Pl/Park Blvd/Magnolia Ave is missing a crosswalk on the western side of the intersection. Students were observed crossing Park Blvd at the approach without the marked crosswalk. The intersection also contains excess space at the corners, due to non-perpendicular alignment and on-street parking.*

10. Finding: *The intersection of Park Blvd/El Camino Real contains excess space at the corners, due to large corner radii, and allows higher vehicle turning speeds. The crosswalks across Park Blvd at this intersection are faded.*

11. Finding: *At Park Pl/El Camino Real, crossing distances are especially long due to the right turn lanes (heading north on Park Pl) curving to the right. The crosswalks along El Camino Real at this intersection are faded.*

- 1 Install sidewalk along the north side of Barcelona Dr and connect it to the sidewalk along the northern side of the parking lot on school grounds.
- 2 Install concrete curb extensions. Install curb ramps and tactile warning pads. Install high visibility crosswalk across Barcelona Dr.

- 3 Install "speed feedback" along the corridor between Barcelona and Magnolia.
- 4 On the north side of Millwood, on school property, widen sidewalks and install vertical 6" curb, instead of rollover style. This may require infringing onto school property (depending on where the right-of-way line is).

- 5 Install 4 paint and post curb extensions. Install tactile warning pads.
- 6 Install high visibility crosswalks on all sides of the intersection. Complete a stop warrant study to consider the addition of stop signs to Broadway. Install curb extensions.

- 7 Install 2 paint and post curb extensions. Install yellow, ladder high-visibility crosswalk at the western approach. Install curb extensions.
- 8 Install 2 paint and post curb extensions. Repaint crosswalk in higher visibility pattern.

- 9 Install yellow, ladder high-visibility crosswalk at the western approach. Install 4 paint and post curb extensions.
- 10 Install a concrete curb extension. Install yellow, ladder high-visibility crosswalk at the western approach. Install curb extensions.

- 11 Install 2 paint and post curb extensions. Straighten the right turn lanes into alignment with the street. Install yellow, ladder high-visibility crosswalk at the western approach.
