## Characterization of Historic Mortar:

Old Town Hall

8 East St.

**April 17, 2025**

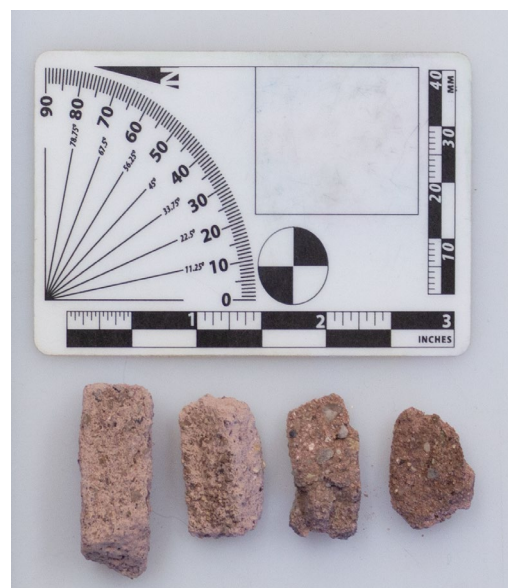
Photograph of a portion of the sample before acid digestion showing clean breaks on the left and weathered faces on the right (fluorescent light, color corrected).

- **Initial Observations:** The sample is in sound condition with a fine texture and a deep pink interior and a slightly dark crimson weathered face. Lime nodules, the remnants of quicklime, are visible but are quite fine and relatively evenly sized suggesting an aged or well-strained putty was used.

- **Color:** The weathered face corresponded to Munsell 10R 6/3 *pale red*.
- **Hardness:** The sample was moderately soft with a Mohs rating of 5, requiring little force to pulverize with a mortar and pestle.

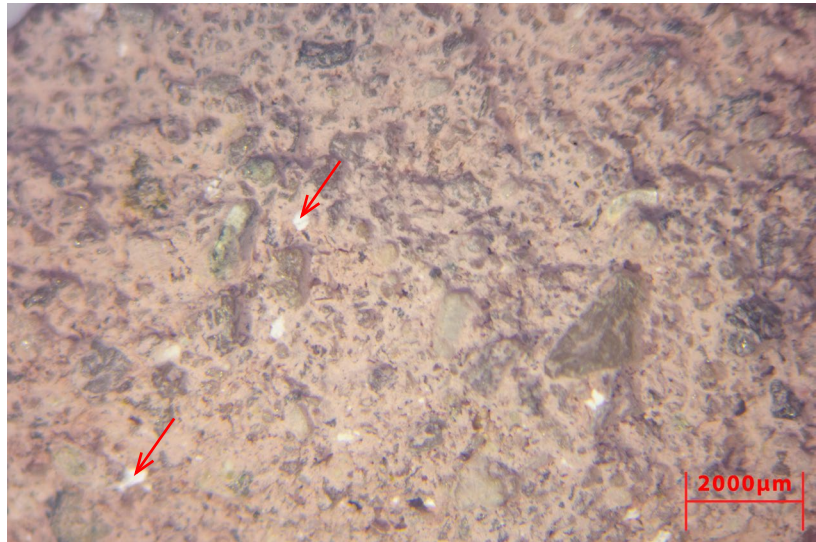
*Photomicrograph of a polished section before digestion with examples of lime nodules indicated by red arrows (incident daylight-balanced light, 10x magnification).*

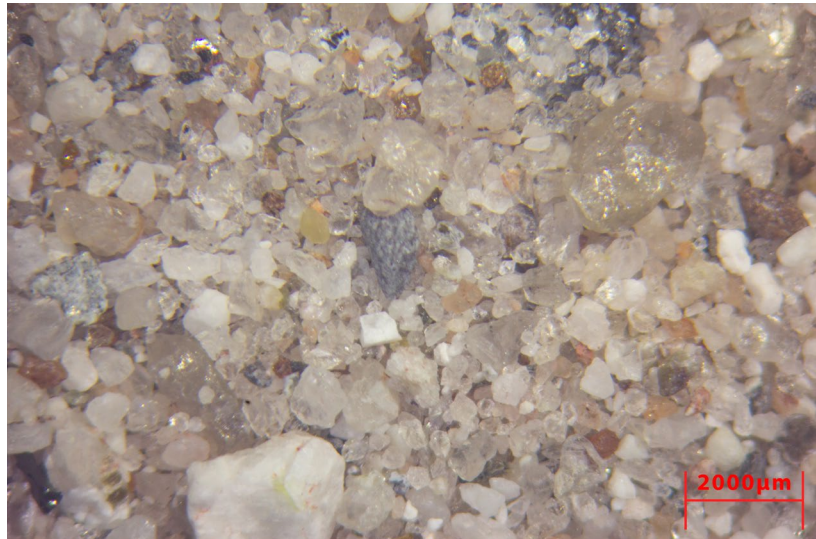
*Photomicrograph of the extracted aggregate before sieving (incident daylight-balanced light, 10x magnification).*

Prior to digestion, semi-lustrous white particles were observed in the sample partially obscured by the binder. These grains were initially suspected to be marble or another calcareous mineral, but many of the particles survived digestion intact. Visual examination suggests they are non-calcareous, possibly a white plagioclase feldspar. PSQ analysis of the binder-to-aggregate ratio supports the idea that very little if any calcareous material was present. However, given the geology of the originating area, the presence of a minor amount of calcareous material in the aggregate cannot be fully ruled out.

The extracted sand was dominated by clear to smoky white quartz, with a significant portion of feldspar, likely plagioclase. Subordinate quantities of lithic fragments, mica, and ferriferrous minerals — including some with weak magnetic properties — were also present. A small number of black, lustrous grains were observed, but without petrographic analysis, their precise mineralogy remains undetermined.

Once separated from the fines, the surviving the aggregate had an overall average color of 5YR 8/1 *light gray*. Average particle shape ranged from very elongate to equant in sphericity and angular to subrounded in roundness. The sand appears typical of a natural sand sourced from glacial deposits or fluvial origins.

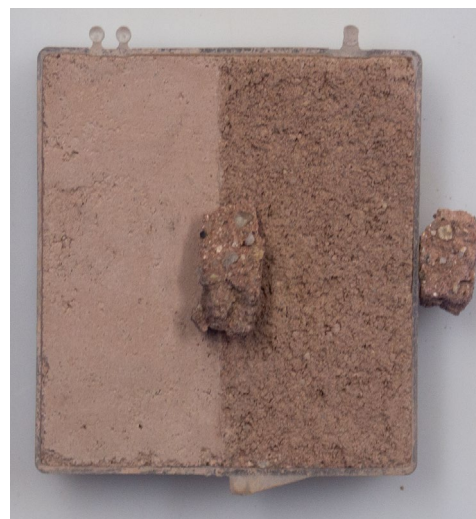
Portions of the tested sample compared to a tile of colored Ecologic™ Mortar (fluorescent light, color corrected).

From the LimeWorks.us product line, a blend of Ecologic™ Mortar in color combination 10% DGM Red / 90% DGM 050 mimicked the look of the tested sample while conforming to the previous recommendations. Please speak to a LimeWorks.us representative to obtain pricing and lead times if any further products or services are desired.

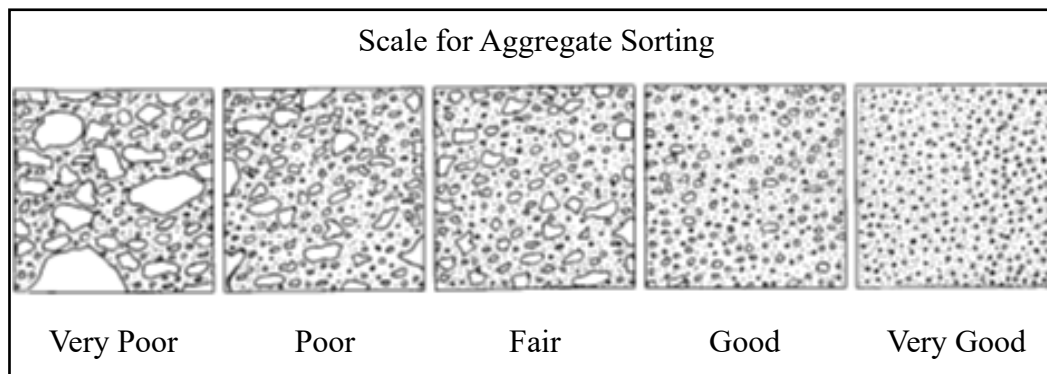
- **Sorting:** Sorting describes the distribution of particle sizes within a sample. Well-sorted samples have uniform particle sizes, while poorly sorted samples contain a mix of various sizes and shapes. The degree of sorting influences the properties of the mortar, including porosity, workability, and durability.
