# FACILITY CONDITION ASSESSMENT

Agnes Stewart Middle School  
900 S 32<sup>nd</sup> Street  
Springfield, OR 97478

January 3, 2025

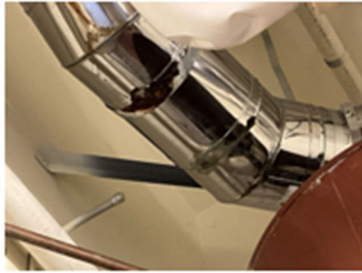
### Piping & Valves in Failed condition.

Piping Ductile Iron, Site Water  
Agnes Stewart Middle School  
Mechanical Room

Continuous Leaking - AssetCALC ID: 8772178

Uniformat Code: G3010  
Recommendation: **Replace in 2025**

Cost Estimate: \$2,900

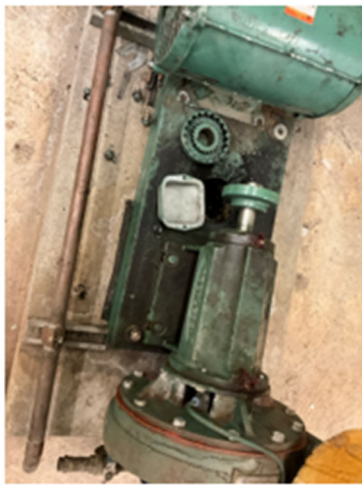
### Pump in Failed condition.

Distribution, HVAC Chilled or Condenser Water  
Agnes Stewart Middle School  
Mechanical Room

Pump is down and slated to be replaced - AssetCALC ID: 8772147

Uniformat Code: D3050  
Recommendation: **Replace in 2025**
