# Mt. Pleasant School District

## Facilities Master Plan

2025/2026

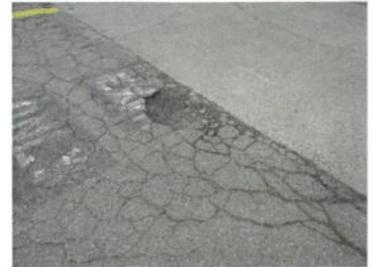
The existing parking lot is too small for this campus student population in our opinion. The parking lot appears to have been designed to affront the front of the school. Drop off and pick up areas

within the parking lot are insufficient. The existing parking lot is in fair condition. There is a strong desire to add a track and field complex at this site but is not shown as this is not feasible at this time. Parking would need to be added should a track be added in the future should that project seek funding. The condition of the pavement is in poor condition. There are signs of past trenching through the parking lot.

The existing parking lot is landlocked but can be expanded toward the street corner, and because the existing pavement of the parking lot is in poor condition, the recommendation is to expand the parking lot toward the corner, remove and repave and restripe the existing parking lot in the next five

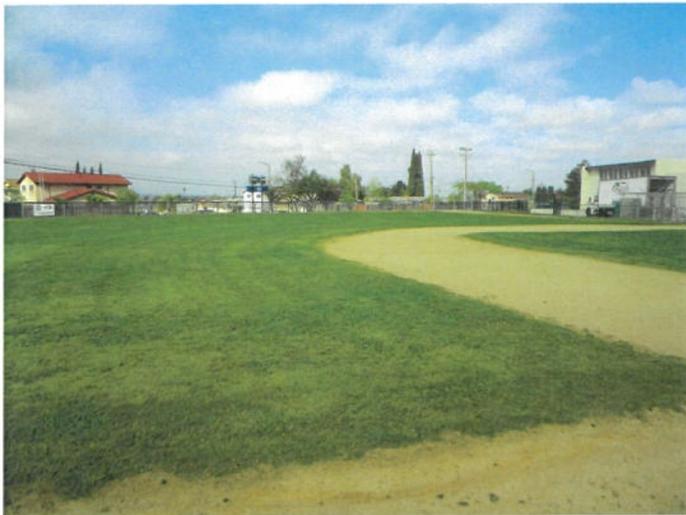
Middle School aged students and is in fairly good condition. The current ball fields are maintained by outside users of the fields. The outdoor bleachers are in poor condition. The basketball backstops are in poor condition. The basketball backstop poles are in need of paint. The users are wanting pickleball to be added to the play area.

It is recommended that the basketball backstops and the existing bleachers be replaced. It is recommended that pickle ball courts be added. The basketball backstop poles should be painted.

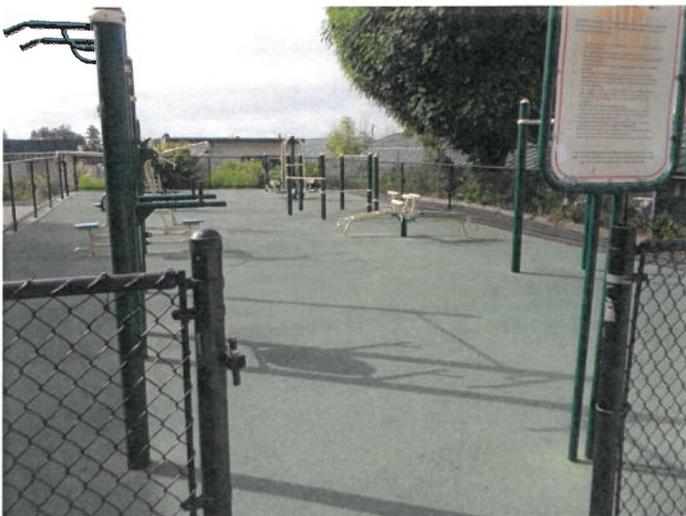
## 3. Play Equipment

This campus has special play apparatus suitable for

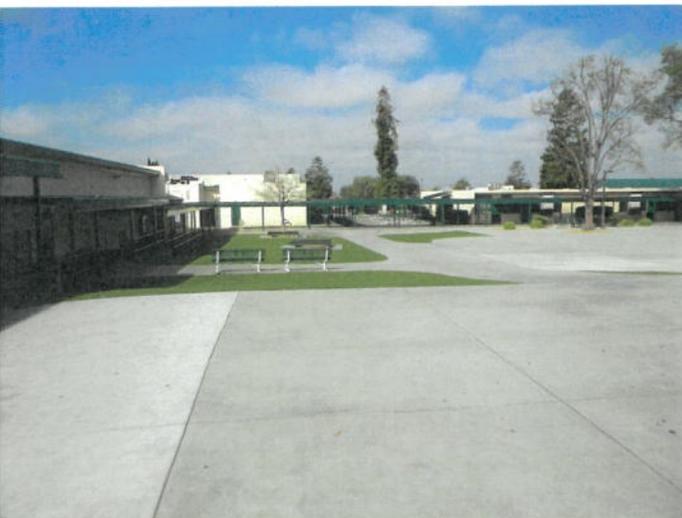
The site lighting is good around this campus except around the cafeteria toward the quad area and the parking lot.

It is recommended that parking lot lighting be altered and added as needed for safety and

that more lighting be added around the cafeteria quad area.

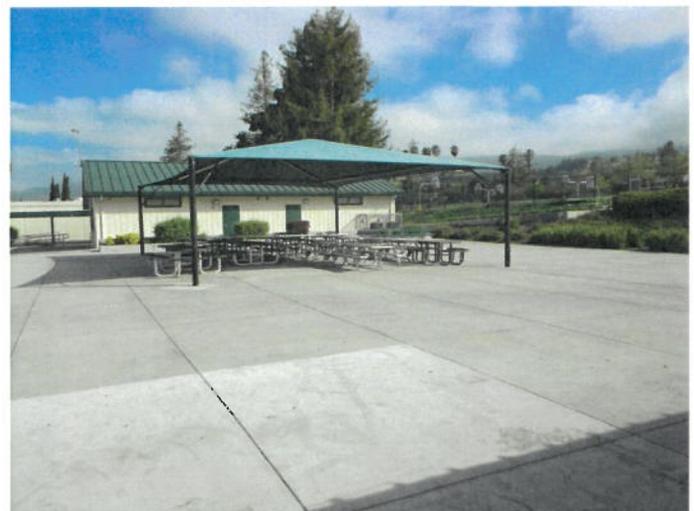
The existing shade structure is in good condition. The material will last for about ten years. There is a need for additional shade structures at this campus.

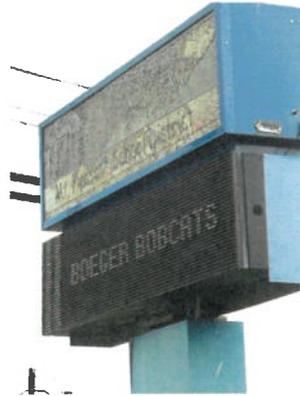
The existing signage is not per the District standards and should be upgraded. The existing Marquee is antiquated and should be replaced.

There should be new directional signage and functional spaces identification added to this campus. The existing Marquee should be replaced.

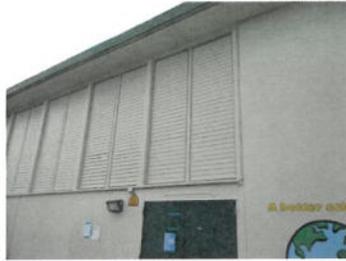
Most all building exteriors are stucco or cement plaster with the exception for some wood siding. The wood siding requires more maintenance with ongoing decay and more frequent painting.

It is recommended that all wood siding, soffits and trim be replaced with a more long lasting material such as cement plaster or cementitious siding.

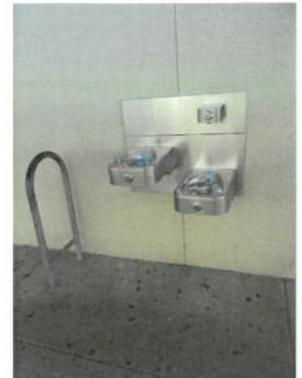
There are a number of ADA complaint stainless steel hi/low drinking fountains on site which are in good condition. There is a need for more bottle fillers at this campus.

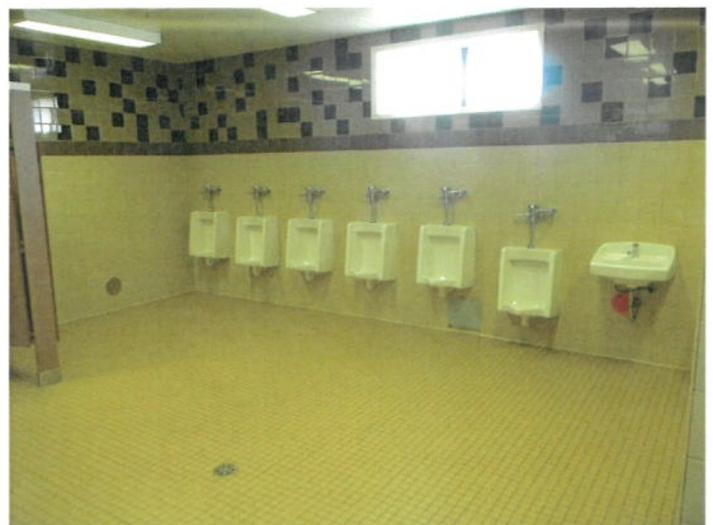
There are numerous sets of large student restrooms that are ADA compliant and in good condition. They have tile floors and walls with painted gyp board ceiling. The partitions are plastic urethane and fixtures are in good condition with ADA compliant hardware at doors. The hallway in the cafeteria and the library restrooms are in poor condition. There is a lack of designated Gender Neutral restrooms.

It is recommended that the restroom in the cafeteria hallway and the library restroom be refurbished.

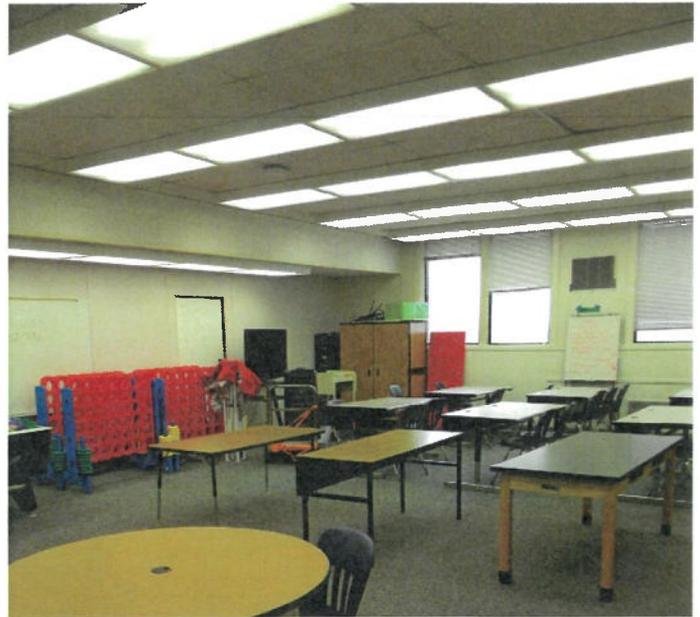
The existing lighting fixtures are in good condition

and have retrofitted recently.

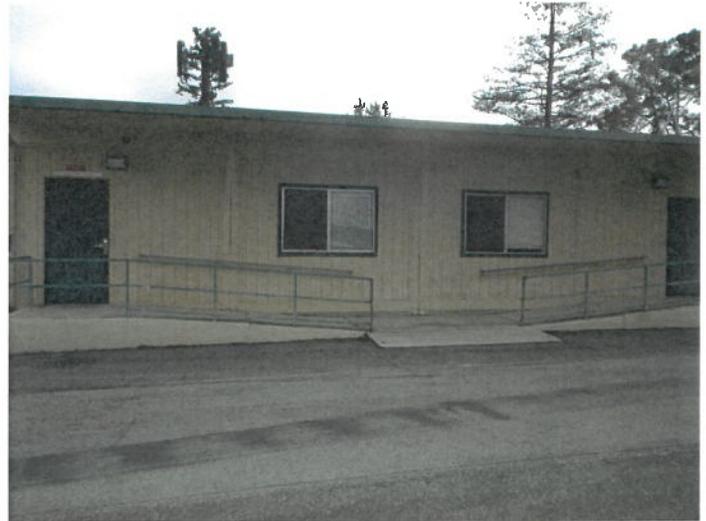
There are a few portable classrooms being used as classrooms adjacent to the District office area. These portables were added at this location without thought of ideal location and should not be in this location. The parking lot was broken up and

awkward with these portables located at this location. These portables are at least 25 years old and have surpassed their intended lifecycle.

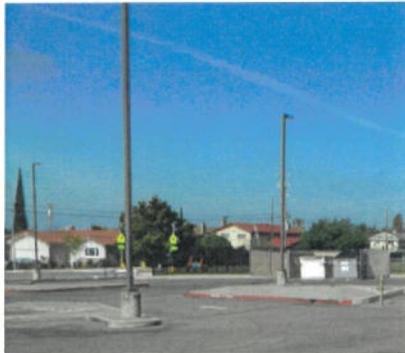
The site lighting is good around this campus generally. However there are still some locations that are dark at night.

It is recommended that a sight survey be taken at night to spot dark locations at this campus. We will assume 25% more added exterior lighting to this campus as part of this report.

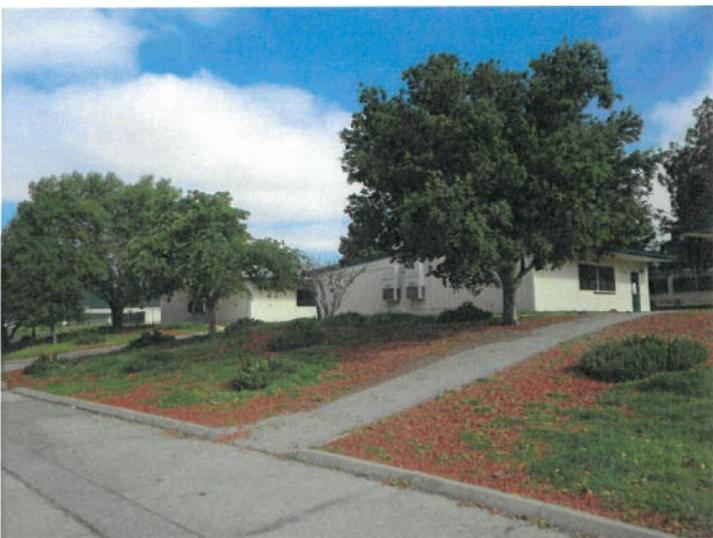
### 13. Concrete Walkways

Most of the existing older concrete walkways are cracked and lifting. There are several locations at this campus where the thresholds do not comply with ADA requirements.

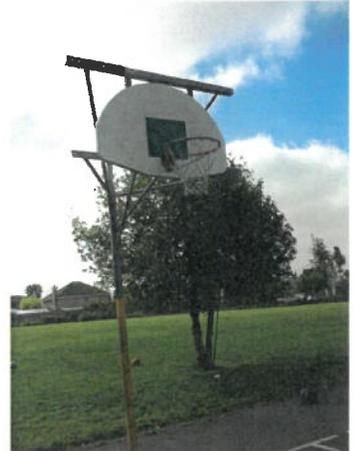
The existing basketball backstops and poles are not in good condition. It is recommended that all basketball backstops and poles be replaced.

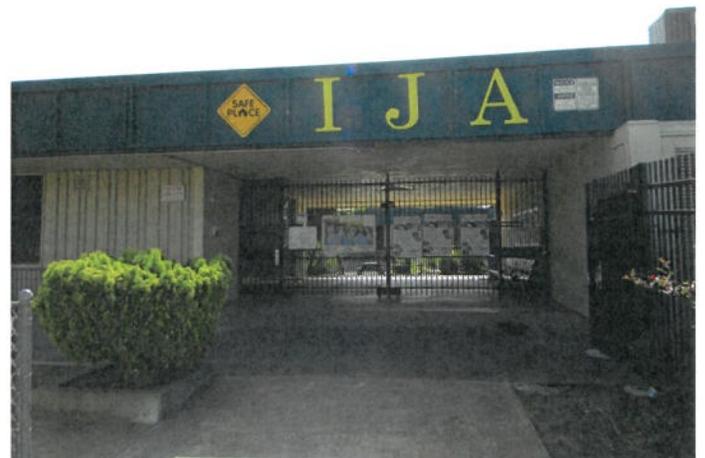
The existing signage is not per the District standards

and should be upgraded. The existing smaller Marquee is antiquated and doesn't have the current name of the school. There are two marquees with the separated school names

There should be new directional signage and functional spaces identification added to this campus.

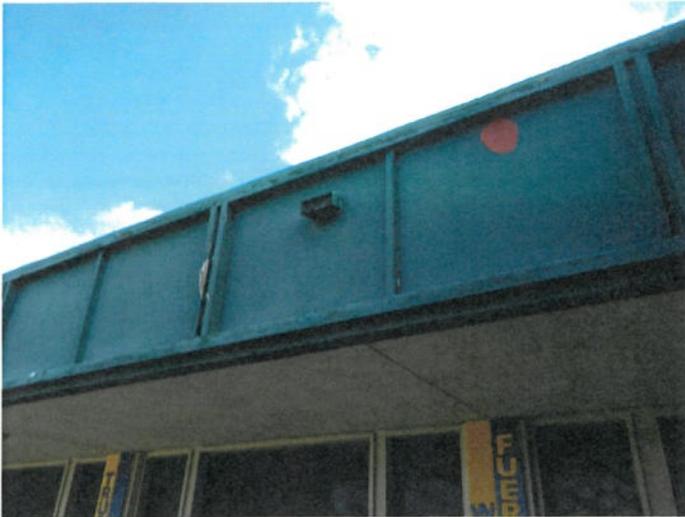
The existing campus has many buildings that are constructed with a wood siding with wood soffits which requires more maintenance with ongoing decay and more frequent painting.

It is recommended that all wood siding, soffits and trim be replaced with a more long lasting material such as cement plaster or cementitious siding. The District has expressed desire to replace all of the soffits and facias above the soffits with metal siding.

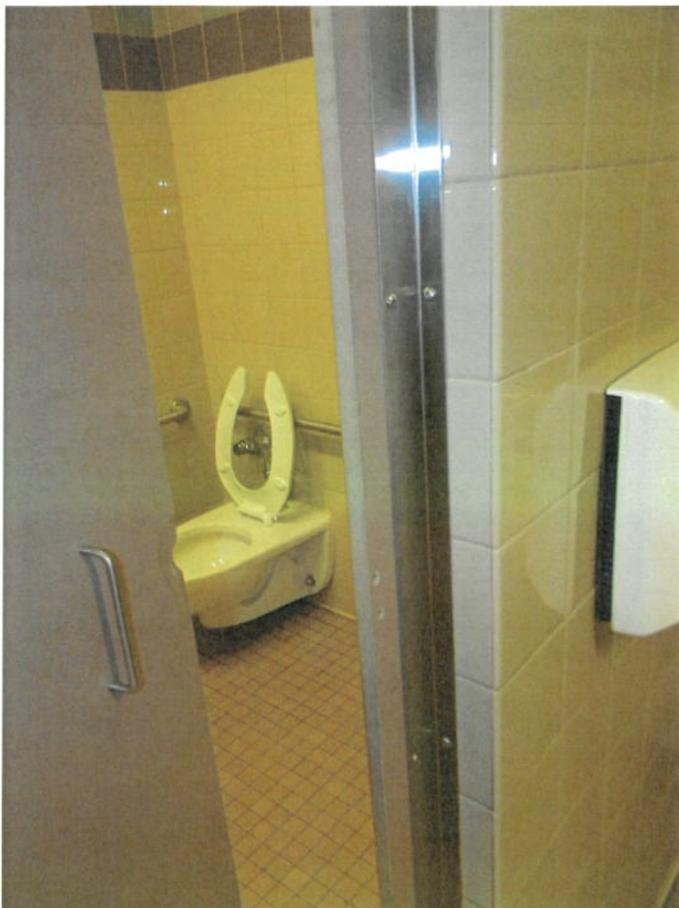
There are numerous sets of large student restrooms that are ADA complaint and in good condition. They have tile floors and walls with painted gyp board ceiling. The partitions and fixtures are in good condition with ADA compliant hardware at doors. There are still 4 student bathrooms that need to be upgraded. There is a lack of designated Gender

Neutral restrooms.

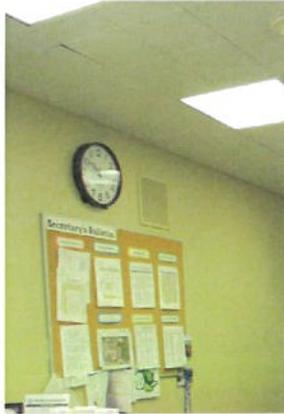
The existing speakers/bell/PA system is antiquated and in need of upgrades.

The existing speakers/bell/PA system should be upgraded to incorporate the data system.

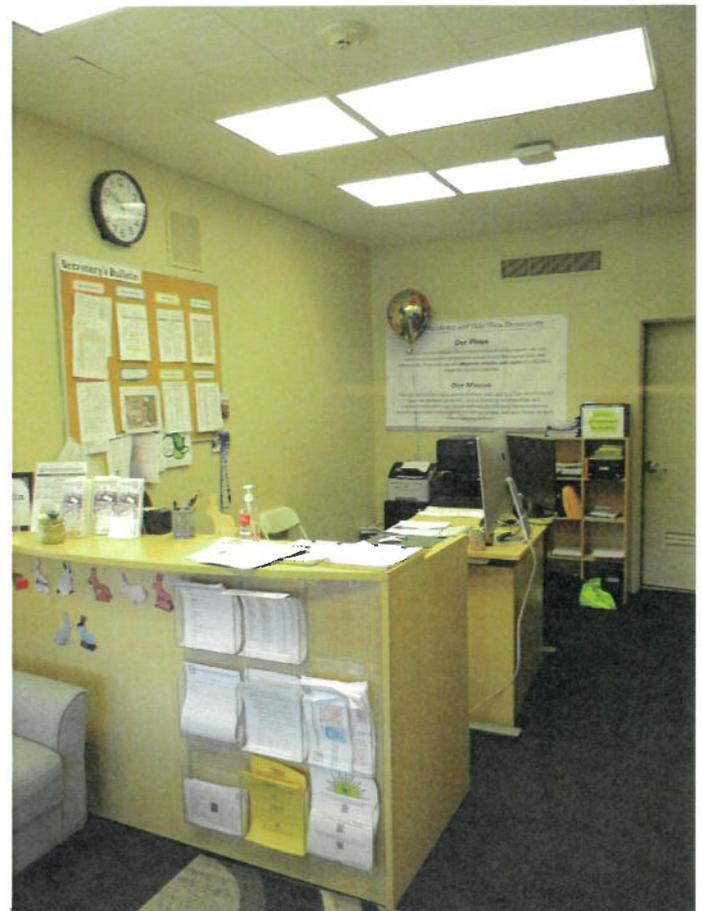
### 47. Administration Office

The existing administrative spaces are too small for this large campus. The overall condition of the administration space is in poor condition.

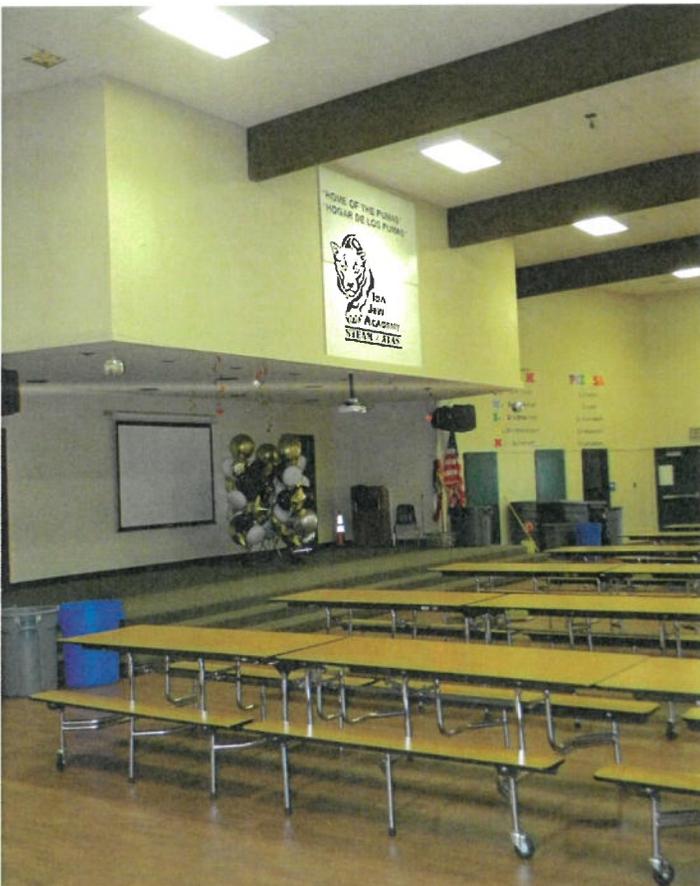
The campus has a very small cafeteria for the current student population with serving kitchen. The existing cafeteria and kitchen are in poor condition.

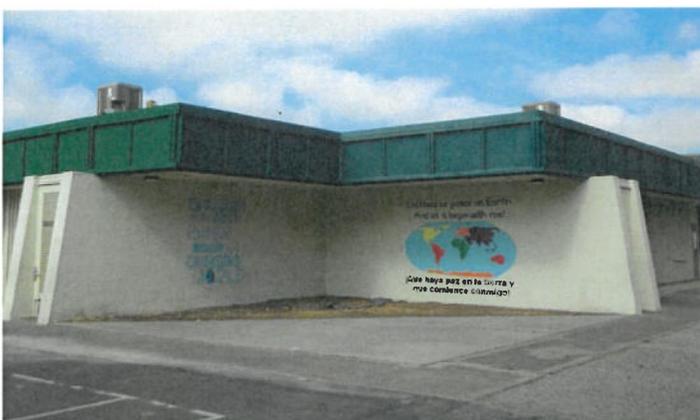
This campus does not have covered walkways. There are locations where the occupants moving from one classroom to another locate will not stay dry during rain. There are overhangs throughout this campus but the pathways of the overhangs are blocked by fin walls at most locations.

It is recommended that new covered walkways be installed throughout this campus.

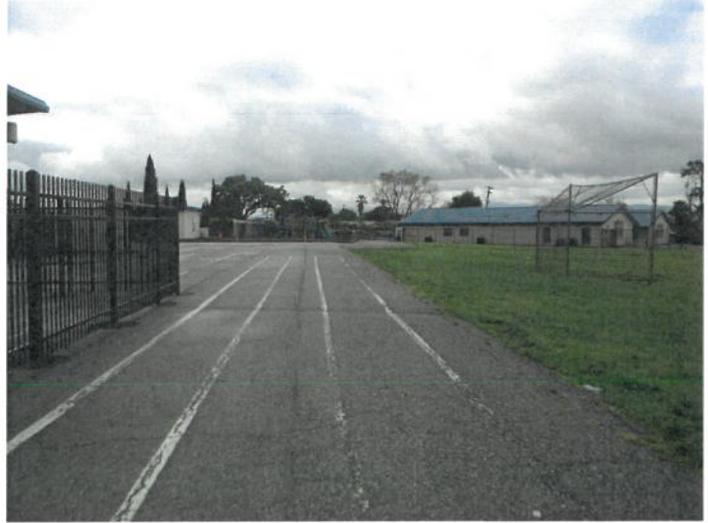
accessible. The parking lot must have current code compliant accessible parking stalls.

It is recommended that the path of travel areas that are obstructed by pavement cracks and unlevel cross slopes be altered to comply with current code. It is recommended that all ADA issues be upgrades during future maintenance project and future modernizations.

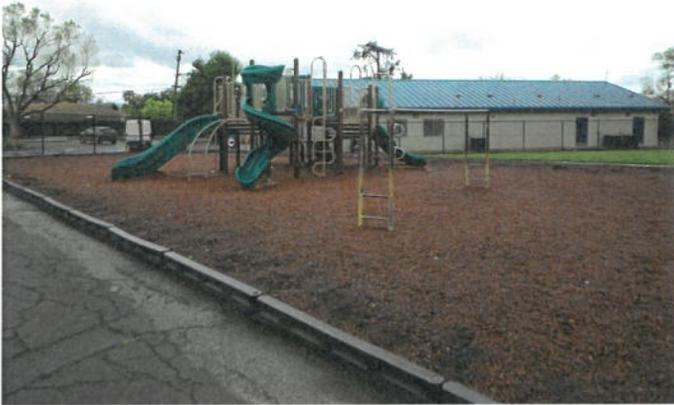
This campus received new play apparatus at the Kindergarten play area in 2023. The upper and lower play structures and fall protection are older and should be replaced.

It is recommended that an upper and lower grade play area with new fall protection matting be installed at this campus.

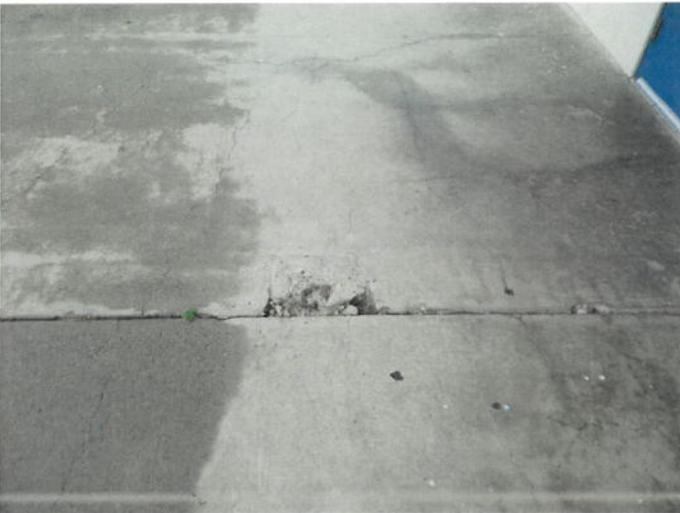
Most of the existing older concrete walkways are cracked and lifting. There are several locations at this campus where the thresholds do not comply with ADA requirements.

It is recommended that all older walkways be removed and replaced except at the quad area and the parking lot area. We will assume 50% replacement as part of this report.

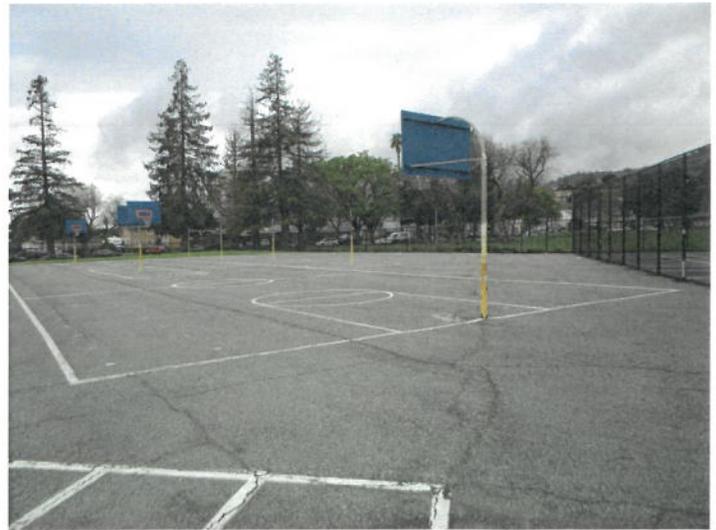
The existing basketball backstops and poles are not in good condition. There is currently no ball wall at this campus.

It is recommended that all basketball backstops and poles be replaced and new ball wall be installed.

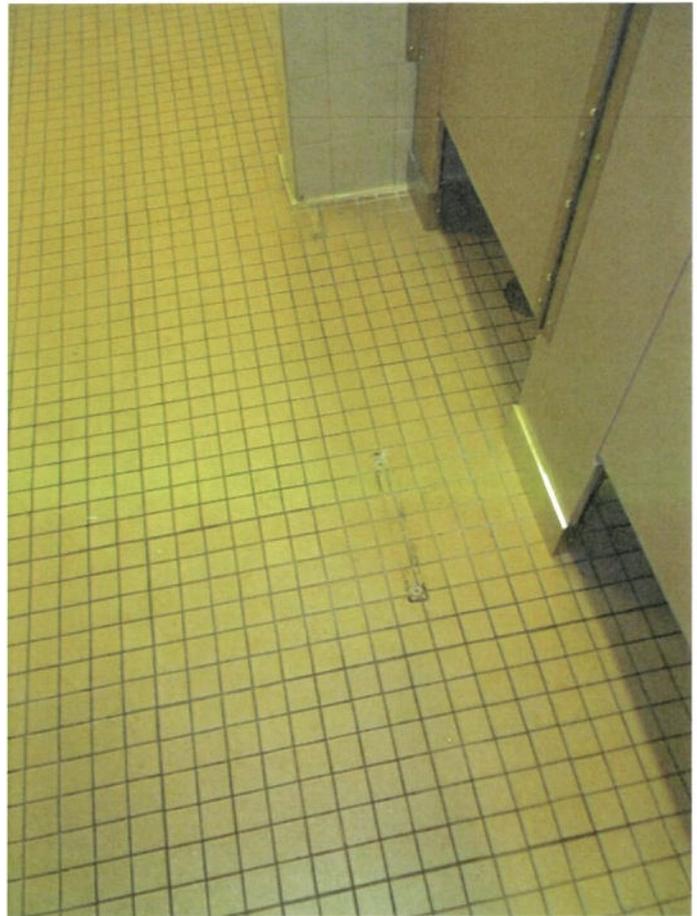
There are numerous sets of large student restrooms that are ADA compliant and in good condition. They have tile floors and walls with painted gyp board ceiling. The partitions and fixtures are in good condition with ADA compliant hardware at doors. There are still 4 student bathrooms that need to be upgraded. There is a lack of designated Gender Neutral restrooms.

It is recommended that the four bathrooms be completed altered and renovated.

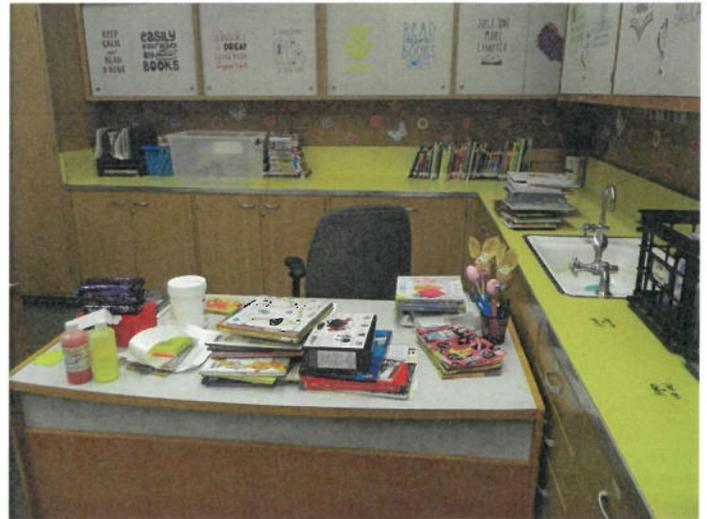
### 40. Casework

The existing classrooms and student support space cabinetry are in good condition. There are some rooms where the cabinetry was not replaced in the past and there are some cabinetry that has been damaged.

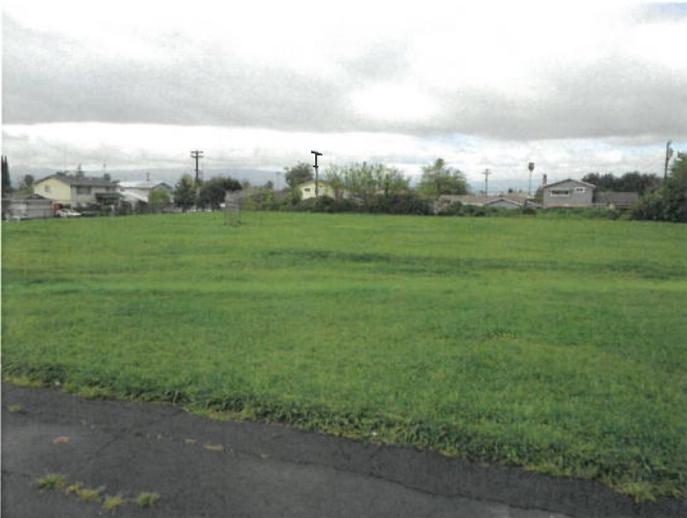
The existing turf play areas are in poor condition. The turf is uneven which could cause issues.

It is recommended that the turf areas be regraded, irrigation be reconstructed and new sod be installed.

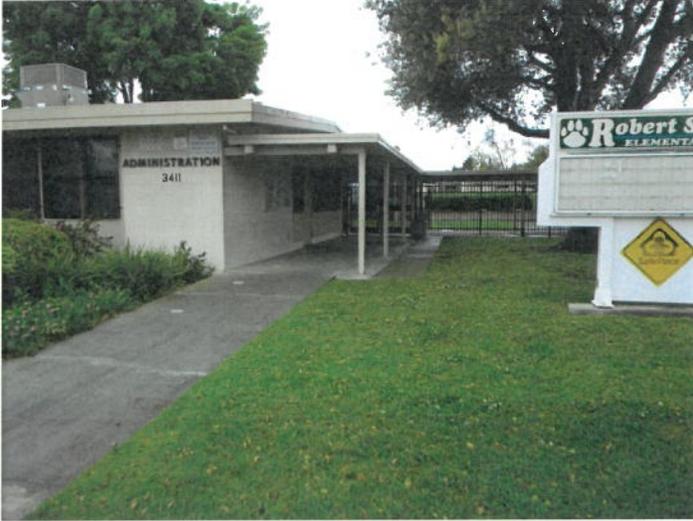
There are several locations where the existing older concrete walkways are cracked and lifting.

It is recommended that all older walkways be removed and replaced. We will assume 50% replacement as part of this report.

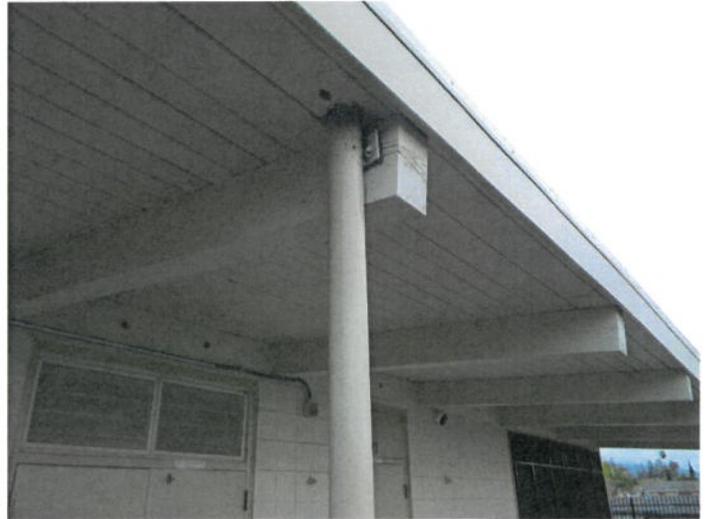
The existing roofing, several gutter locations and related areas are all in poor condition.

The roof at this campus should be replaced as soon as possible. New gutters and downspouts should be replace all of the existing gutters and downspouts.

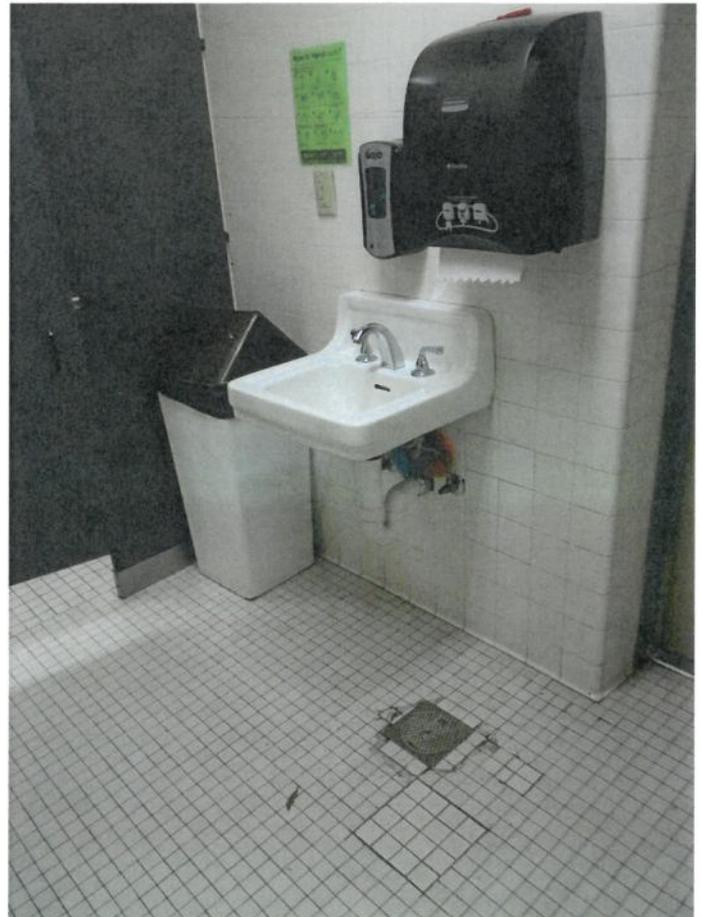
The staff bathrooms do not comply with current accessibility requirements.

It is recommended that all staff bathrooms be altered and upgraded to meet current ADA requirements.

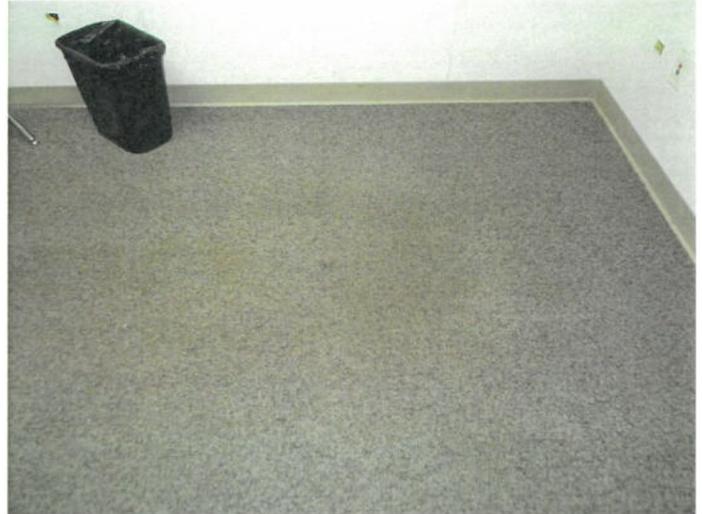
The existing tackable wall surfaces are in poor condition and should be replaced with new tackable wall surfaces.

It is recommended that 20% of the wall surfaces be repaired or replaced with new tackable wall surfaces.

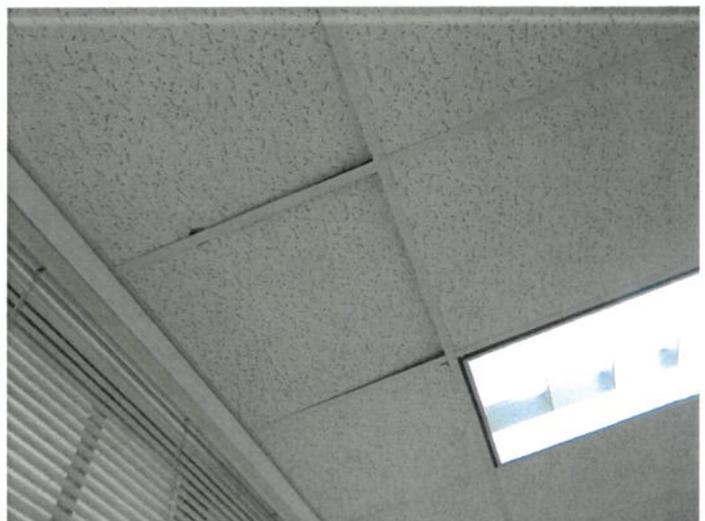
The existing ceiling systems are original and starting to have a poor appearance. Existing suspended ceiling systems have chipped and scuffed ceiling tile. Other rooms with hard lid ceilings are in fair condition.

It is recommended that the existing suspend ceiling systems have the grid painted and all of the ceiling tile replaced.

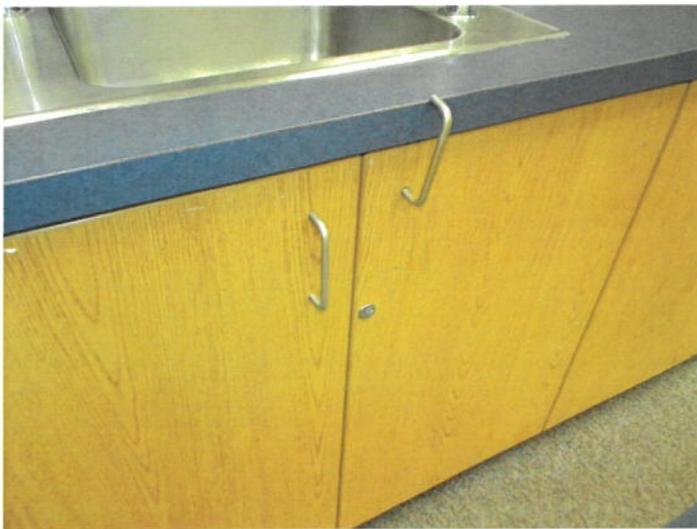
The existing classrooms and student support space cabinetry are in fair condition. There are some rooms where the cabinetry was not replaced in the past and there are some cabinetry that has been damaged.

It is recommended that about 25% of the casework at this campus be removed and replaced with new casework.

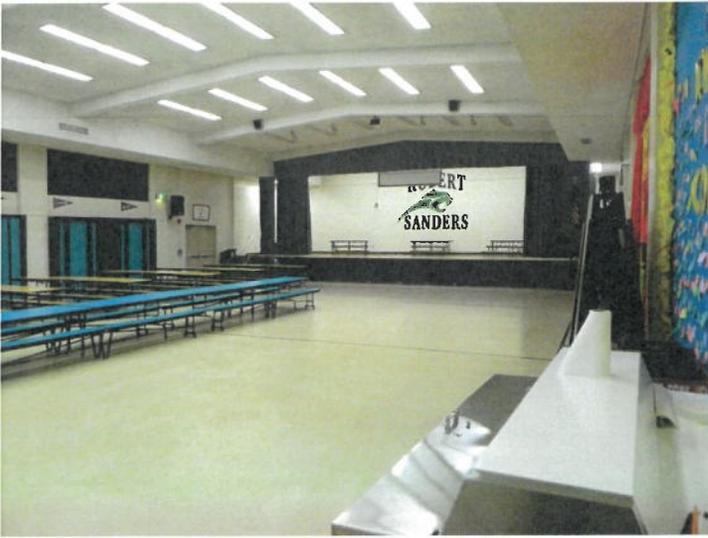
The campus has a very small cafeteria for the

current student population with serving kitchen. The existing cafeteria and kitchen are in poor condition.

It is recommended that the cafeteria and kitchen be completely altered and renovated.

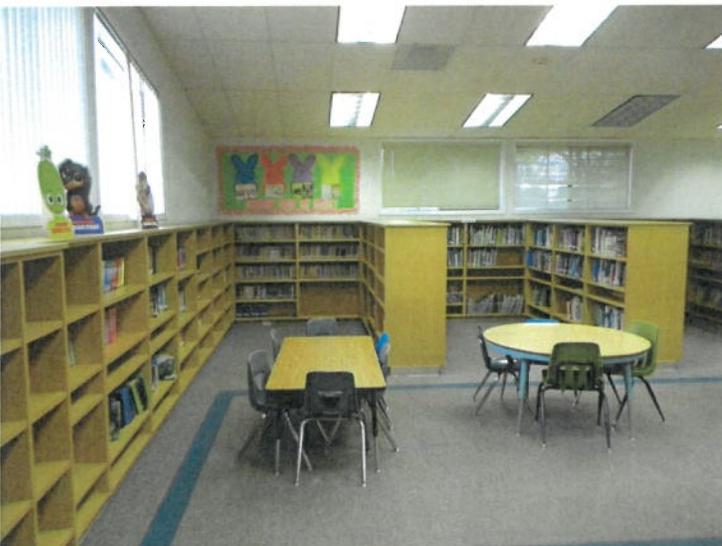
**50. Library**

The existing library is in poor condition.

It is recommended that the library be upgraded and reconfigured to meet the District standard for a collaborative space with the addition of a wellness center.
