# SEYMOUR PUBLIC SCHOOLS BUNGAY ELEMENTARY SCHOOL

35 Bungay Road, Seymour, Connecticut, 06483

## EXISTING EDUCATIONAL FACILITY ASSESSMENT

June 15, 2025

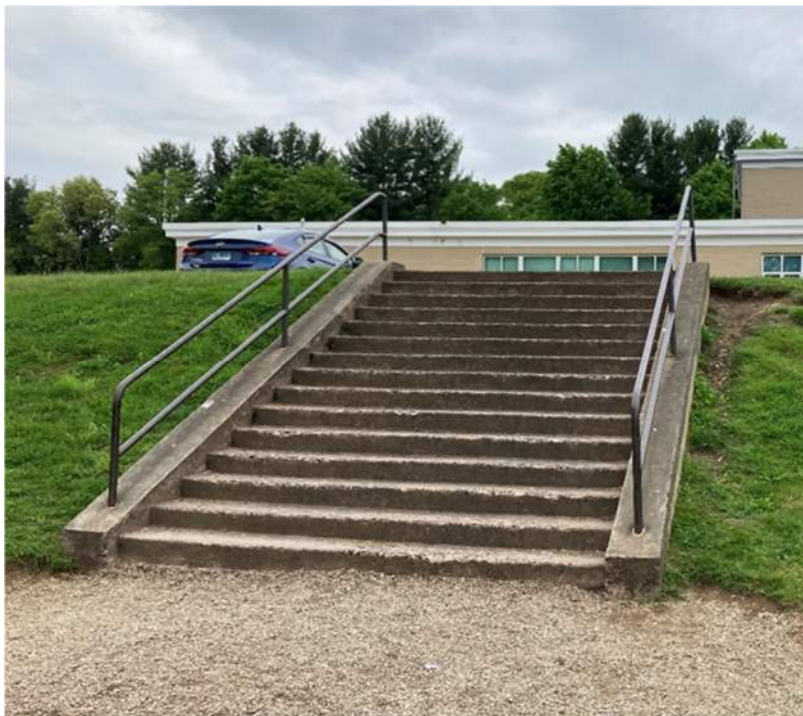
Existing exterior concrete stairs leading from the school level to the lower fields.

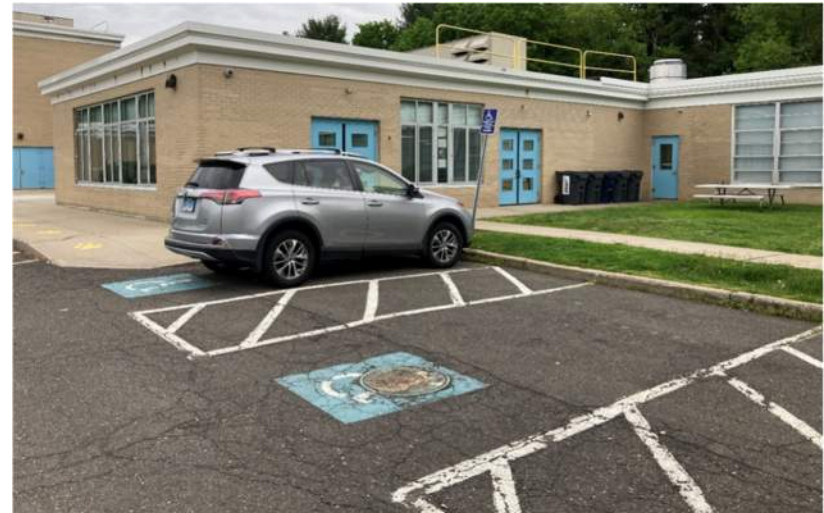
Partially marked accessible parking spaces and aisles (above).

It does not appear that accessible parking spaces, signs, ramps and accessible routes to the building fully meet ADA requirements. Bituminous pavement at parking areas is in poor condition showing cracks and deterioration. There is no formal separation for buses and cars at the site which may pose traffic/pedestrian circulation safety concerns. The crossing of the driveway at the main curb cut is not marked by a crosswalk and the crossing length is approximately 100 feet making this an unsafe crossing condition.

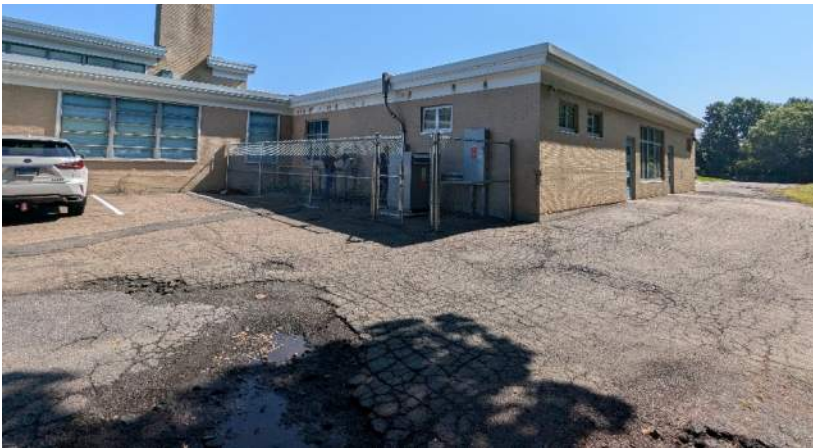
The condition of the paved drives and parking located on the site reflect areas of patching and periodic maintenance. Some of the older sections of pavement located along the south-west side of the school exhibit excessive cracking, surface erosion and an exposed aggregate base. If left unaddressed, the cracks will permit water infiltration subjecting the bituminous paved surfaces to further deterioration during freeze-thaw cycles.

Visible surface deterioration of the existing south access drive and parking

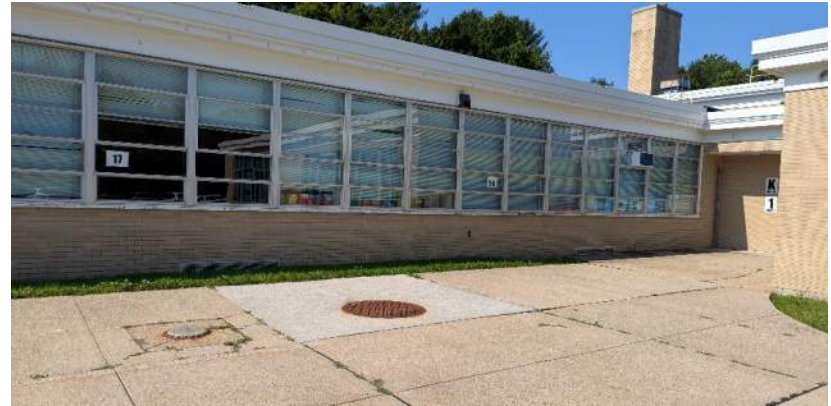
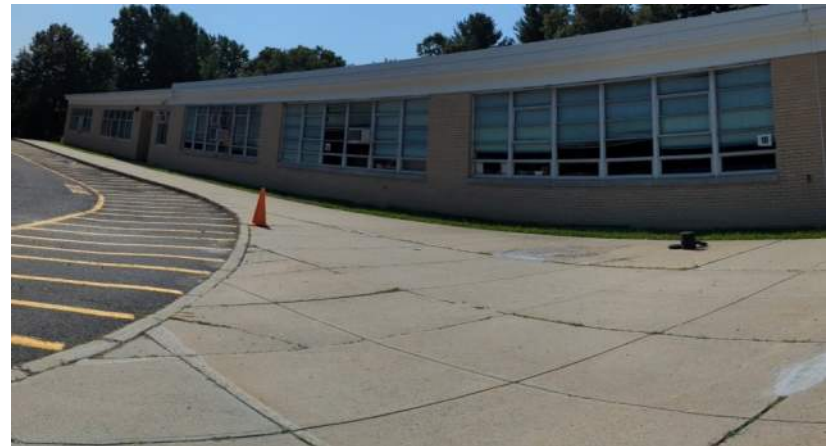
The perimeter of Bungay Elementary School is served by large expanses of perimeter concrete walks. The majority of concrete flagging appears uniform but the surfaces are worn and have begun to expose its stone aggregate. There is evidence of replaced sections of concrete pavement. The joints between sidewalk flags shows deterioration of prior sealants through the presence of vegetative growth.

A representative view of the existing exterior walk conditions (above and below)

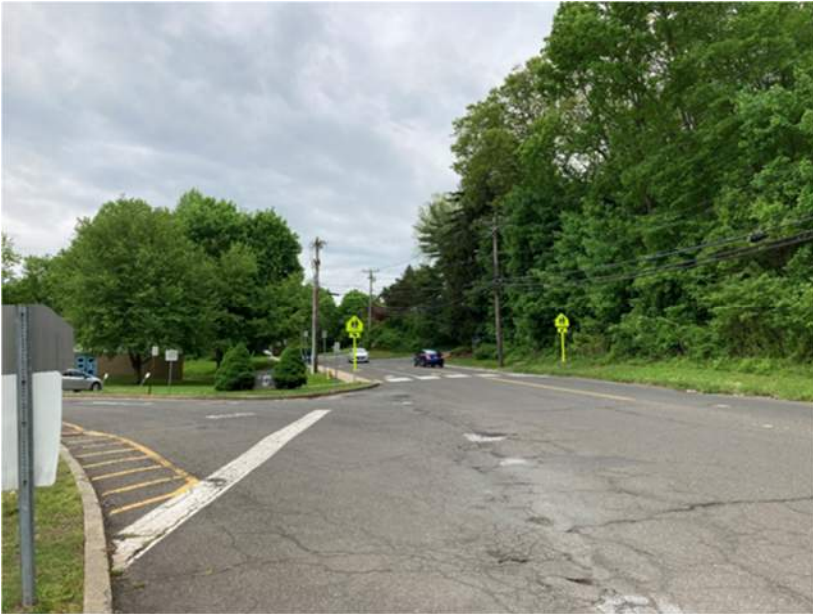
*The main entry drive (left) accessed from a curb cut on Bungay Road.*

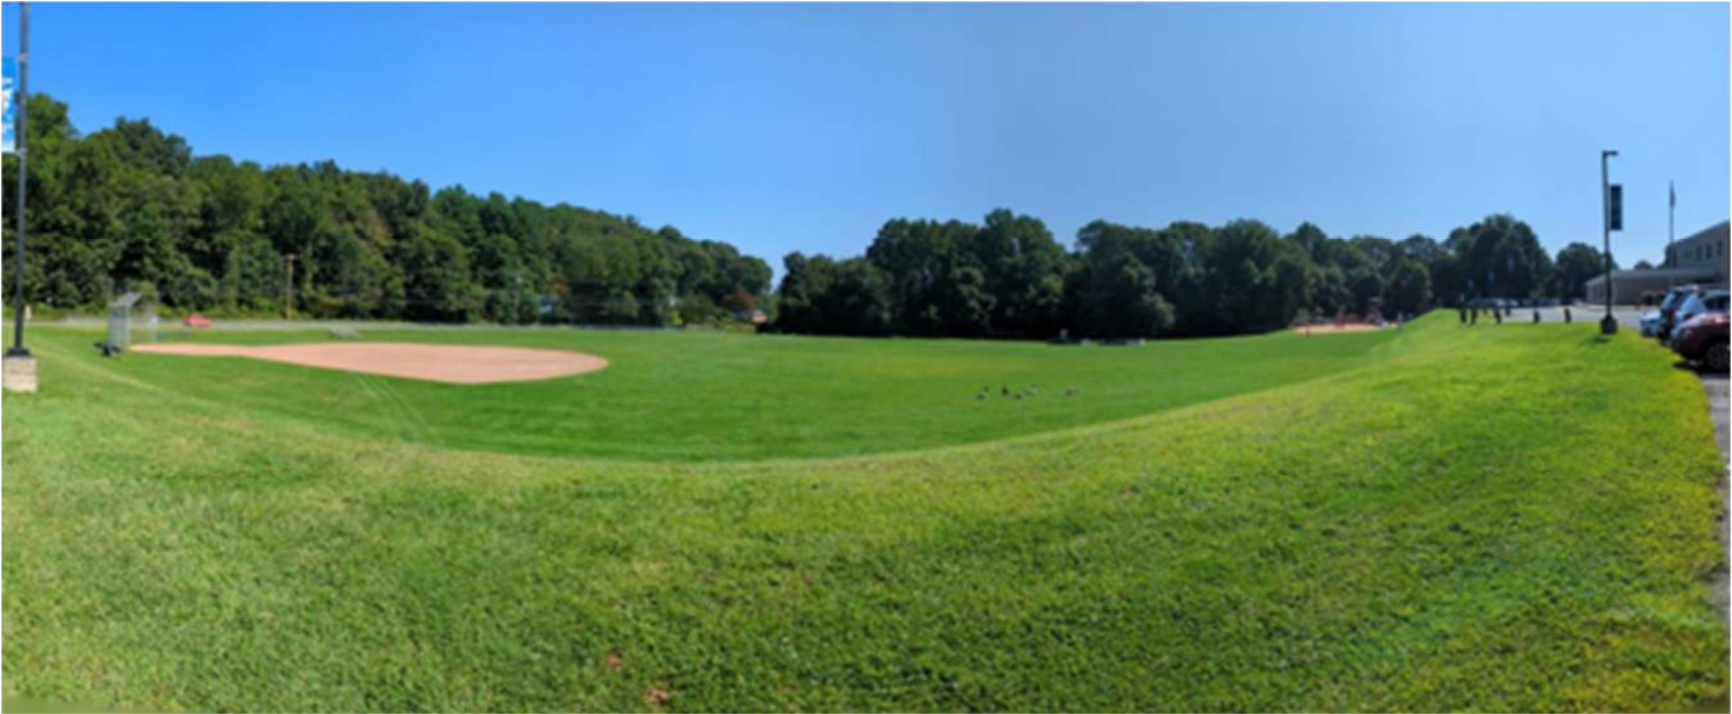
*A view of the existing outdoor athletic field located at the bottom of berm. The level of the field is approximately 10 feet below the existing school's ground floor.*

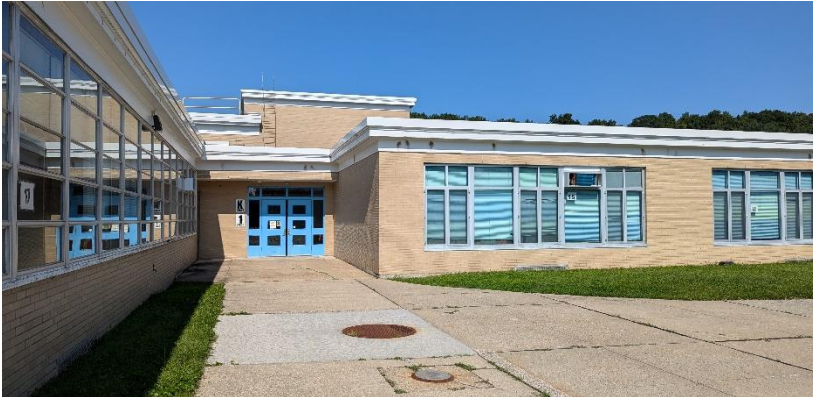
Bungay Elementary School's east elevation leading to its main entrance

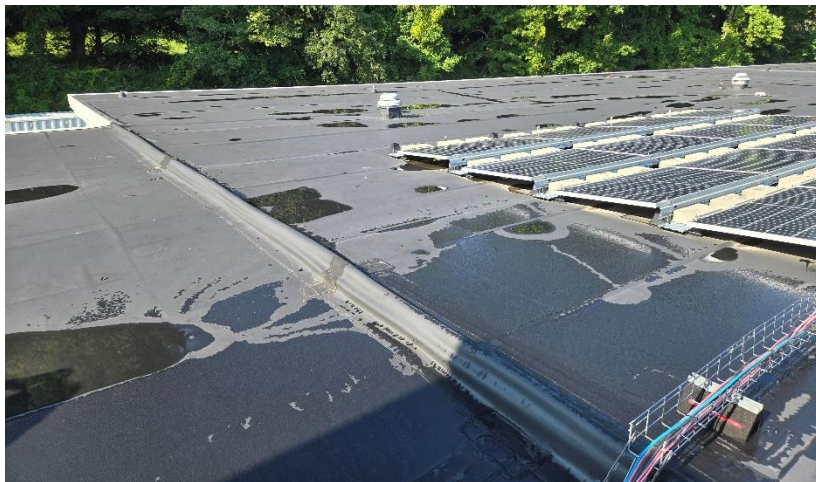
The roof material is an EPDM membrane. In the absence of visible fasteners, the roof is assumed to be a fully adhered system over rigid insulation. No record documents of the roof construction project were retrieved as part of the study process. As a State grant funded project, the roof system is required to have a minimum, non-prorated, no dollar limit, warranty of 20-years.

Although there appears to be some pitch to the low-sloped roof, there is observed ponding in numerous locations along the roof's surface. Though not an immediate concern, prolonged

ponding could accelerate the deterioration of the roof material.

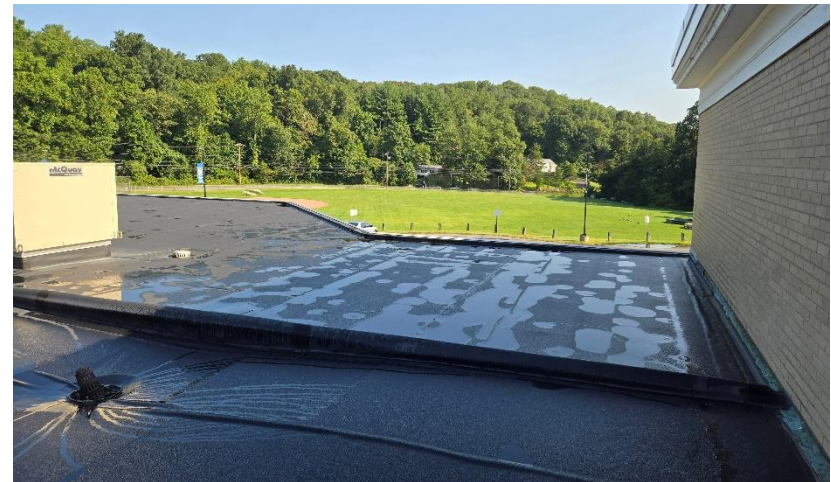
Building additions have been separated from previously completed structures through the use of construction joints. These separations are visible in the roof assembly. The majority of roof drains are protected by stainers, though a few were missing in or not fully seated within the drain assembly. This could result in the accumulation of debris leading to clogging.

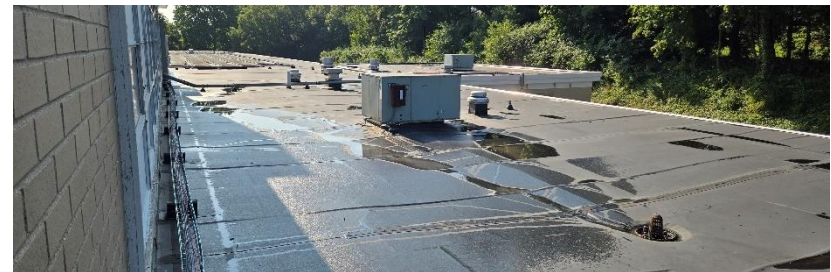
There is also evidence of the membrane moving across the roof's surface. If not addressed, this could also reduce the membrane's service life.

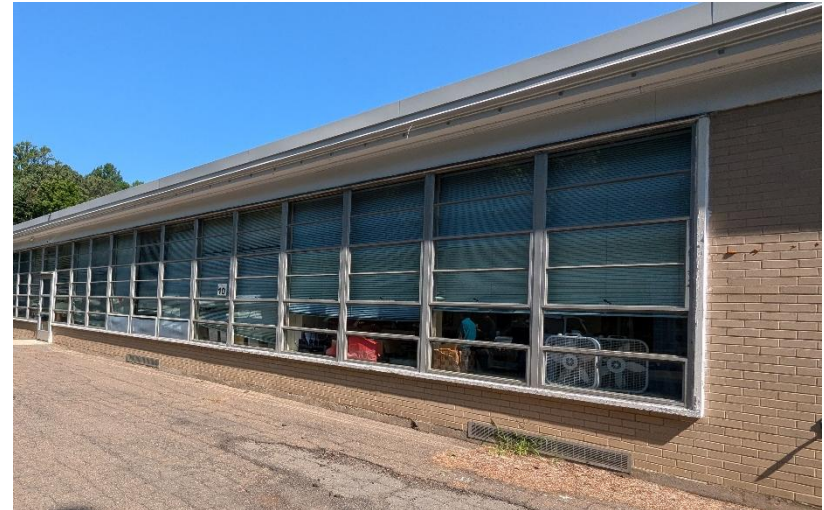
Horizontal louver blinds, in varying states of deterioration, are used to control light in the classrooms.

*Storefront window assemblies used at pre-1996 classrooms (above)*

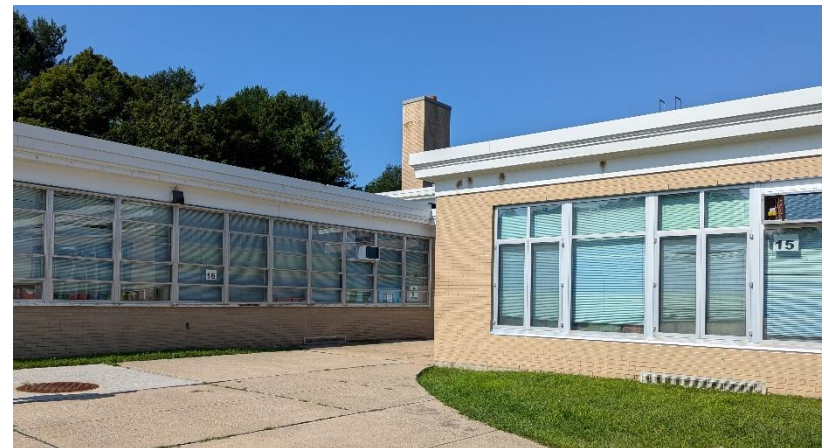
*Storefront glazing utilized during the 1996 improvements project at the right of the image with the older pattern storefront windows used in classrooms on the left (above).*

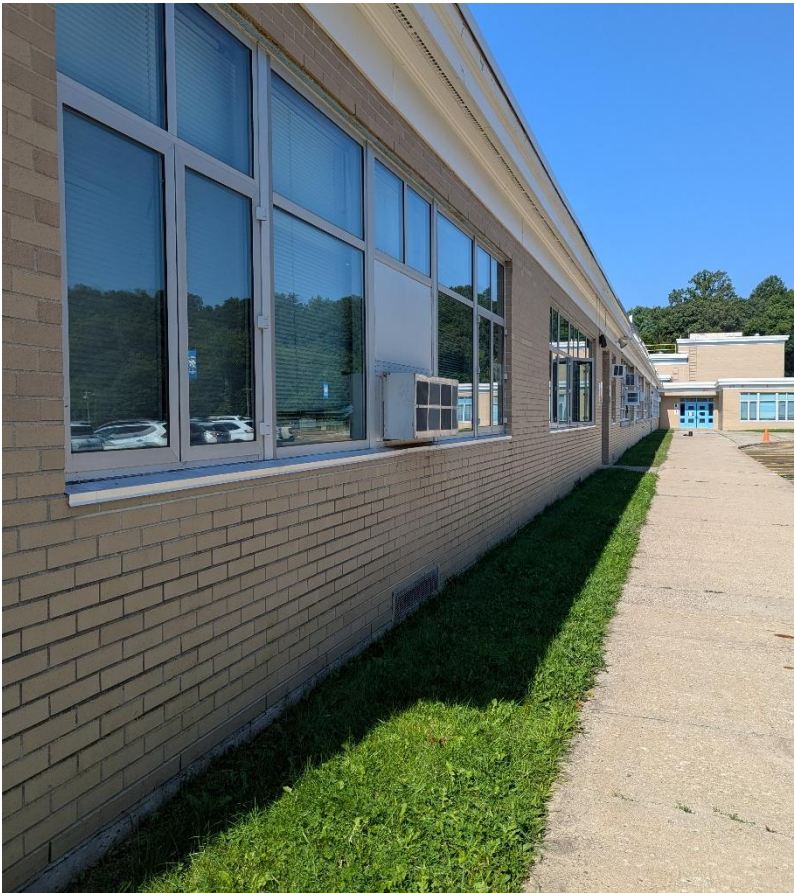
Storefront glazing utilized during the 1996 improvements project at the right of the image with the older pattern storefront windows used in classrooms on the left (above). Note the addition of individual window units providing classroom air conditioning and the presence of rescue windows for emergency egress due to the absence of a full fire sprinkler system.

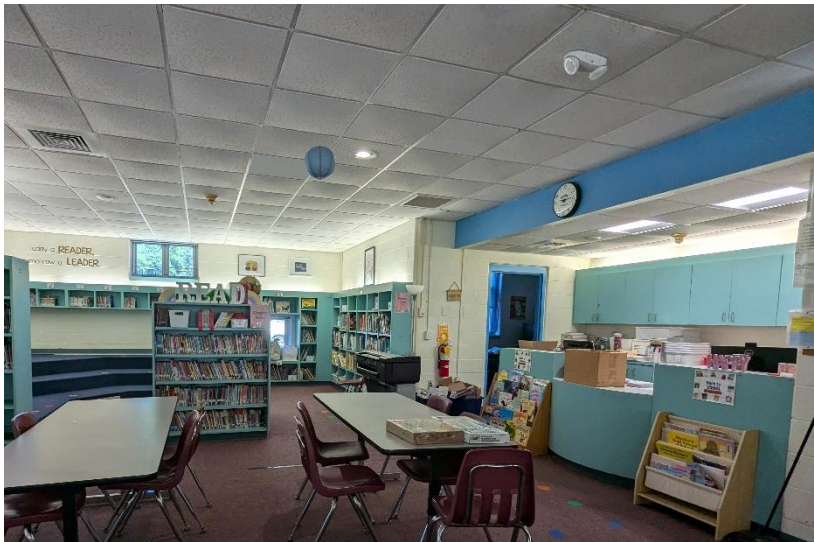
Upon closer inspection, there is evidence of underlying issues that are reflected in the interior finishes. The raking light of perimeter room lighting illustrates the deformation of ceiling panels, like the Media Center in the image, below.

This type of distortion, particularly for ceiling panels installed in 2 feet by 2 feet metal grid, suggests exposure to prolonged high humidity levels. This condition would not be expected in a Media Center and suggests that the ventilation system serving the space is not capable of effectively moderating humidity levels.

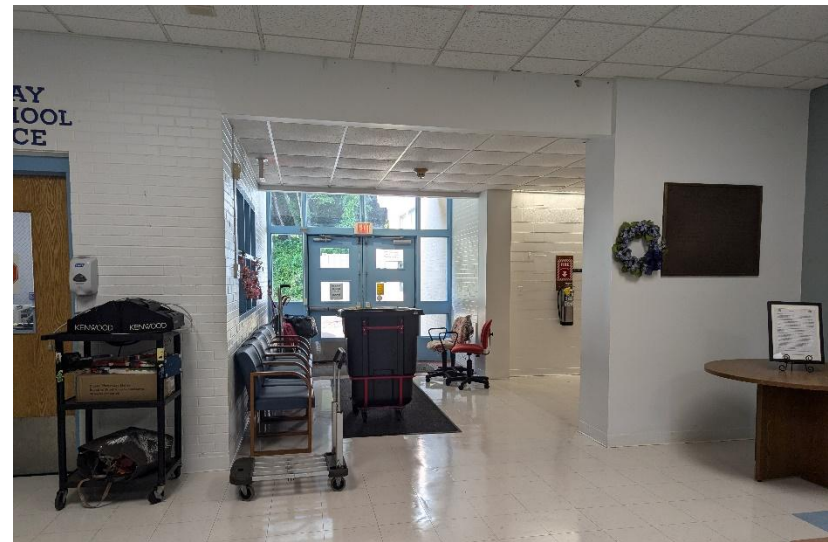
A similar condition was observed with exposure to raking exterior light across ceiling panels within a corridor located in proximity with one of the school's south exits. This exit lacks a vestibule and the ceiling panels in the foreground of the photograph which are further into the school's interior and are not highlight by raking light.

This particular example may be influenced by the school's ventilation system and aspects of its exterior envelope likely lacks the benefit of thermal insulation and controlled air infiltration afforded by contemporary wall systems.

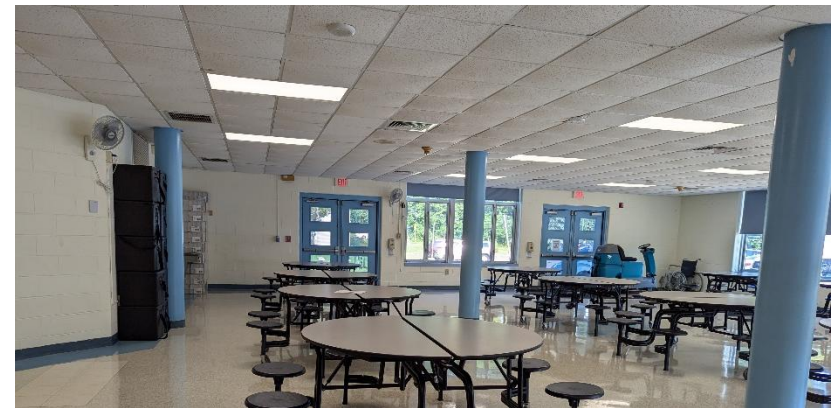
A similar distortion of ceiling panels is observed in the Cafeteria that was expanded in the school's 1996 building project.

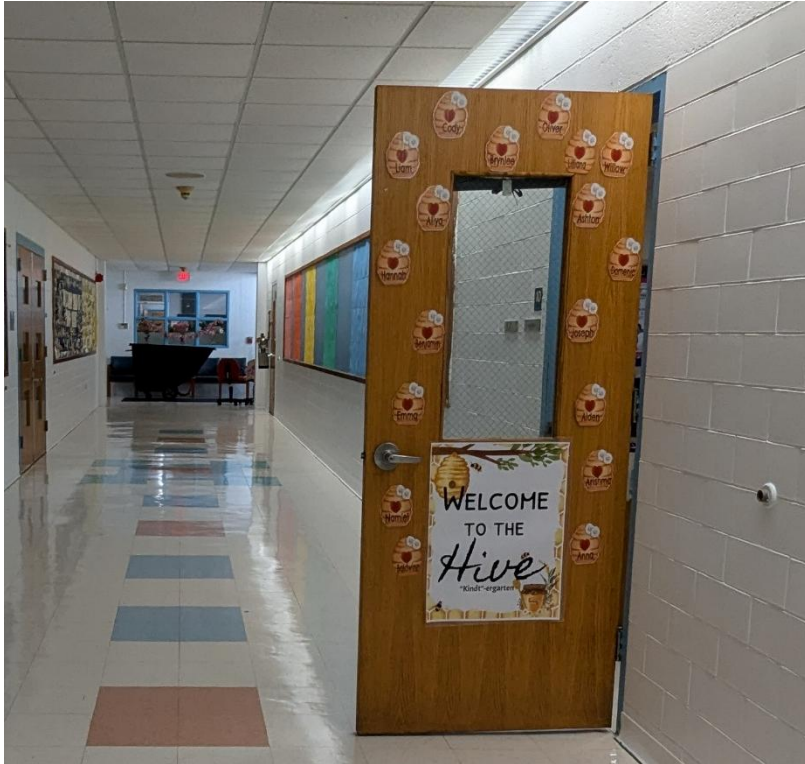
The door in the example above illustrates a typical classroom door. Though permitted under prior Building Codes, the use of wired glass (assumed to achieve a rated assembly) has been discontinued due to the hazard the wire poses to personal injury in an emergency egress situation. The size of the lite offers little

security for room occupants in a lockdown scenario both from the aspect of view into the classroom and potential access to interior facing locking hardware should the glass be broken. Regarding aspects of fire safety, this door is located in a corridor wall that should provide a rated separation in a school that lacks fire sprinklers. The open door does not appear to be equipped with an automatic closing device necessary to maintain the continuity of the fire rated separation.

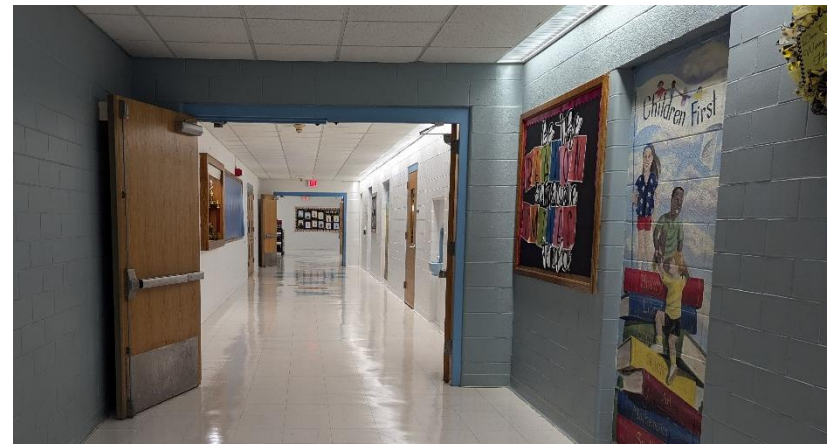
Fire compartmentalization of the school appears to have been achieved through the use of rated door assemblies on magnetic-opens. The doors in this image permit egress travel in both directions and are fitted with emergency exit devices, automatic closers, surface mounted positive latching hardware and metal kick-plates.

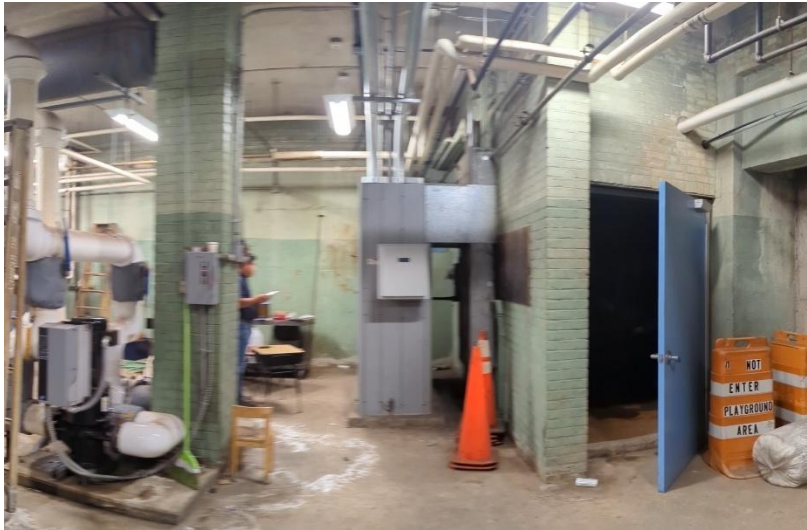
Utility service doors, such as the example in the following photograph are metal flush doors. Though the door appears to have been fitted with accessible lever trim hardware and an automatic closer, the closer appears to have been defeated to leave the door in an open position.

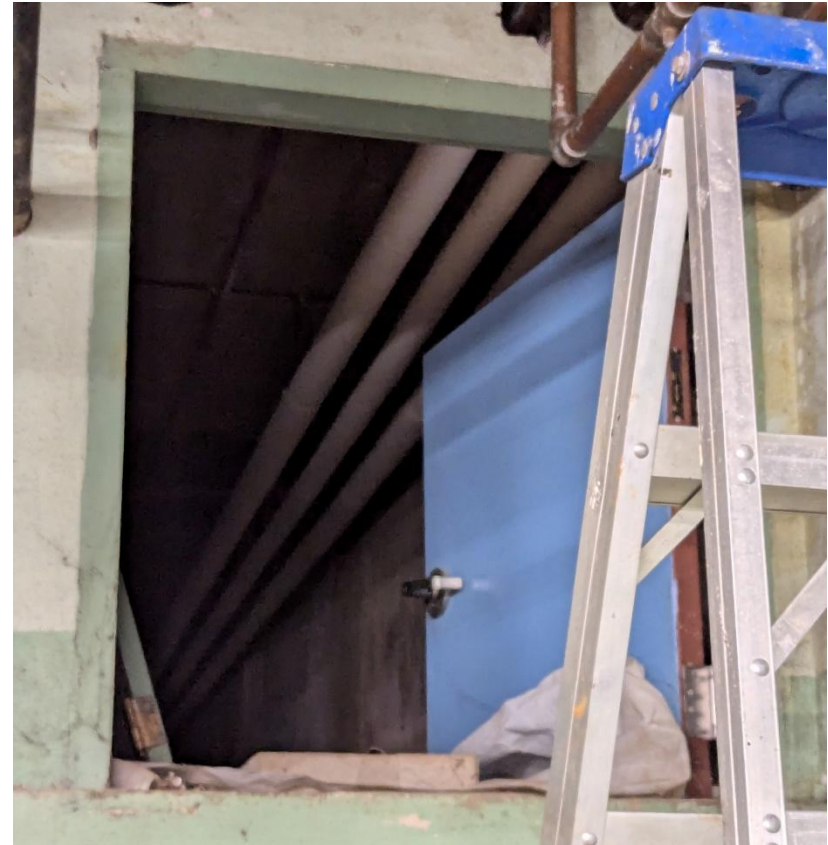
A partial height door providing access to a mechanical system crawl space that serves a portion of the original school.

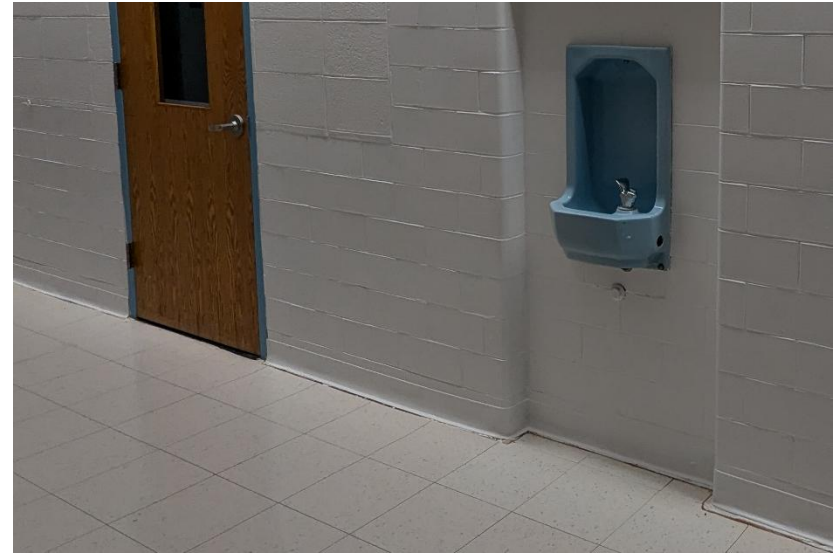
The consistent level of maintenance of resilient flooring is in keeping with other interior finishes within Bungay Elementary. Area finished in resilient floor tiles do reveal open seams between tiles which accumulate dirt making the seams more apparent in light colored floor tiles. The open seams may have resulted from changes in temperature and uncontrolled humidity within the school.

A more significant deterioration of the floor system is apparent along the perimeter of corridors where the tile appears to have separated leaving a pronounced gap along the wall perimeter along the resilient base. This condition is not isolated to a single location, but rather, results in proximity to expansion joints, pilasters and transitions between wall materials, as can be viewed in the following images.

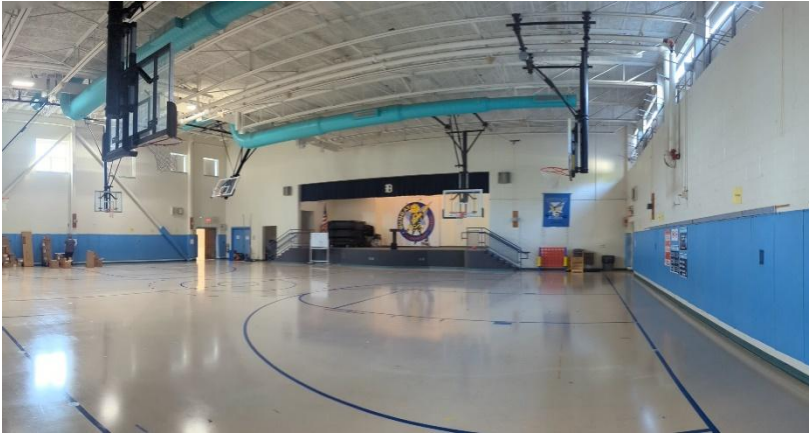
The gymnasium is the school's primary assembly space. It was expanded as part of the 1996 building project to provide a full basketball court. The original gymnasium had an exposed Tectum while the addition is an exposed steel roof deck over steel joists. There is no bleacher seating provided in the gymnasium. A monolithic athletic floor has been installed for the gymnasium floor surface. The Superintendent of Schools has expressed concern regarding this flooring product associated with reported connective tissue injuries. The gymnasium's perimeter wall surfaces are protected by wall pads. There are six retracting basketball goals, two for the main court and four for half-court play.

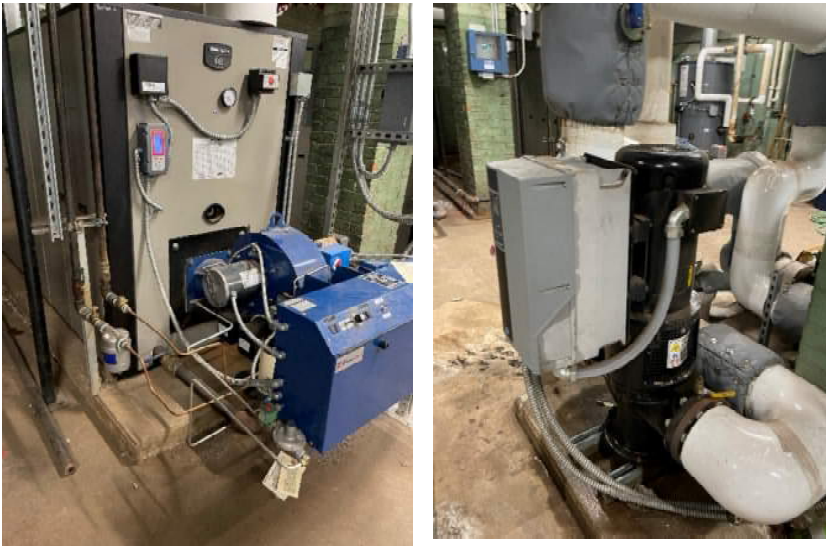
Two (2) Dual Fuel boilers manufactured and installed in 2019. Boilers are capable of operating on fuel oil and natural gas. Boilers manufactured by Weil McLain, Model 88. Two (2) Burners by Power Flame, Model CR3-GO-25. Both boilers equipped with circulating pumps.

*A view of the hot water heater (left) and circulating pumps (right).*

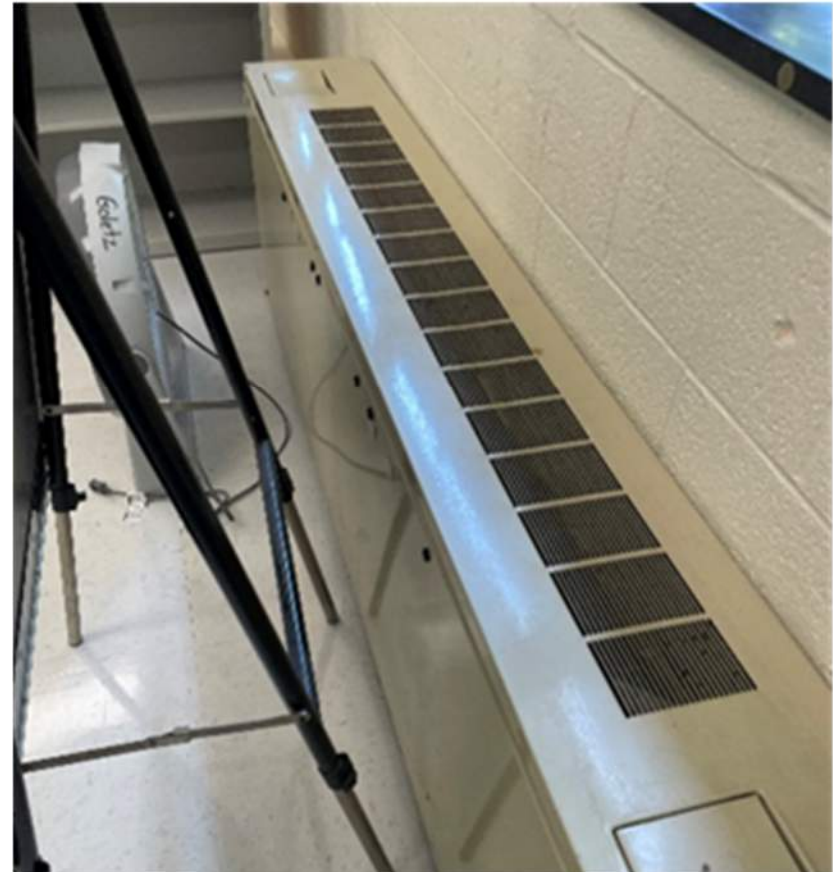
*Typical perimeter unit ventilator used in classrooms.*

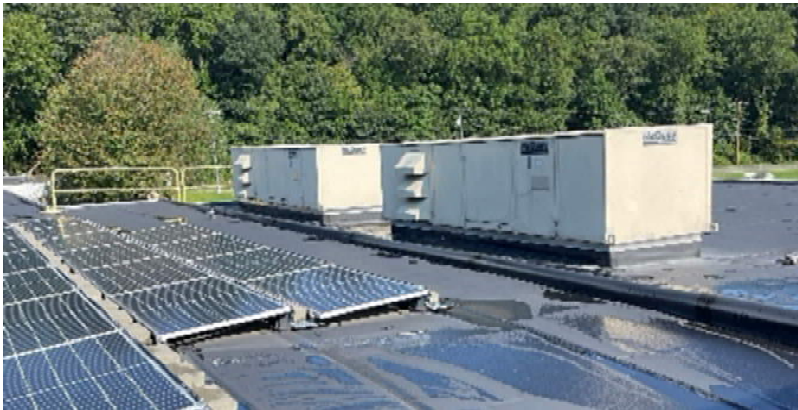
The gym is provided with heating and ventilation (no cooling) via two Rooftop units (RTU-1 and RTU-2). The units were installed in 1996. These units are past their useful life.

*A view of a typical rooftop unit serving the gymnasium.*

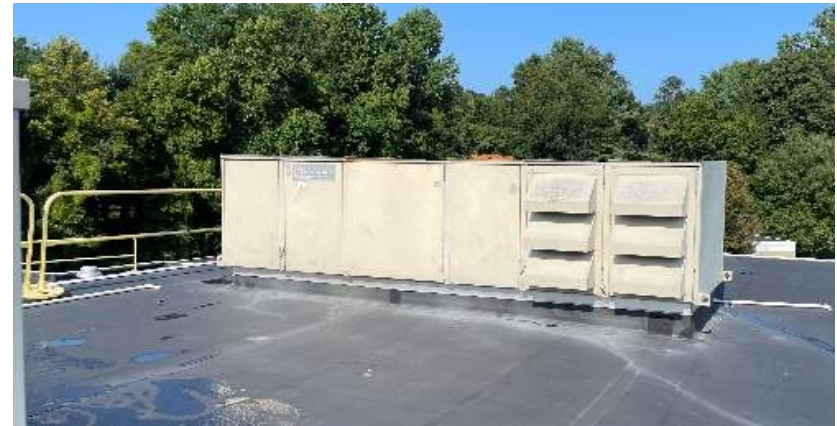
The cafeteria is provided with heating and ventilation (no cooling) via two Rooftop units (RTU-3 and RTU-4). The units were installed in 1996. These units are past their useful life.

*Rooftop units serving the cafeteria.*

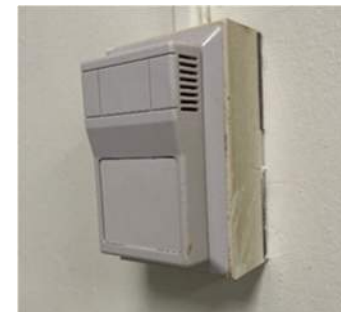
The building systems are controlled by a Building Management System (BMS or BAS). The existing system is a Tridium based system by Environmental Systems Corporation (ESC). The BMS is a direct digital control system (DDC). The BMS controls the RTU's and the unit heaters.

*Typical BMS thermostat.*

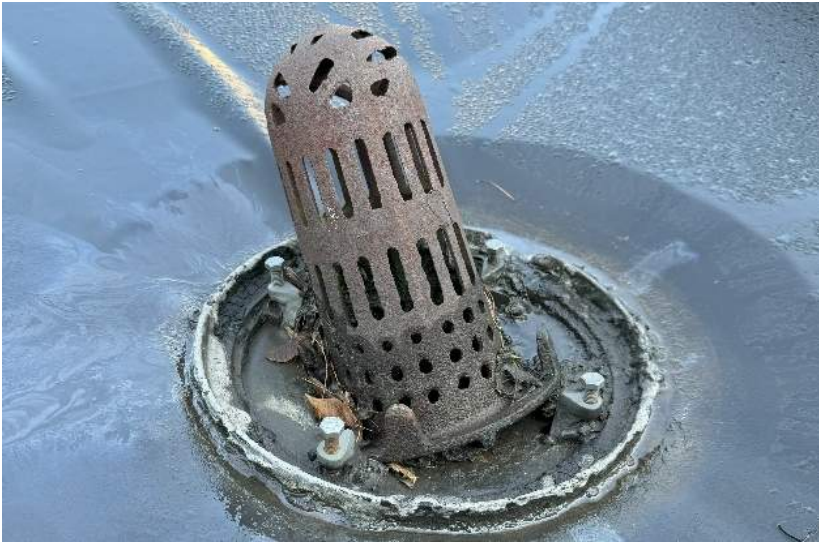
The existing storm drains were observed to in vary levels of disrepair. Drains are missing or observed to be damaged and sunken into the roof likely to cause leaks.

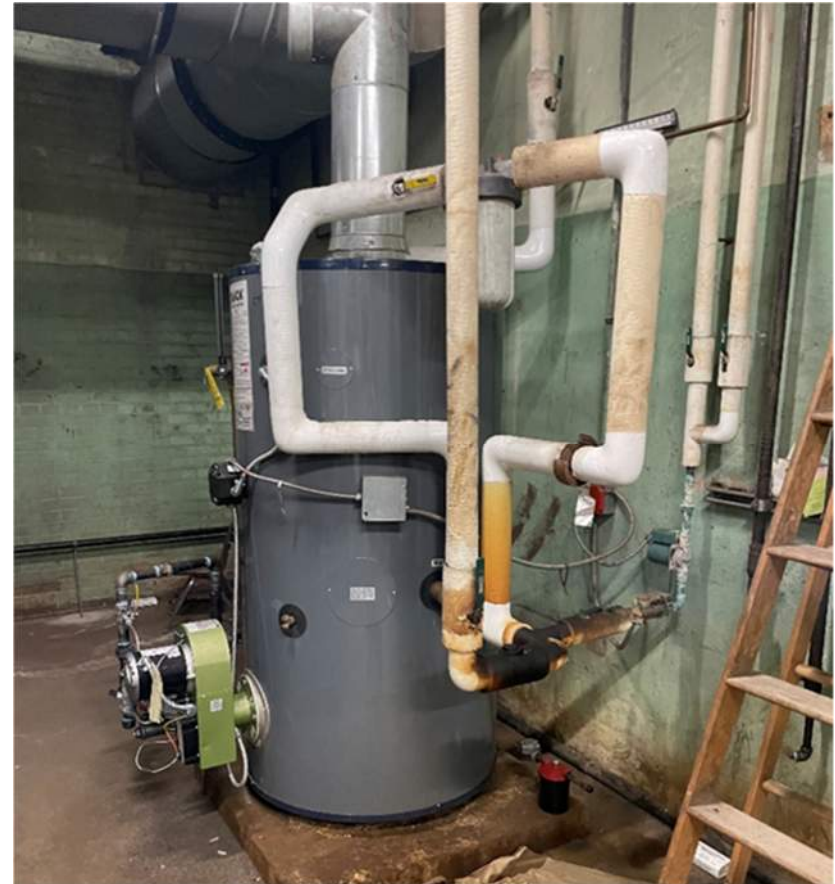
Domestic hot water is provided by a Bock fuel oil fired water heater with an 83-gallon storage capacity and 648 gph recovery at 90°F rise. The water heater was observed to be in good working order but dated.

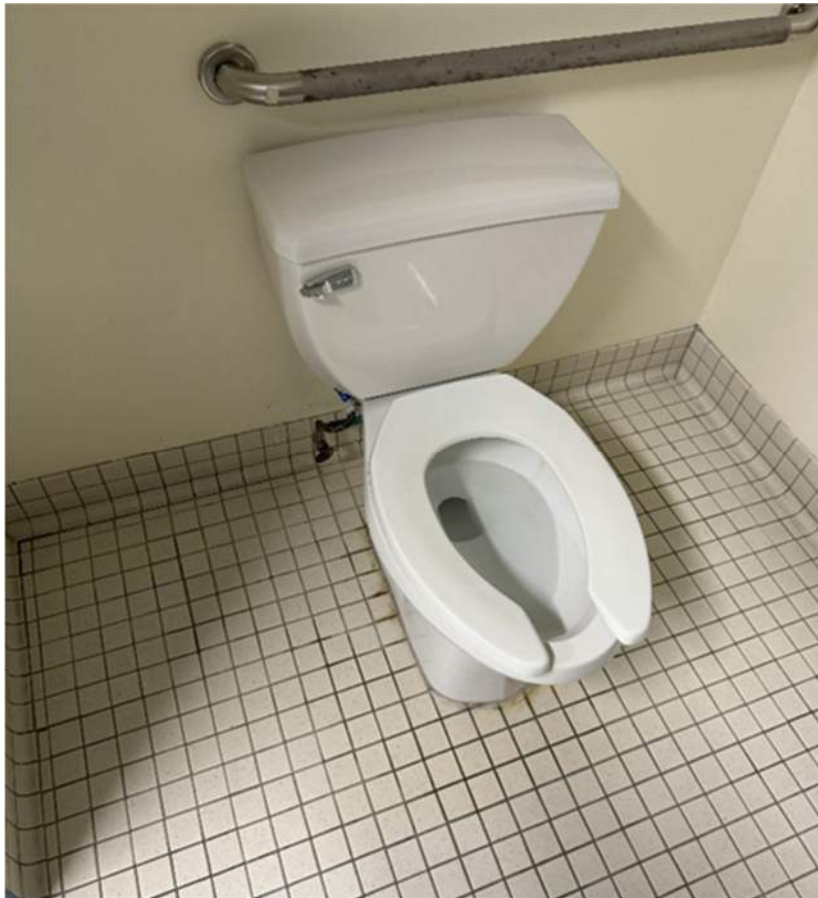
Water closets are flush tank type in good working condition. Lavatories are generally wall hung vitreous china in good working order but dated.

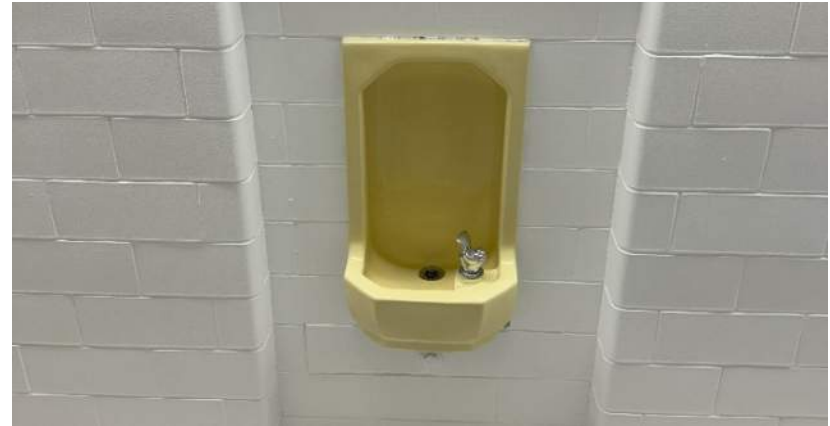
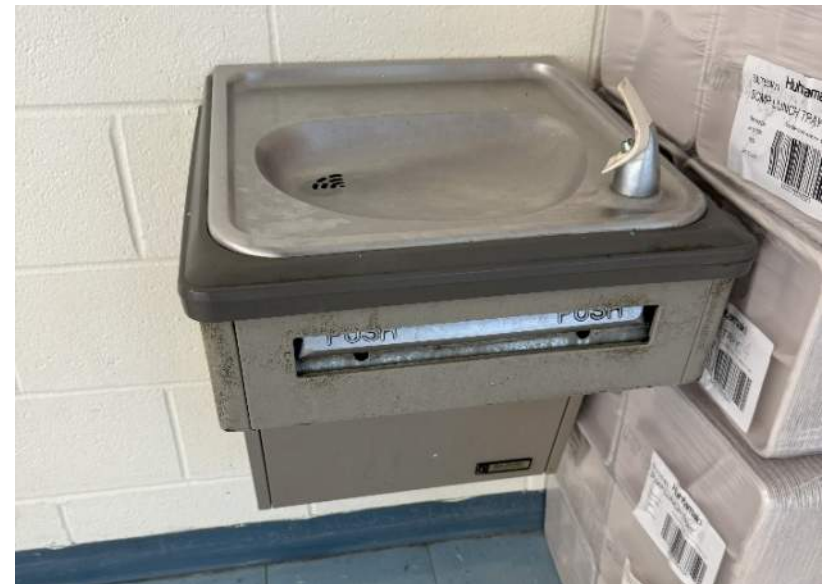
Water fountains are dated and well beyond their useful service life. One water fountain was observed to be over 20 years old. An existing water fountain was observed to have a broken dispense button that had been pushed into the fixture's housing.

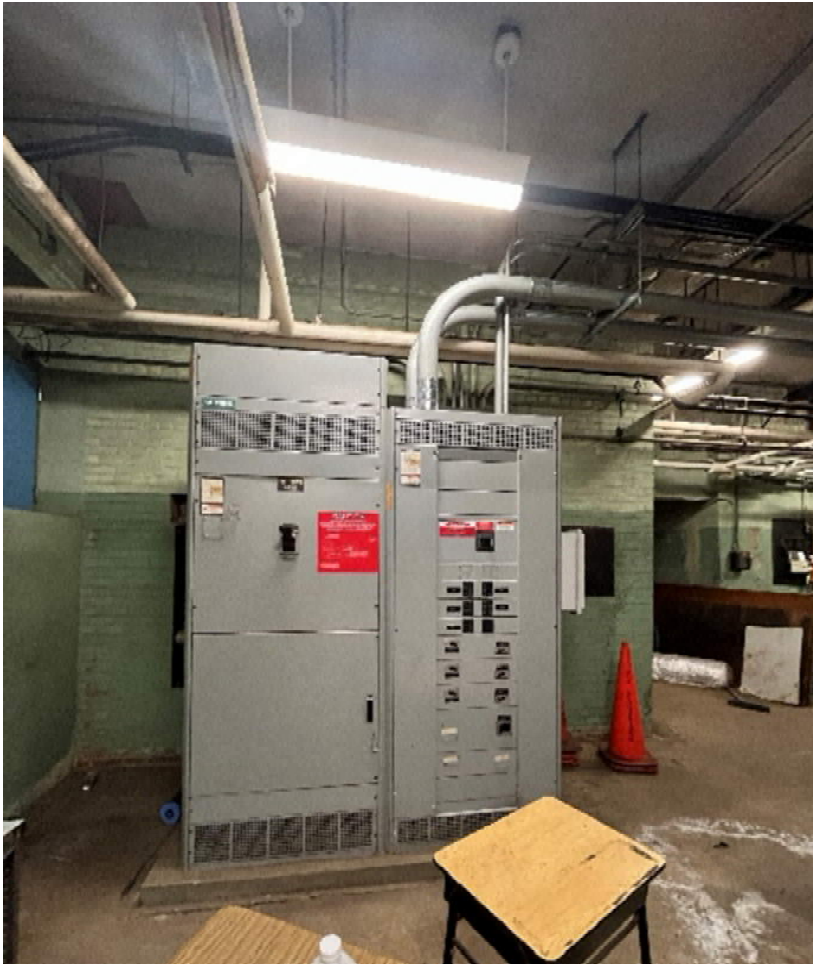
*Main switchboard in basement boiler room.*

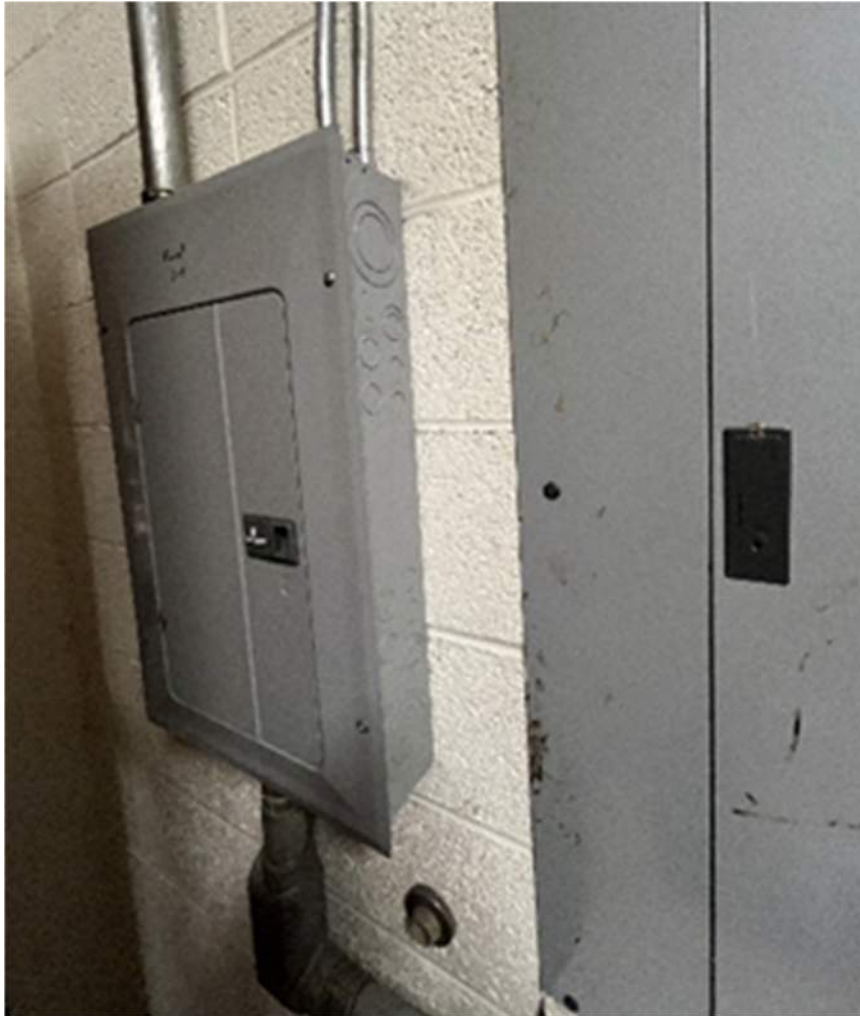
*Electrical Distribution in MDF Room*

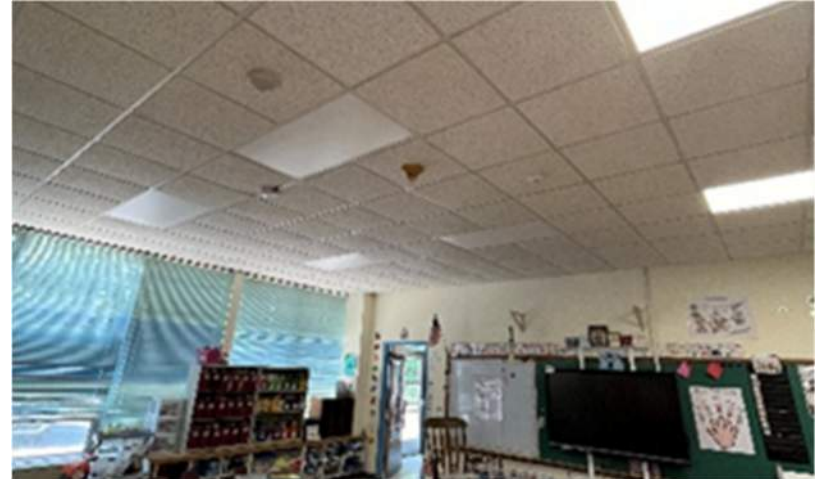
*Typical Classroom Lighting*

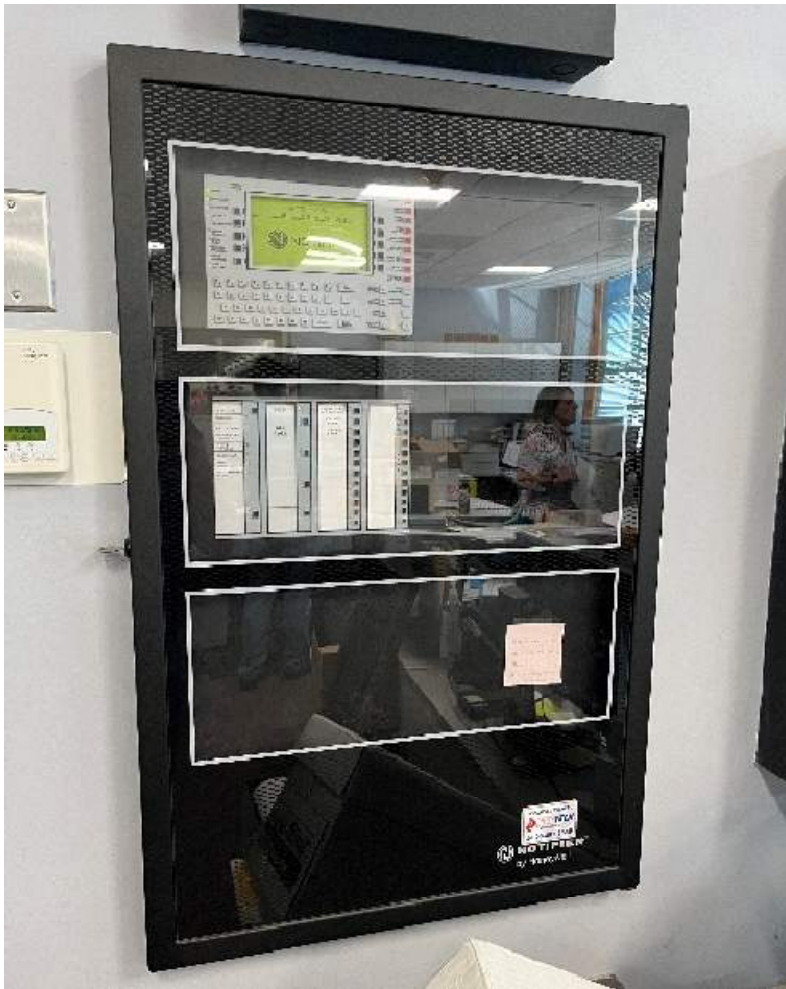
*Notifier Fire Alarm Control Panel in the Administration Suite.*

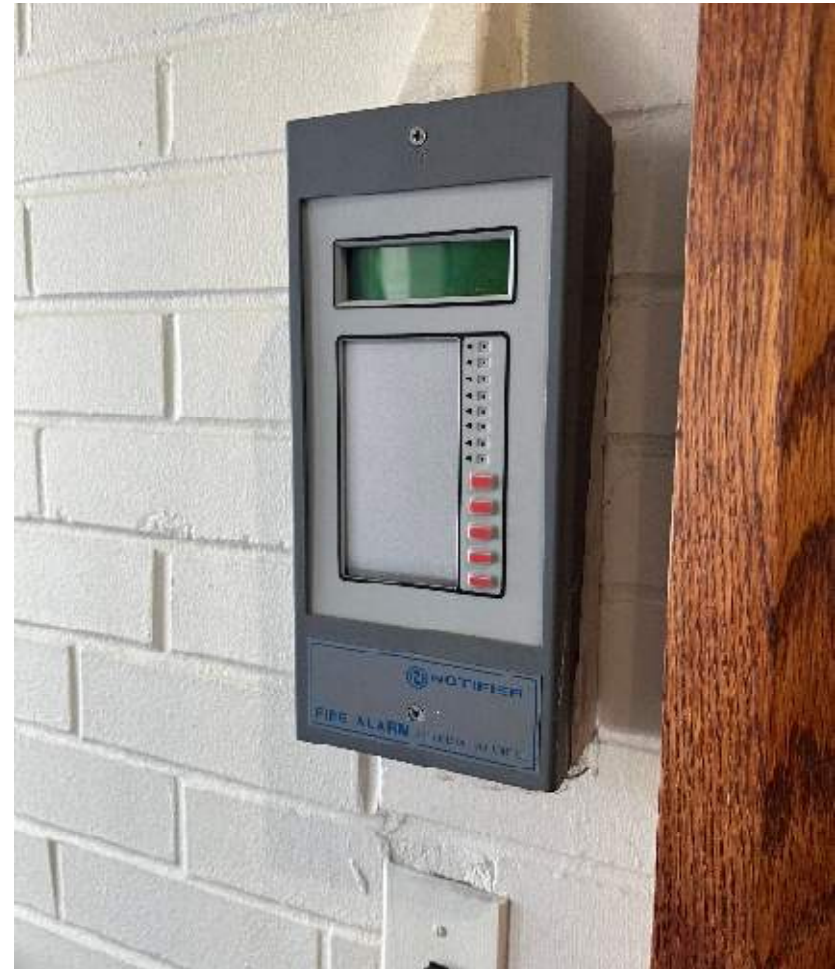
*Inoperable (abandoned) fire alarm annunciator panel in the entry vestibule.*

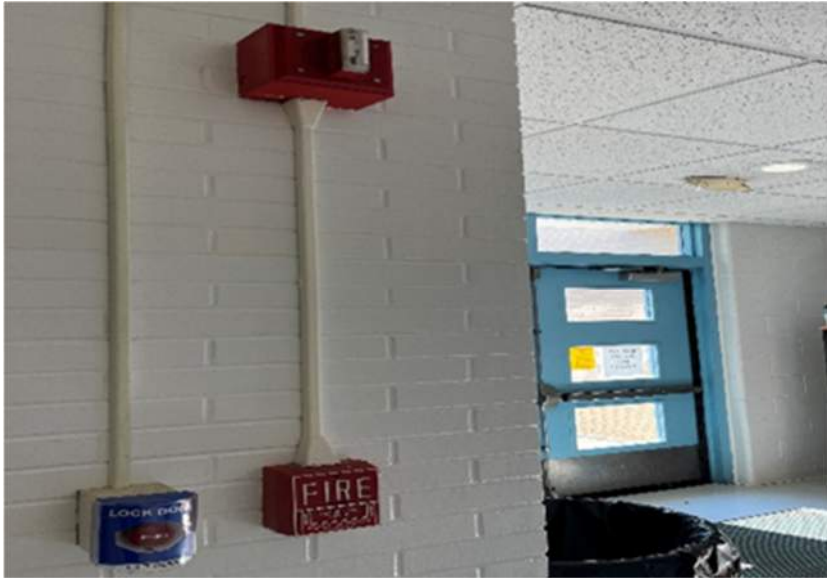
*Fire Alarm manual pull station and strobe in a corridor*
