# SEYMOUR PUBLIC SCHOOLS BUNGAY ELEMENTARY SCHOOL

35 Bungay Road, Seymour, Connecticut, 06483

## EXISTING EDUCATIONAL FACILITY ASSESSMENT

June 15, 2025

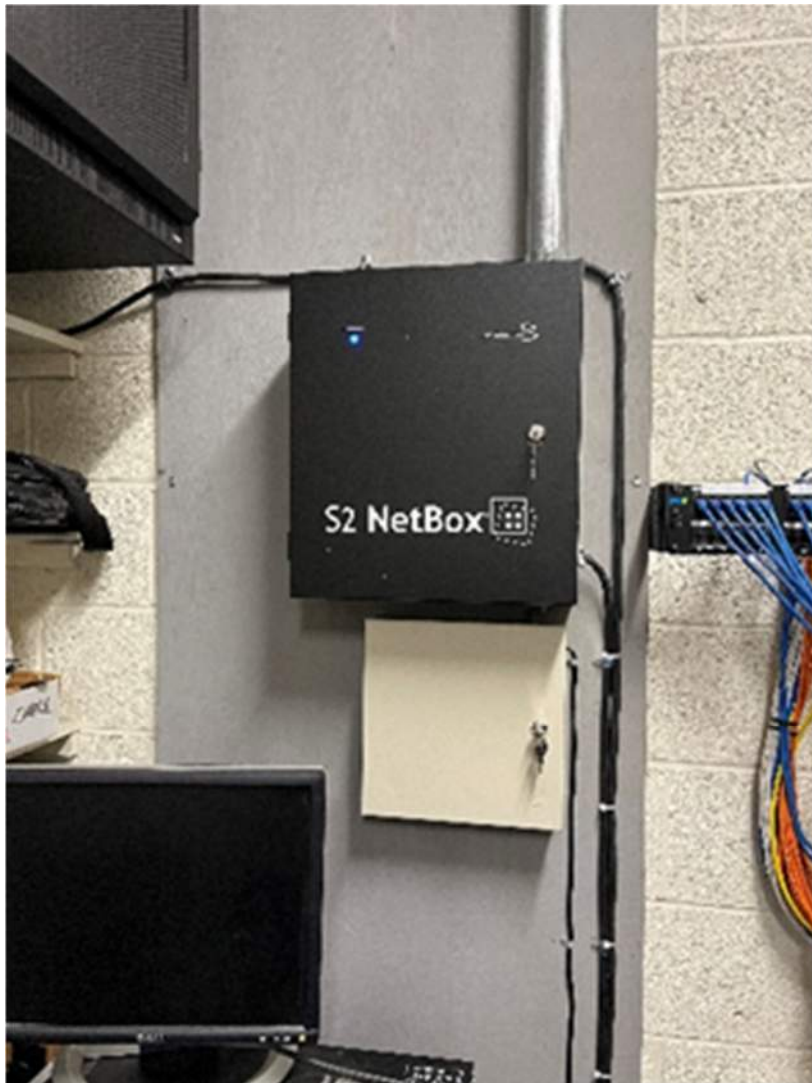
*S2 Security Headend MDF Room*

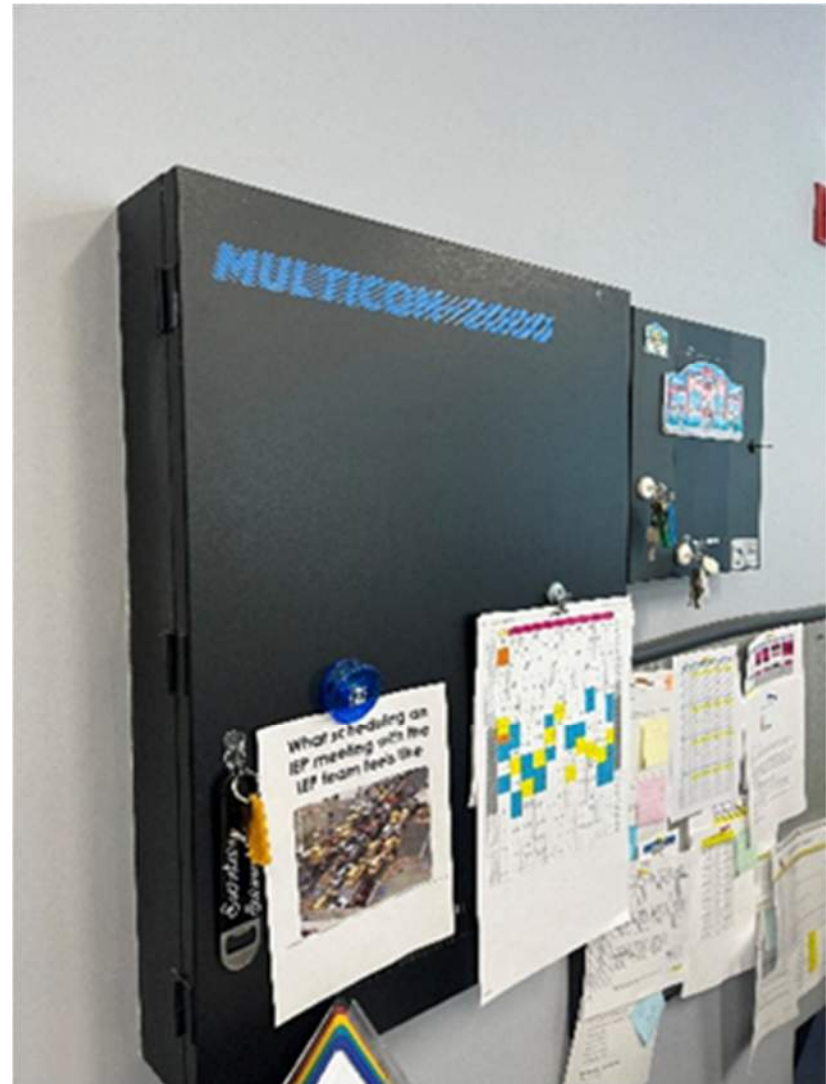
*Multicom PA System in the Administration Suite*

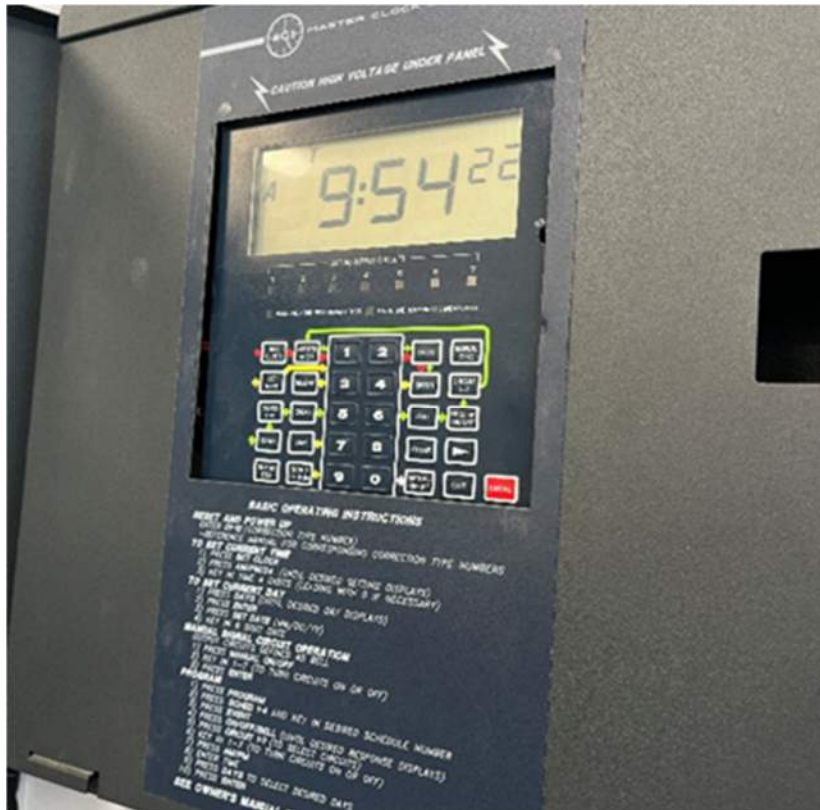
Notifier clock system in the Administration Suite.

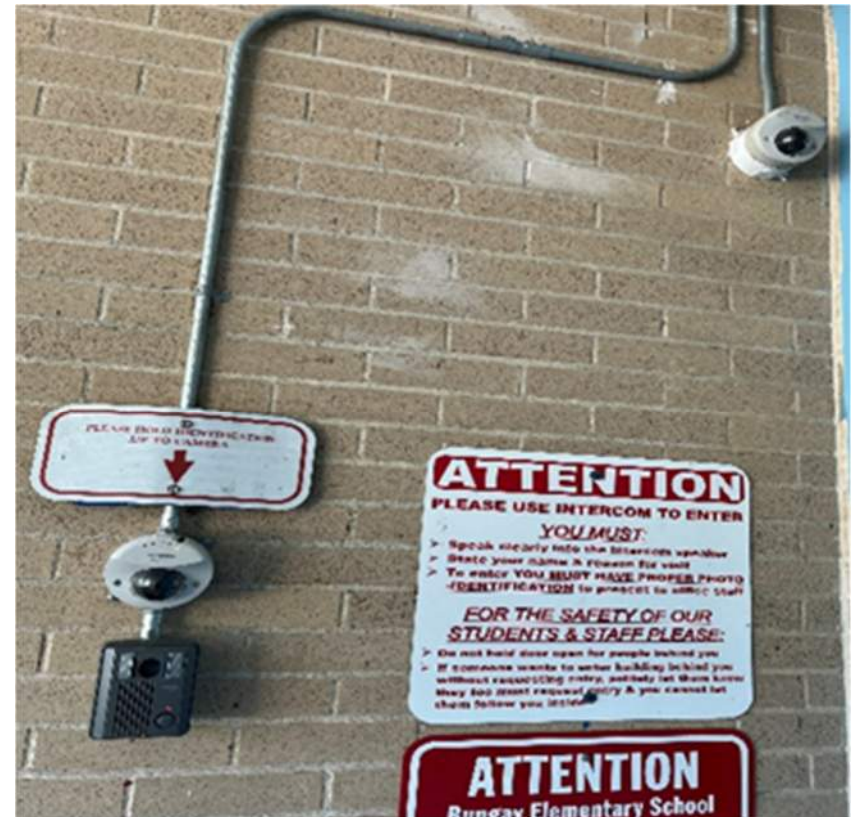
Security camera at the Building Main Entrance

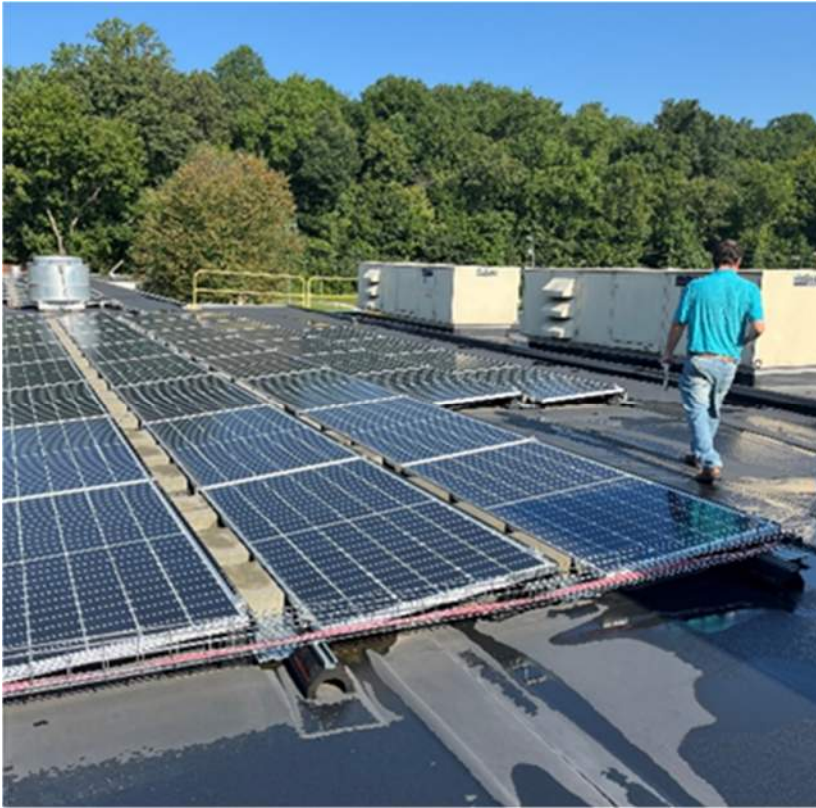
*Roof top photovoltaic system.*

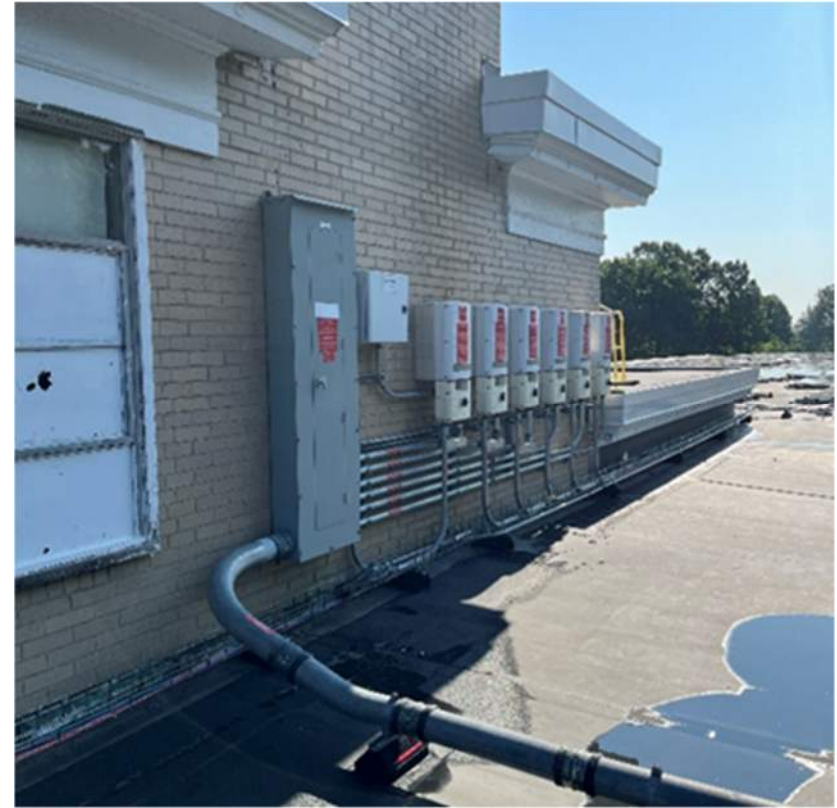
*Roof top 480V Solar Equipment.*
