**HAZARDOUS MATERIALS SURVEY  
FINAL REPORT**

**California Montessori Project - Capitol Campus  
2635 Chestnut Hill Drive  
Sacramento, CA 95826**

**Full Campus Survey  
Campus Renovation Project**

**Entek Project #25-7797**

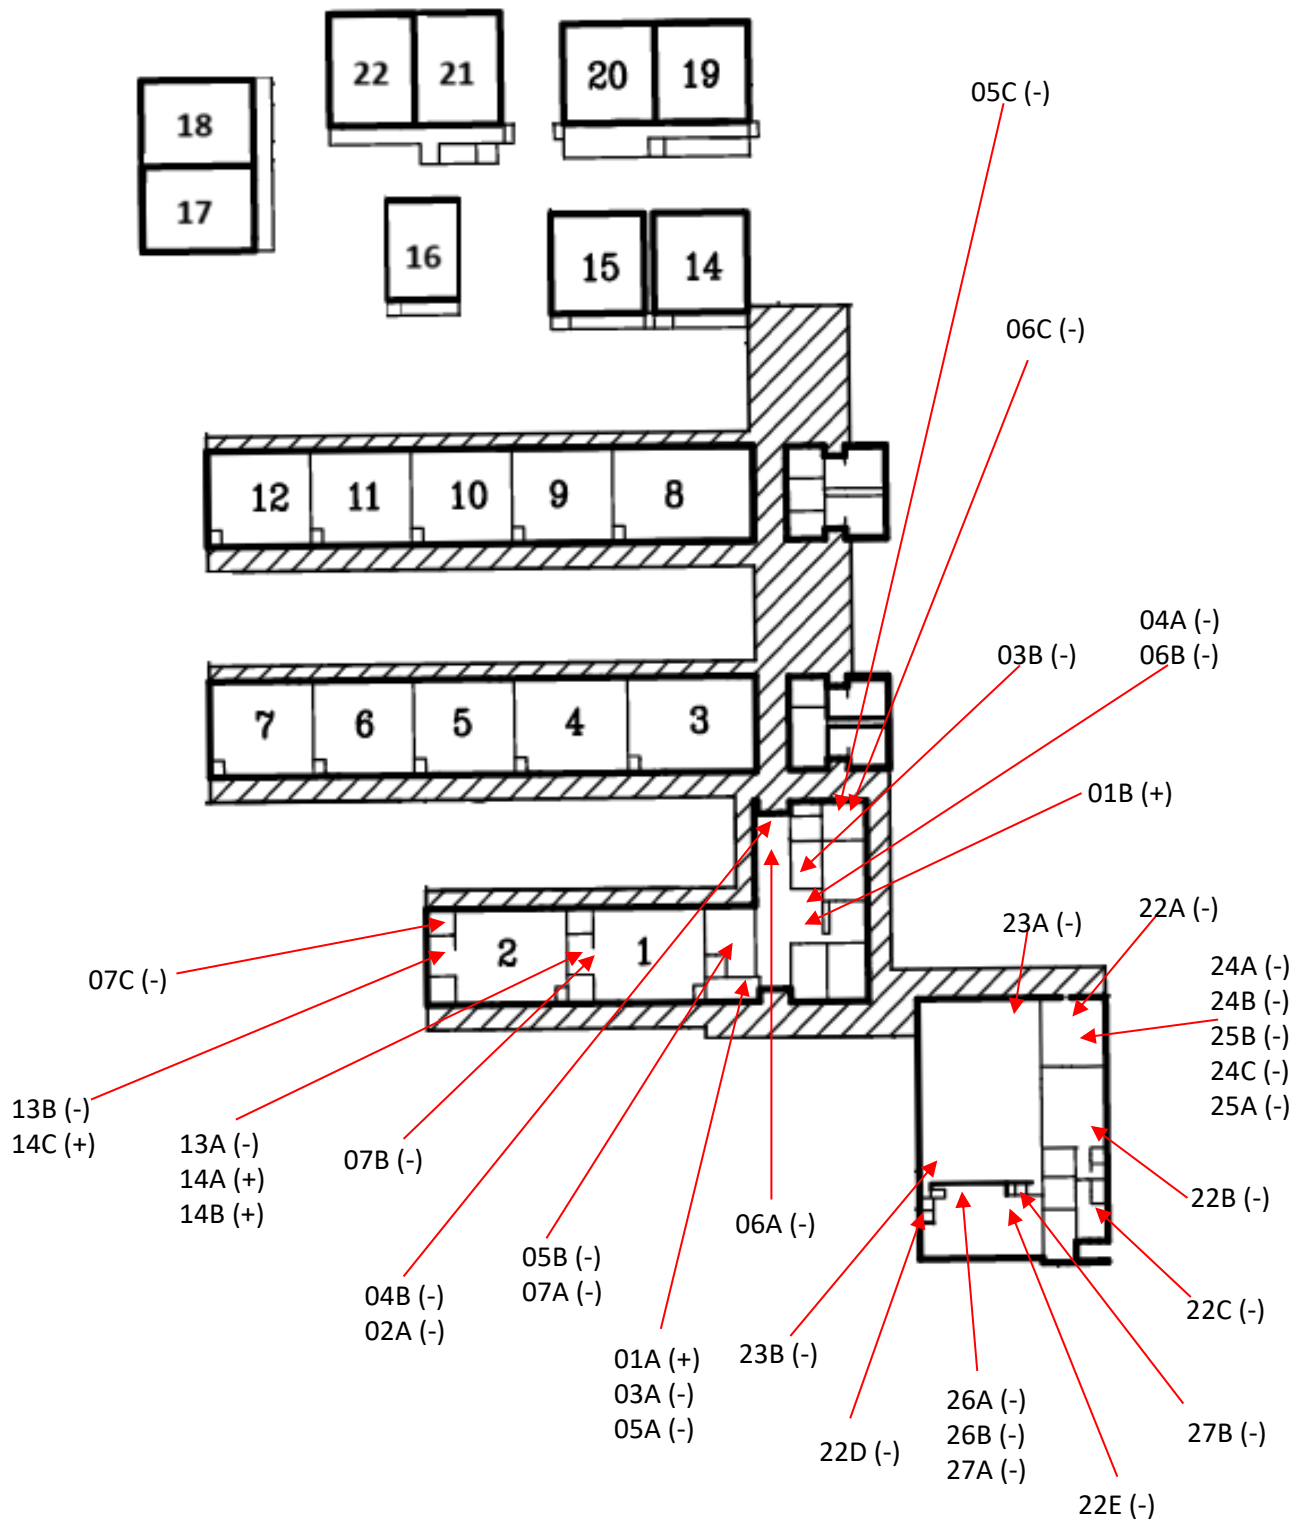
Asbestos Bulk Sample Locations  
Collected by Blake Howes  
On July 30-31, 2025  
Project #25-7797

The attached drawings show approximate sample locations and also identify those bulk sample materials analyzed and found to contain asbestos greater than 1% with a (+) after the sample number. Materials analyzed and found to contain less than 1% asbestos or reported as none detected have a (-) after each sample number.

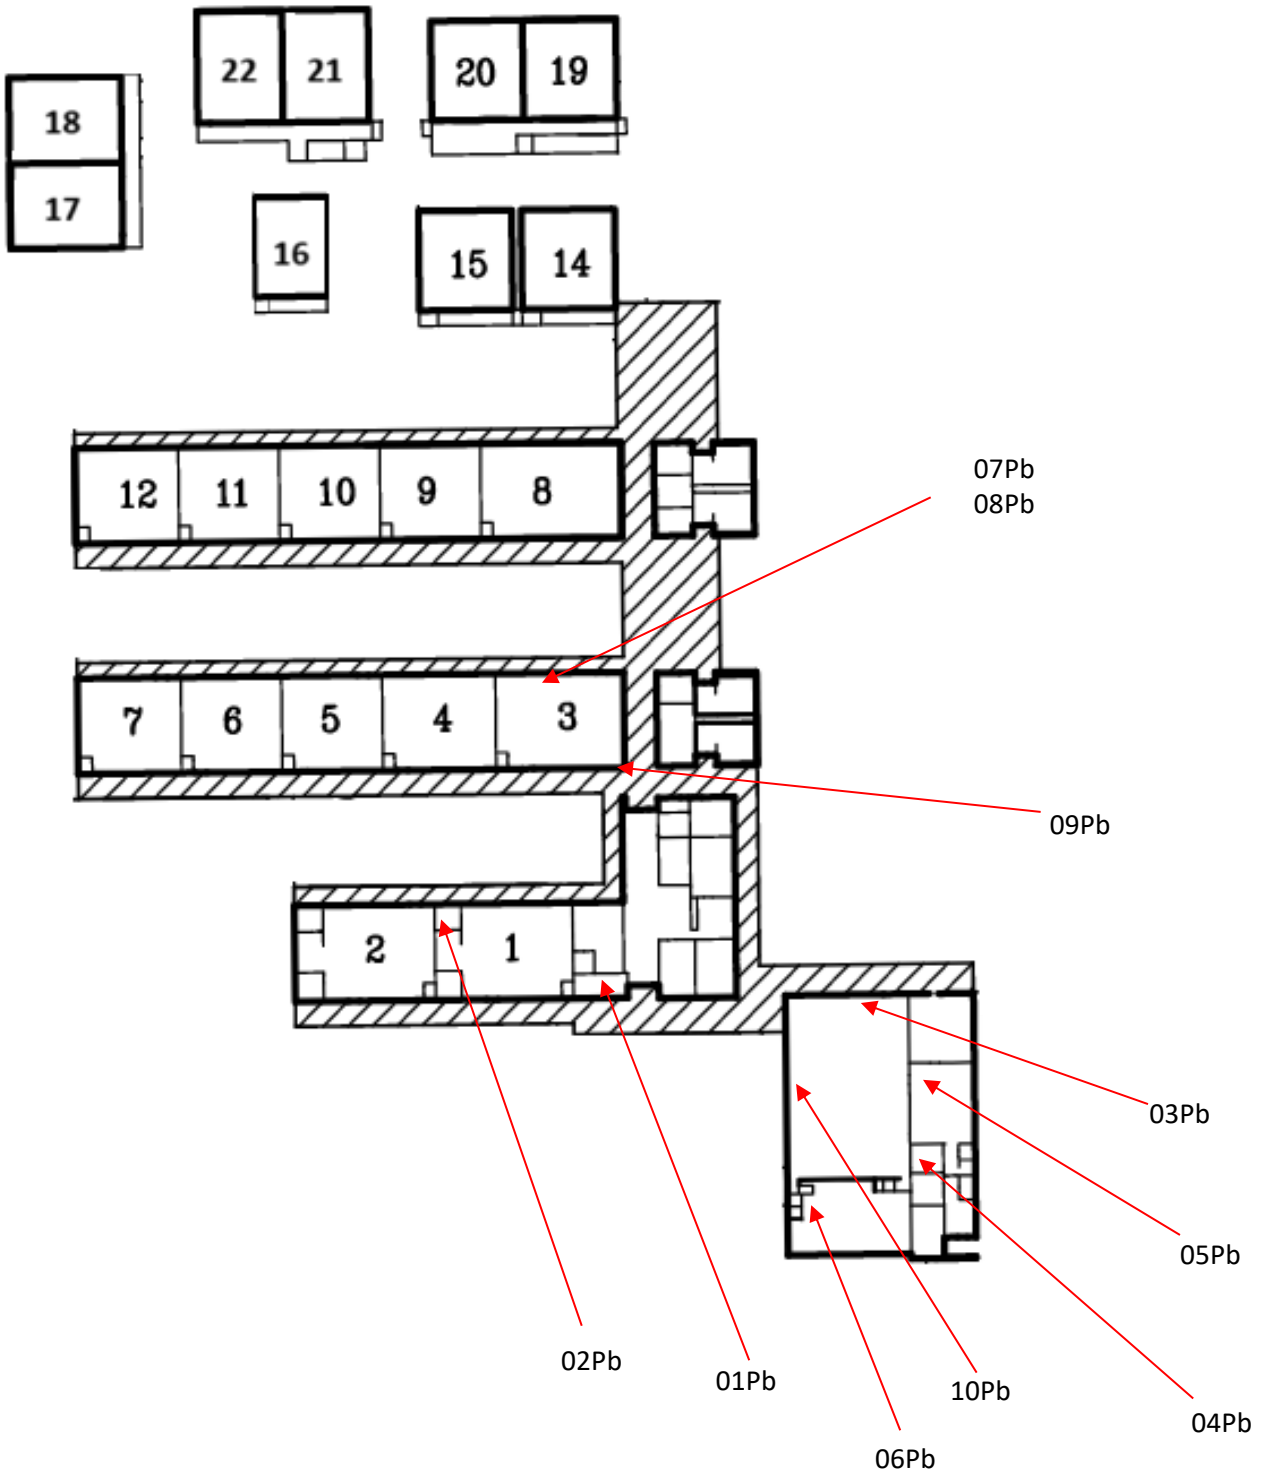
Sacramento City USD  
CMP – Capitol Campus (FKA Thomas Jefferson)  
2635 Chestnut Hill Drive  
Sacramento, CA 95826

An X-Ray Fluorescence (XRF) instrument was utilized as a screening tool in order to determine the presence or absence of lead in paints, coatings, and glazed ceramic tiles throughout the campus. Results shown in the following tables have a margin of error as indicated on the data sheet found in Appendix B.
