DISTRICT FACILITY STUDY

NOVEMBER 2025

EXECUTIVE SUMMARY

The Monroe-Gregg School District Facility Study has been prepared through an in-depth conditional assessment of all existing facilities, gathering of staff input, and review of space needs with the goal of providing the District a detailed “road map” for short-, mid-, and long-term upgrades and projects over the next five to seven years.

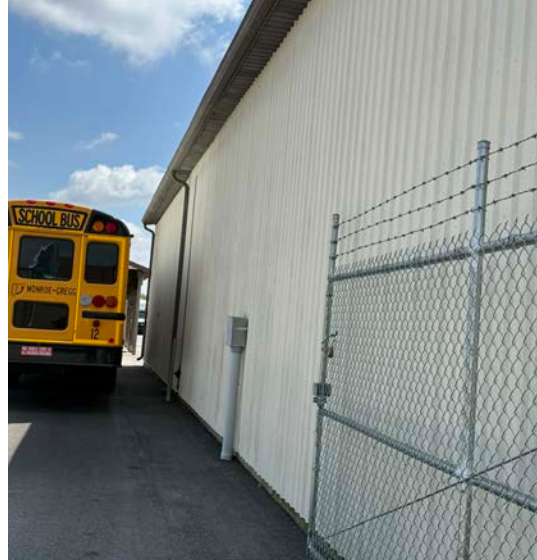
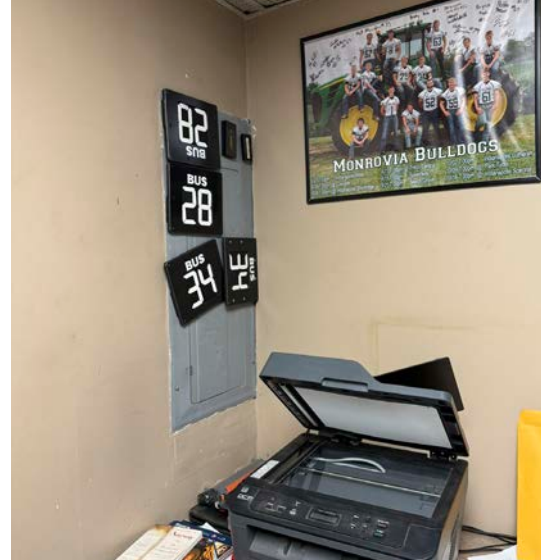
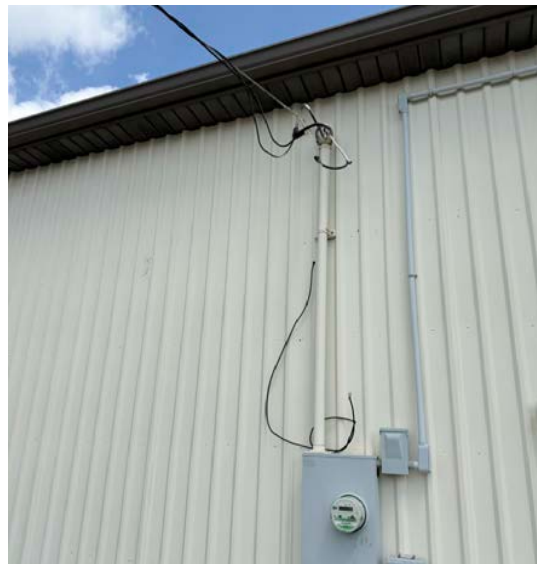
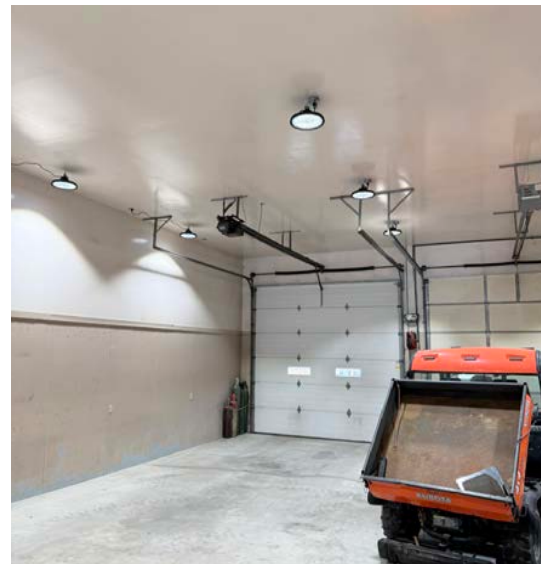
OVERALL: The service entrance and general power are in good shape but are dated. There is minimal power available for any future equipment. Interior lighting is LED. Exterior lighting appears to be fluorescent and does not cover the entire building/lot. Egress lighting is minimal. Fire alarm system does not exist.

FIRE ALARM SYSTEM: Does not exist.

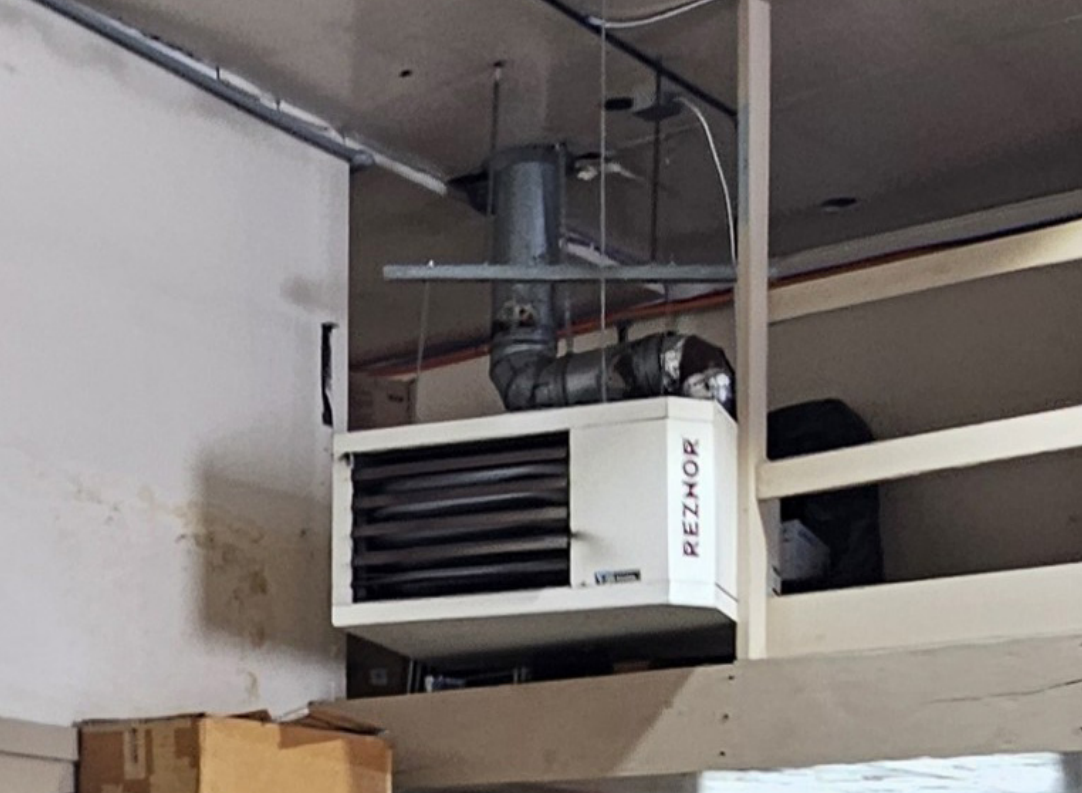
The transportation building is heated by one propane prop heater that is in fair condition.

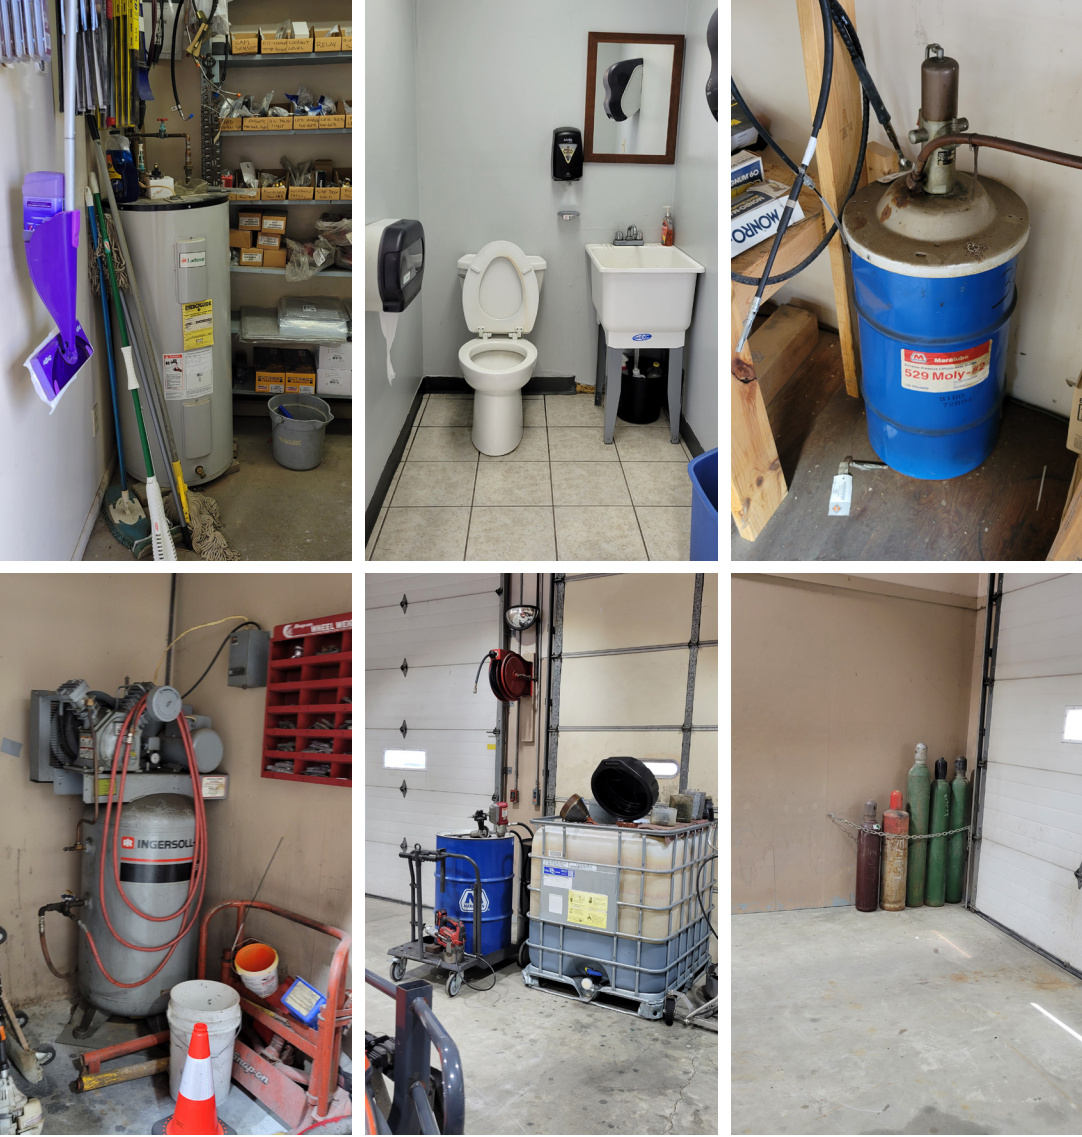
The plumbing and fire suppression systems are of original construction (built prior to 2004), with some repairs and replacement throughout. The domestic water systems and equipment, including the water heaters, were in poor condition.

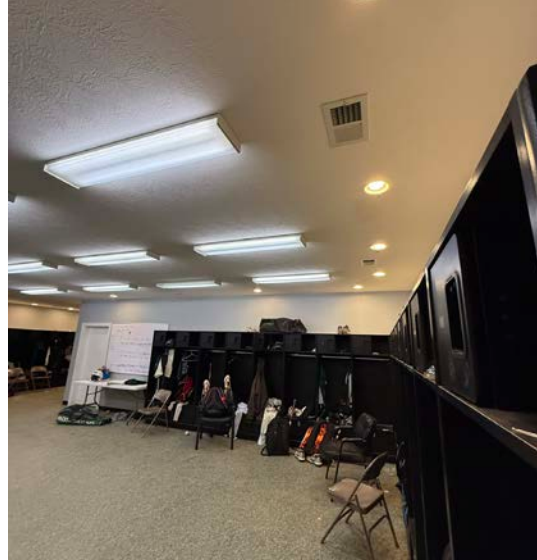
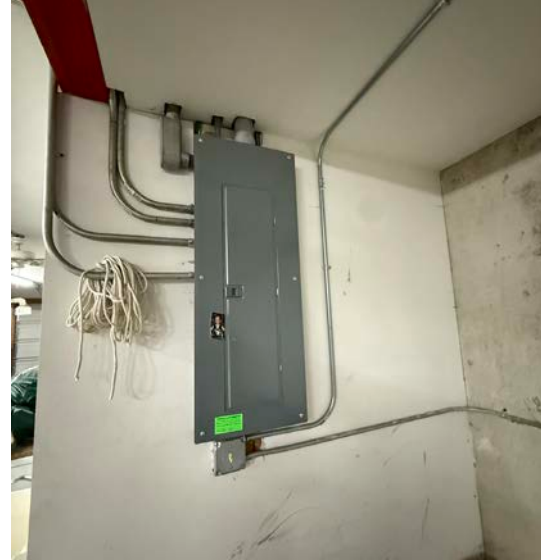
OVERALL: Most of the lighting is fluorescent. Exterior lights appear to be metal halides. Egress lighting appears to be minimal. Service entrance installation is not up to standard and a potential trip hazard. Original wiring devices before the addition/renovation need replaced. There is no fire alarm system in the building.

ELECTRICAL SERVICE / POWER DISTRIBUTION: Service entrance installation is not up to standard and is potentially a trip hazard for the egress path. The conduit goes up through the floor and over to the wall to a 400 Amp disconnect switch and a 400 Amp 120/240 load center. The load center is dated and near end of life. The load center in the locker room is in good condition but has minimal space.

GENERAL POWER: Wiring devices in the addition area seem adequate. The wiring devices original to the building need replaced.

FIRE ALARM SYSTEM: Does not exist.

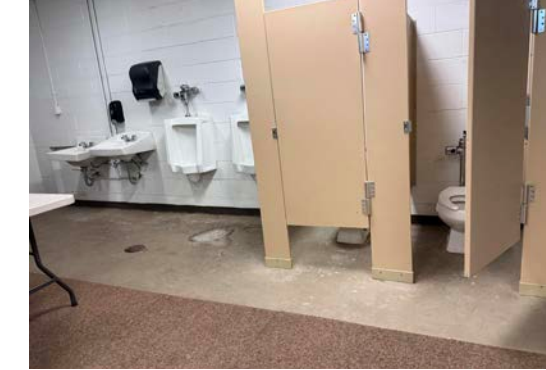
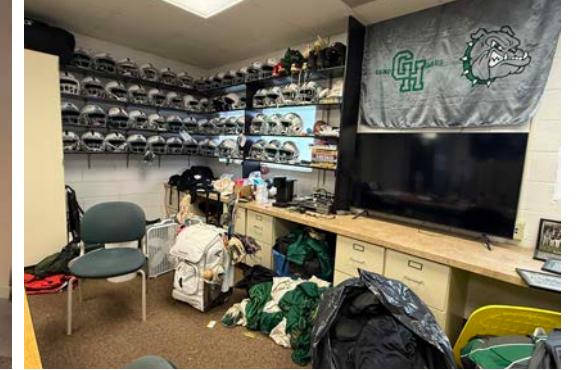
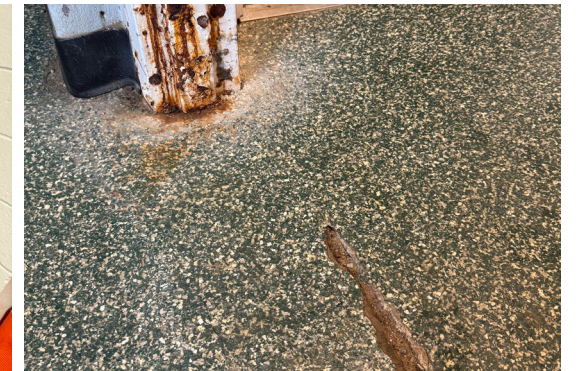
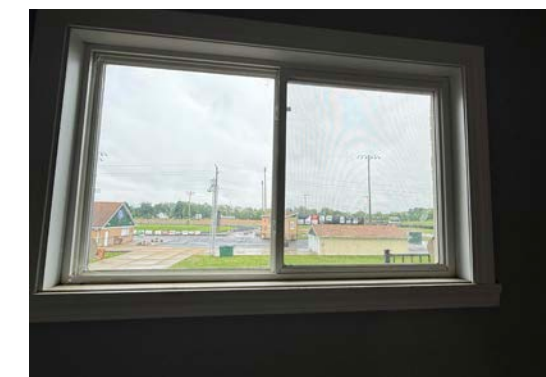
The urinals are too close to the lavatories and the existing concrete flooring is in need of repair.

In the corridor leading to the varsity locker room, the resinous flooring has deep gouges, and the door frames exhibit rusting and corrosion.

The windows are residential and need to be upgraded to commercial grade for increased longevity.

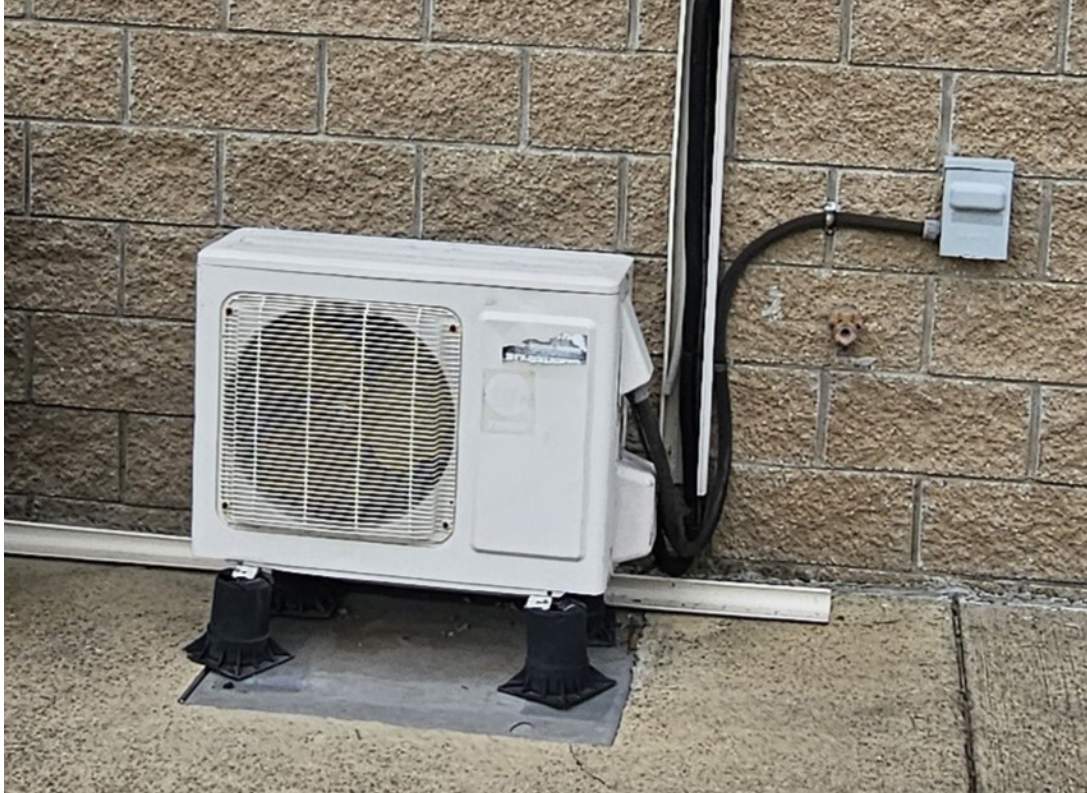
The building is conditioned by two DX split residential type units with electric heat. These units are in fair condition. The high-wall mini-split that conditions and dehumidifies the lower floor is in fair to poor condition and should be considered for replacement in the near future.

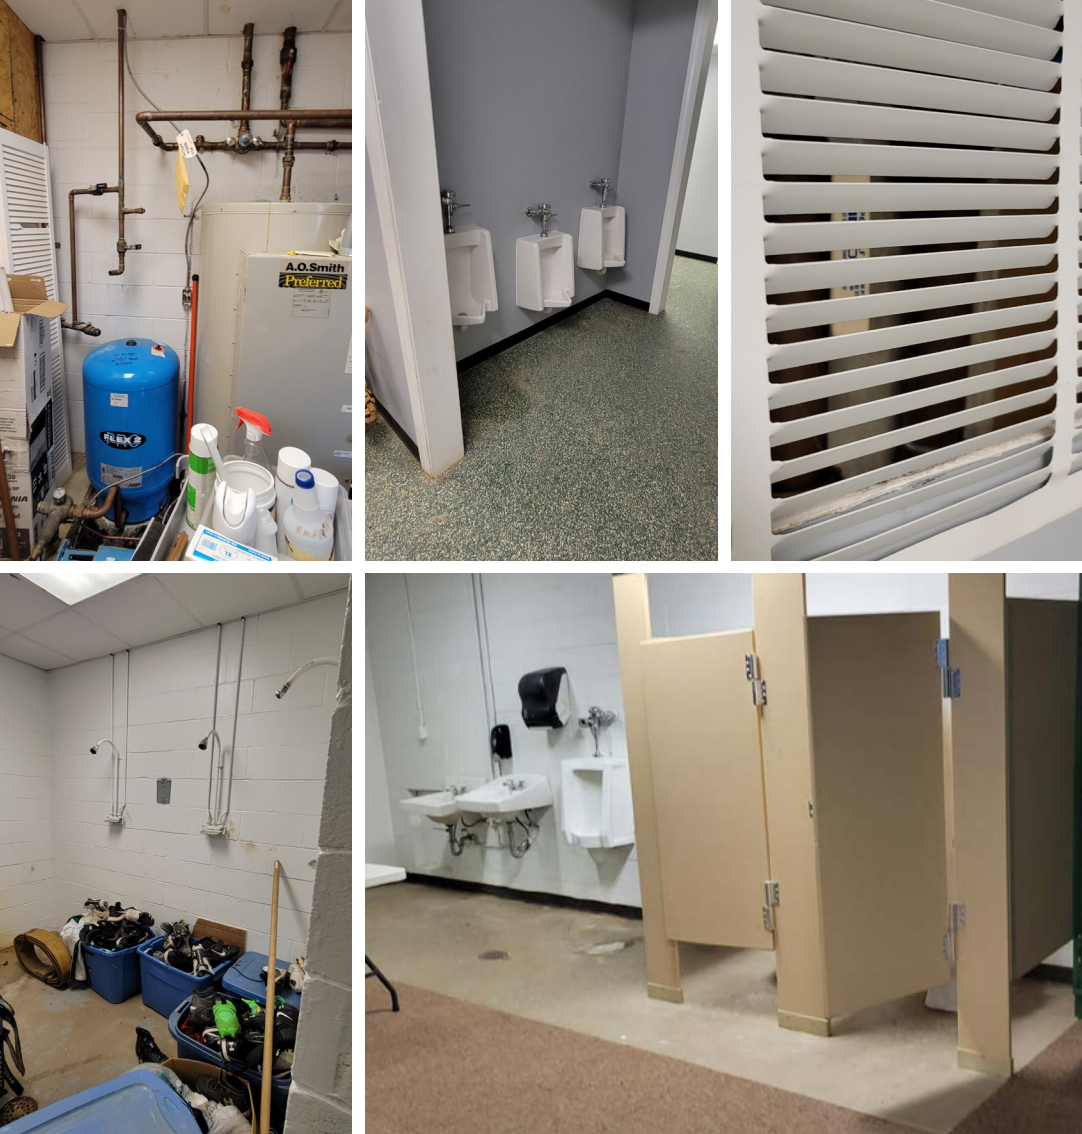
The plumbing and fire suppression systems are original construction, with parts of the original building built prior to 2004 and the addition built in 2014 with some repairs and replacement throughout. The domestic water equipment, including water heaters and circulation pumps, were in poor condition.

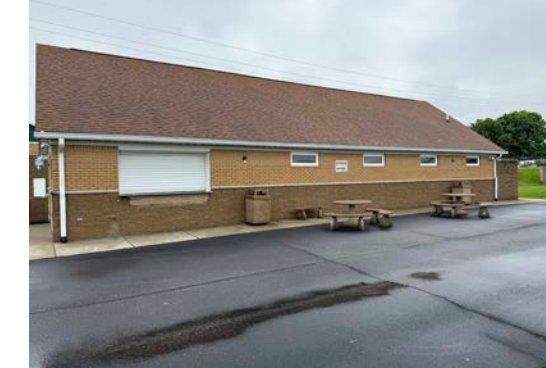
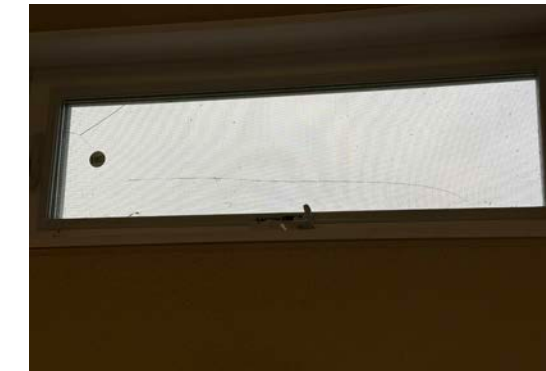
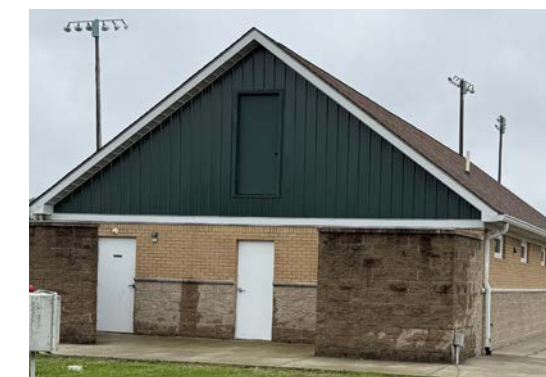
The exterior envelope is in good overall condition. There are some cracked mortar joints in the brick over the door lintels where no control joints were installed. The door frame sealant joints have deteriorated and should be removed, and sealant replaced. The door frame head at the men's restroom has significant rust and should be evaluated further. The other doors look okay but are scuffed and could be repainted. There is some discoloration on the split face block at the restroom screen walls from dirt coming off the precast caps. The dimensional shingle roof appears to be in good condition. There is cracked glass in one of the windows to the restroom. The textured ceiling looks good.

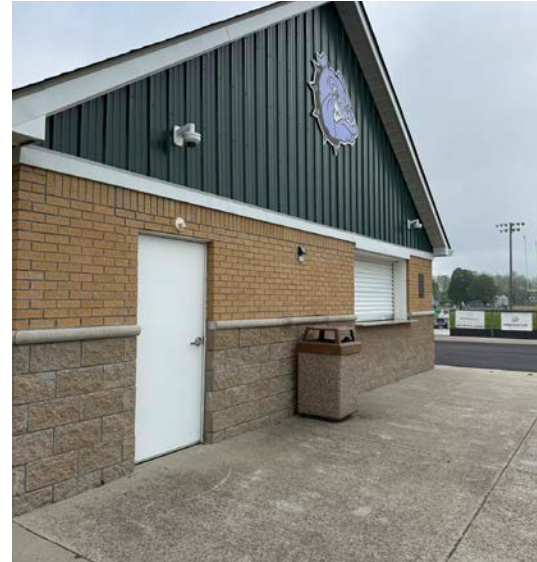
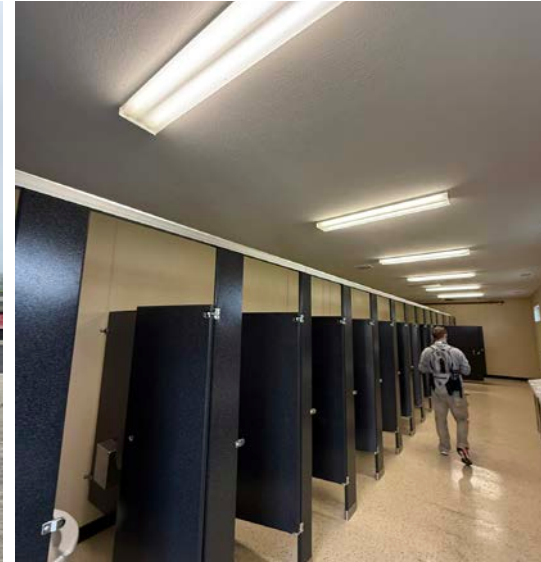
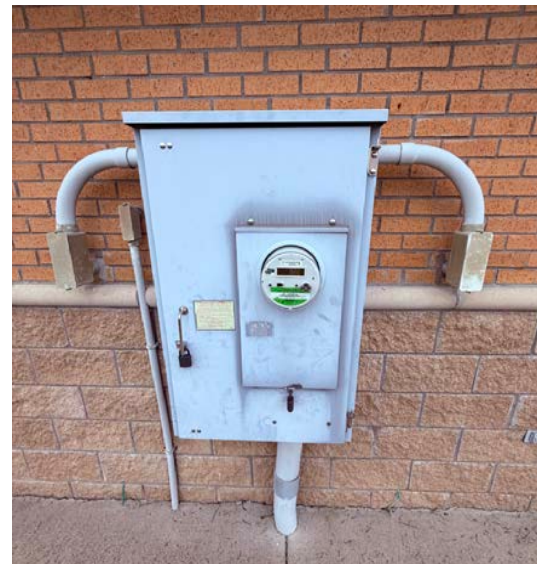
OVERALL: Lighting is mostly fluorescent. Exterior lights appear to be metal halides. Egress lighting appears to be minimal. Service entrance installation and panelboards are in good condition. Wiring devices are in good condition.

GENERAL POWER: Wiring devices are in good condition. Minimal devices.

FIRE ALARM SYSTEM: Does not exist.

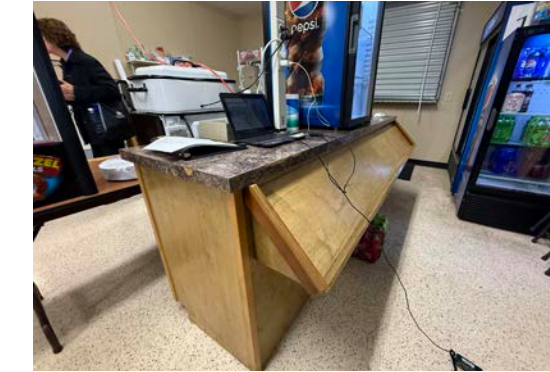
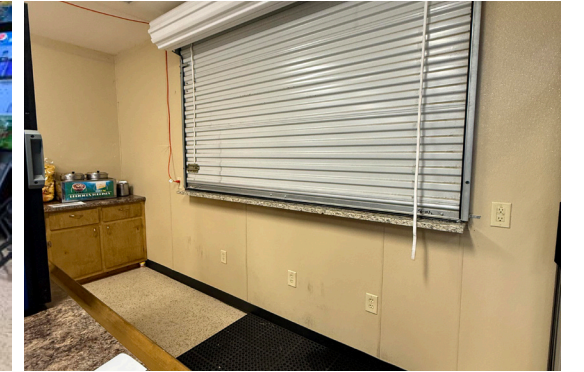
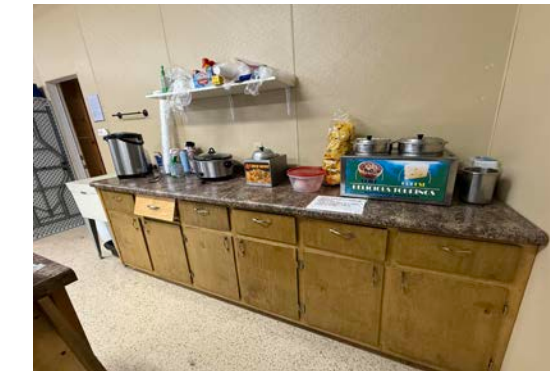
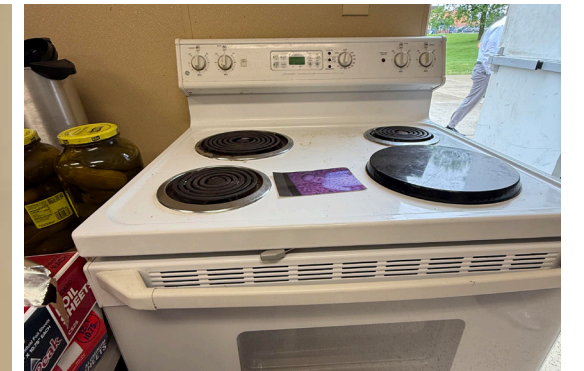
In the concessions space, the epoxy flooring is in good condition.

ADA clearances are not met at the main entry door due to the placement of the stove and other movable equipment.

A rework of this layout would benefit the space long-term.

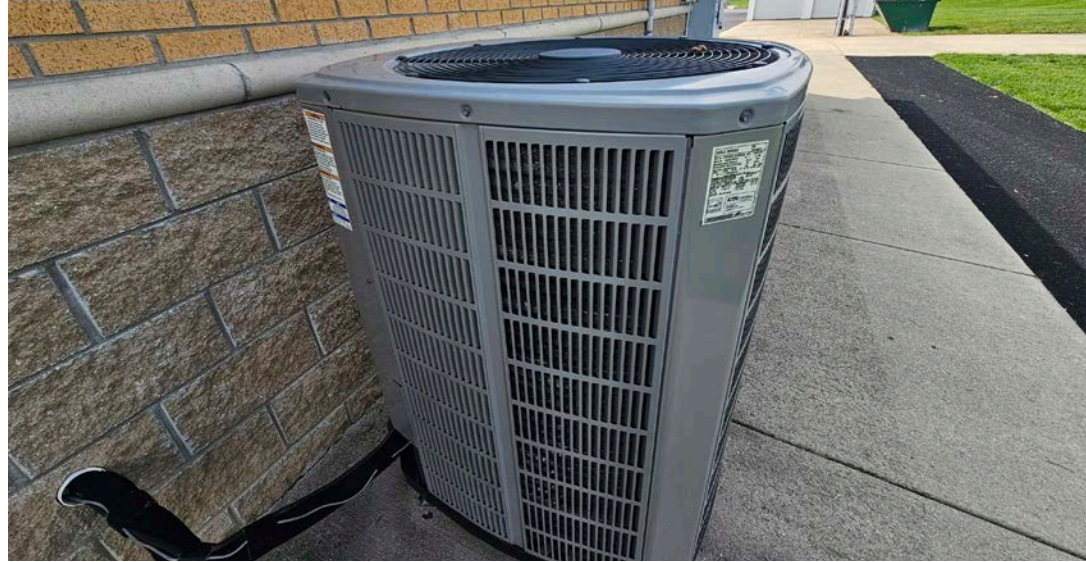
The building is conditioned by one DX split residential type unit with electric heat. This system is in fair condition.

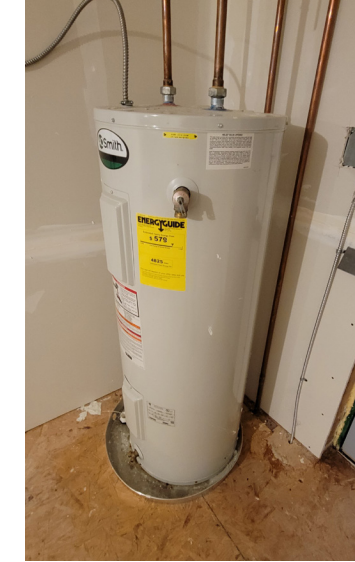
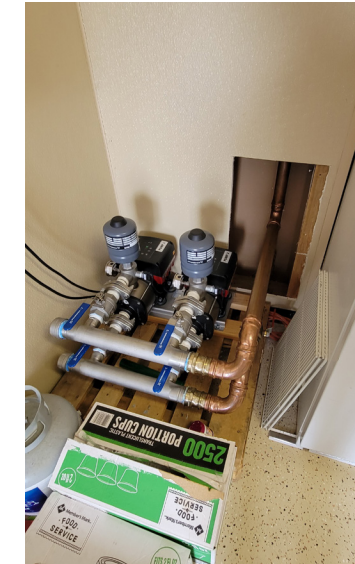
The plumbing and fire suppression systems are of original construction, built in 2014, with some repairs and replacement throughout. The domestic water systems and equipment, including water heaters, were in poor condition.

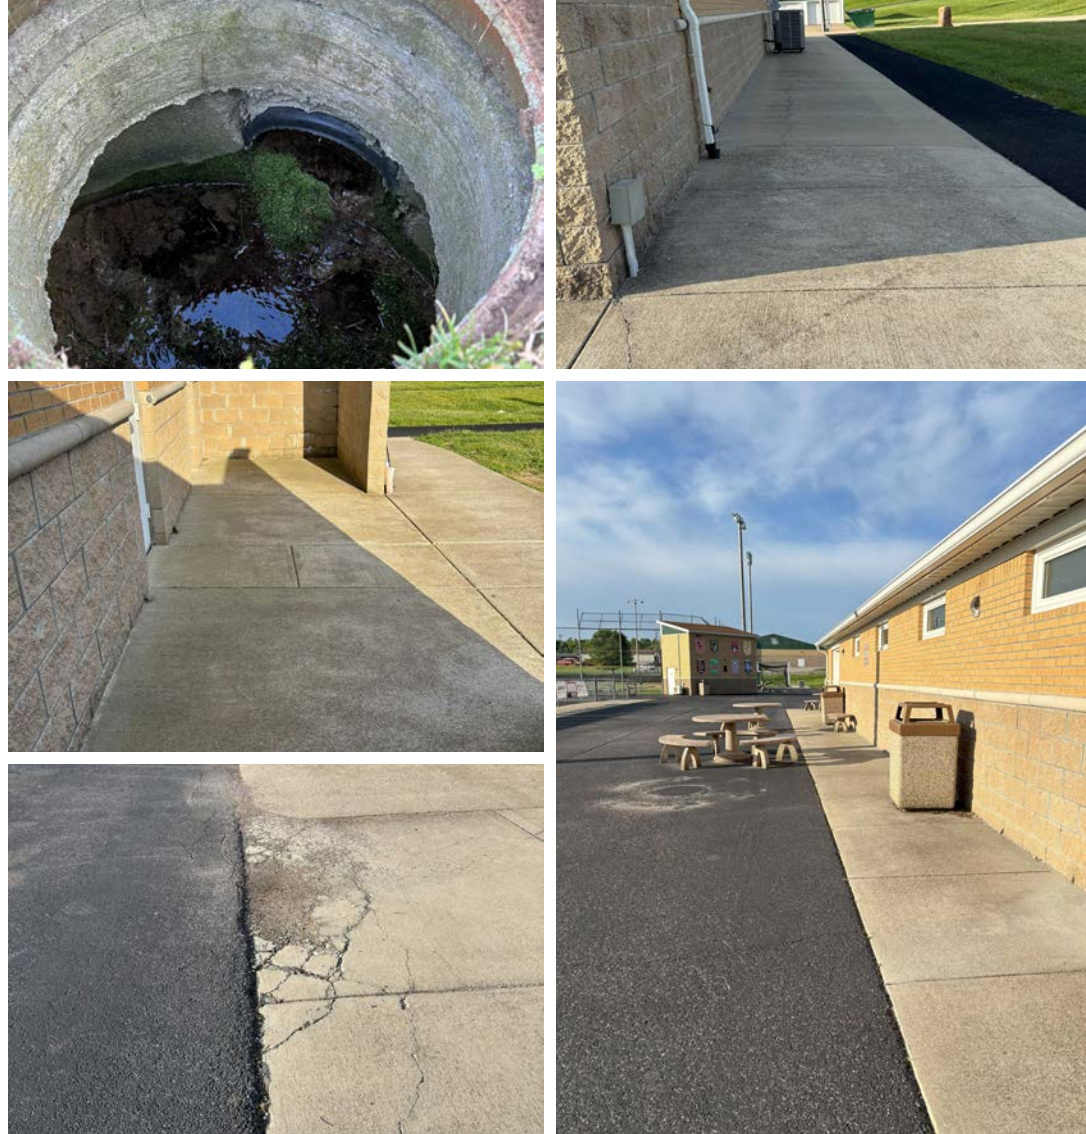
Overall, the site is in fair to good condition. The sidewalk between the pole vault runway and the building is non-compliant with ADA cross-slope requirements. The pavement and plaza around the east and south side of the building are in good condition. The concrete entrance to the restrooms is in good condition. Concrete south of the building by the storage garage is spalling and needs to be repaired. All concrete around the building could be power washed to remove excess surface sediment and bring back to the original color. The storm structure to the north of the building contains moss and greenery growing within the structure. The lift station is in good condition, although it could be pumped and jetted for maintenance.

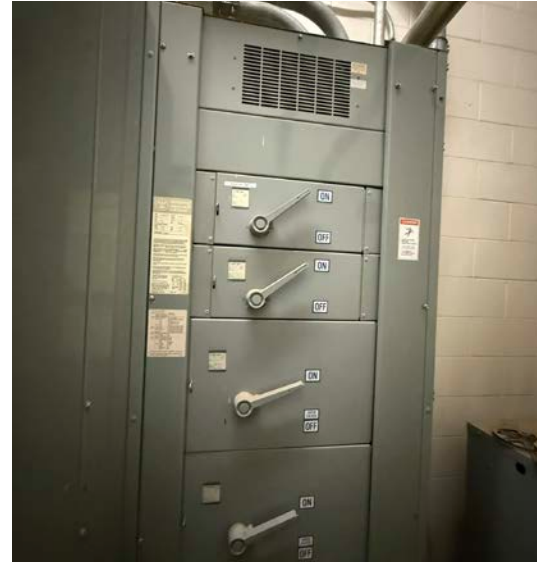
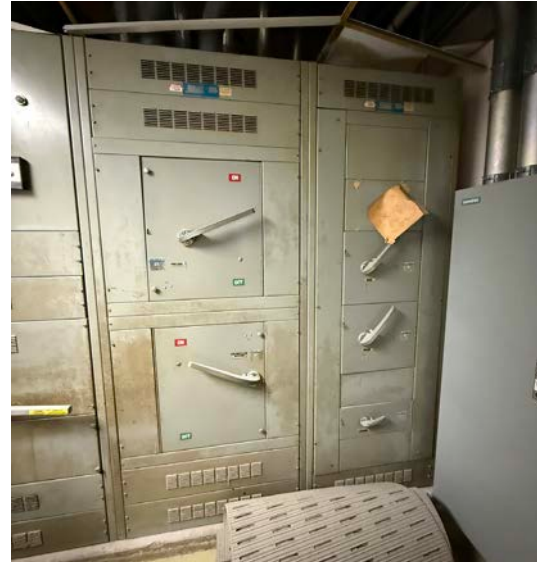
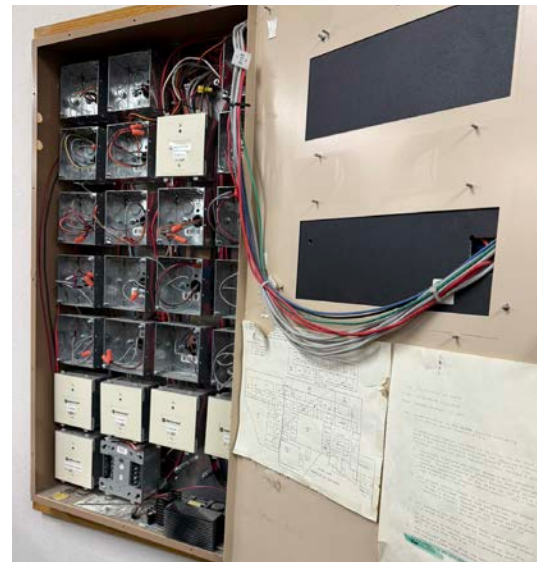
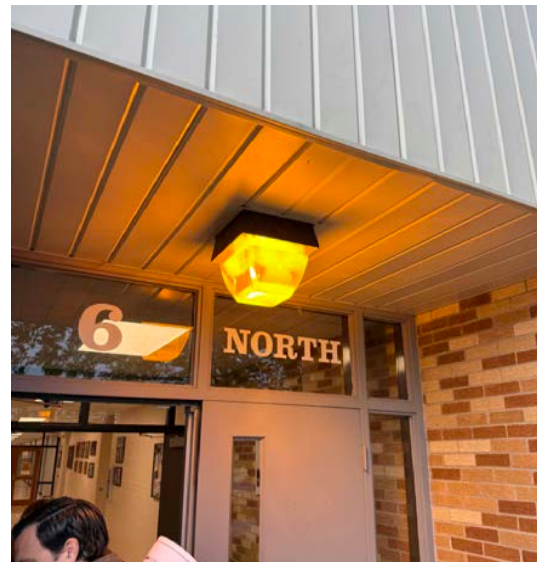
OVERALL: Lighting is in good shape but could use dimming and occupancy sensors. Spacing of emergency lighting does not seem adequate. Service entrance switchboards and power distribution panelboards from 1960-1985 need replaced. General power throughout the building needs upgraded. Fire alarm system needs replaced. Emergency power is not to code.

GENERAL POWER: Minimal outlets throughout the building. Some outlets are loose, do not work, or have circuit issues.

SITE LIGHTING: LED fixture heads on existing poles. Some poles are crumbling, and several poles are dented.

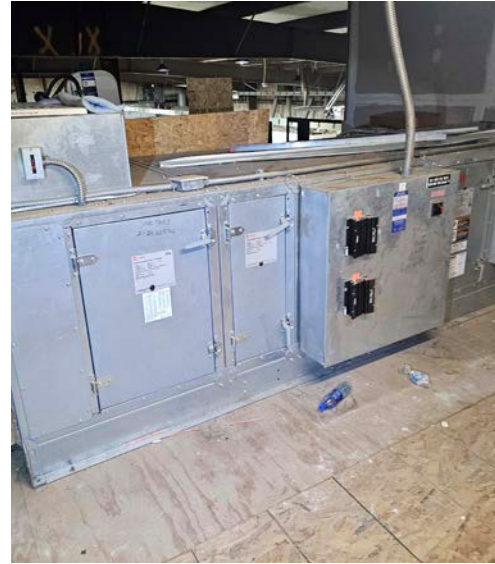
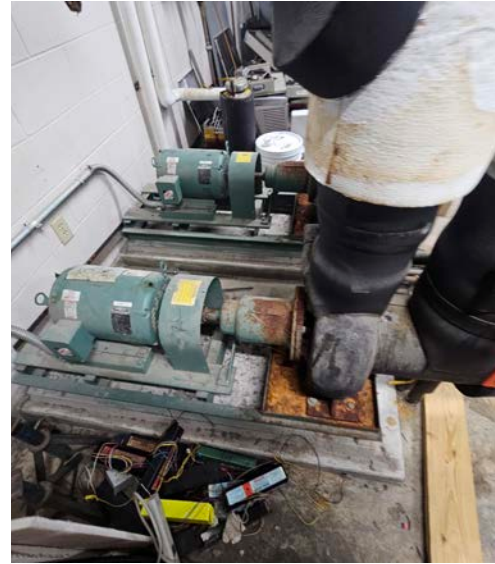
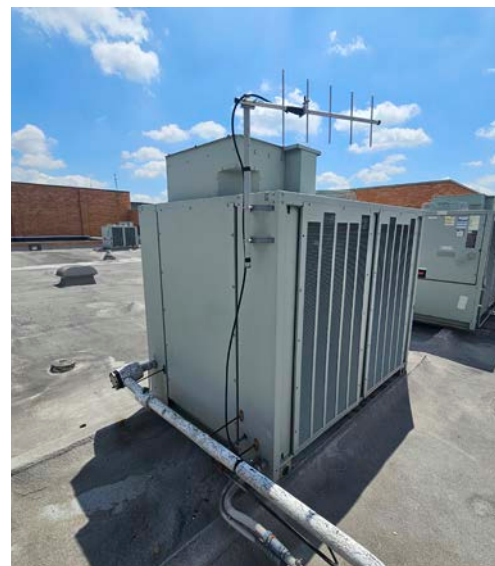
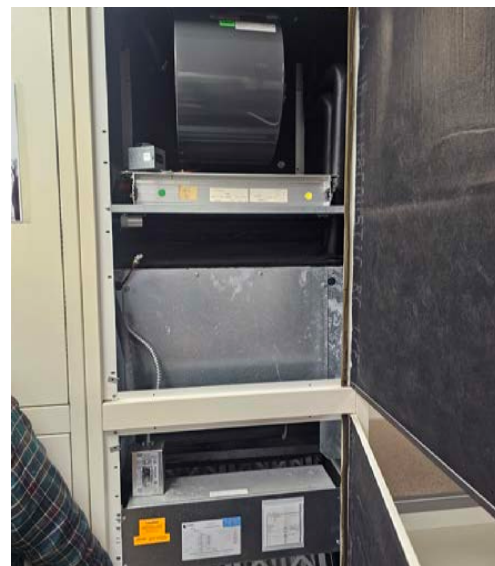
The mechanical system comprises DX air handlers with or without electric heat, a dual-temp hydronic system that provides heating or cooling to air handlers and VUVs, as well as packaged rooftop units and small split systems. The dual temp system provides heating via three electric boilers, two from 2006 that are in fair condition and one from 2022 in new condition. Chilled water is produced from two split Chillers in fair condition. One 100-ton chiller is from 2015 while the other 90-ton chiller is from 2006 and nearing the end of its expected service life. Primary chiller pumps are in good condition, but main dual temp pumps are in fair to poor condition. The dual temp pumps, 90-ton chiller, and 2006 boilers should be considered for replacement in the next five years.

The VUVs that condition many classrooms are in good condition and should remain. Classrooms not conditioned by VUVs are conditioned by fan-powered electric heat VAV boxes, all of which are in poor condition and should be replaced.

There are several types of air handlers, including packaged rooftop units, indoor split air handlers, indoor dual temp air handlers, and energy recovery units. Two rooftop cooling-only units provide air to VAV boxes at the high school and are in fair condition. Five indoor dual-temp units provide air to the high school main gym, multi-purpose room, and locker room and are in fair condition. Additionally, two split DX indoor air handlers with electric heat provide air to the library and offices. These units were manufactured in 2010, and the indoor units are in good condition while the outdoor units are in fair condition. Prior to vertical unit vent installation, outdoor air was provided by packaged rooftop units. Most of these have been abandoned; however, one still remains in use and is in poor condition. Two small energy recovery units with electric heat exist at the small gym locker rooms and are in fair to poor condition. Each of these units/systems are candidates for replacement in the next five years.

Exhaust fans throughout the building are near or at the end of their life and are candidates for replacement.

The building automation system is aged and does not have a front end that the operations staff can use. Actuators are failing and some equipment is running in hand. Recommend full replacement of controls system.

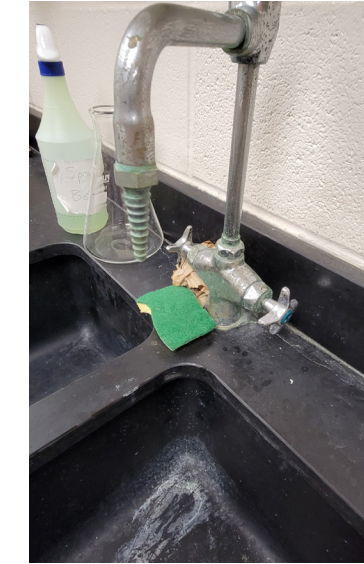
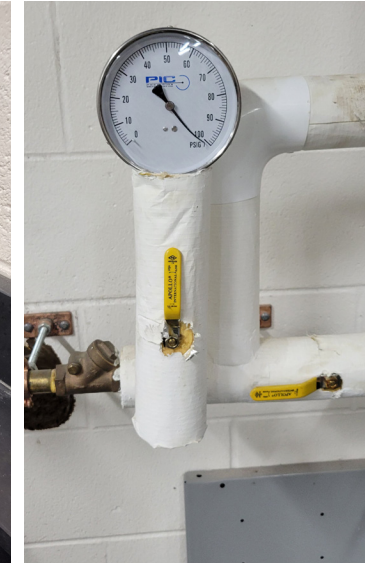
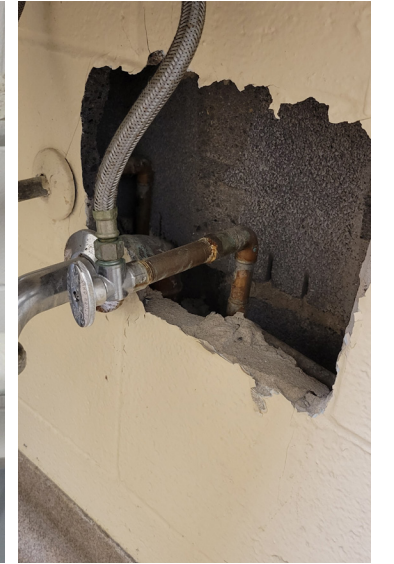
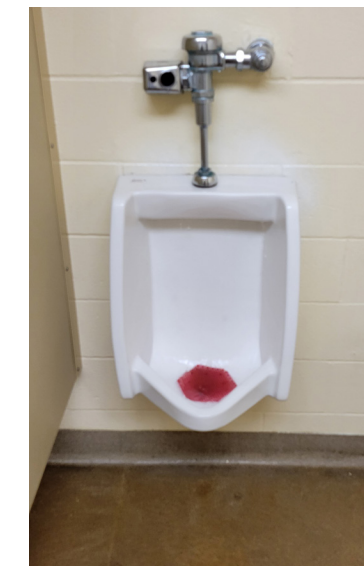
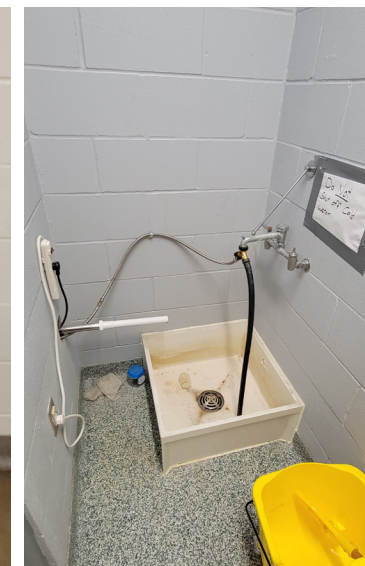
The plumbing and fire suppression systems are primarily original to the building (built in 1966) with some spot repairs throughout.

The domestic distribution system and equipment, including water softeners, heaters, and circulation pumps, have passed their life expectancy and should be considered for replacement.

The existing sanitary waste and storm drainage systems are in fair condition, but concealed piping should be scoped for a full evaluation.

The existing propane fuel gas system is in fair condition and comprises mostly steel pipe at select locations and applications but lacks sizing and distribution to take full advantage of the efficiencies gas equipment can use.

Plumbing fixtures are in poor to fair condition and appear to have had some trim replaced and china replaced.

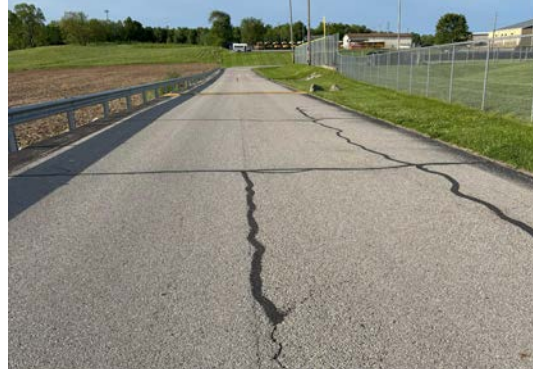
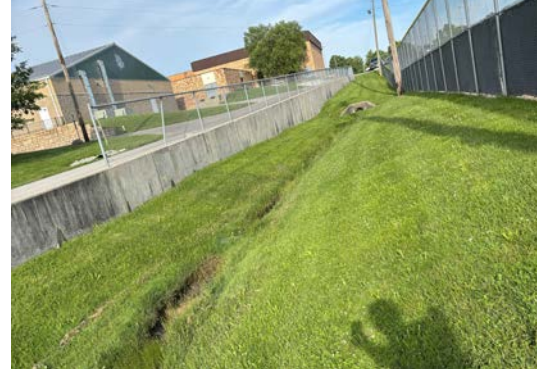
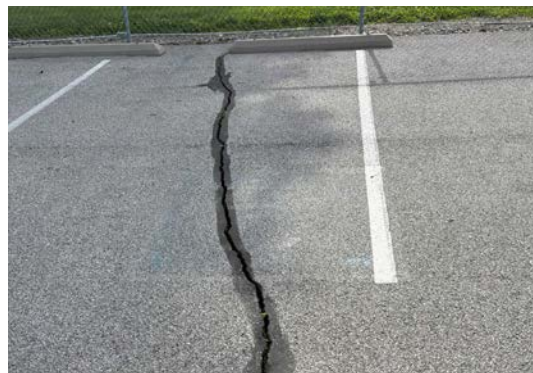
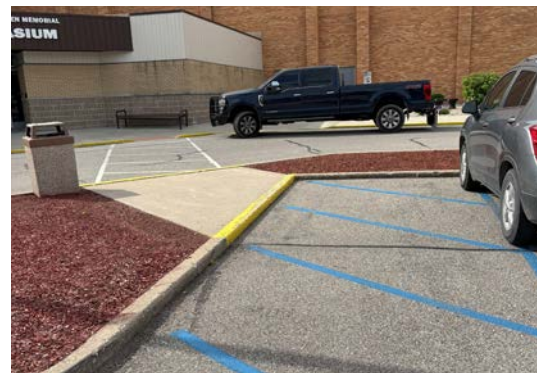
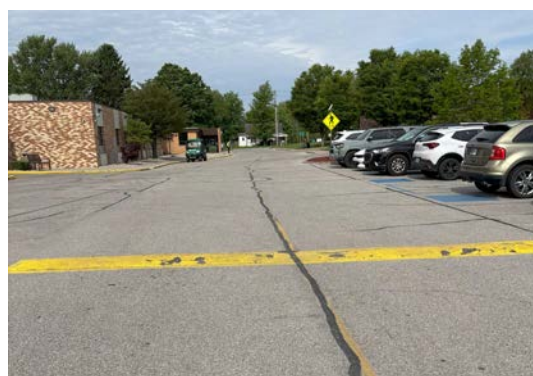
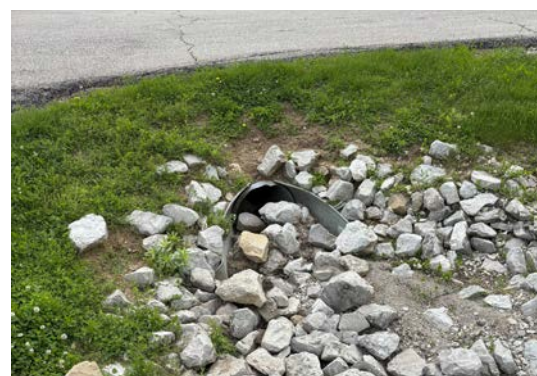
Overall, the site is in fair to good condition. Hardscapes are structurally in good shape, with typical wear such as cracking and fading.

Athletic facilities are in fair condition. The football field has good drainage and the grass is well grown. Field lighting is outdated, and multiple poles are starting to lean.

There are multiple low spots on the track that hold water.

The baseball and softball dugouts are in good condition; however, the baseball field has non-standard dimensions.

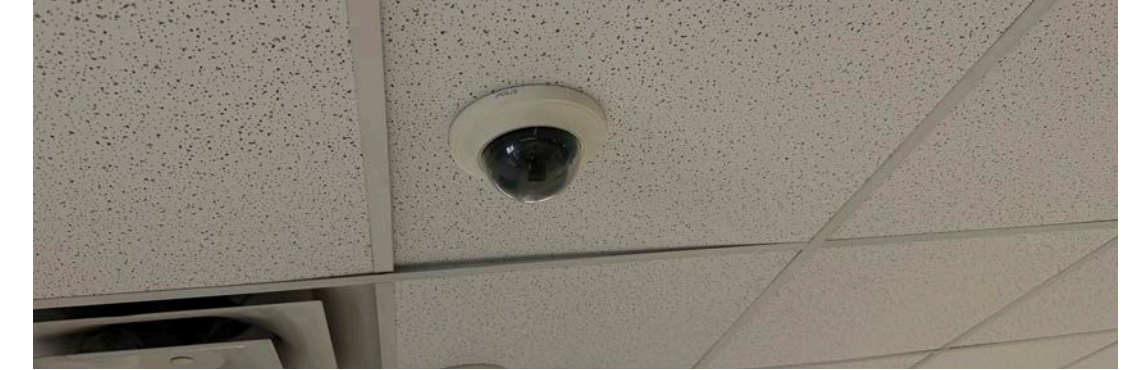
The high school building has a mix of Category 5, 5e, 6, and 6a data cabling. Category 5 and 5e should be replaced.

There is a mix of old and new video surveillance cameras. The older Sony and Samsung cameras should be replaced.

Most other systems are in good working order or already planned for to be upgraded.

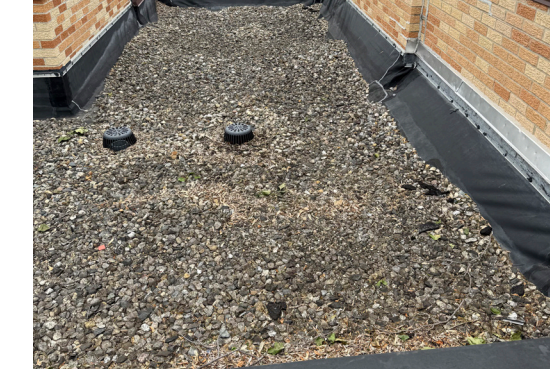
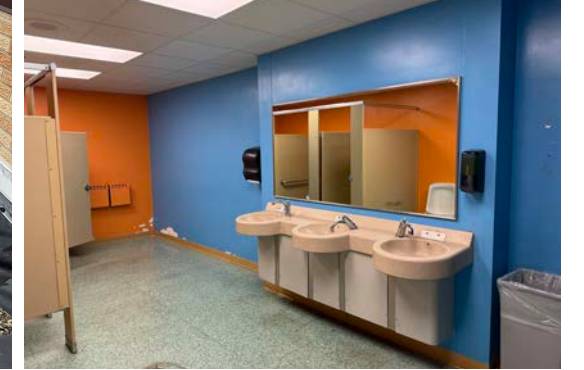
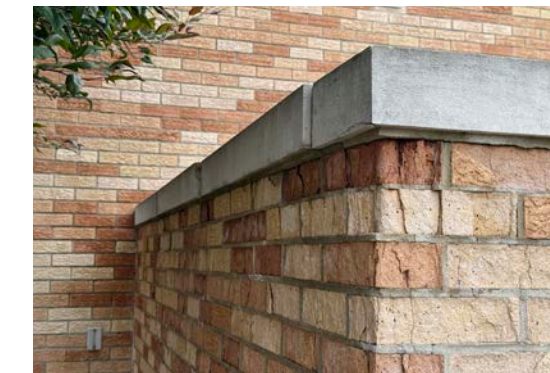
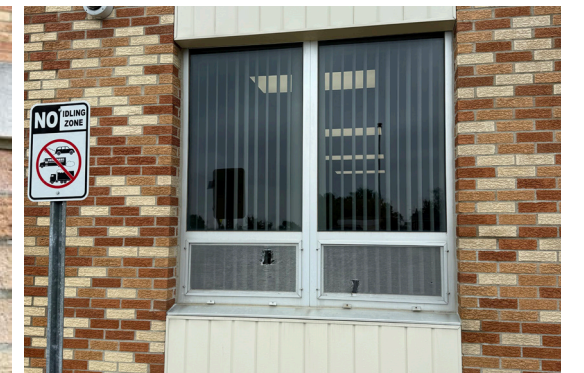
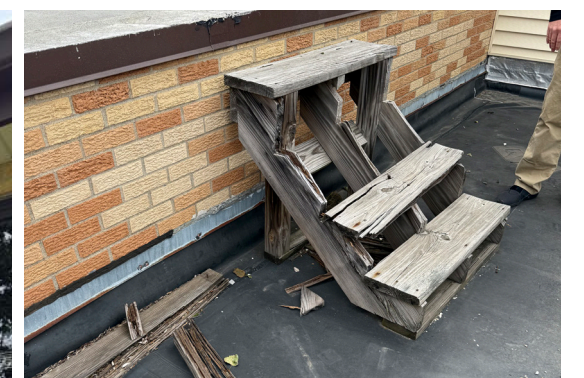
The exterior envelope has expanded over the years, with several additions since the original 1956 elementary portion. The gym addition's exterior masonry walls are in good condition. The older single-story classroom portions have open mortar joints at window and louver locations. There is significant brick spalling at the screen walls at the cafeteria delivery area and wing walls and scattered throughout the exterior brick walls. The metal fascia panel at the entrance has dents and faded panels. Sealant in control joints is failing or gone in several areas. The hollow metal doors at Entrance 2N is faded and rusting at the base. Doors to courtyard are missing weather stripping between doors. The kitchen delivery door is rusting.

The roof types vary and are generally in poor condition. There is ballasted roof membrane visibly pulling away from the parapet. There are visible bubbles in the membrane roof and other areas with alligator cracking on the surface. There is ponding in areas and no overflow drains. A wood access stair is breaking apart, with exposed rusting nails on the membrane roof. There is staining on the metal soffits adjacent to the gutters. There are multiple areas of stained ceiling tile throughout the older areas of the building, suggesting multiple roof leaks.

Classroom windows are aluminum in clear anodized and bronze anodized, with integral blinds and without. There are ripped screens on several windows on the north classrooms on the exterior and in Room 124 on the interior. The windows should be reviewed further due to adjacent cracking brick, missing mortar at lintels.

The aluminum entrance systems appear to be in good condition but should be reviewed for sealant and weatherstripping.

Restrooms have blistering drywall at the base off the walls. Toilet partitions are newer plastic partitions in decent condition. It appears graffiti has already been buffed from the panels. There were no urinal screens between fixtures.

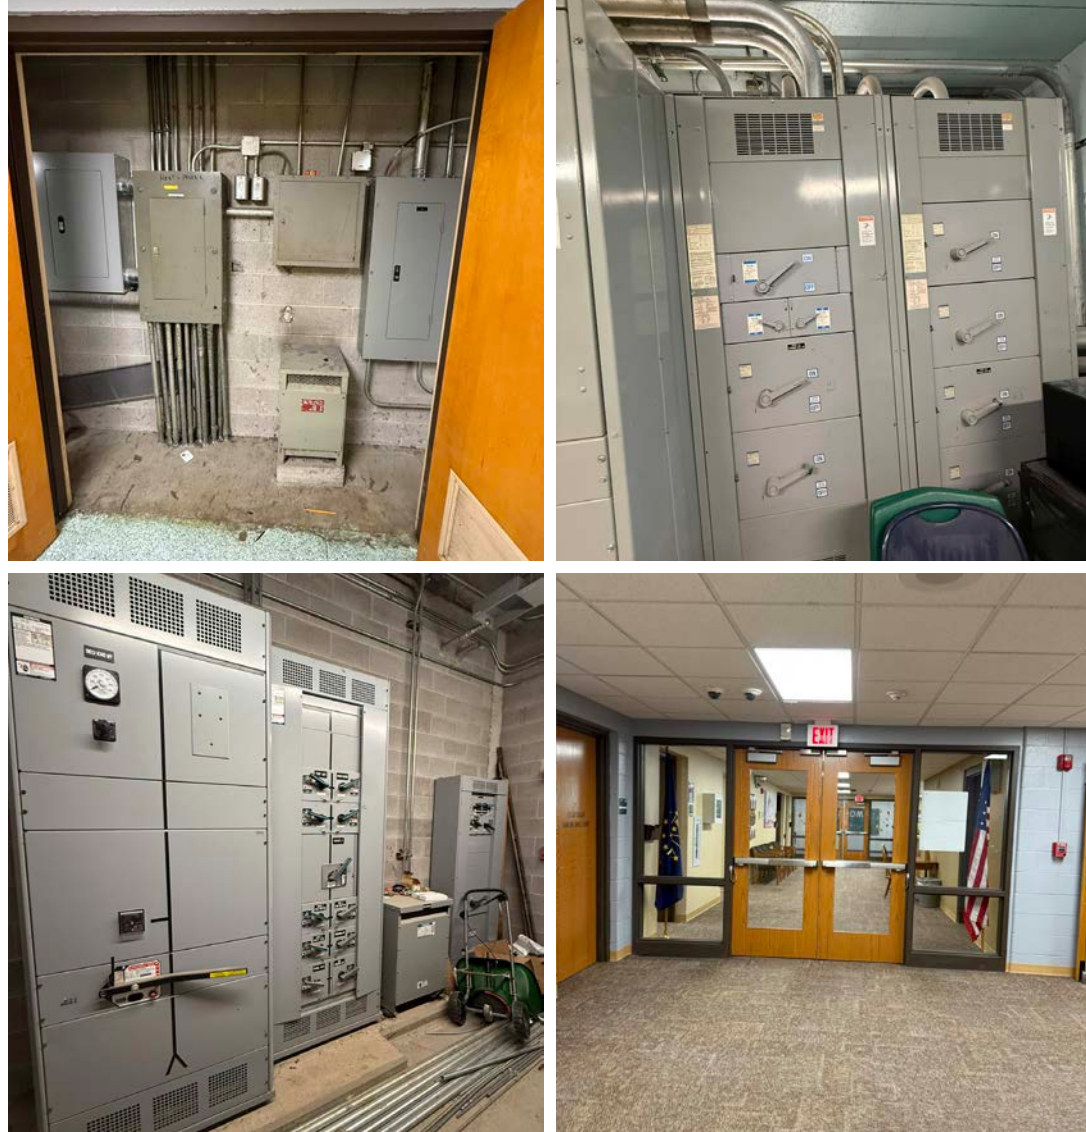
FIRE ALARM SYSTEM: Notifier 2005. Nearing end of life expectancy. Minimal devices and spacing issues.

SITE LIGHTING: LED fixture heads on existing poles. In good shape.
