DISTRICT FACILITY STUDY

NOVEMBER 2025

EXECUTIVE SUMMARY

The Monroe-Gregg School District Facility Study has been prepared through an in-depth conditional assessment of all existing facilities, gathering of staff input, and review of space needs with the goal of providing the District a detailed “road map” for short-, mid-, and long-term upgrades and projects over the next five to seven years.

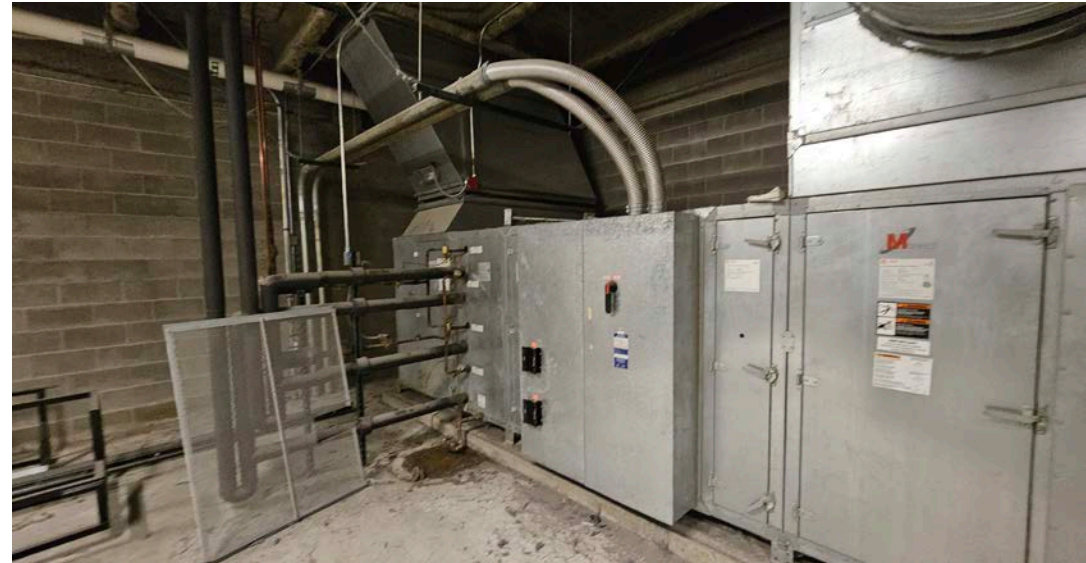
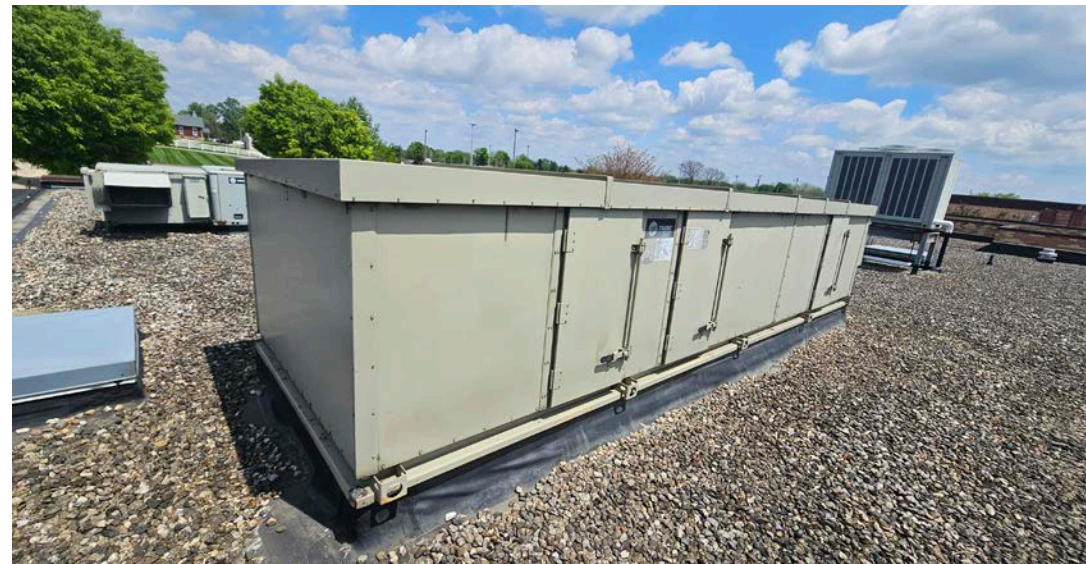
The air handlers are both indoor split DX cooling electric heat units in fair to poor condition. The office VAV boxes are provided air by a rooftop air handler with a split DX coil that is in fair to poor condition. All three of these air handlers are candidates for replacement in the next five years. The VAV boxes that serve classrooms and offices are beyond the end of their service life and should be replaced. The VUVs in the classrooms were replaced in the last 10 to 15 years and are in good to fair condition.

The VUVs receive their heating and cooling from the central plant at the high school. Building automation system comments and central plant comments can be found under the high school summary.

Several shared spaces exist that are occupied by the middle school and high school, including the AG area, weight room and wrestling, auditorium and cafeteria. Two heating and ventilation only units exist in the Ag/ Building Trades area. These units are candidates for replacement due to their age, their poor condition and the fact that they do not have cooling. Four packaged DX/electric rooftop units provide air to the auditorium; these units are in good condition and should remain. Four packaged Trane air source heat pump units provide heating and cooling to the wrestling and weight rooms. These units are from 2017 and are in fair condition, but operations staff reports having many issues with the units. Expected service life for this type of equipment is 15 years, so they are approximately halfway through their life. The cafeteria is conditioned by a DX split, electric heat indoor air handler. The indoor unit is in good condition, and the outdoor unit is in fair condition.

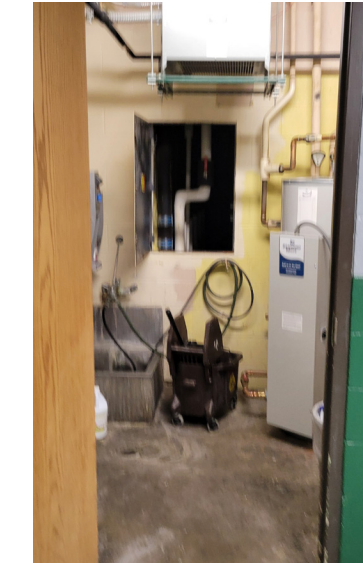
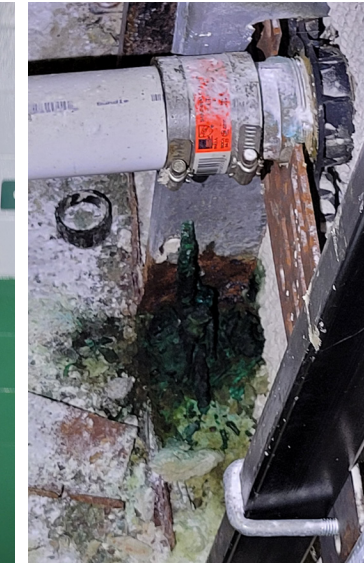
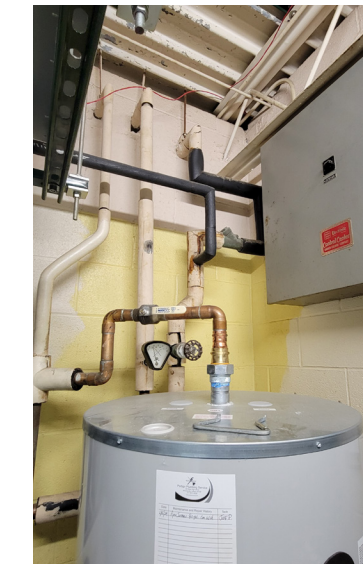
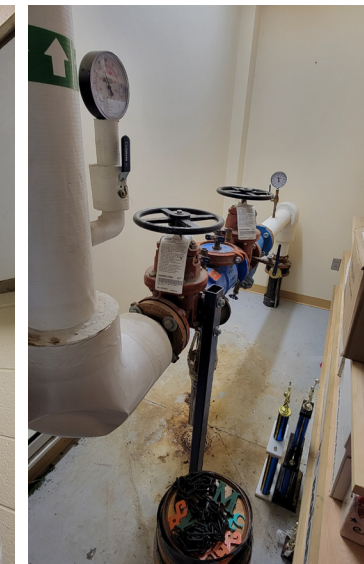
The plumbing and fire suppression systems were originally constructed in 1957 and largely renovated in 2004, with an addition to build the auditorium in 2017.

The domestic distribution system and equipment, including water softeners, heaters, and circulation pumps, have passed their life expectancy and should be considered for replacement.

The existing sanitary waste and storm drainage systems are in fair condition, but concealed piping should be scoped for a full evaluation.

The existing propane fuel gas system is in fair condition and comprises mostly steel pipe at select locations and applications but lacks sizing and distribution to take full advantage of the efficiencies that gas equipment can utilize.

Plumbing fixtures are in poor to fair condition and appear to have had some trim replaced and china replaced. Odors were observed in restrooms and attributed to waterless urinals and/or leaks in the waste piping.

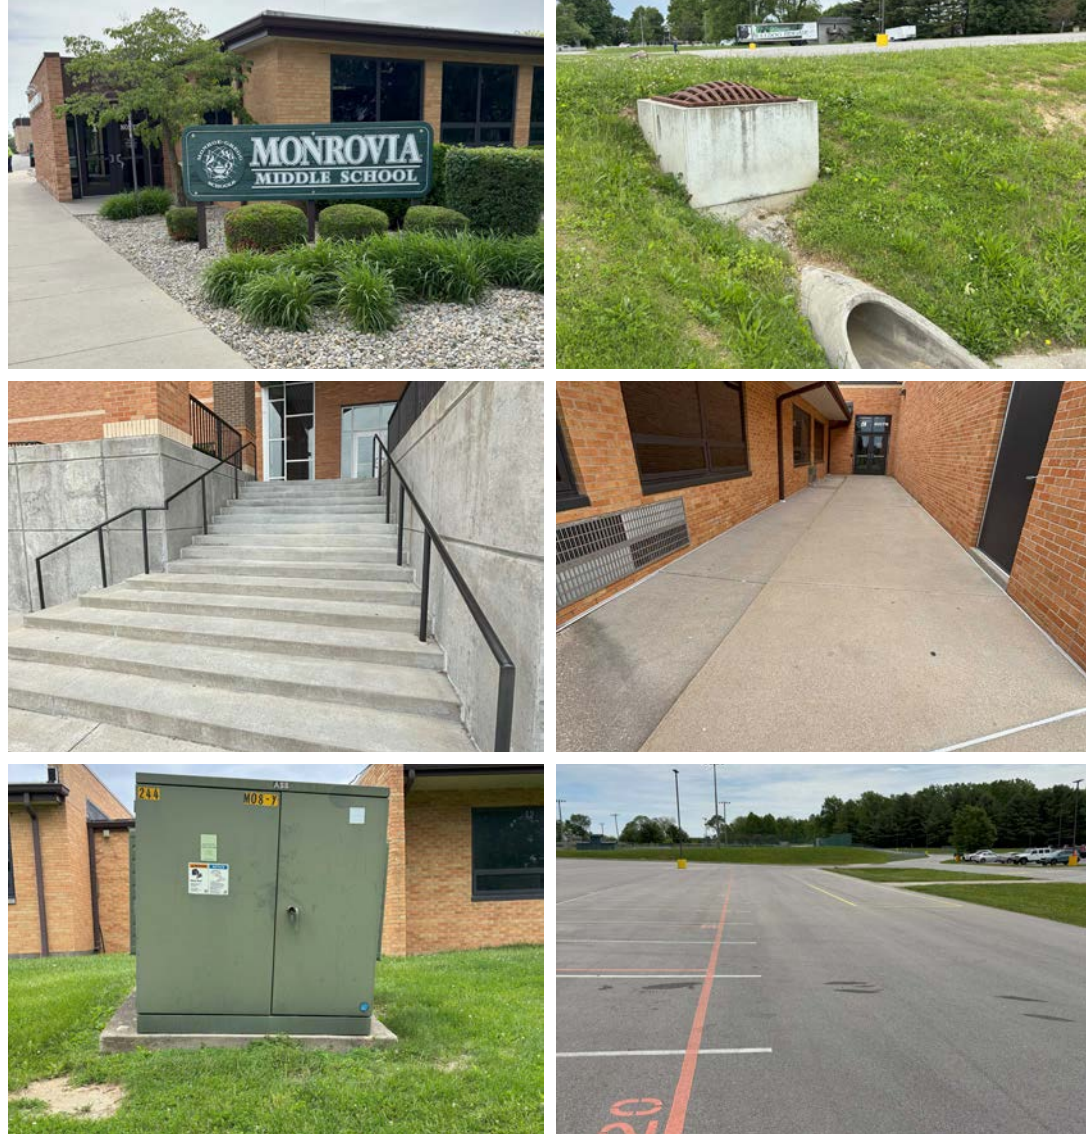
The middle school site is in fair to good condition overall.

The ramp and stairs to the main entrance are in good condition.

The transformer and pad are leaning heavily.

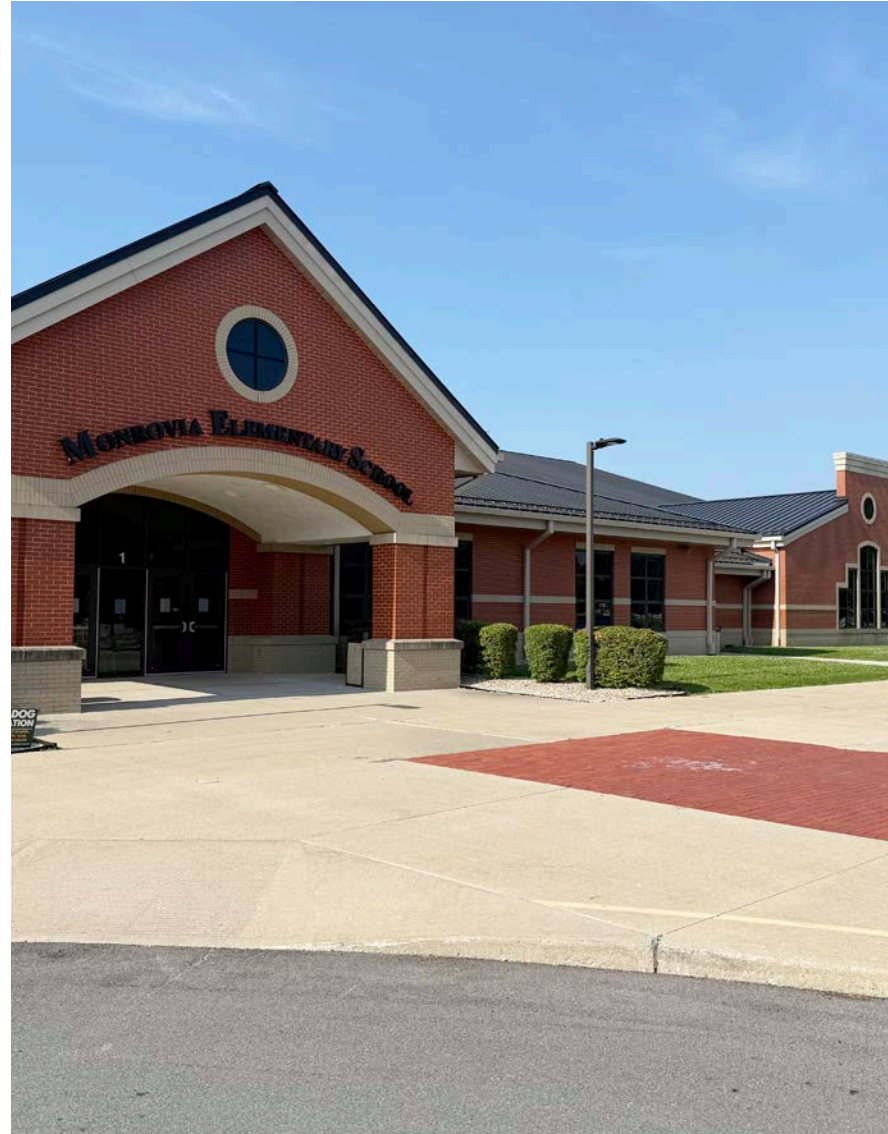
OVERALL ASSESSMENT **MONROVIA ELEMENTARY SCHOOL**

CONDITIONAL ASSESSMENT

RATING **225.00** | POSSIBLE **324.00** | OVERALL SUITABILITY **69%**

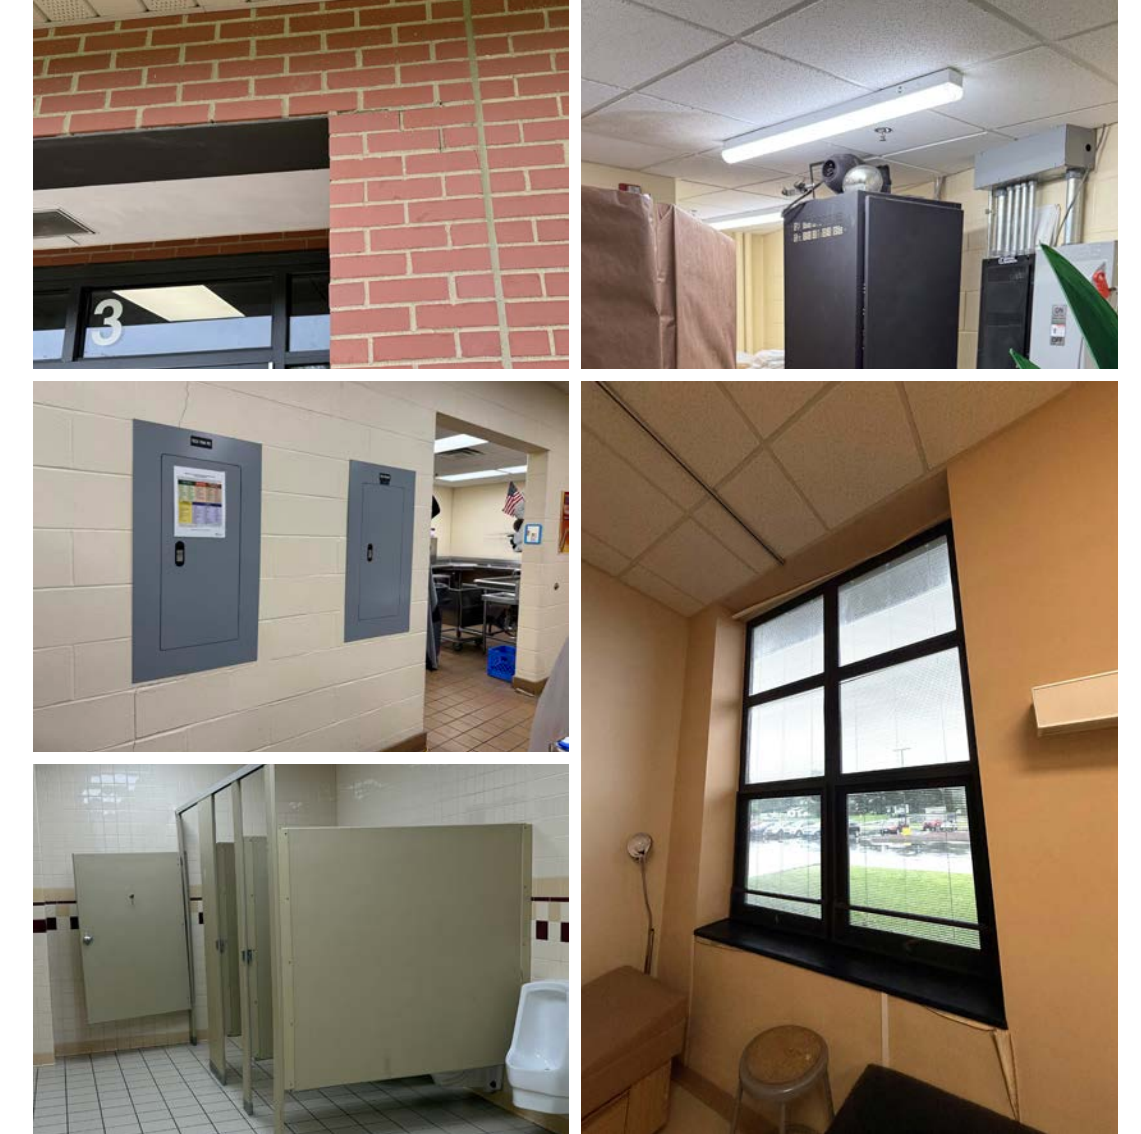
The plastic toilet partitions in at least one of the restrooms have heat sink trim piece detaching from the bottom of the panel and a door is sagging.

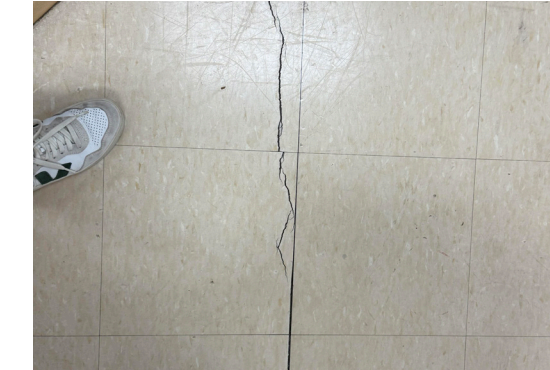
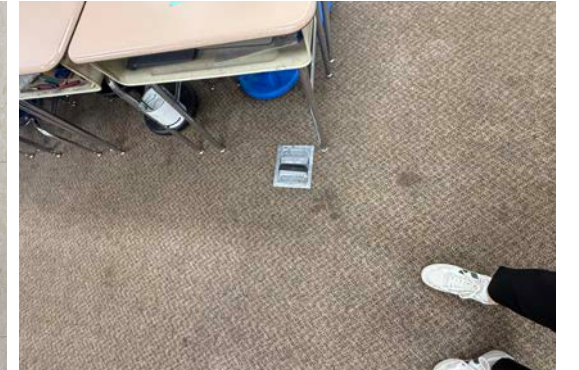
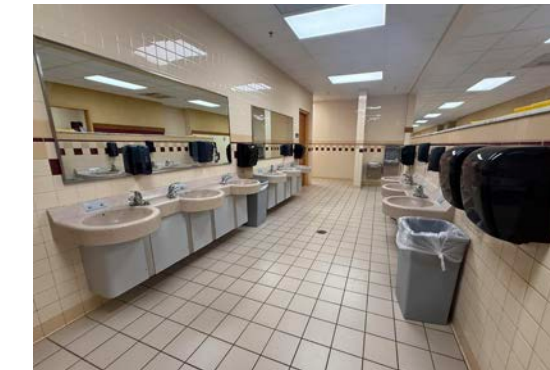
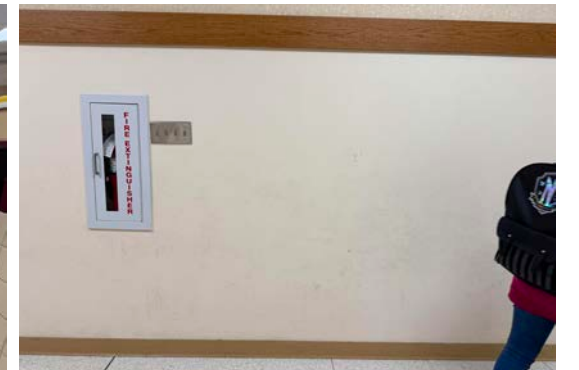
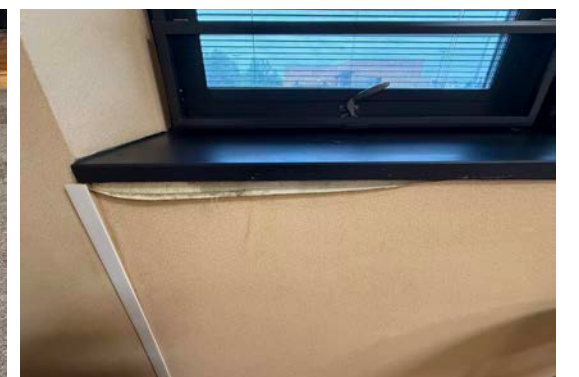
MONROVIA ELEMENTARY SCHOOL INTERIORS ASSESSMENT

The overall interior condition of the elementary school is excellent due to the building age and upkeep.

General classrooms are in great condition. Most classrooms have original broadloom carpet that is stained in some areas and starting to show wear.

Some vinyl composition flooring in the classrooms shows cracking and happens where there are expansion joints.

Classroom casework and equipment meet standard clearance requirements. The casework, furniture, and visual display units show minimal to no wear.

Ganged restrooms meet proper clearances, and existing finishes and fixtures have been well-cared-for and are in good condition.

The wall protection in the corridors is showing dirt buildup from handprints and general use, but a thorough cleaning will renew the durable wall finish.

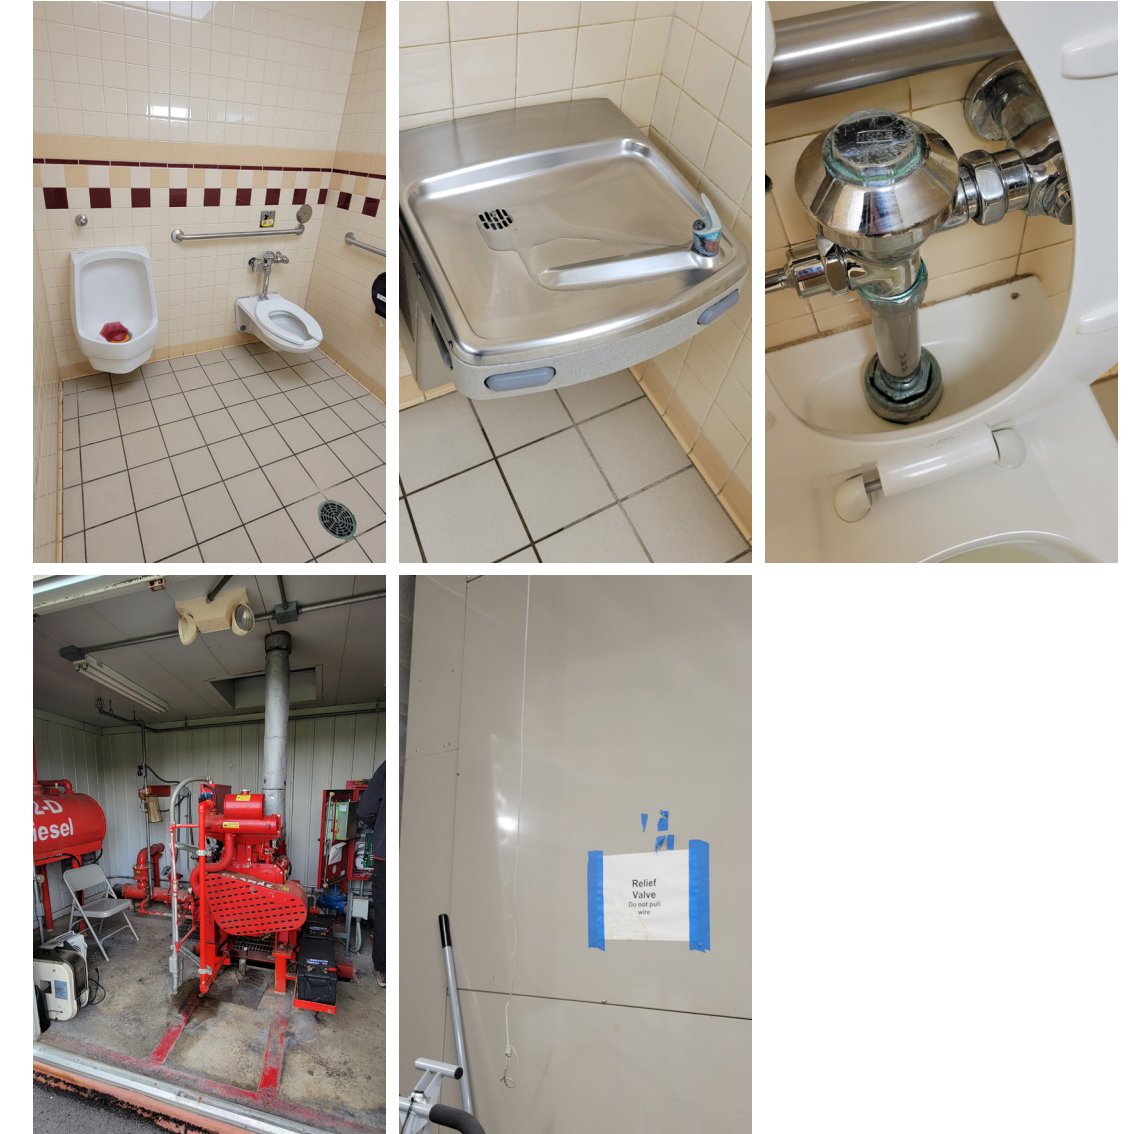
Plumbing fixtures are in poor to fair condition and appear to have had some trim and china replaced.

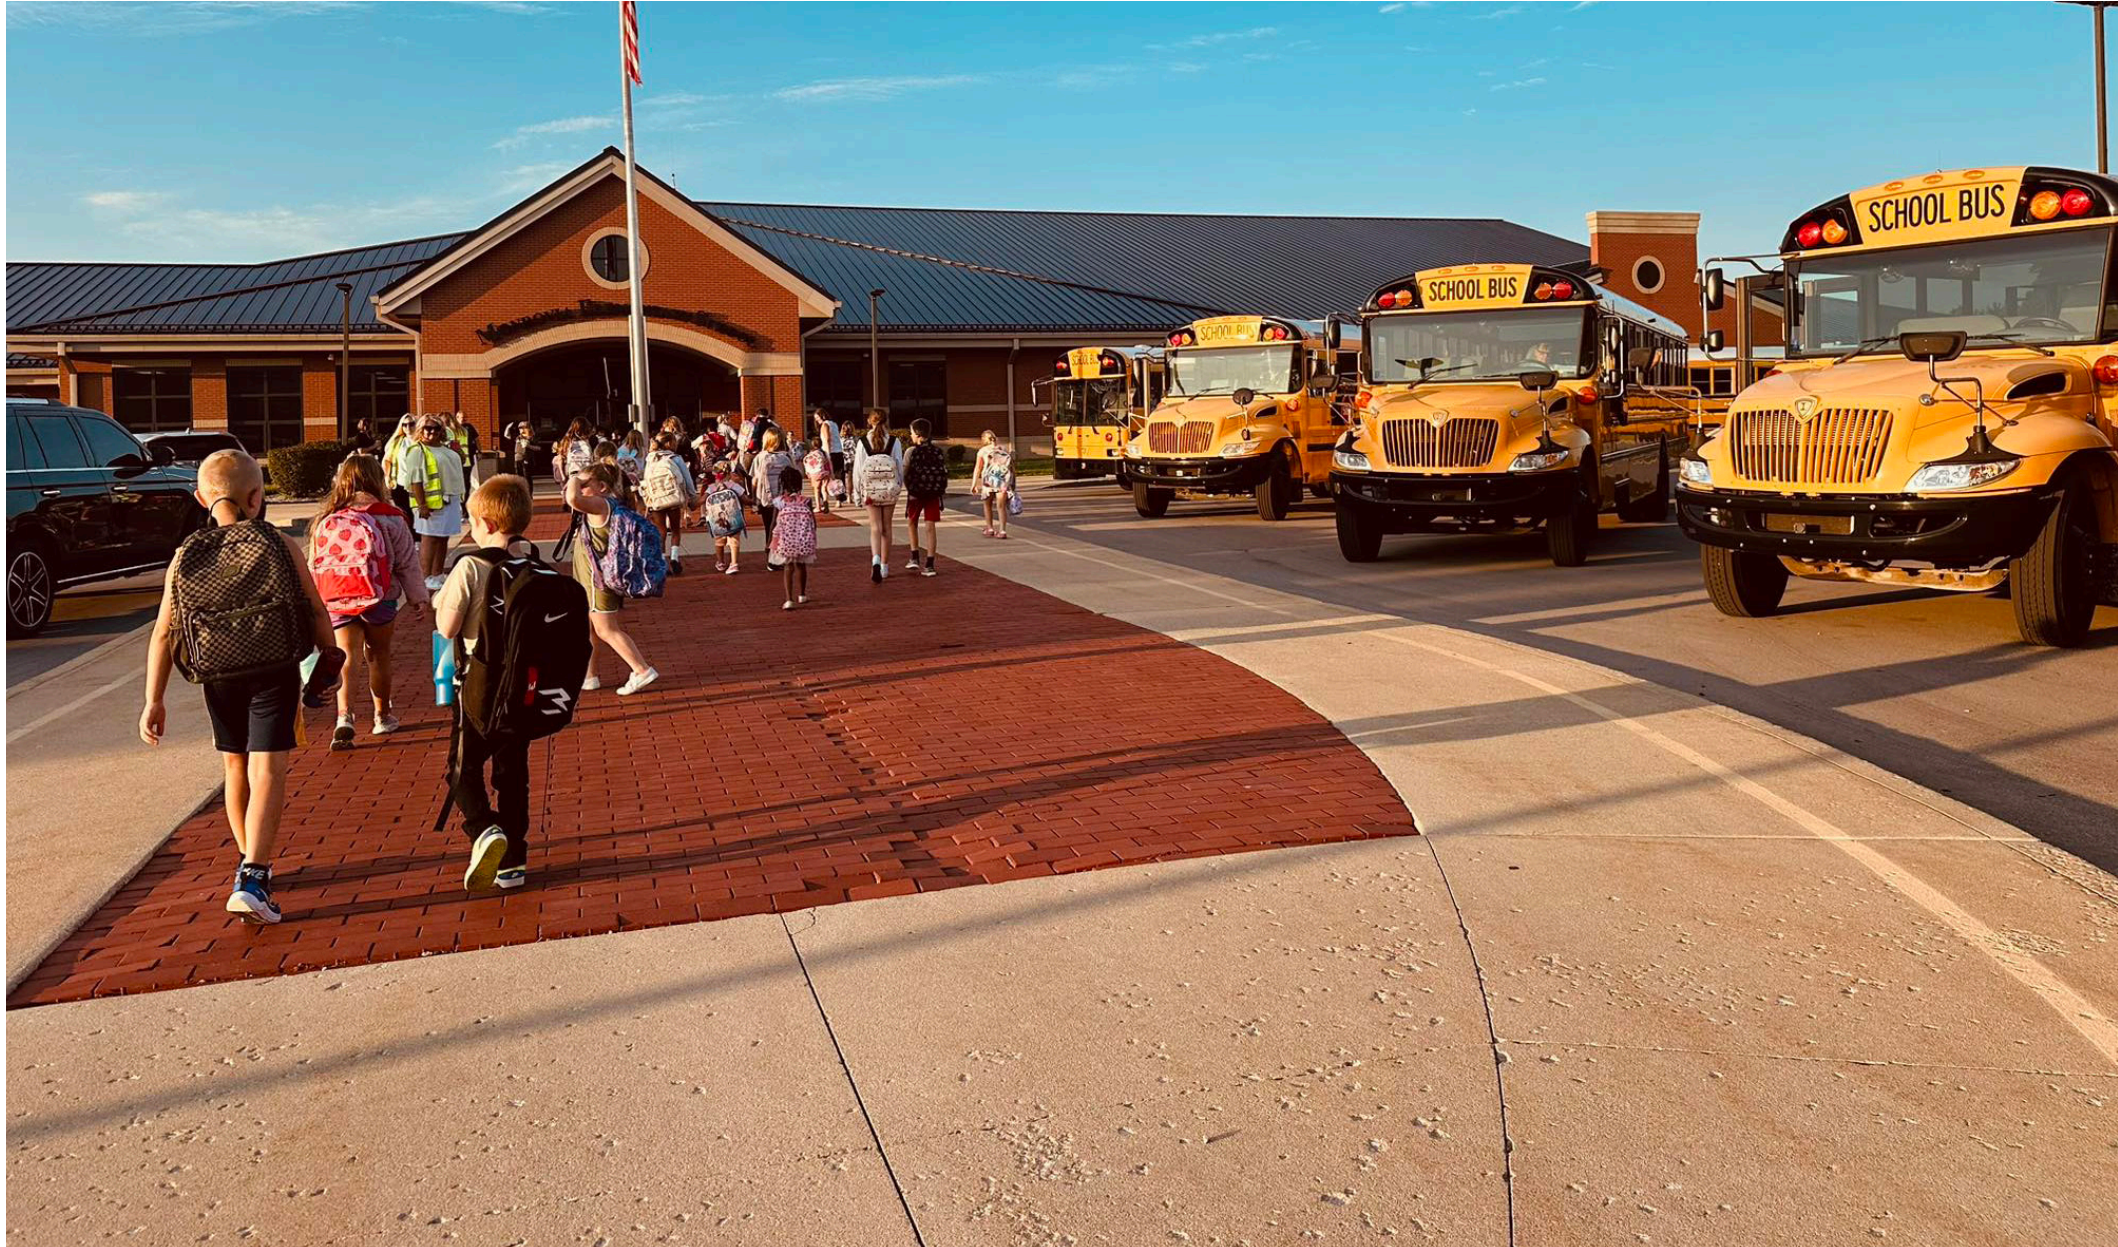
PROGRAM SQUARE FOOTAGE MONROVIA ELEMENTARY SCHOOL

EXISTING SF REQUIRED SF

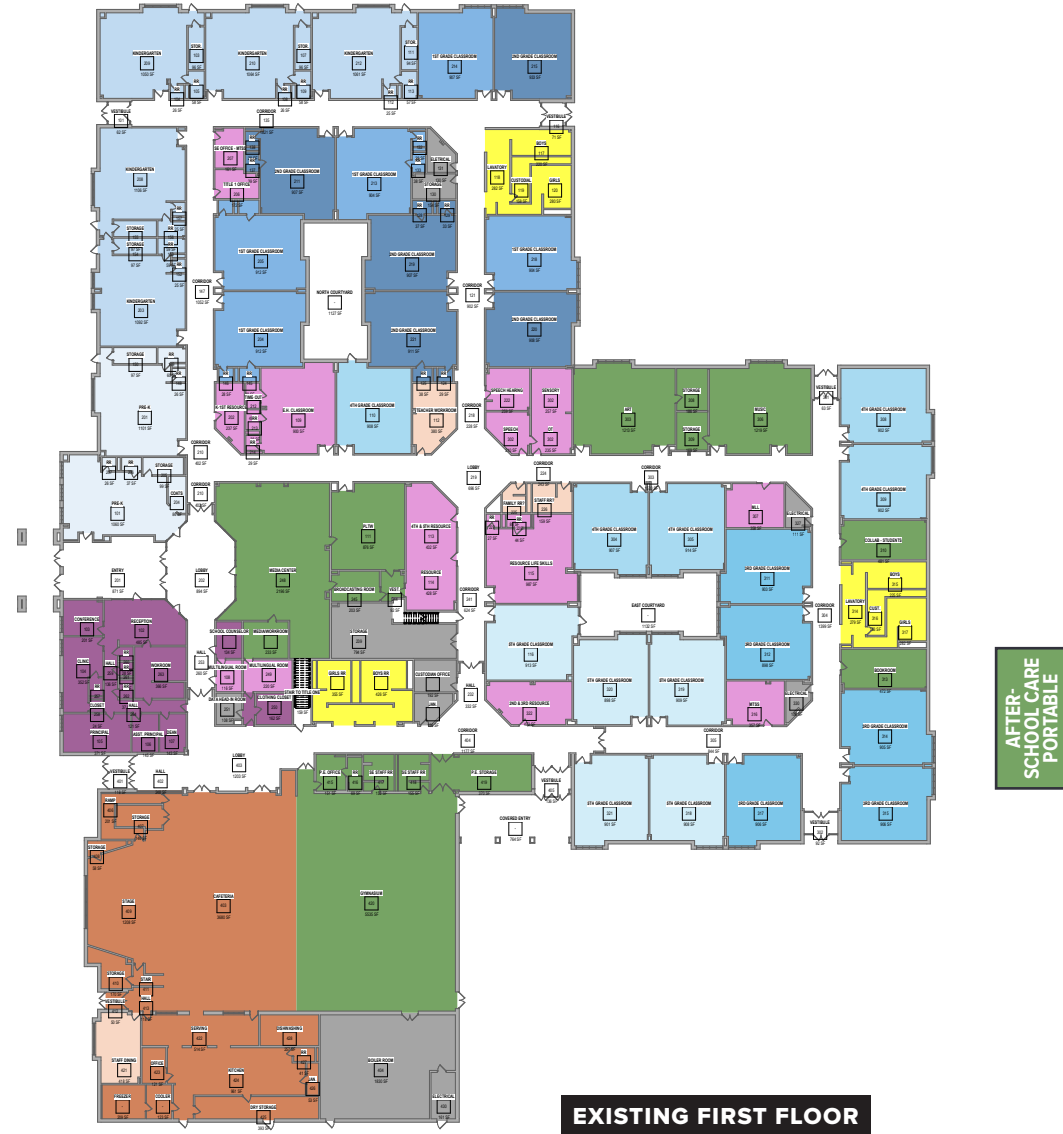
MONROVIA ELEMENTARY SCHOOL SPACE UTILIZATION

- CLASSROOMS
- SPECIAL ED + STUDENT SUPPORT
- STUDENT RESTROOMS
- SPECIALS
- CAFETERIA + KITCHEN
- ADMINISTRATION
- STAFF SUPPORT
- MEPT, STORAGE, CUSTODIAL
