**Monona Grove School District**  
**Maywood Elementary School**  
**Facility Assessment**

## Maywood Elementary School Overview

Maywood Elementary School located at 902 Nichols Road in Monona; WI was originally built in 1956. The building has gone through some past renovations which include the south corridor of the building. Maywood currently has a footprint of 42,000 sq ft but is 46,500 sq ft in total. Price breakdown, insights and assets are found below. Work assumed to be put in place 2026-2031. Pricing excludes abatement and hazardous materials.

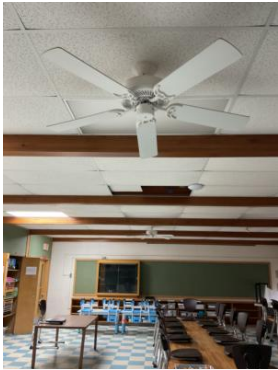
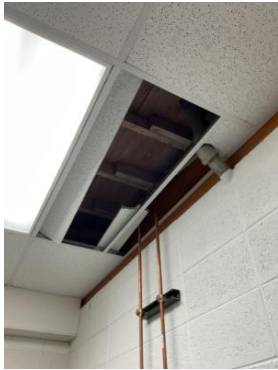
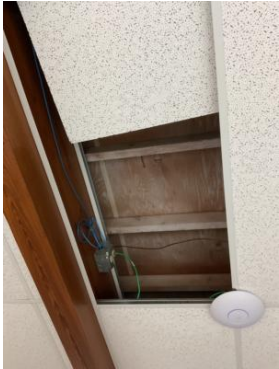
### Add Fire Protection to Building - Maywood Elementary School

| <b>Category:</b> D40 - Fire Protection | | <b>Size:</b> N/A | |
| <b>Manufacturer:</b> N/A | | <b>Observed Remaining Life:</b> 5-10 yr | |
| <b>Model:</b> N/A | | <b>Condition:</b> TBD | |

Note: Fire protection system not currently installed in building. If 50% of school is renovated, then fire protection will be required for occupancy.

**Fire Protection:** No current sprinkler system is present, however, if over 50% of school is needed to be renovated then code will require the adding of fire protection to the entire building.

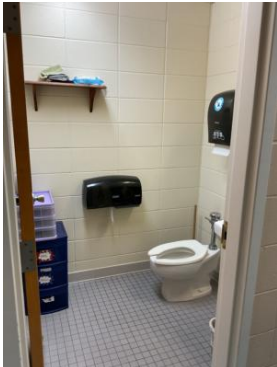
### Bathroom Remodel Allowance - Maywood Elementary School

| <b>Category:</b> C30 - Interior Finishes | | <b>Size:</b> N/A | |
| <b>Manufacturer:</b> N/A | | <b>Observed Remaining Life:</b> 5-10 yr | |
| <b>Model:</b> N/A | | <b>Condition:</b> Fair | |

Note: Further code review is necessary to verify if proposed work will mandate bringing bathrooms up to code.

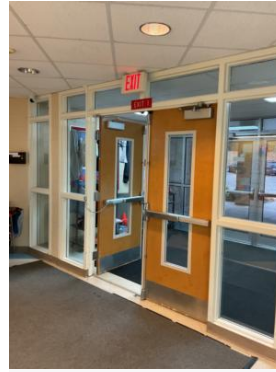
### Main Entrance access control - Maywood Elementary School

**Category:** D50 - Electrical

**Observed Remaining Life:** 5-10 yr

**Condition:** Fair

Note: Cost reflects adding access control/call box at main entrance. Secure entrance may be desired depending on future use.

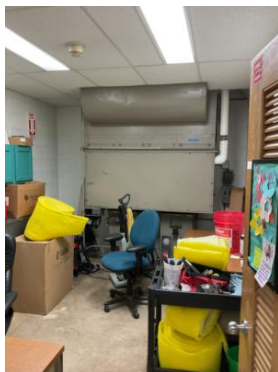
### New Air Handling Unit - Maywood Elementary School

**Category:** D30 - HVAC

**Observed Remaining Life:** 0-1 yr

**Condition:** Very Poor

**HVAC:** Overall, the HVAC system is in poor condition. All HVAC equipment seems to be close to or past its useful life including RTUs and AHU. Classroom unit vents are original to the building and are no longer reasonable to repair. Air conditioning can be added for comfort.

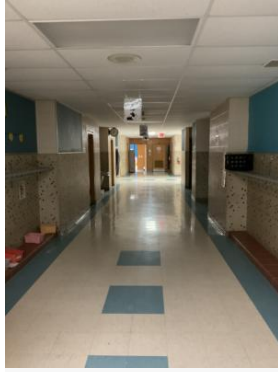
## New Cameras - Maywood Elementary School

**Category:** *D50 - Electrical*

**Observed Remaining Life:** 2-5 yr

**Condition:** *Poor*

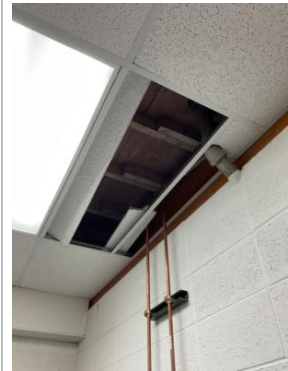
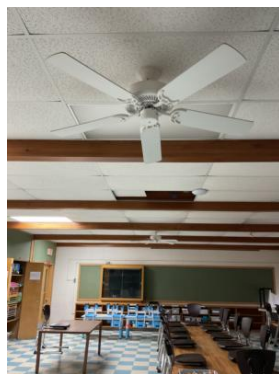
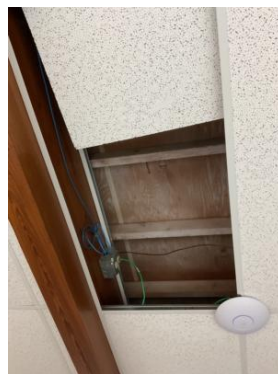
**New Ceiling Tile - Maywood Elementary School**

**Category:** C30 - Interior Finishes

**Observed Remaining Life:** 5-10 yr

**Condition:** Fair

Note: Code Review required to confirm intended occupancy of the building is compliant with construction type. See unprotected wood ceiling construction.

The building requires several maintenance and upgrade tasks to improve its condition and functionality. The acoustic ceiling panels need thorough cleaning or upgrading to enhance both aesthetics and acoustics. A fresh coat of paint is necessary to improve visual appeal and protect the surface. The window system is old and inefficient, including the lintels, requires upgrading to improve structural integrity and energy efficiency.

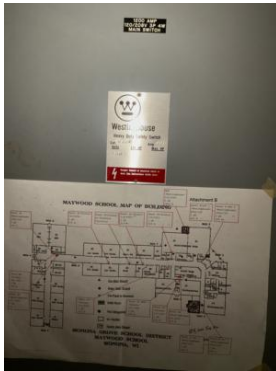
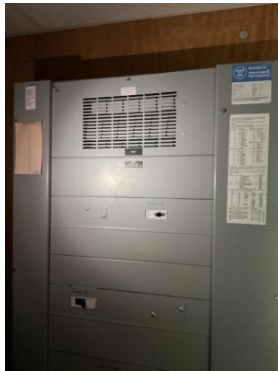
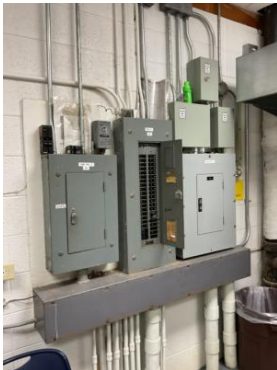
### New Electrical Sub Panels - Maywood Elementary School

| <b>Category:</b> <i>D50 - Electrical</i> | | <b>Size:</b> N/A | |
| <b>Manufacturer:</b> N/A | | <b>Observed Remaining Life:</b> 2-5 yr | |
| <b>Model:</b> N/A | | <b>Condition:</b> <i>Poor</i> | |

**Electrical:** The building requires several electrical tasks. This includes replacing the main lighting fixtures for efficiency, power distribution and electrical panels. Upgrade all lighting to LED throughout the school. Upgrading outdated low voltage systems like fire alarm, clock/PA system and tele/data will be required.

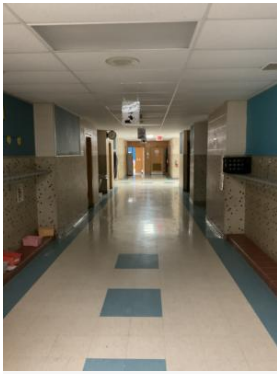
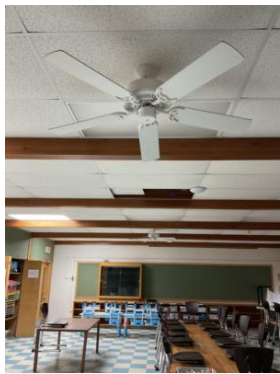
### New LED Lighting - Maywood Elementary School

| <b>Category:</b> <i>D50 - Electrical</i> | | <b>Size:</b> N/A | |
| <b>Manufacturer:</b> N/A | | <b>Observed Remaining Life:</b> 2-5 yr | |
| <b>Model:</b> N/A | | <b>Condition:</b> <i>Poor</i> | |

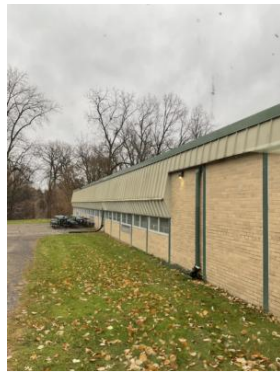
**New Site Lighting/ Wall Pack Lights - Maywood Elementary School**

**Category:** D50 - Electrical

**Observed Remaining Life:** 2-5 yr

**Condition:** Poor

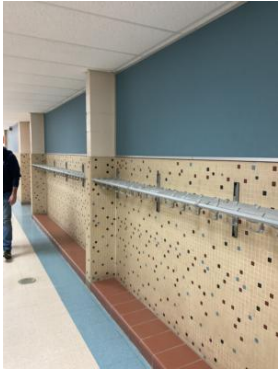
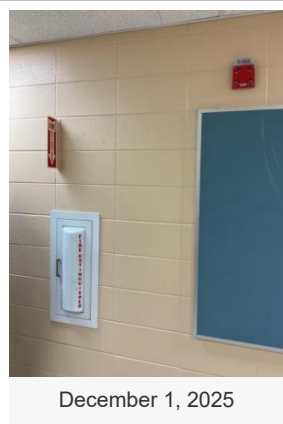
### Painting Allowance - Maywood Elementary School

**Category:** C30 - Interior Finishes

**Observed Remaining Life:** 2-5 yr

**Condition:** Poor

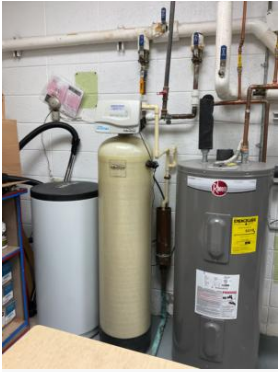
Replace 1 Water Heaters - Maywood Elementary School

**Category:** D20 - Plumbing

**Observed Remaining Life:** 2-5 yr

**Condition:** Poor

**Plumbing:** The plumbing system requires several maintenance and upgrade tasks. This includes a replacement of existing fixtures to low flow efficient fixtures. Domestic hot water heaters are close to over half of their useful life and should be replaced before

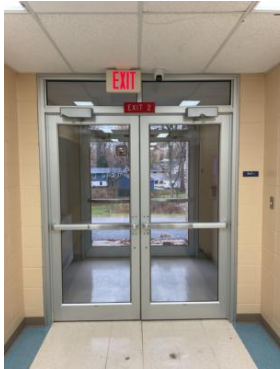
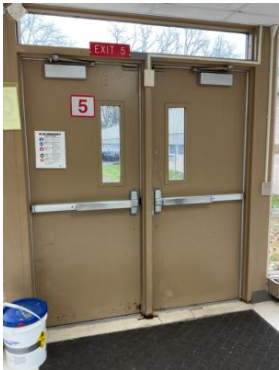
## Replace Exterior Doors - Maywood Elementary School

| <b>Category:</b> B20 - Exterior Enclosure | | <b>Size:</b> N/A | |
| <b>Manufacturer:</b> N/A | | <b>Observed Remaining Life:</b> 0-1 yr | |
| <b>Model:</b> N/A | | <b>Condition:</b> Very Poor | |

**Exterior:** Overall, the exterior of the building is in fair condition. However, the exterior doors, door frames, door kick plates and the lintels above the doors are rusty and need to be replaced.

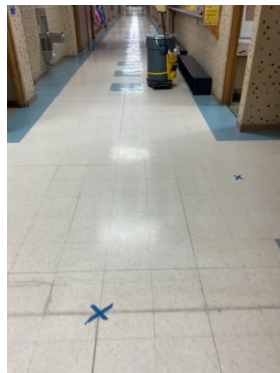
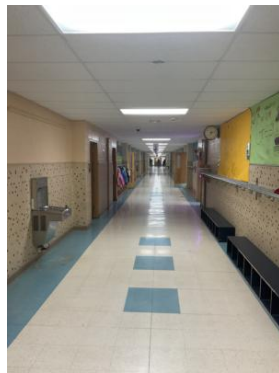
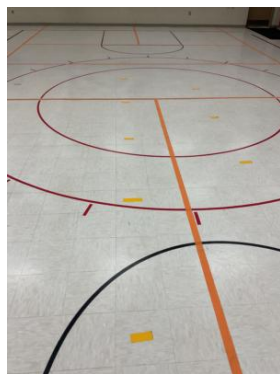
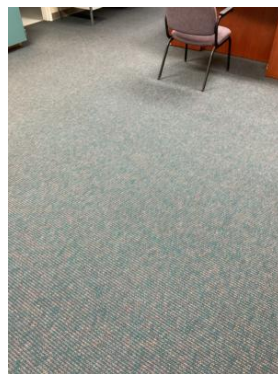
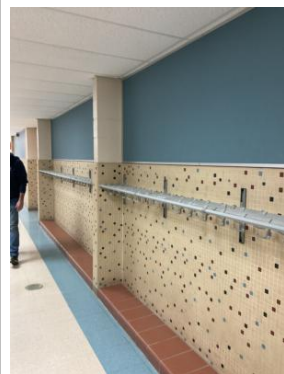
## Replace Flooring Throughout - Maywood Elementary School

**Category:** C30 - Interior Finishes

**Size:** 42,000 SF

**Observed Remaining Life:** 2-5 yr

**Condition:** Fair

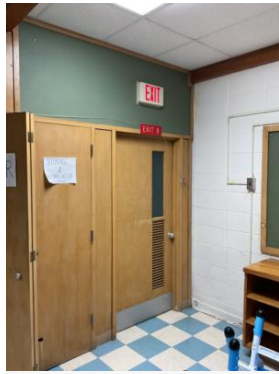
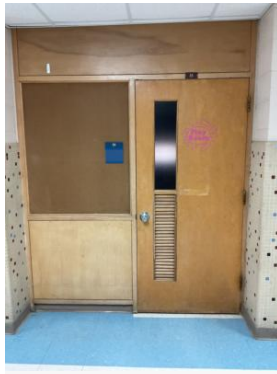
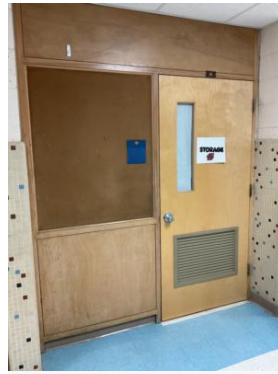
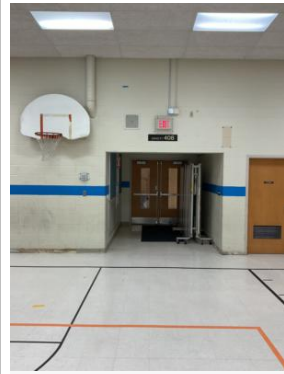
### Replace Interior Doors - Maywood Elementary School

**Category:** C30 - Interior Finishes

**Observed Remaining Life:** 0-1 yr

**Condition:** Very Poor

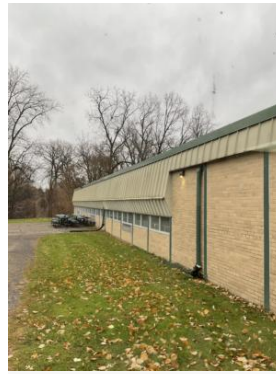
### Tuckpointing Allowance - Maywood Elementary School

**Category:** B20 - Exterior Enclosure

**Observed Remaining Life:** 10+ yr

**Condition:** Good
