RE: Indoor Air Quality Inspection Report
Frog Pond Elementary School – Roof Leaks
Epic Project No. 26-1055

Epic Environmental Services, LLC (Epic) was retained by the Little Egg Harbor Township Board of Education (District) to perform an indoor air quality inspection at the Frog Pond Elementary School. The purpose of the inspection was to evaluate for residual moisture and potential mold activity throughout the building (6 locations) after recent winter storms caused numerous roof leaks. The district plans to address the leaks as soon as the weather warms; however, as the leaks have been present for several weeks, air quality was evaluated out of an abundance of caution.

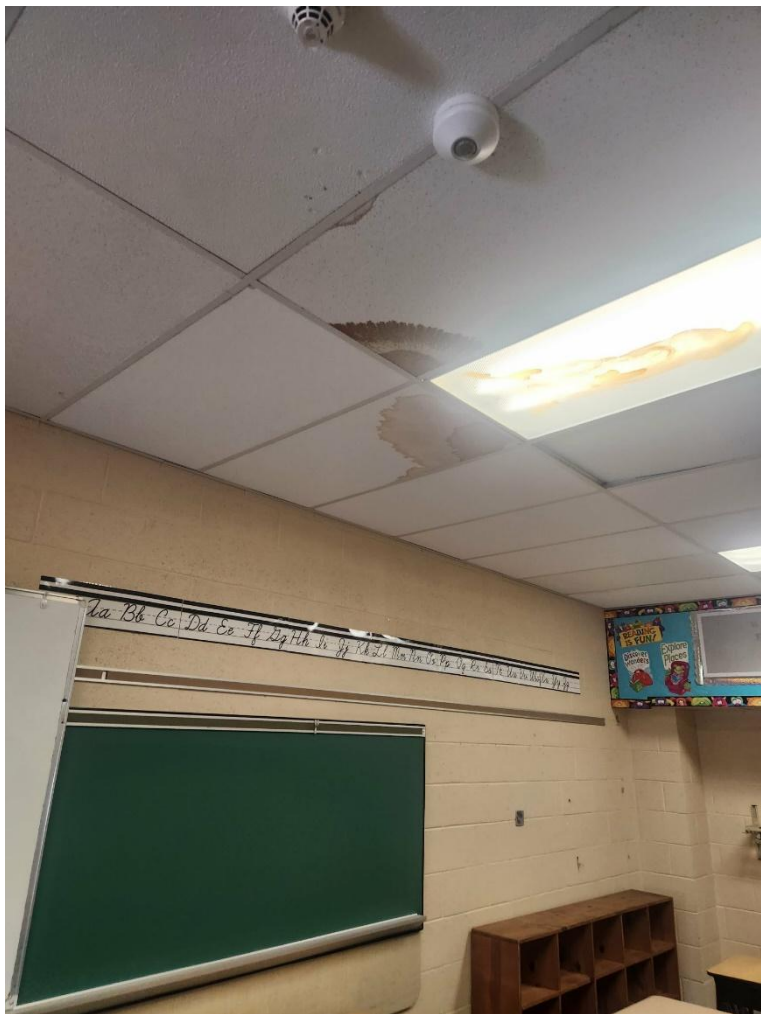
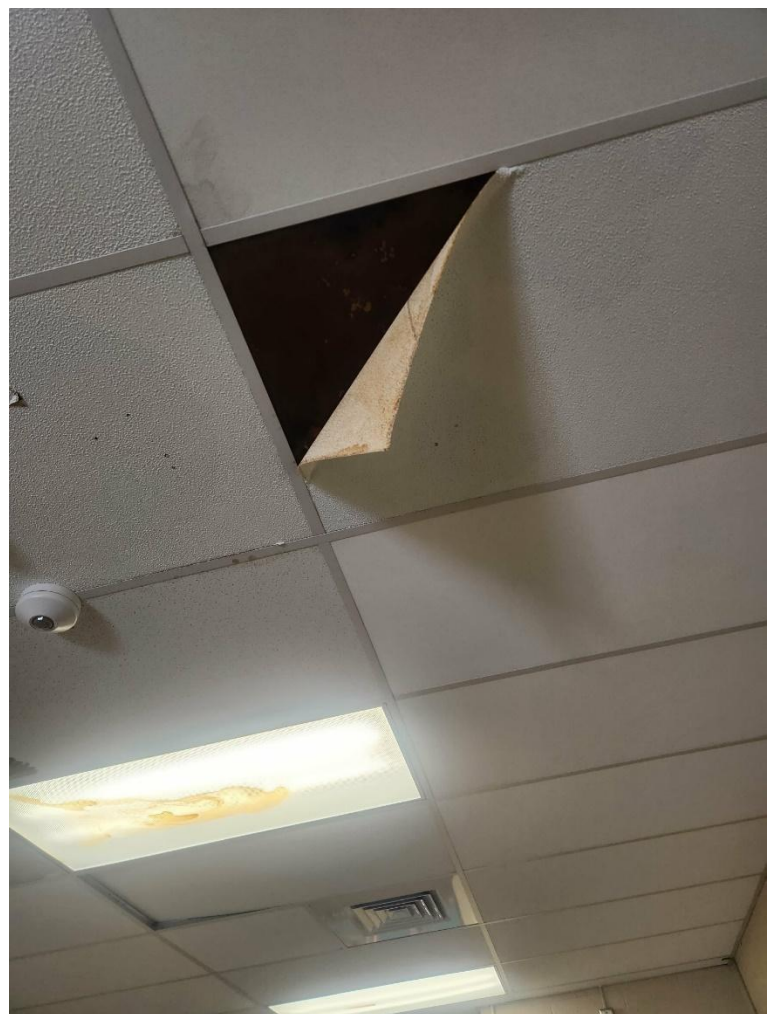
**EXAMPLES OF
WATER DAMAGE
ON CEILING TILES
(ABOVE) AND
CARPETS (RIGHT)**

- Modify air purifiers are in use in most areas. Assure that these units are maintained and cleaned at regular intervals.
- Ensure the sources of the roof leaks are addressed/repared as soon as feasible.
- Clean or replace any surfaces impacted by the leaks. Special attention should be paid to the wet carpets; they should either be thoroughly dried and cleaned or replaced completely.
