Existing Conditions Report
of
Foodservice Equipment
for the
Timberlane School District

Submitted by

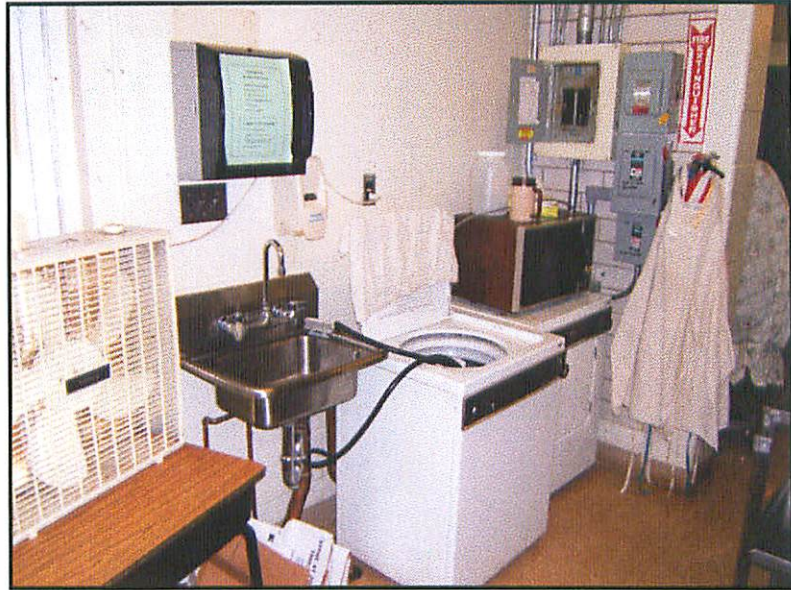
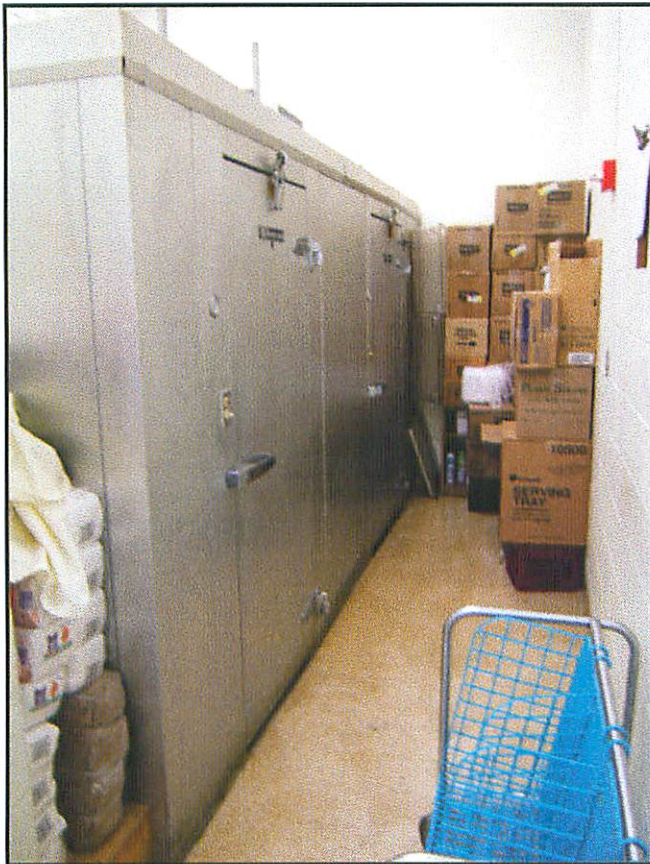
Due to a lack of space in the storage room, paper storage is placed in what available space can be found. Organized, adequate storage facilities will aid with inventory control.

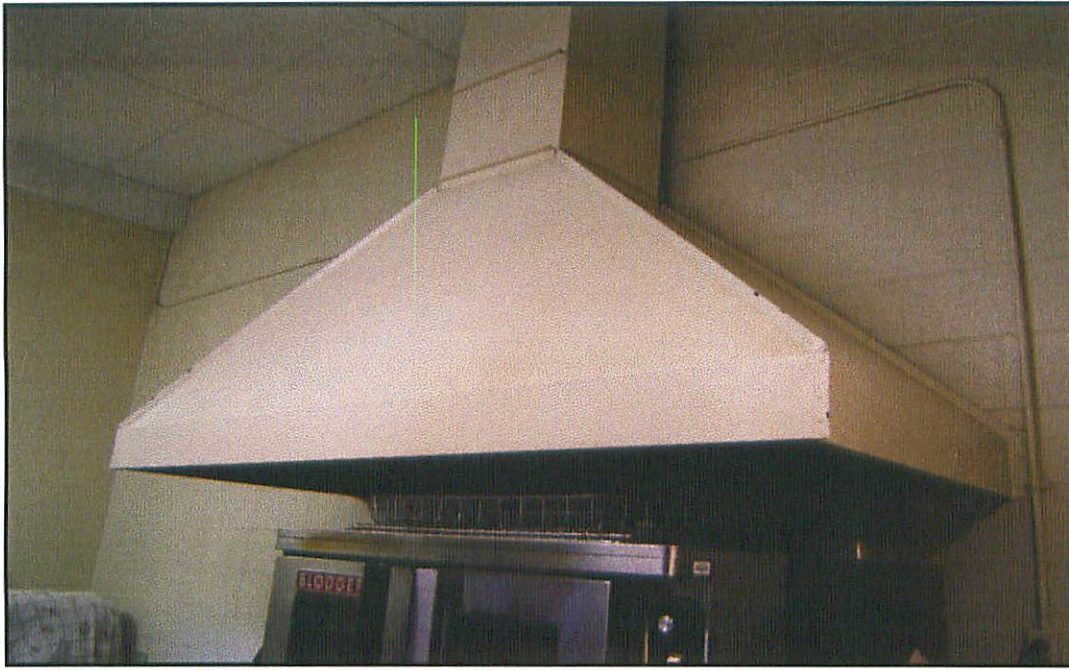
The exhaust hood seen here is inadequate on many levels. The most obvious is the two adjacent pieces of equipment shown below, they are not located under any type of hood. The heat, grease and fumes generated by these pieces contribute to the excessive heat in the kitchen. A fire suppression system is not present and the construction of this hood does not meet modern fire code standards.

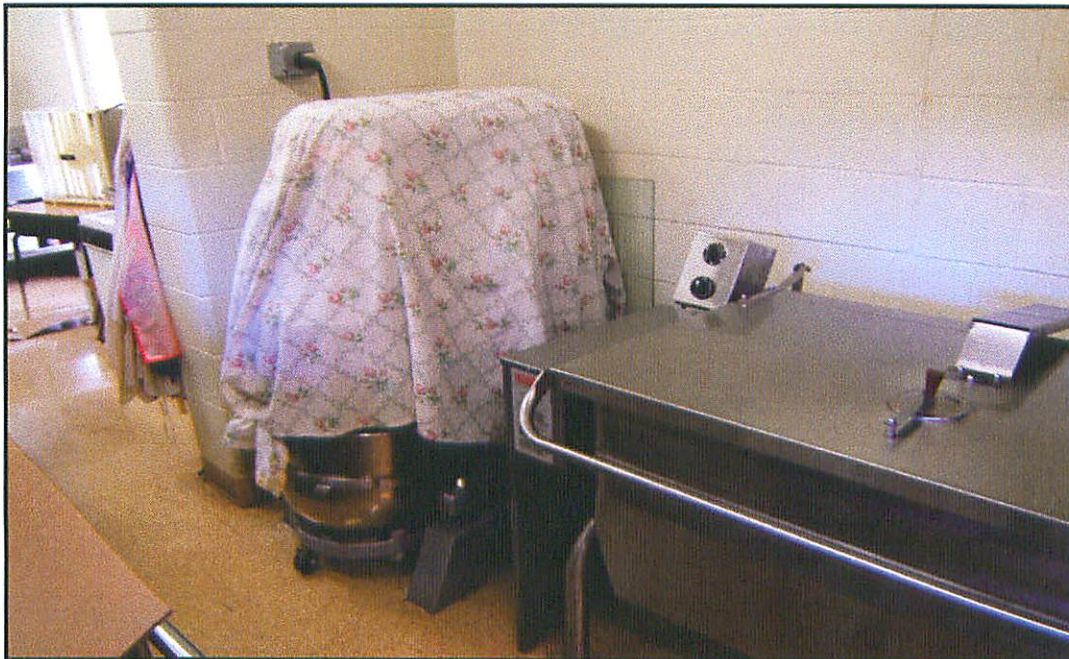
The cooking equipment located adjacent to the braising pan is a problem. The mixer should be located closer to the baking area and not near the cooking equipment. This braising pan is not located under any type of exhaust hood or fire suppression system.

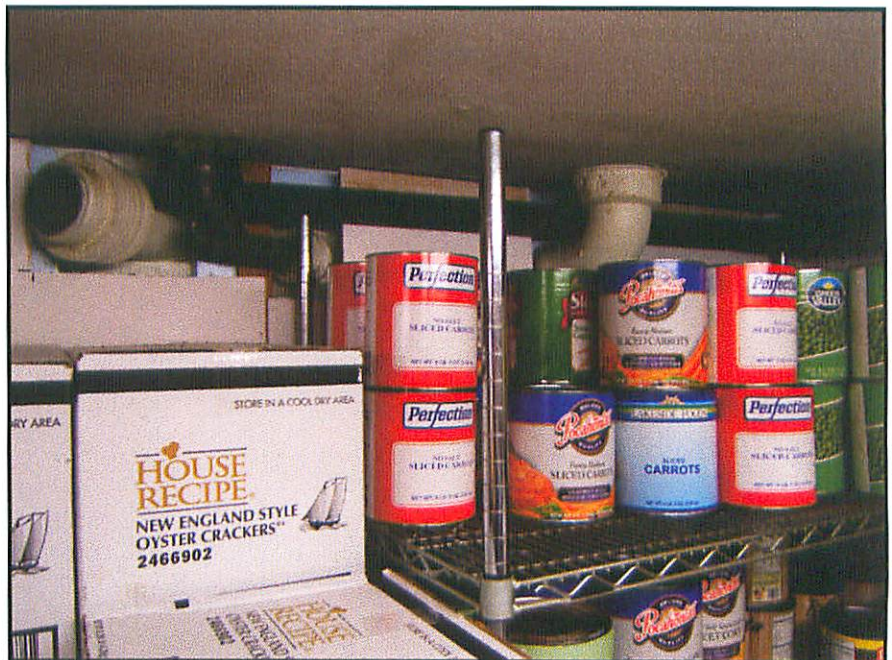
Waste pipes run through the storage room exposed. This is a violation of the health code. In addition, low ceiling height restricts storage, the room is damp and has had problems with mold growth in the past. Consideration should be given to moving this space in an overall re-planning of the kitchen space.

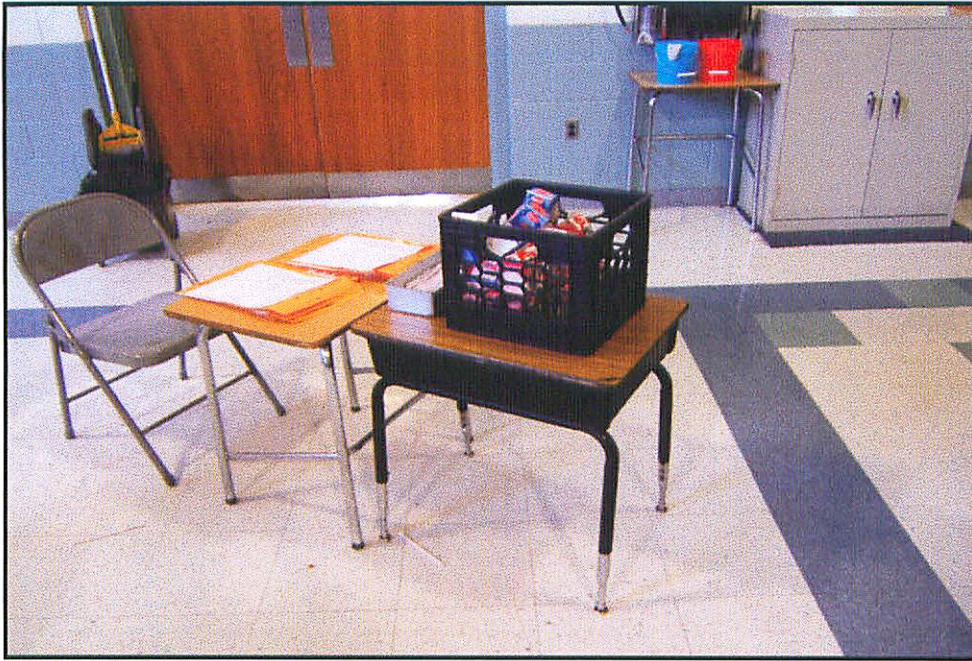
The checking station at the end of the serving line is in need of a refrigerator to keep the milk at the proper temperature. The lack of proper equipment forces the staff to have to improvise in order to create the serving counters that are needed here.

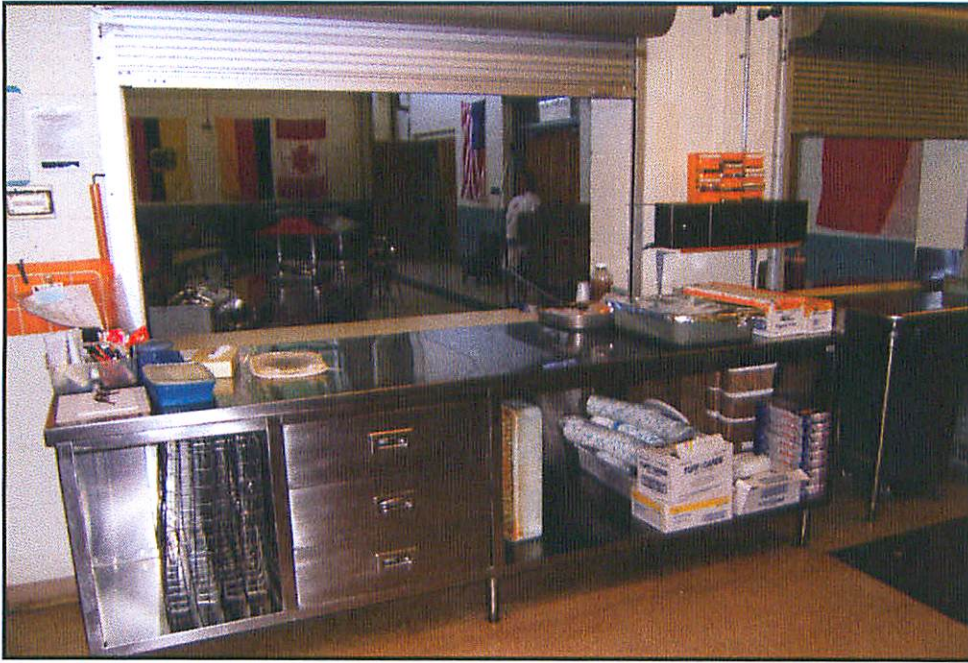
Many pieces in this kitchen are new such as this stainless steel counter and the serving counters seen beyond in the cafeteria (above). The problem lies with the efficiency of the space. For example the staff passes the food through the window seen here and then places it into the serving counters. They are forced to handle the product more times that they should.

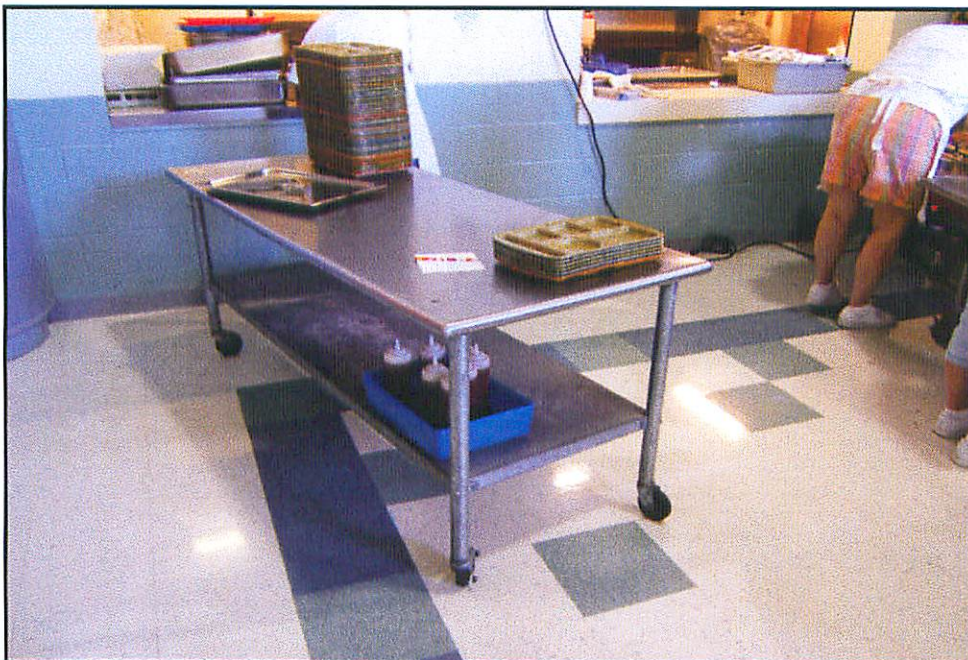
The actual serving line is located in the cafeteria. The serving line should be located within the kitchen space so that it can be accessed easily for service and secured after hours when not in used. Currently, at the end of every day, the serving lines are wheeled into the kitchen to be secured for the night.

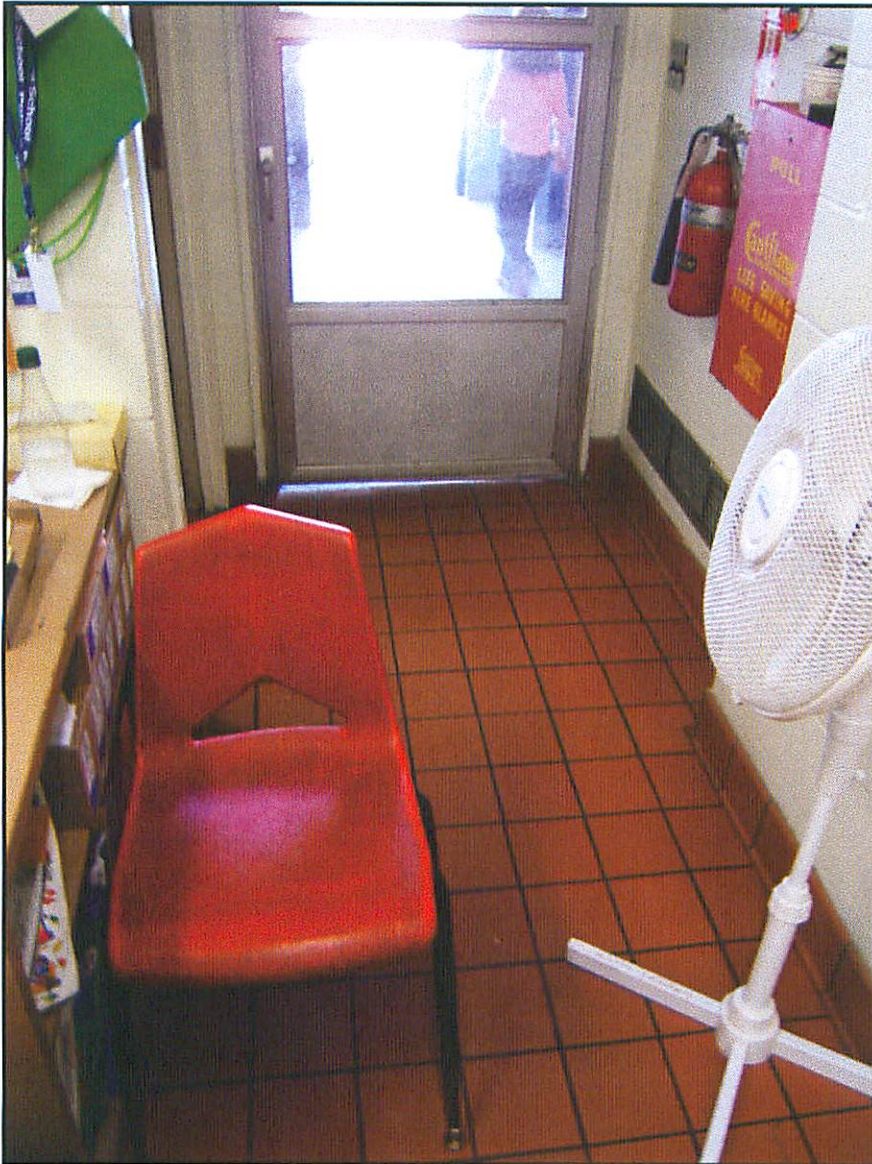
The receiving area is not large enough to handle the typical delivery. This area should be enlarged to accommodate the needs of this facility.

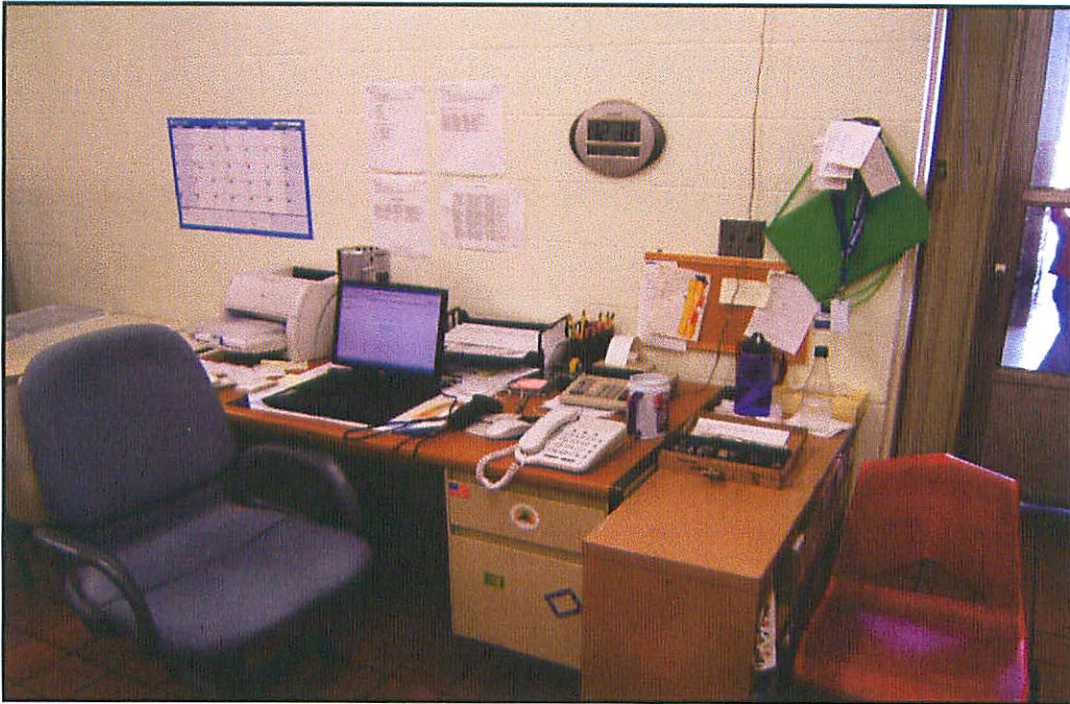
The kitchen manager's desk is located within the kitchen. It is best to locate it in its own space with visual access to the kitchen and receiving. In its present location, it meets this criteria except for being within its own space.

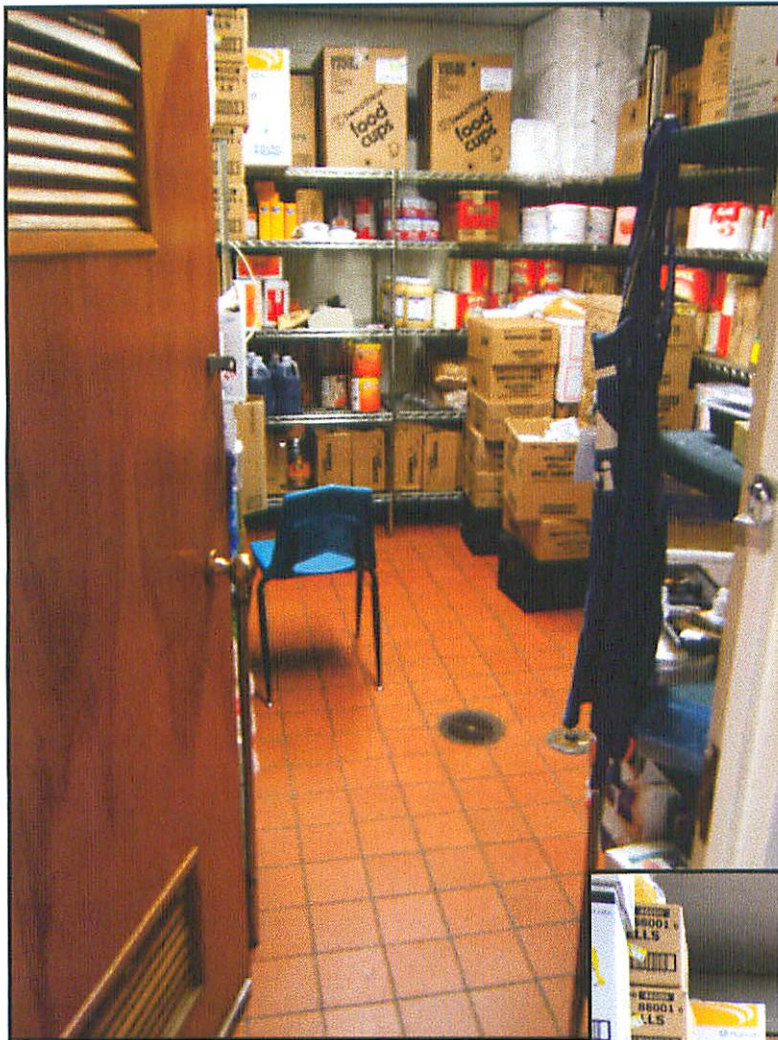
Floor drains should not be located in storage rooms. Since the floor in here is rarely wet the traps in the drains dry out allowing sewer gases to infiltrate the space. Additionally this is a conduit for insect infiltration. Whenever possible drains in storage rooms should be avoided.

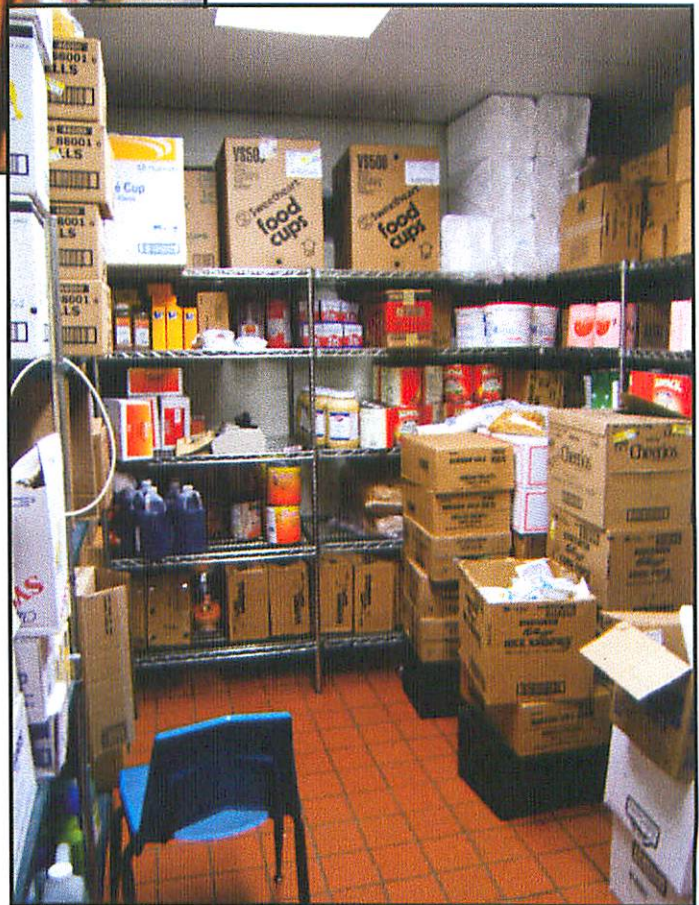
Dunnage platforms would assist in the storage of bulk items and allow the space to be used and cleaned more efficiently.

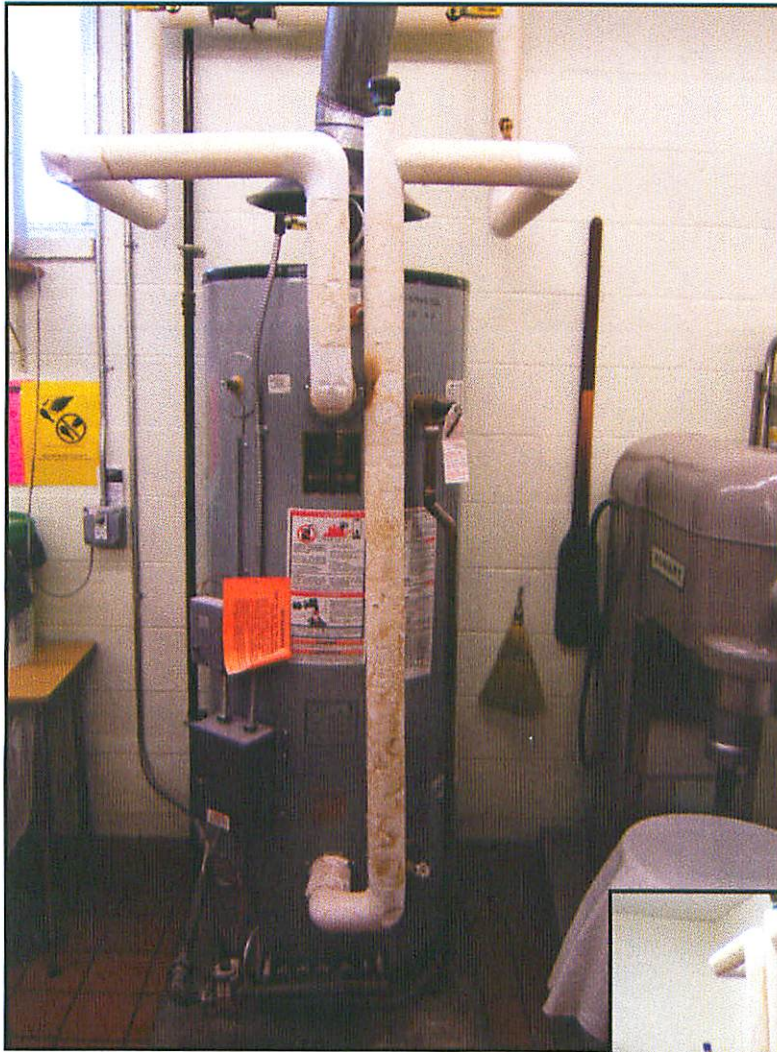
The hot water heater should not be located in the kitchen, this is a violation of the health code. The proximity of this heater to the mixer is problematic. When the mixing of flour is done the dust will work its way into the burner intake and potentially foul it.

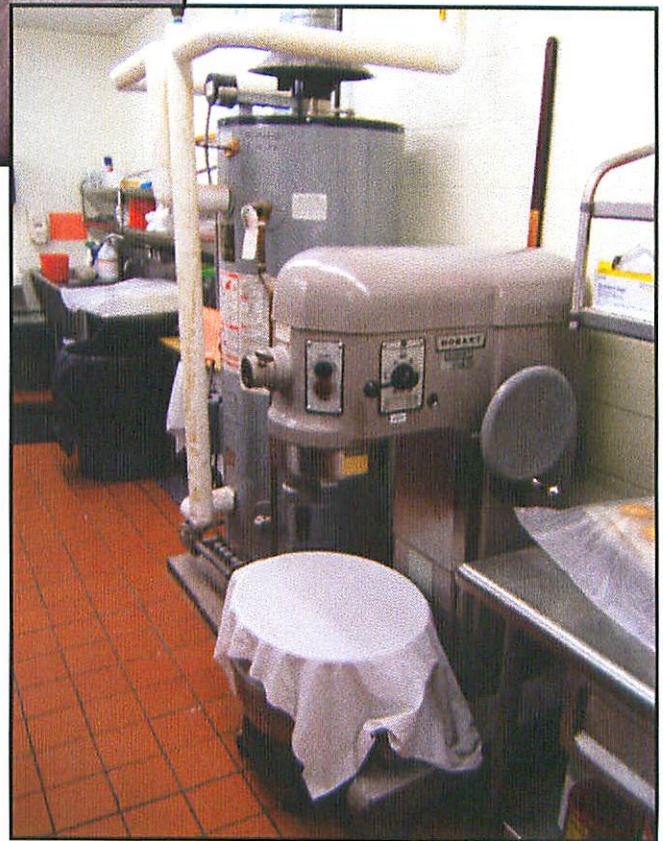
Cleaning in and around the heater is difficult. The heater itself has many crevices where dust and dirt can collect and be difficult to keep clean.

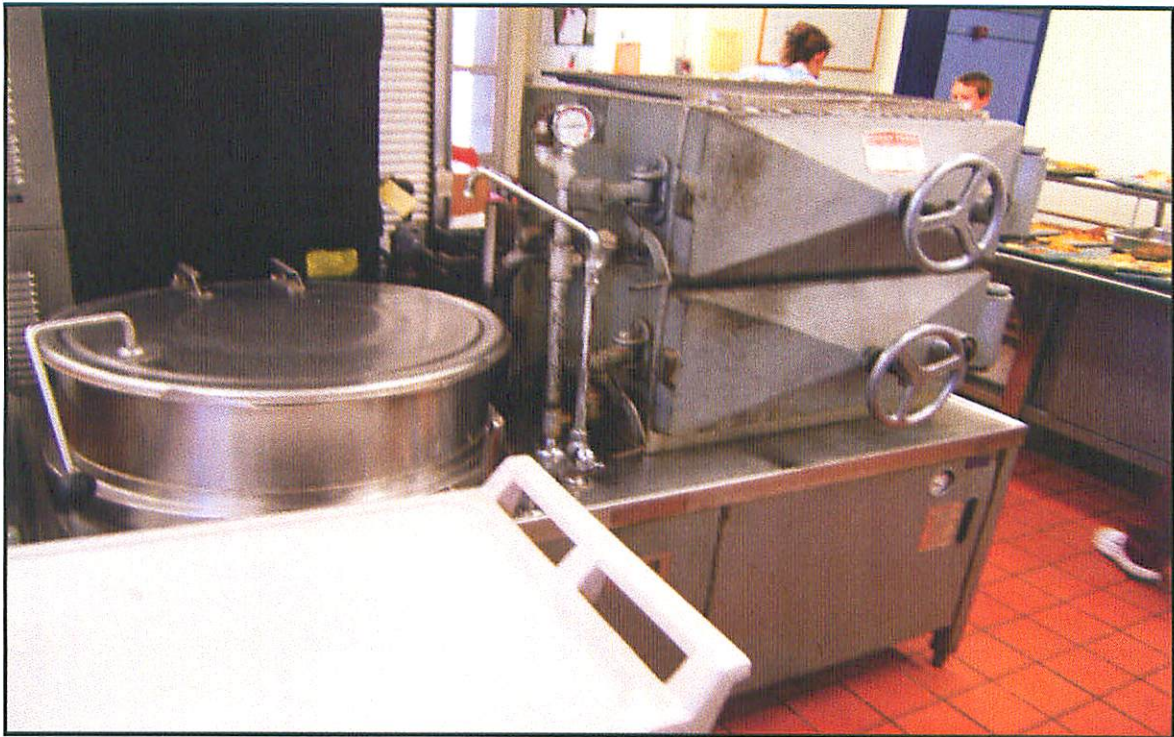
The cooking equipment shown here is outdated and replacement is recommended.

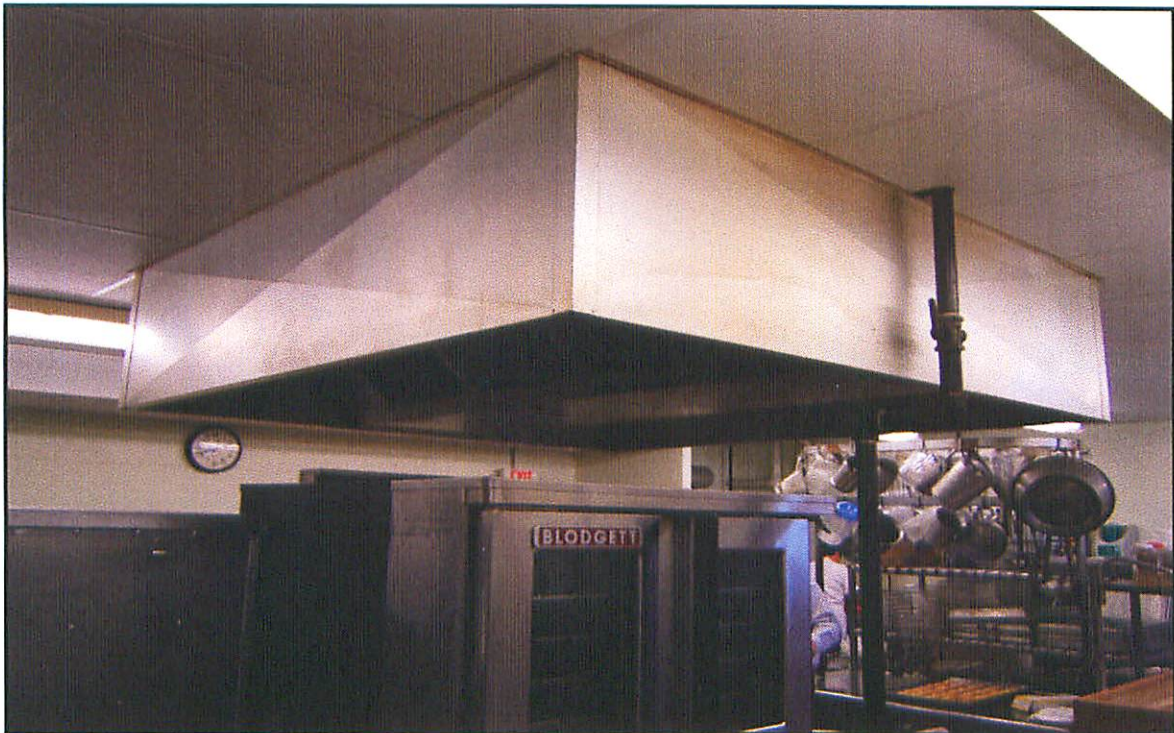
The convection oven seen here is in great condition. The exhaust hood is not code compliant and should be replaced. In addition, the ductwork and fans attached to this hood should be evaluated for code compliance.

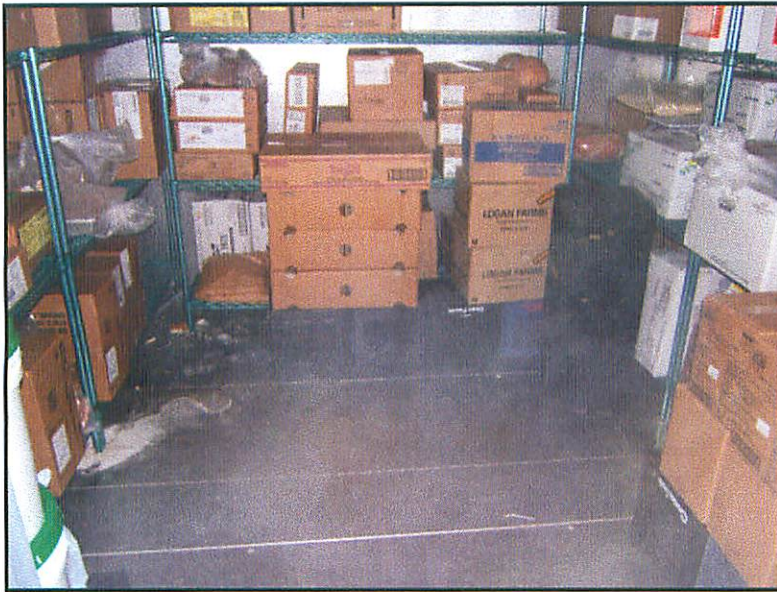
This walk-in freezer could benefit from dunnage platforms, allowing the center aisle to be used for storage and to keep product from being placed on the floor.

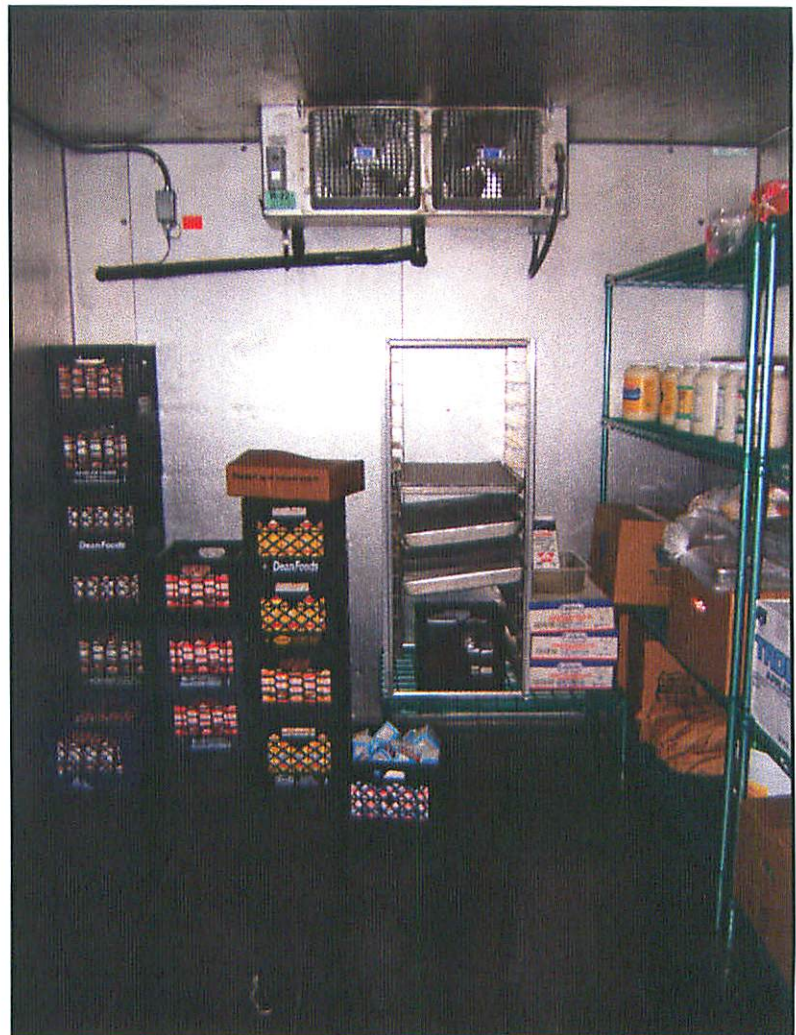
This walk-in cooler and freezer assembly is in excellent condition. It is currently located outdoors with access to it from the kitchen. This unit could remain in place or be moved should a remodel occur.

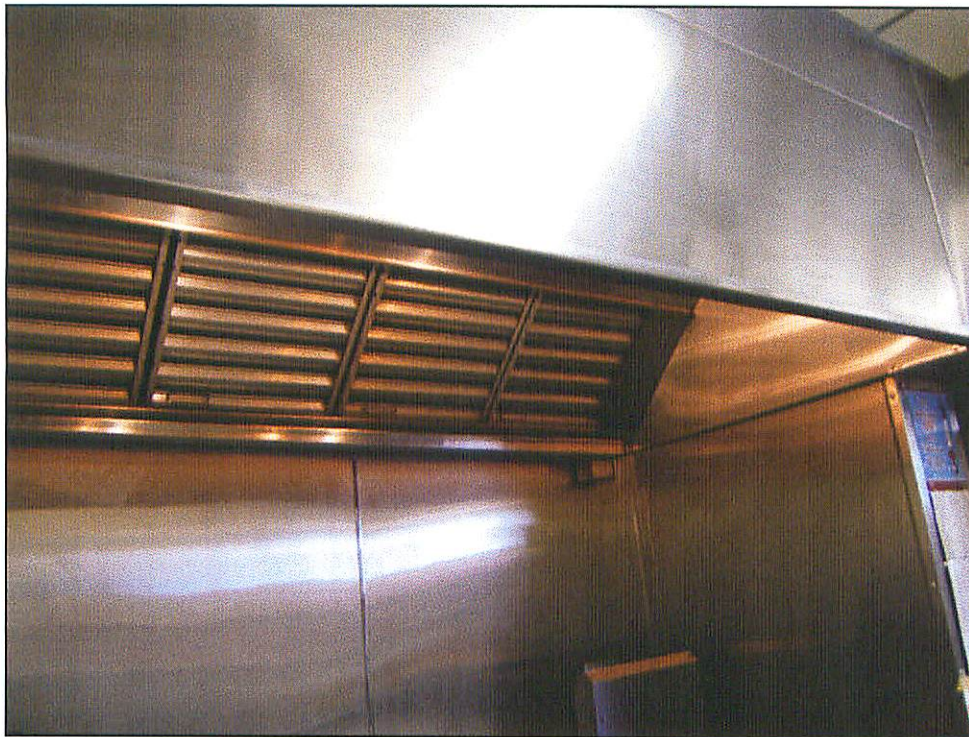
The exhaust hood filters are incorrectly mounted in the horizontal position. They should be turned to the vertical position to allow grease to drain from them and flow to the collection cup located at the right end of the hood. The hood lacks a fire suppression system located over the open burner range and the tilting braising pan.

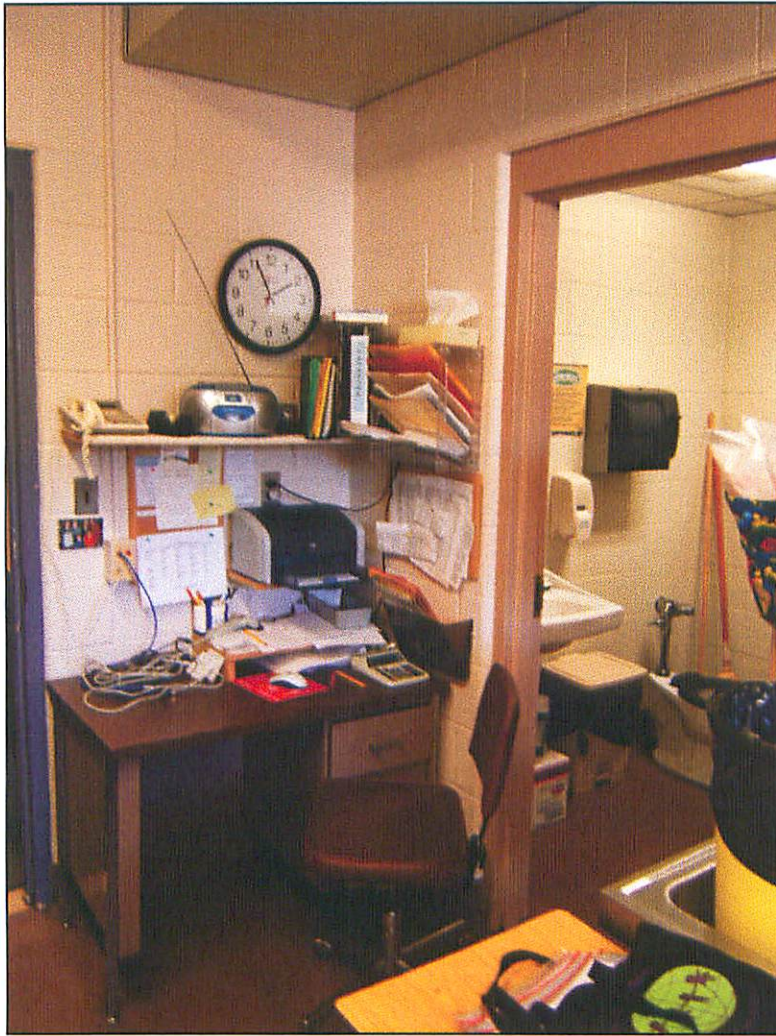
The kitchen manager's desk is located within the kitchen space. These functions should be located away from food production.

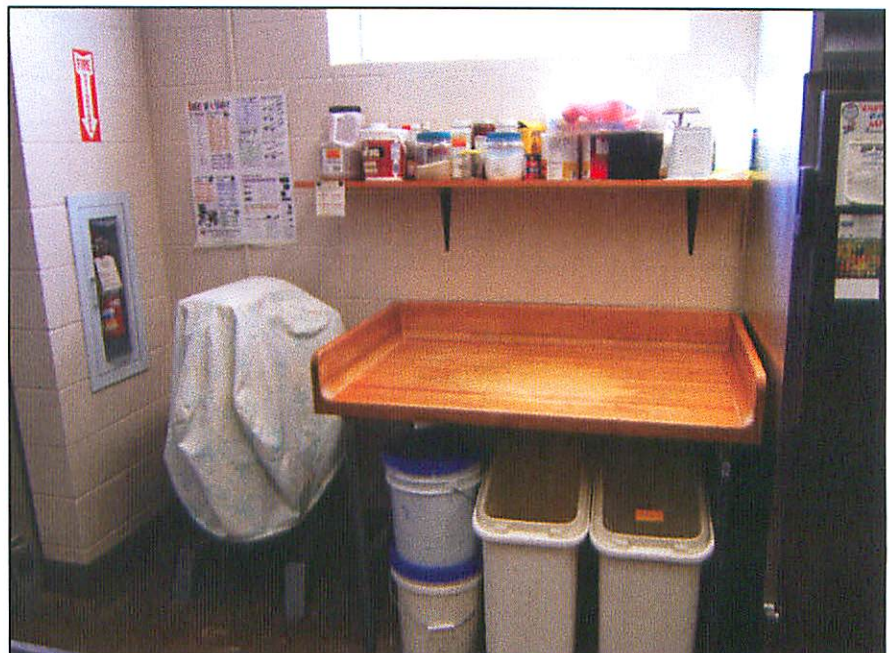
The baker's table is undersized. Consideration should be given to a larger table with a stainless steel top.

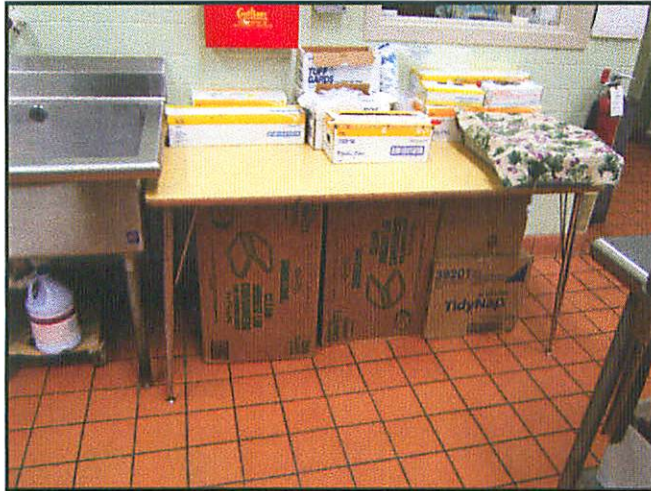
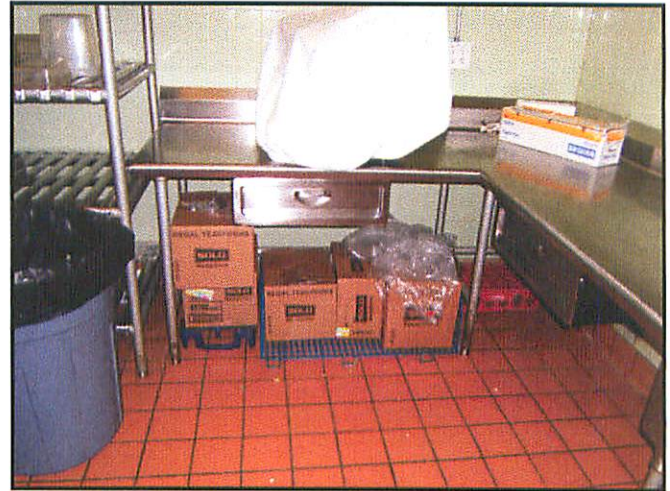
The photographs above represent the need for adequate storage space. The staff is required to find storage where available and in some cases inappropriate locations such as these. Paper goods should be stored in a central location so that it can be monitored and dispensed efficiently.

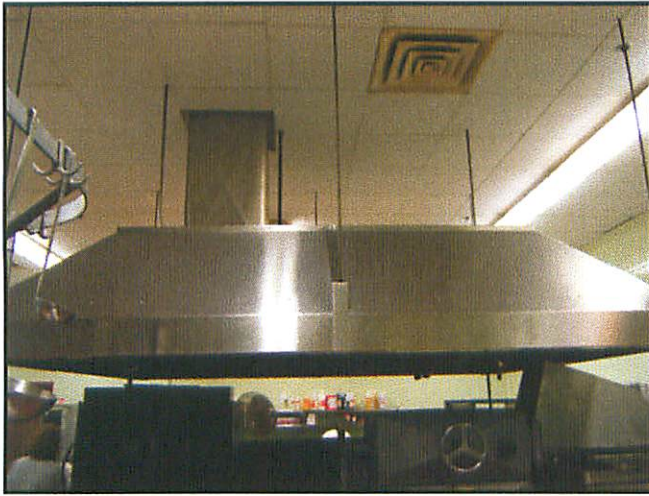
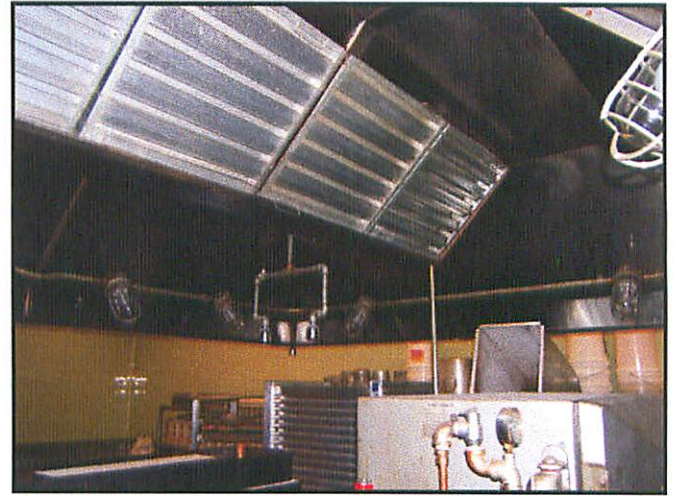
This exhaust hood, though made of stainless steel, is not code compliant. The modern day hood is fabricated to be a fully welded unit with no mechanical seems. The filters on the right are installed incorrectly. They should be in the vertical position so that grease can drain from the filters.

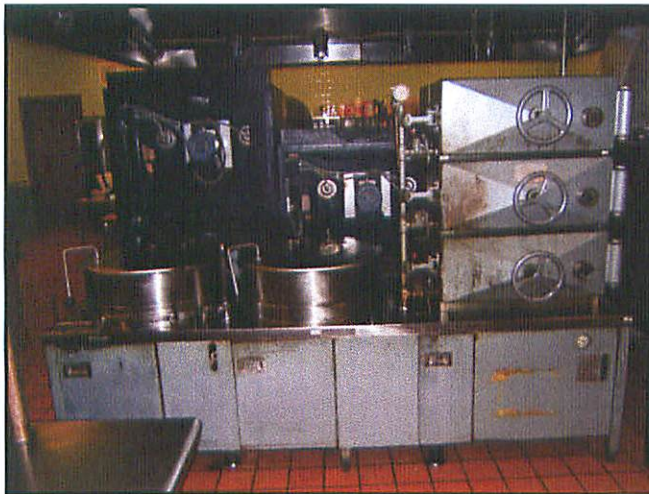
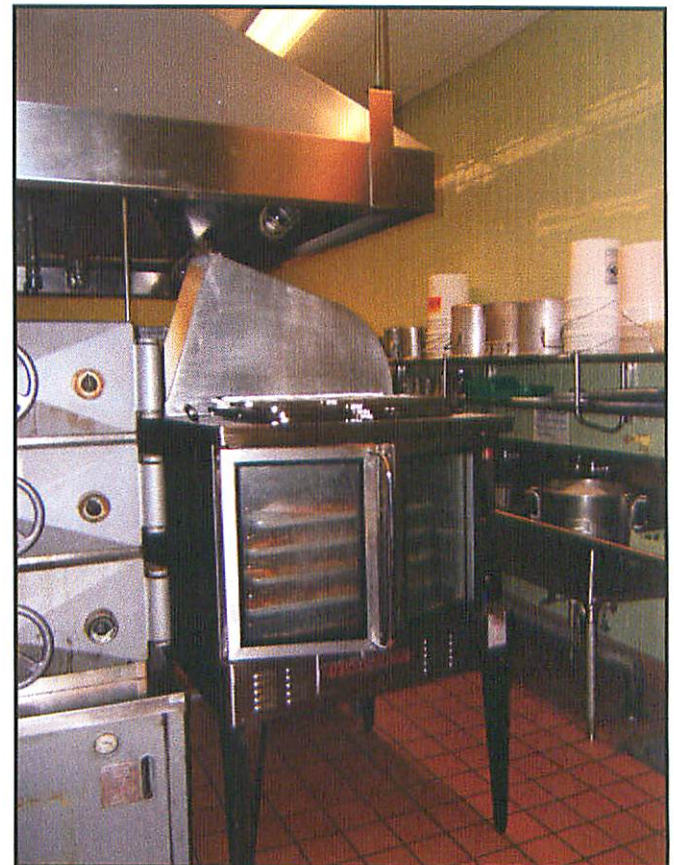
The general condition of the cooking equipment is poor. The steam equipment shown on the left is outdated and requires an upgrade. The convection oven located on the right is partially located outside the footprint of the hood requiring an oddly shaped diverter mounted to the top of it to capture the cooking and exhaust gases. A new exhaust hood and cooking equipment is needed to better address today's needs.

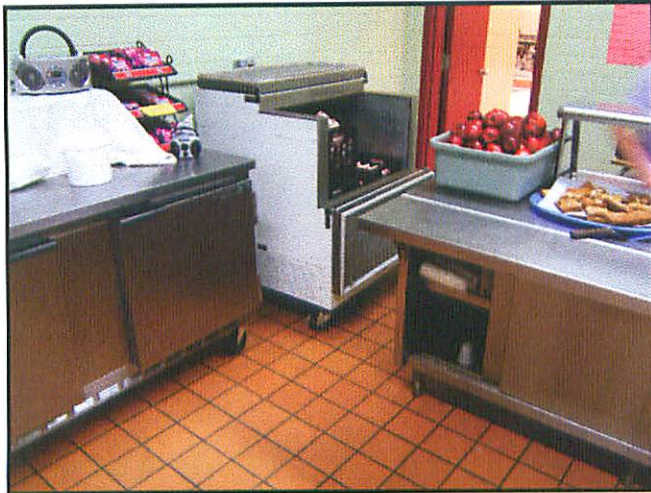
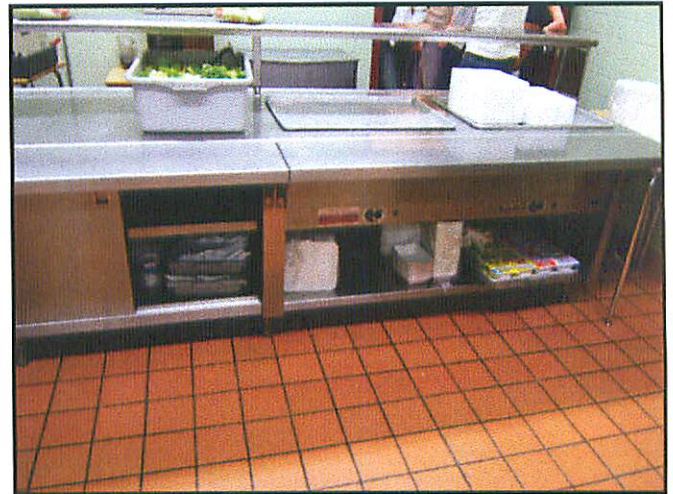
The serving counters need reorganization. Many of the equipment components within them are in need of replacement or are not working and other useful equipment is missing. An updated serving line would speed service and allow the foodservice staff to offer more attractive and healthy food. Too often students select the quick and easy, less healthy alternative.

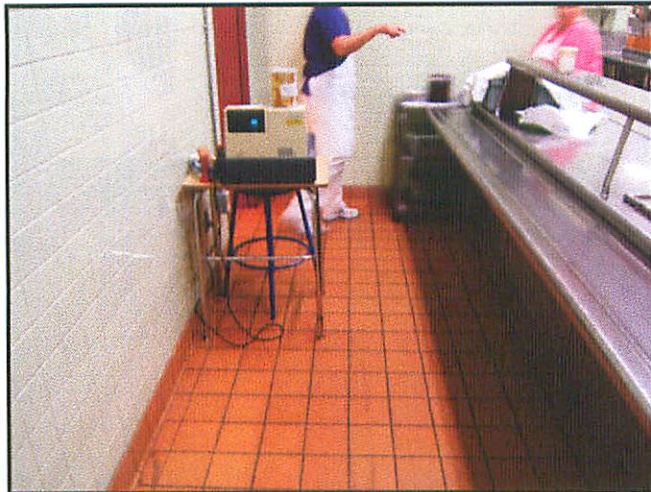
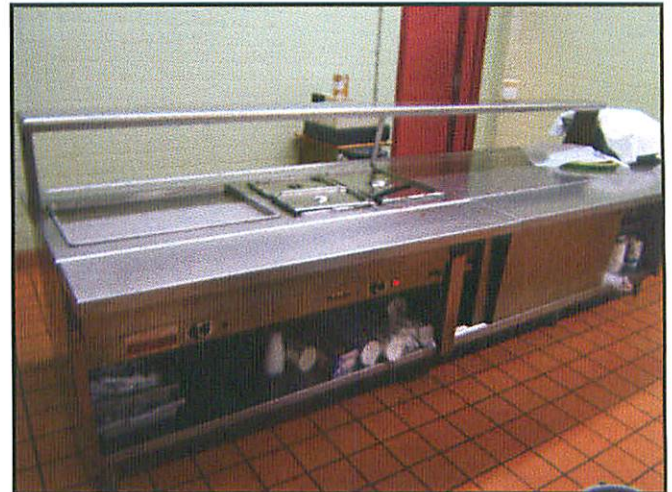
The cash stand is inadequate. Moving students through this line could be made faster by updating the cash stand so that it can operate in two directions and offer the student a place to put down an item while making the cash transaction. The photo on the right is a good example of an underutilized service point. With the addition of more appropriate serving equipment the full use of the counter could be realized.

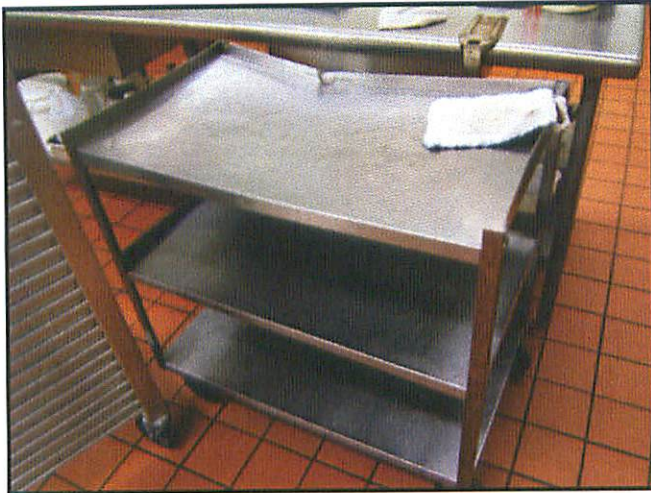
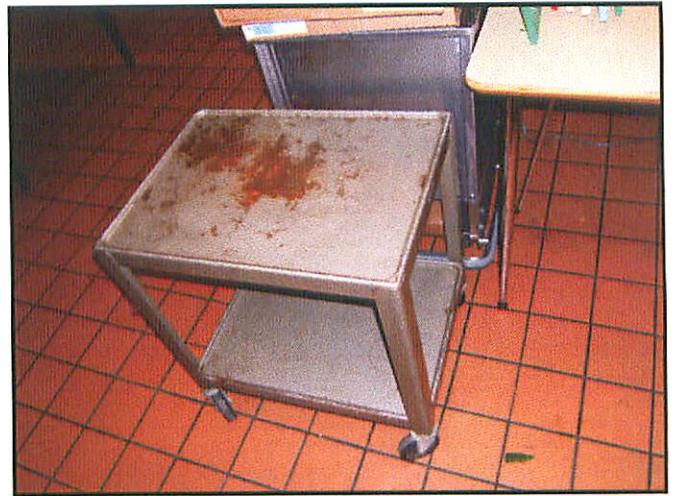
The above photos demonstrate the need for some new equipment. The unit on the left is good quality stainless steel cart that has been damaged. The unit on the right is a painted steel equipment stand that has worn and is now corroding. The finish material on most of the original equipment legs and bases is painted and is in similar condition. This type of finish is not code compliant and should be replaced with stainless steel.

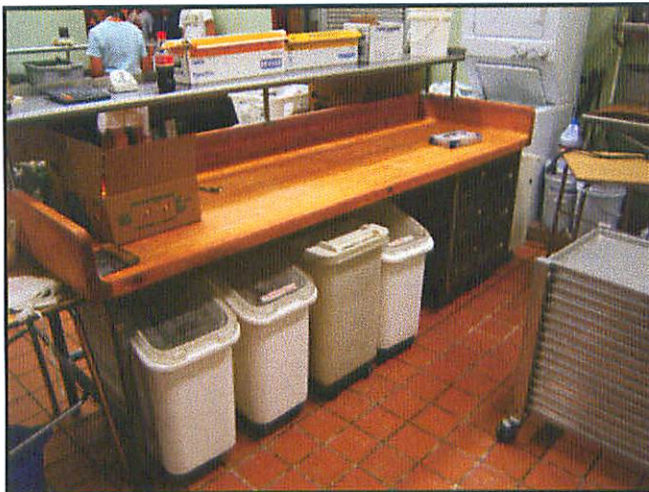
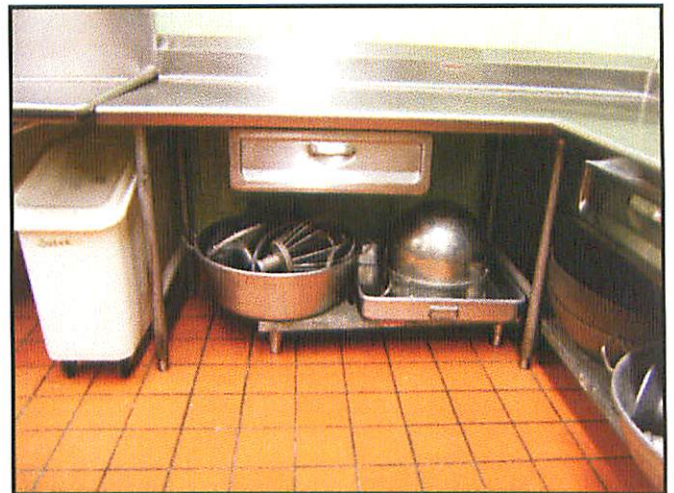
The photo on the bottom right is of a wood topped baker's table. Wood baker's tables are generally accepted today but for ease of cleaning and general upkeep we recommend making this a stainless steel table. Notice the clothes washer and dryer in this shot, it is in among the baking and pan washing area. The clothes washer and dryer should be segregated from any food preparation area.

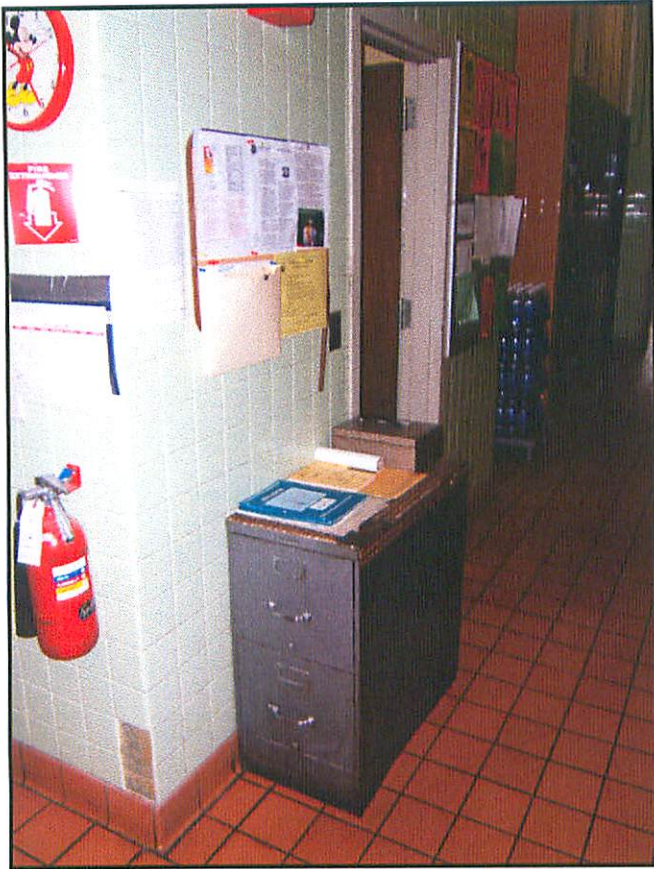
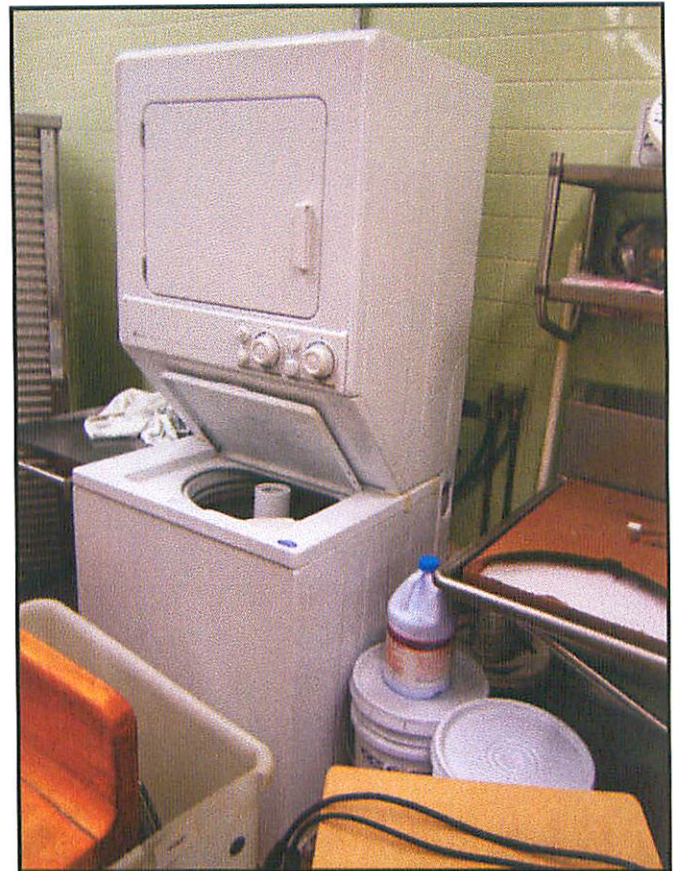
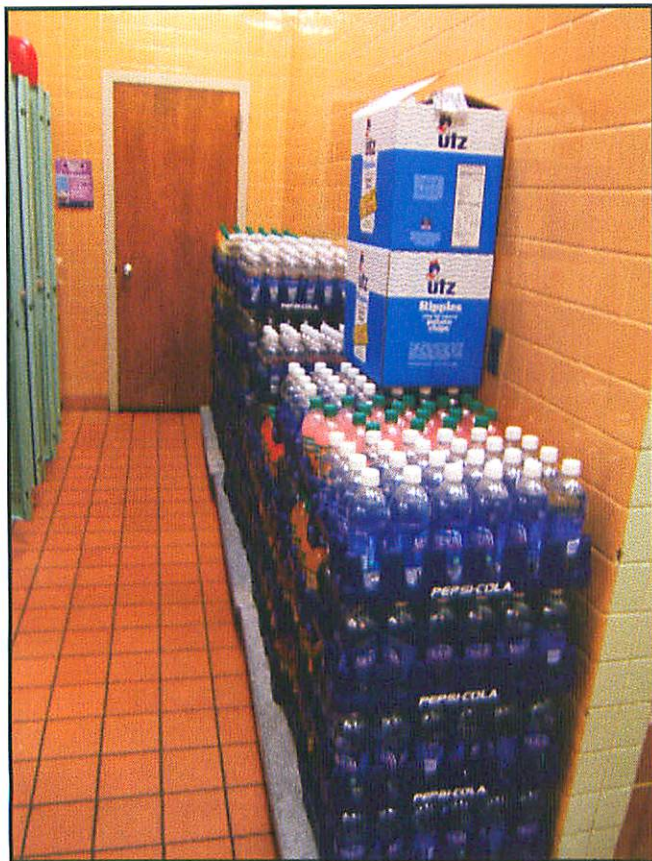
(Top Left)
Office supplies are being stored in the kitchen. Some tile repair work is needed but generally the walls and floor are in good condition.
