Existing Conditions Report
of
Foodservice Equipment
for the
Timberlane School District

Submitted by

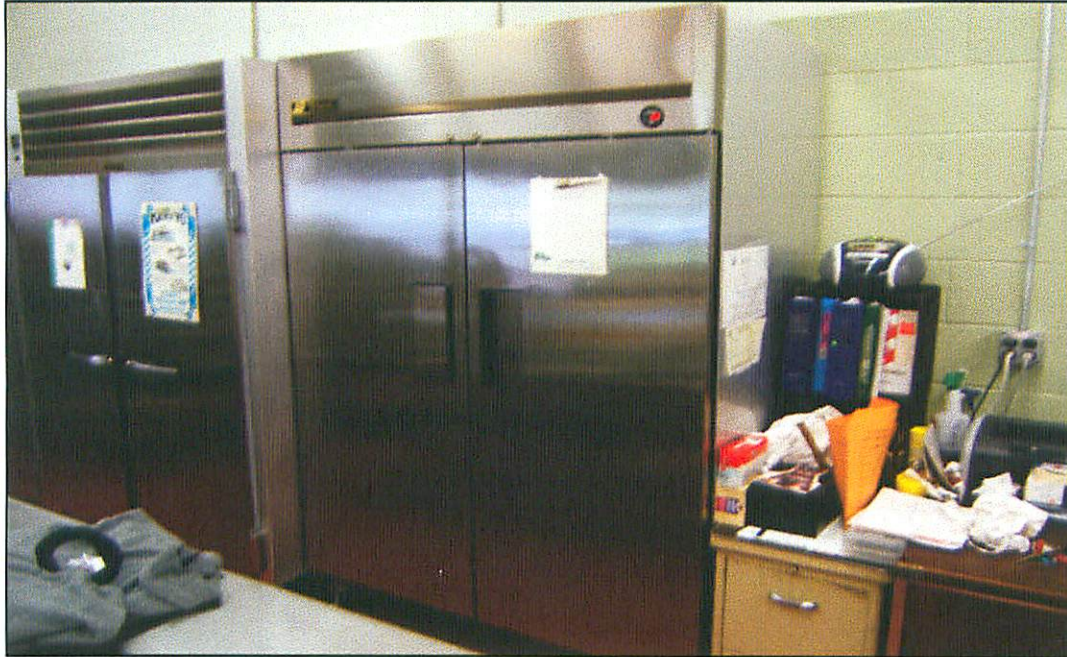
Refrigerated storage is serviced by a series of reach-in cabinets seen here. The facility has a total four reach-ins. A more efficient use of space would be to have this function served by a walk-in refrigerated room.

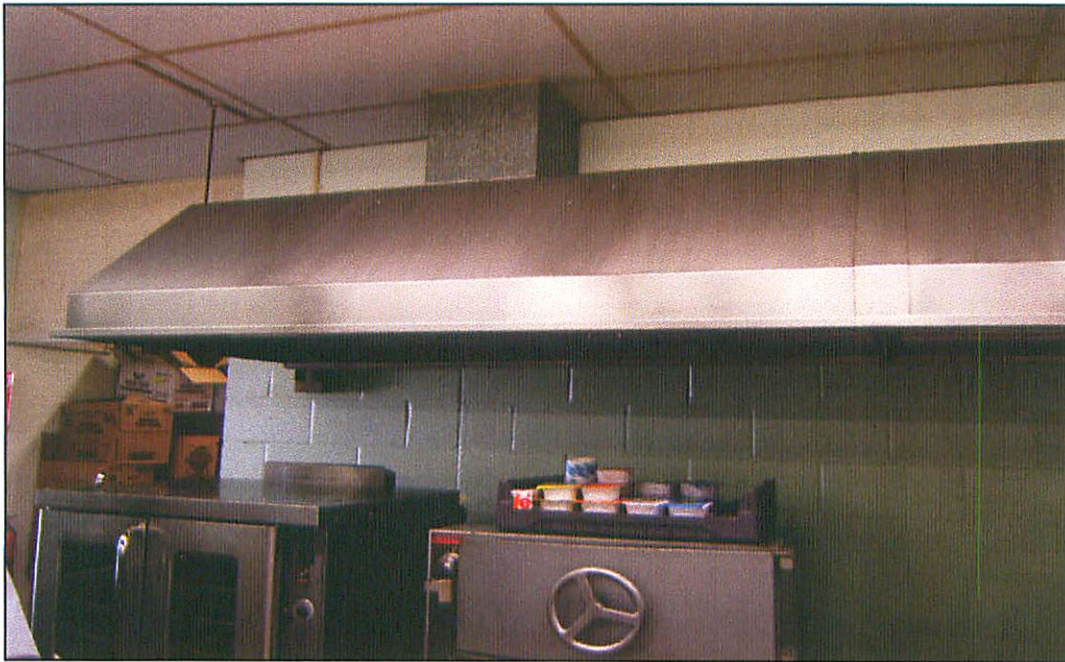
The exhaust hood, though made of stainless steel could be improved. The area above the hood should be sealed from the kitchen environment so that dust and grime do not collect on the front slope of the hood.

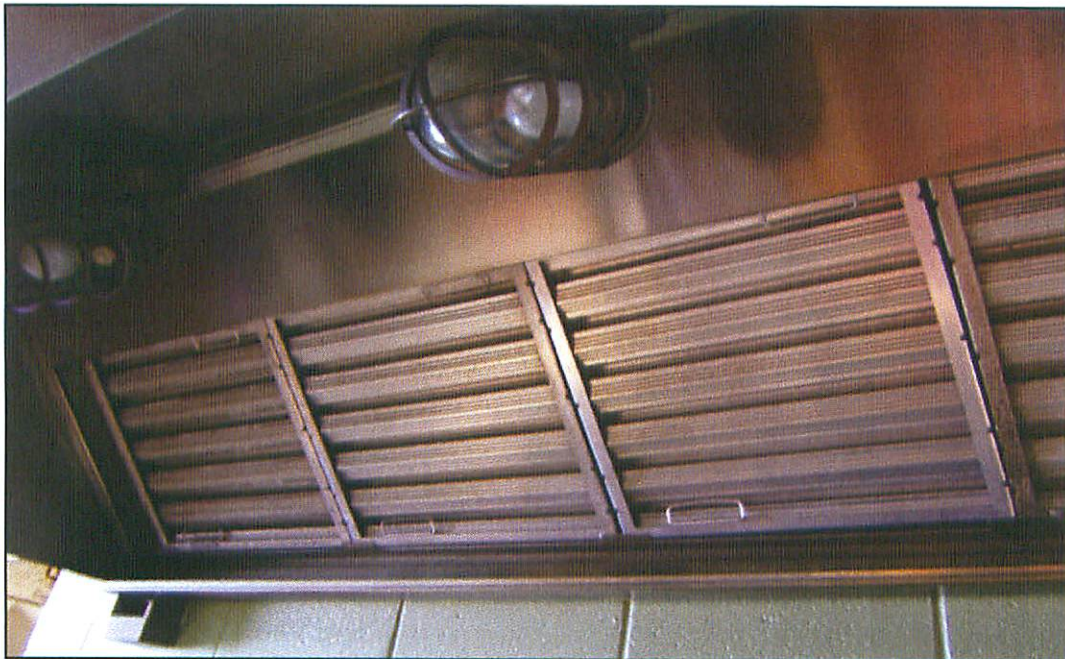
The filters shown here are installed incorrectly. They should be in the vertical position so that grease can drain from the filters and not pool inside the filter. The function of the filter is to extract airborne grease and deposit it into collection cups for disposal.

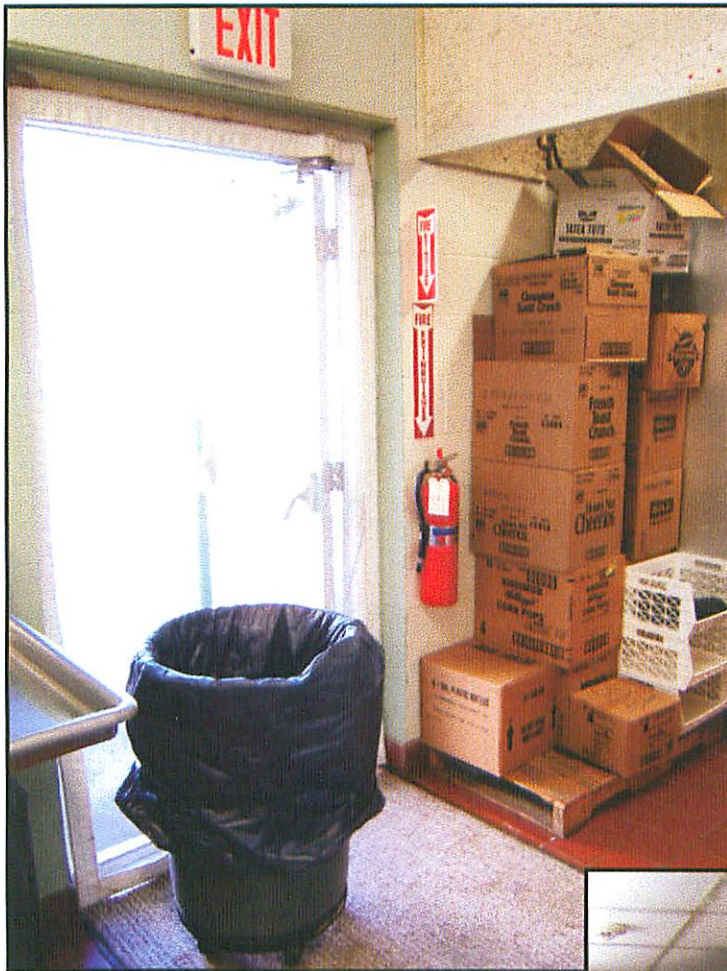
Storage space is a premium here. This photo demonstrates the need for additional storage space and dunnage platforms.

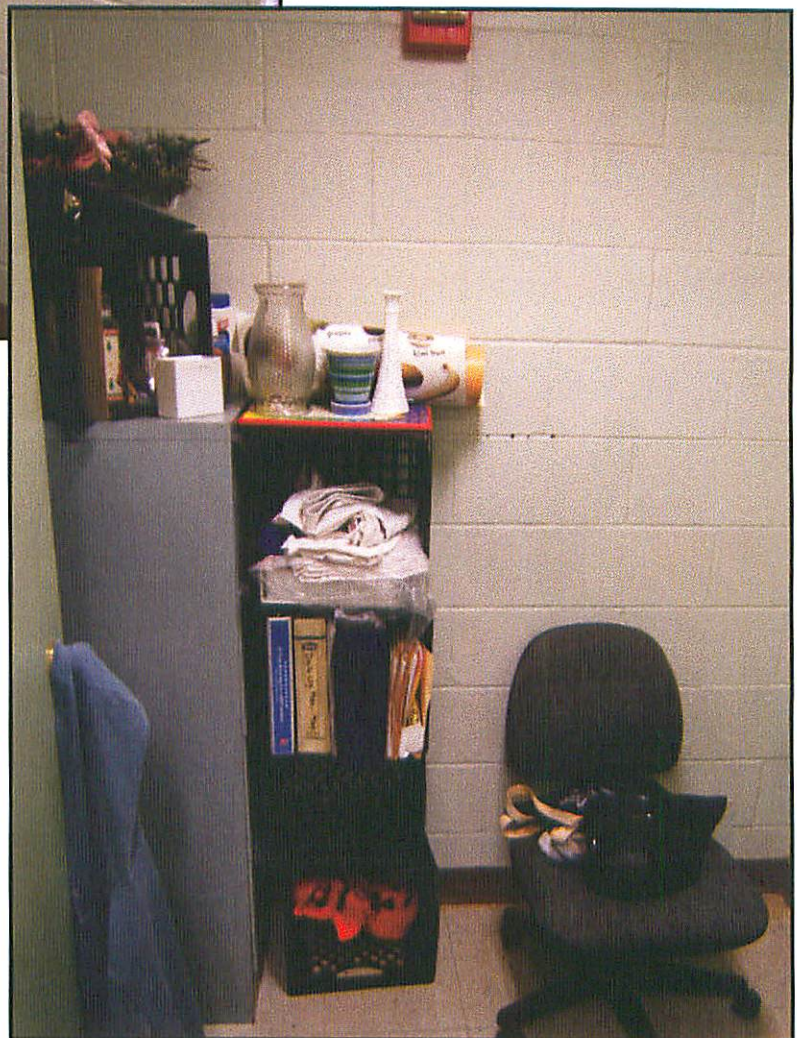
Additional space for dry and refrigerated storage, office, dedicated mop sink, and chemical storage room is needed.

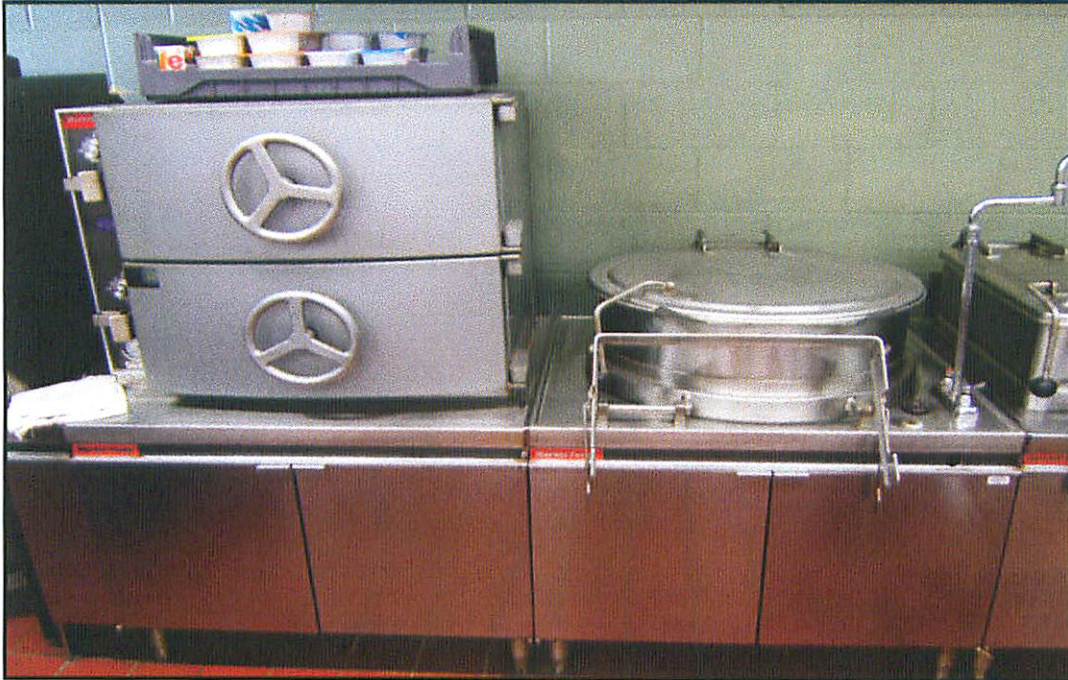
The cooking equipment in this facility is outdated and is in need of replacement. With new equipment more production can be achieved within the existing footprint.

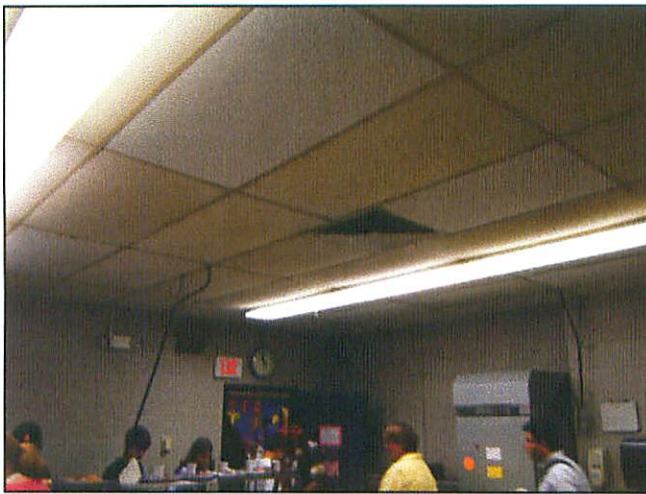
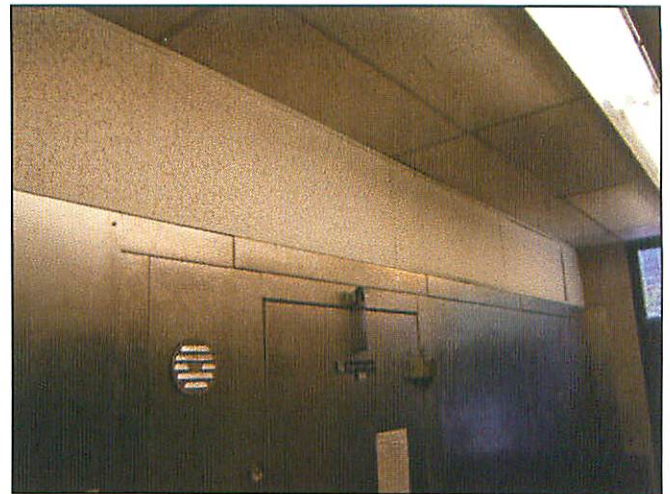
Perforated ceiling tiles should be replaced with non-pours smooth washable tiles.

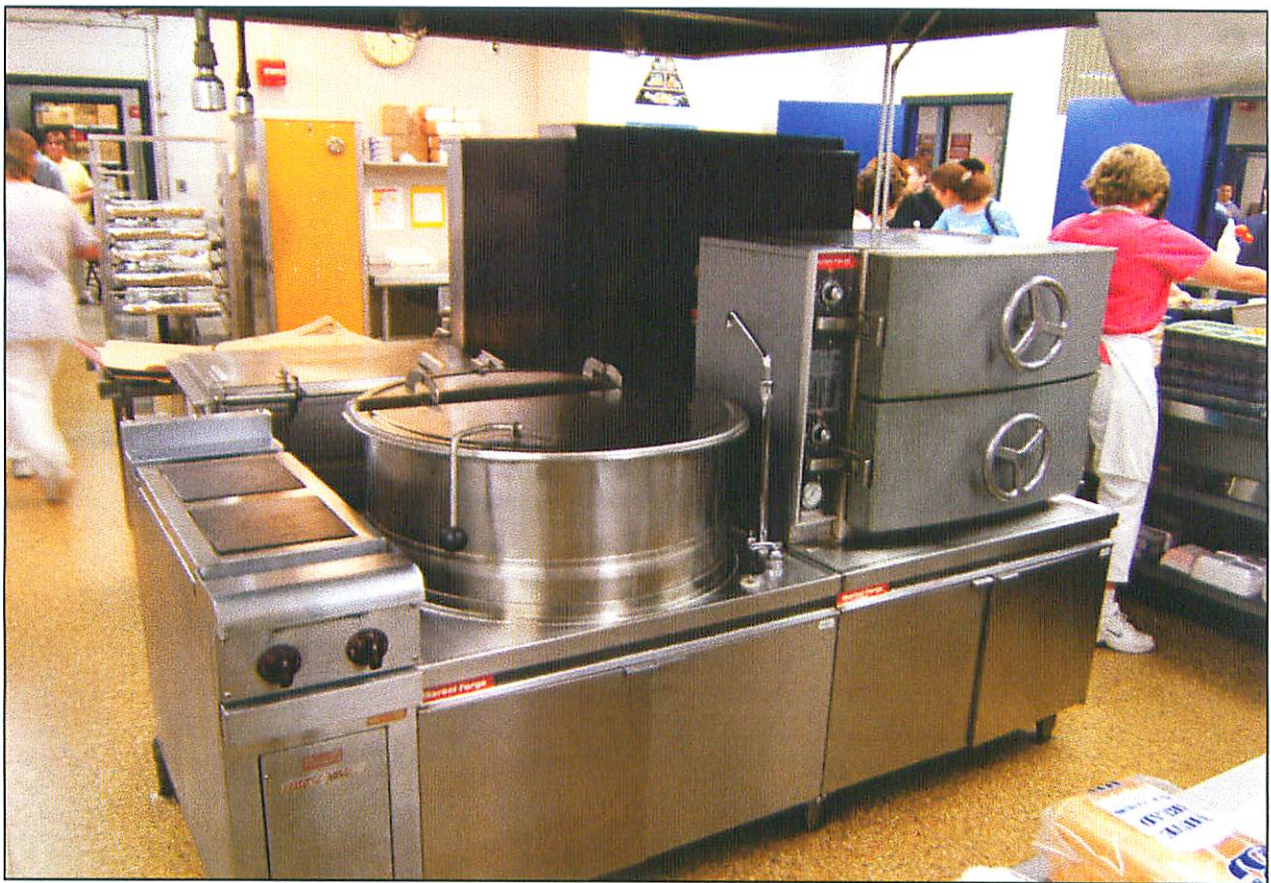
The cooking battery is outdated and needs replacement so that it can better serve the modern school lunch program. The kettle and steamer is difficult to use. New equipment can address ergonomics and reduce the risk for potential injury.

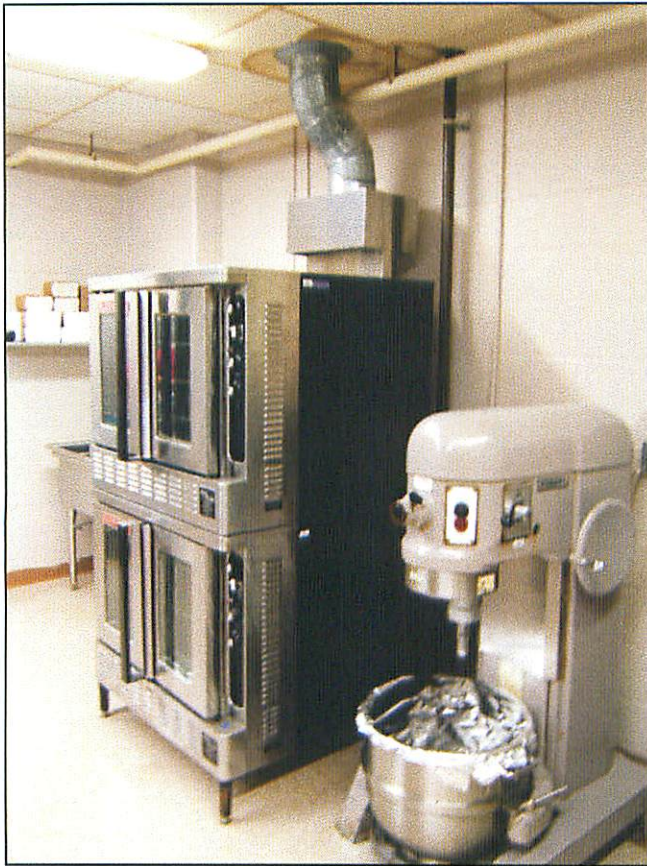
This convection oven should be located under an exhaust hood. It is not in violation of code because it is directly vented but the heat generated by the oven cavity is not exhausted and adds to the overall heat present in the kitchen. This can cause temperatures to rise to 95 or 100 degrees and make it an unpleasant work environment.

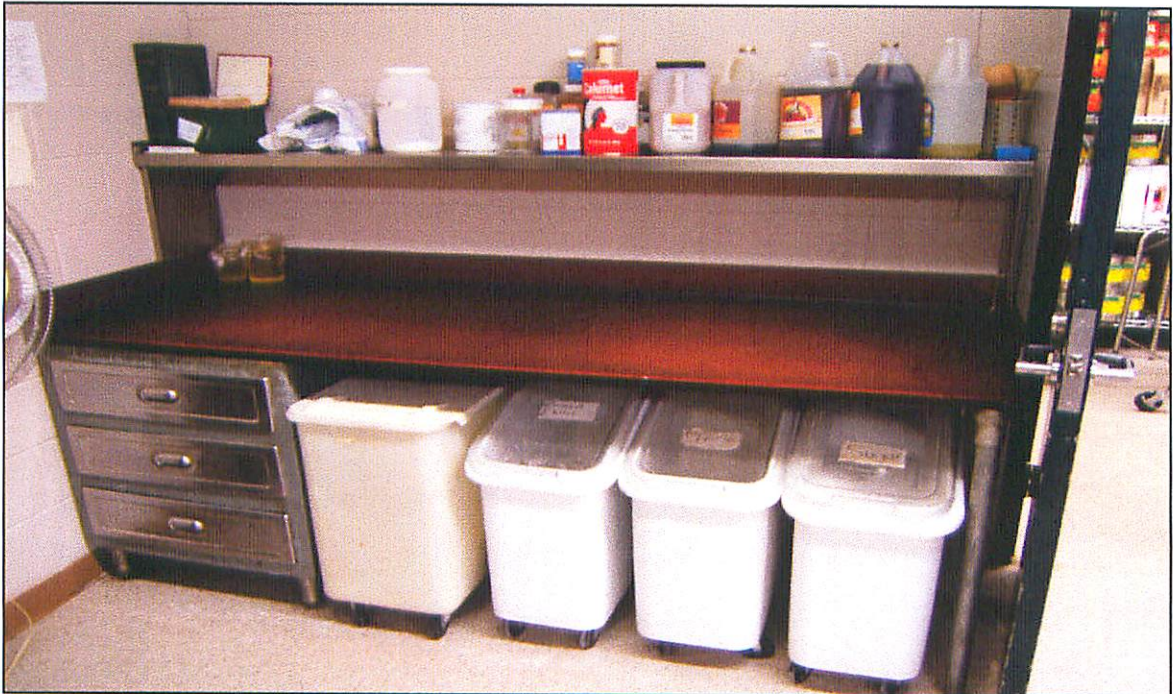
The baker's table shown here is ready for replacement. The work surface should be stainless steel. As a stainless steel surface it will be easier to clean and maintain. The ingredient bins located under the tabletop are new and suitable for reuse.

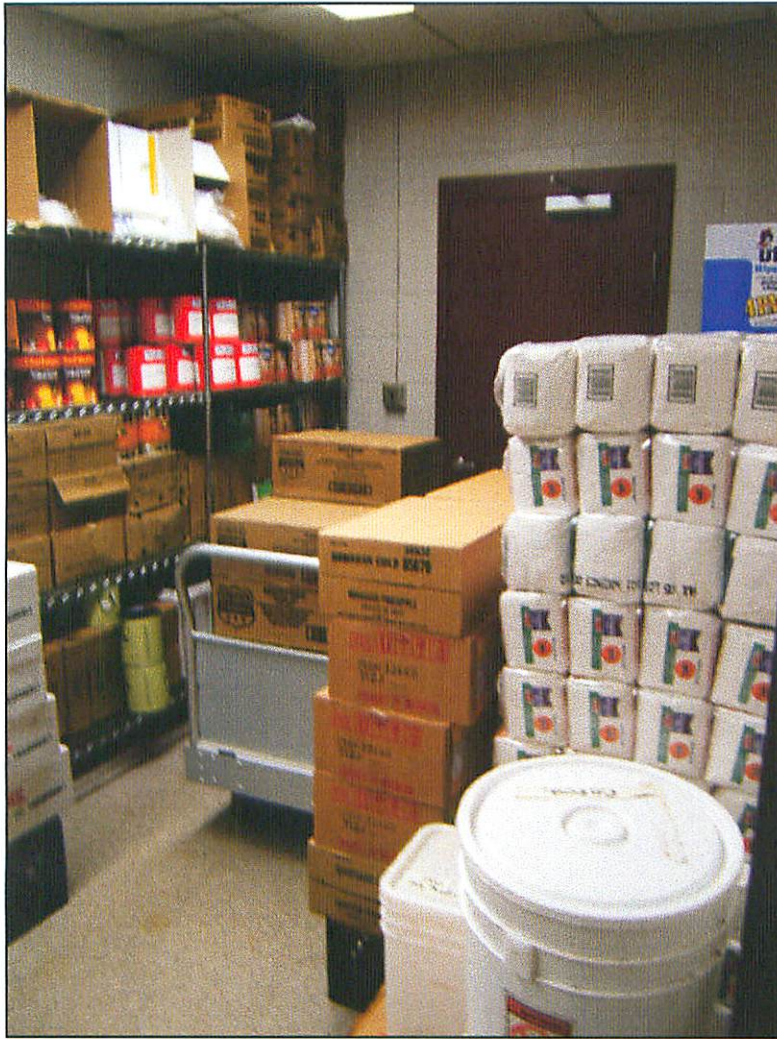
The storage room is well stocked. Notice the product that is stored on milk crates. We commend the staff for keeping the product off the floor but the need for dunnage platforms is evident. The addition of mobile dunnage platforms would allow the staff to store the product off the floor and have the ability to move it when necessary for cleaning or getting at other bulk products.
