Project: **Vista Academy (VAPA) Kitchen**

Thank you for allowing Accurate Concrete Moisture Testing to perform the concrete slab moisture testing for the Vista Academy (VAPA) Kitchen project located at 600 N. Santa Fe Avenue, Vista, CA 92083. Concrete moisture and surface pH readings were taken at four various locations on the ground floor level. The concrete moisture was measured by two different methods; internal relative humidity and moisture vapor emission rate. The internal relative humidity (RH) was determined by using the in-situ probe testing method, performed in accordance with the procedure set forth by the American Society of Testing and Materials (ASTM) F2170-19a and the testing equipment manufacturer's instructions. The concrete moisture vapor emission rate (MVER) was determined by using the anhydrous calcium chloride testing method, performed in accordance with the procedure set forth by the American Society of Testing and Materials (ASTM) F1869-23. You will find the results of the concrete Internal Relative Humidity (RH), Moisture Vapor Emission Rate (MVER), along with the concrete surface pH level and concrete surface porosity condition, test locations, and other u

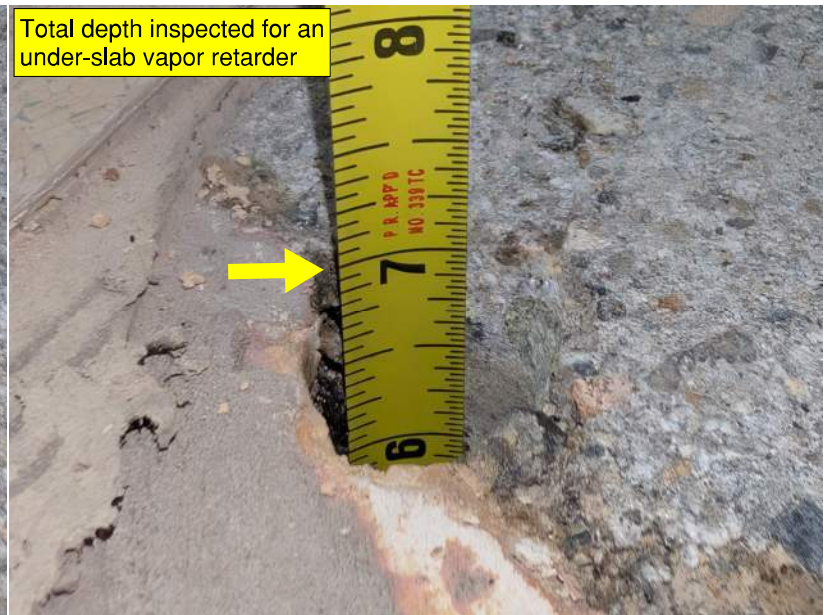
5. The concrete slab thickness is 3 inches and was confirmed by a visual inspection of a penetration made near test site #3.
6. An inspection 4 inches below the concrete slab was performed at the penetration made near test site #3. The presence, location, and/or quality of an under-slab vapor retarder were not confirmed; however, it was confirmed there is visually moist soil in direct contact with the bottom of the concrete slab. When a concrete slab is in direct contact with on-grade soil or aggregate, without a properly functioning under-slab vapor retarder, the slab can allow available ground moisture to permeate through it and the concrete slab moisture conditions may change depending on the availability to ground moisture, environmental conditions, and permeate rating of the floor covering or coating applied to the surface of the concrete slab.

Concrete Slab thickness verification

Total depth inspected for an under-slab vapor retarder

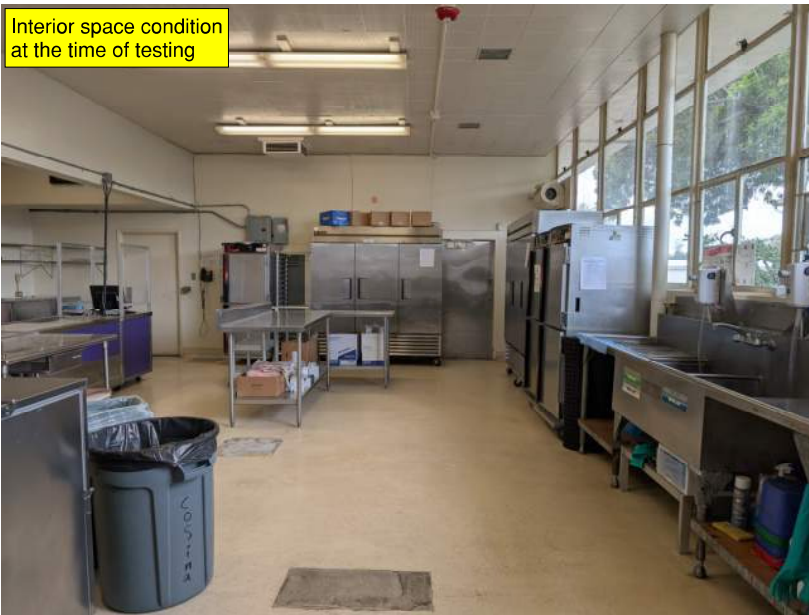
11. Beneath the resilient sheet flooring installed at test sites 2, 3, & 4, there is a cement topping material, approximately 1/4" thick. This cement material was in a damp condition.

There a cement topping material, approximately 1/4" thick, beneath the resilient sheet flooring at test sites 2, 3, & 4
