# FACILITY MASTER PLAN REPORT

*for the* TOWN OF WILMINGTON

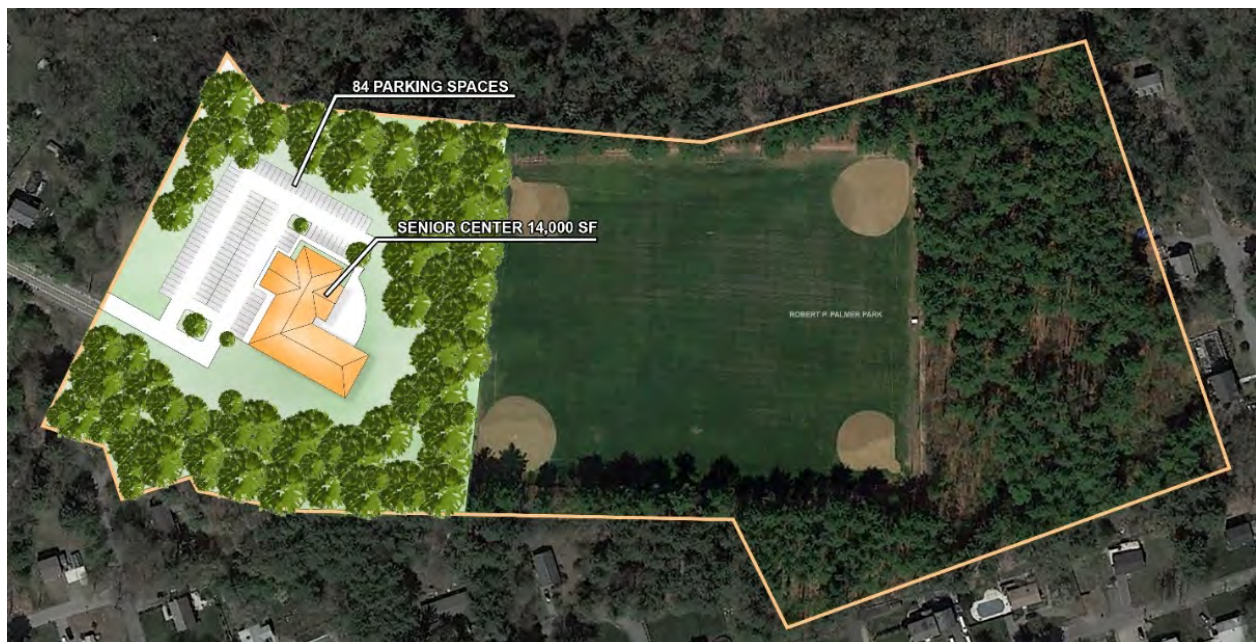
## SITE PLAN:

A new and enlarged Senior Center would be created at the site currently occupied by the Town Hall. In addition to the parking and site improvements associated with the Senior Center, access to existing recreational parking will be retained. Depending upon phasing, the facility could be constructed adjacent to the Town Hall or occupy its current site, if it is demolished prior to commencing construction.

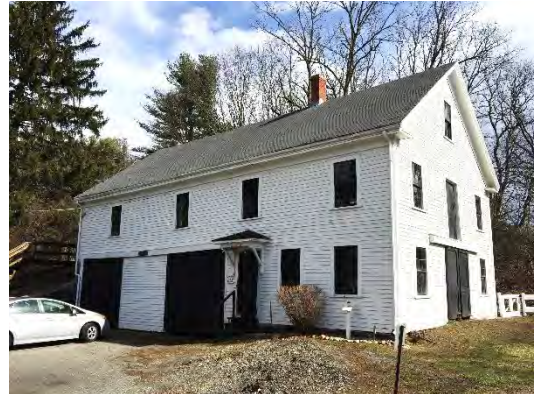
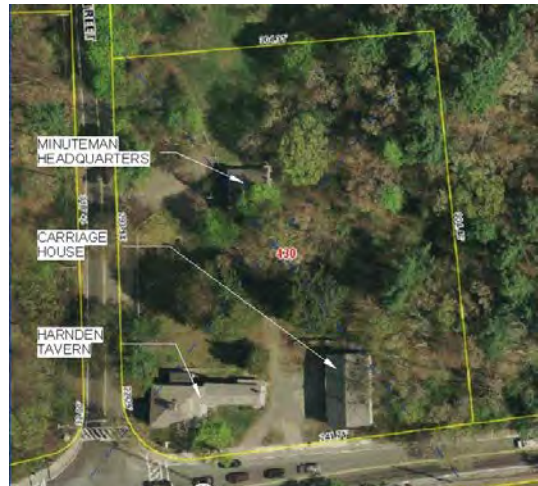
Site and Landscape - Site improvements should be undertaken to create a more attractive presence. The parking area should be striped as it is currently unstriped asphalt that extends to the building front. An exterior ramp should be provided for handicap accessibility to the front door. Crushed stone drip strips will improve drainage along the south and west facades. Plantings should not be in contact with the building's exterior.

Building Exterior - Significant rot was observed at exterior trim, fascia, and sliding door hardware shrouds should be repaired. The building should be repainted. Exterior siding and trim in direct contact with the ground should be modified to prevent decay.

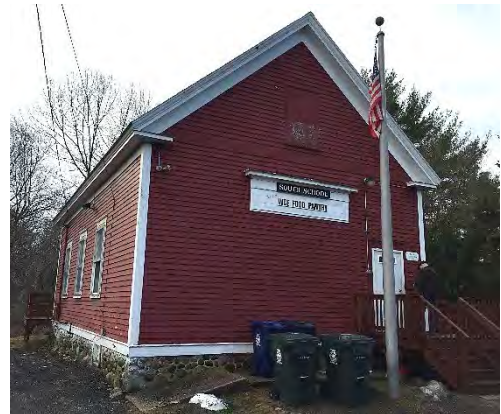
Building Exterior - The entire exterior siding and trim should be refinished including the water table board and cap which have significant deterioration. Attic window openings have been covered with painted plywood, which should be removed and windows installed that are in keeping with the architectural aesthetic of the building. Wood framed window screens have been affixed over three windows on the north-east façade and need repair.

Concrete slab at front façade is heaved and should be repaired. Siding and trim repairs are required on the exterior, especially where it contacts stone foundation. Insulating the exterior walls and attic should be considered during the course of renovation as well as new insulated windows.

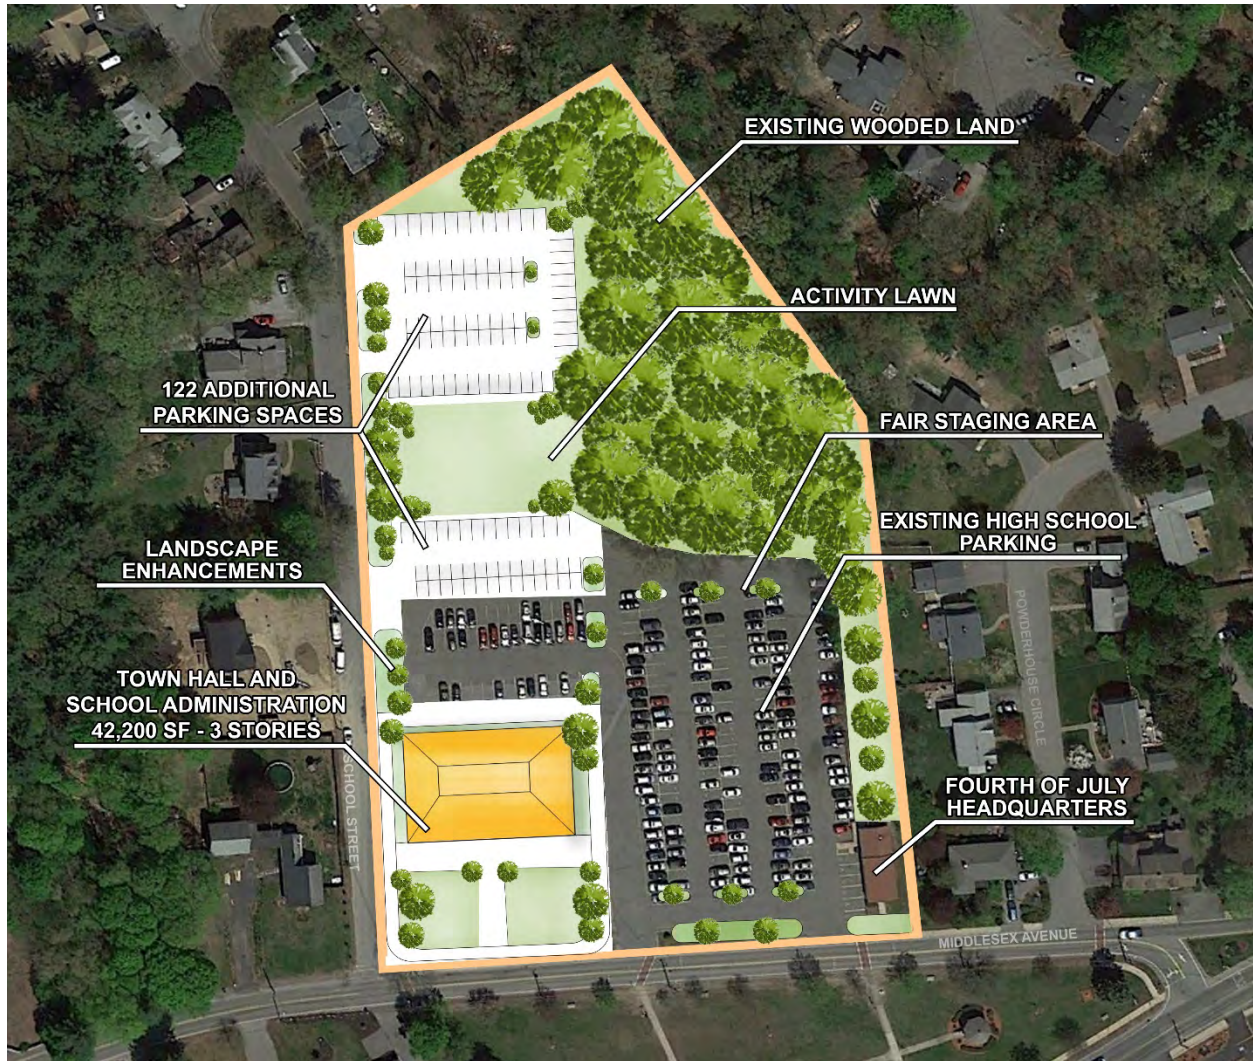
## SITE PLAN OPTION A:

This new municipal building might best fit the site as a three-story structure with a footprint of about 14,000 square feet. The building would have a prominent entrance facing the Town Common, and would be set back from the adjacent streets to create generous landscaped areas. A secondary entrance would be located facing the parking that would serve the Town Hall.

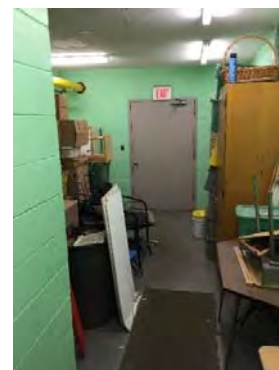
The Shawsheen School has a significant egress issue at the lower (A) level. An exit sign within a corridor leads into a storage room which has a marked exit door at the other end. This second door swings inwards, not in the direction of egress, and does not have panic hardware, both of which are standard requirements for egress routes from buildings. As a storage room, the exit path could be blocked by stored materials.

The exiting requirements for this portion of the building should be reviewed to provide either an alternate path or upgrade this path to meet appropriate current building code standards. It appears likely that the exit path can conform to code requirements, for example, by removing the door shown in the photograph and converting the room to serve as a corridor by removing the stored items.

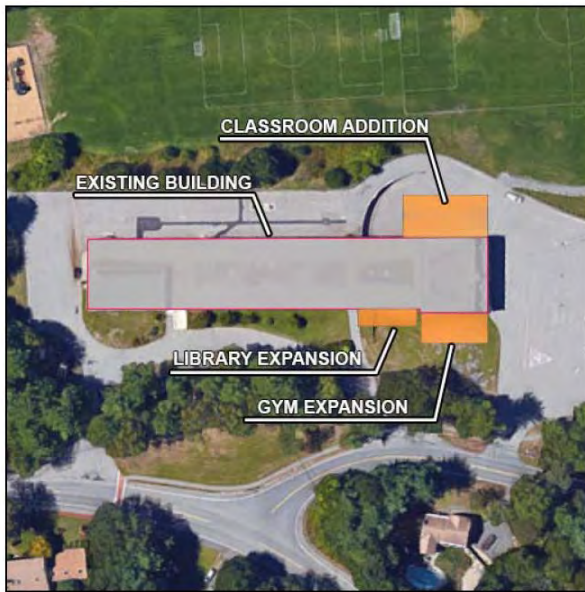
**WOBURN**

The following diagrams illustrate how additional space can be added to the existing buildings, expanding their capacity while limiting disturbance of the ongoing educational functions.
