**RFP-2526-538 Addendum 1
Construct and Install Elevator
May 27, 2026**

Danville Public Schools
Glenwood School Campus -Elevator Addition
RFP – 2526-538
Addendum No. 1
May 27th, 2026

**Minutes to Pre-bid Conference
Danville Public Schools
Glenwood School Campus – Elevator Addition
April 27, 2026, at 10:00am**

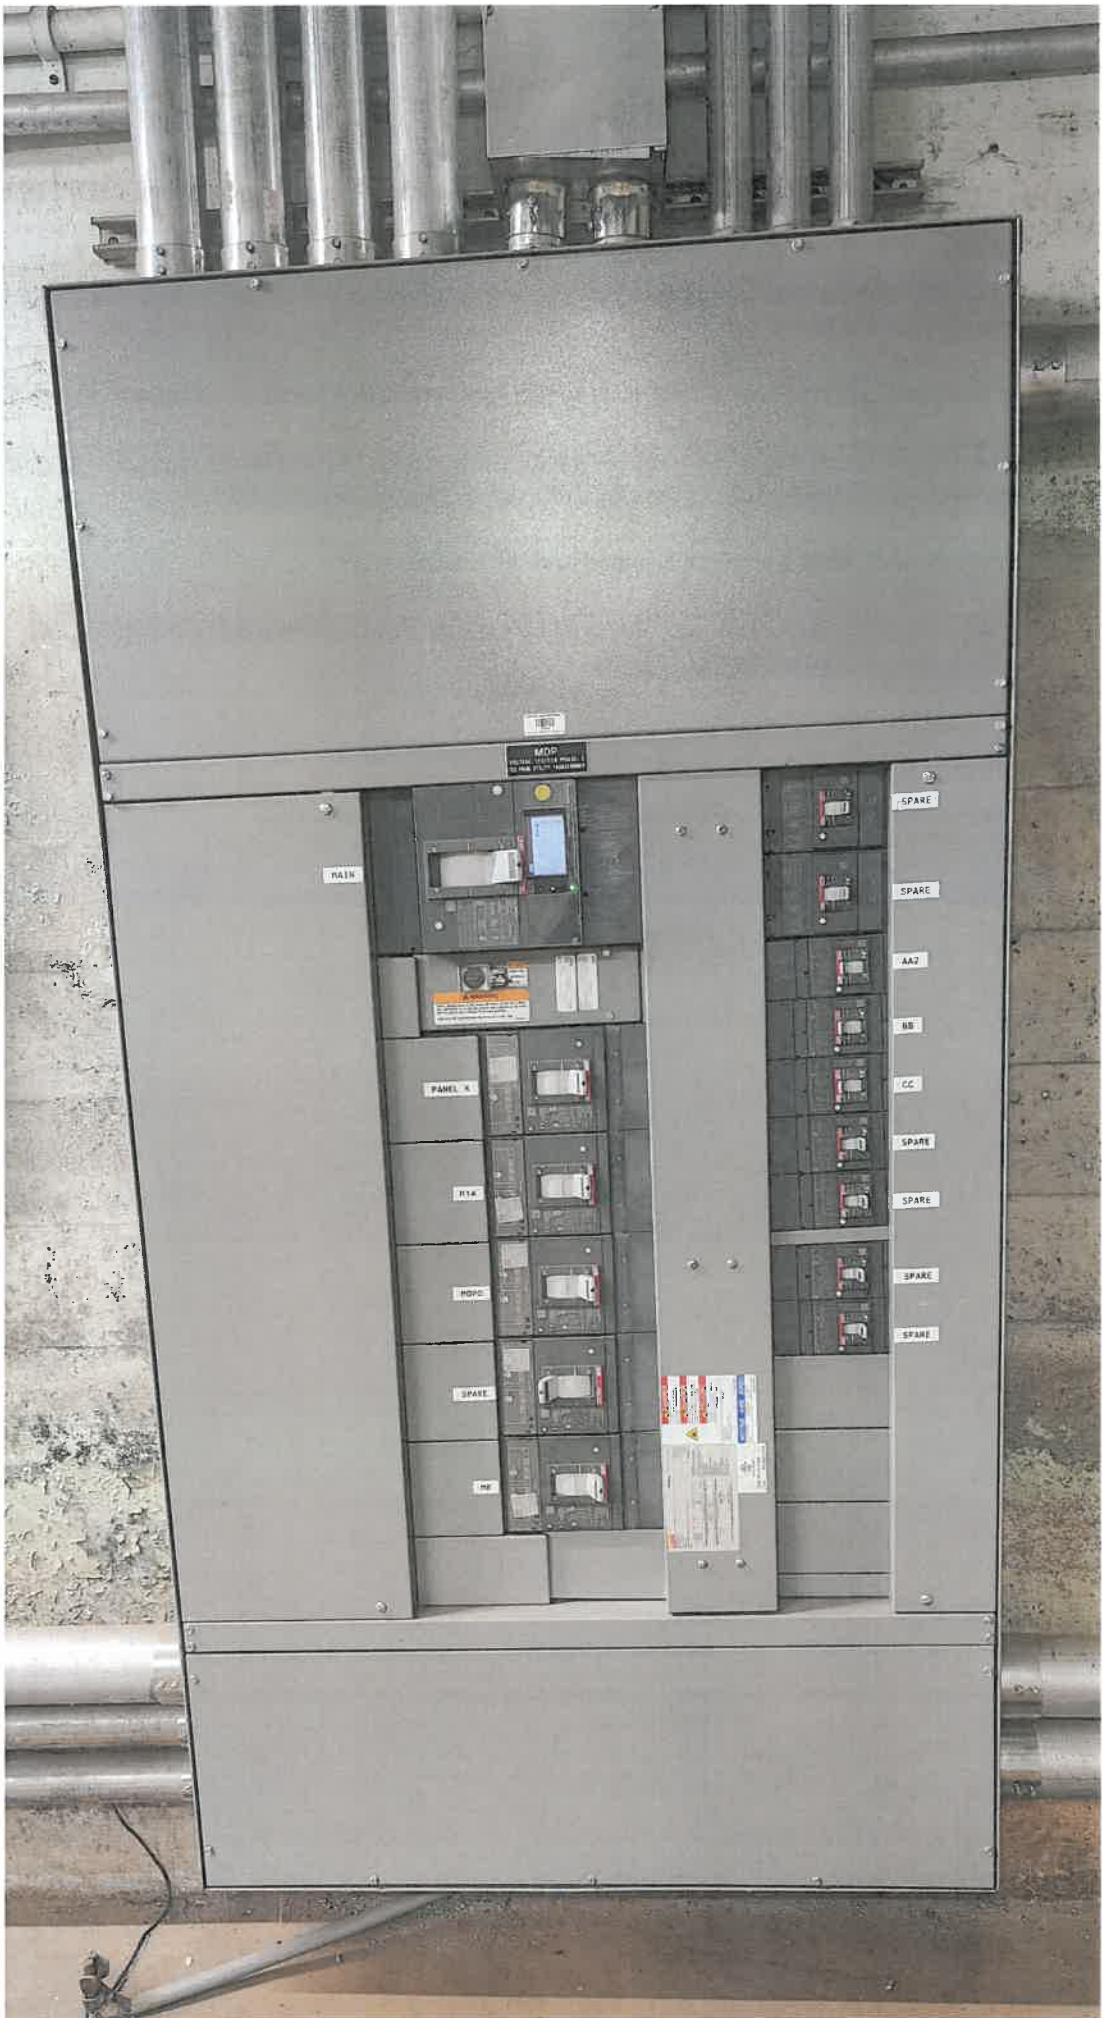
Response: Panel MDP is a 208V, 3-phase, 1200A, with main breaker, ABB panelboard located in the basement. See pic enclosed.

Item No.4; Drawing Sheet E101; Plan Note #3 stated to provide a new breaker in Panel MDP, IS there any information available on this panel?

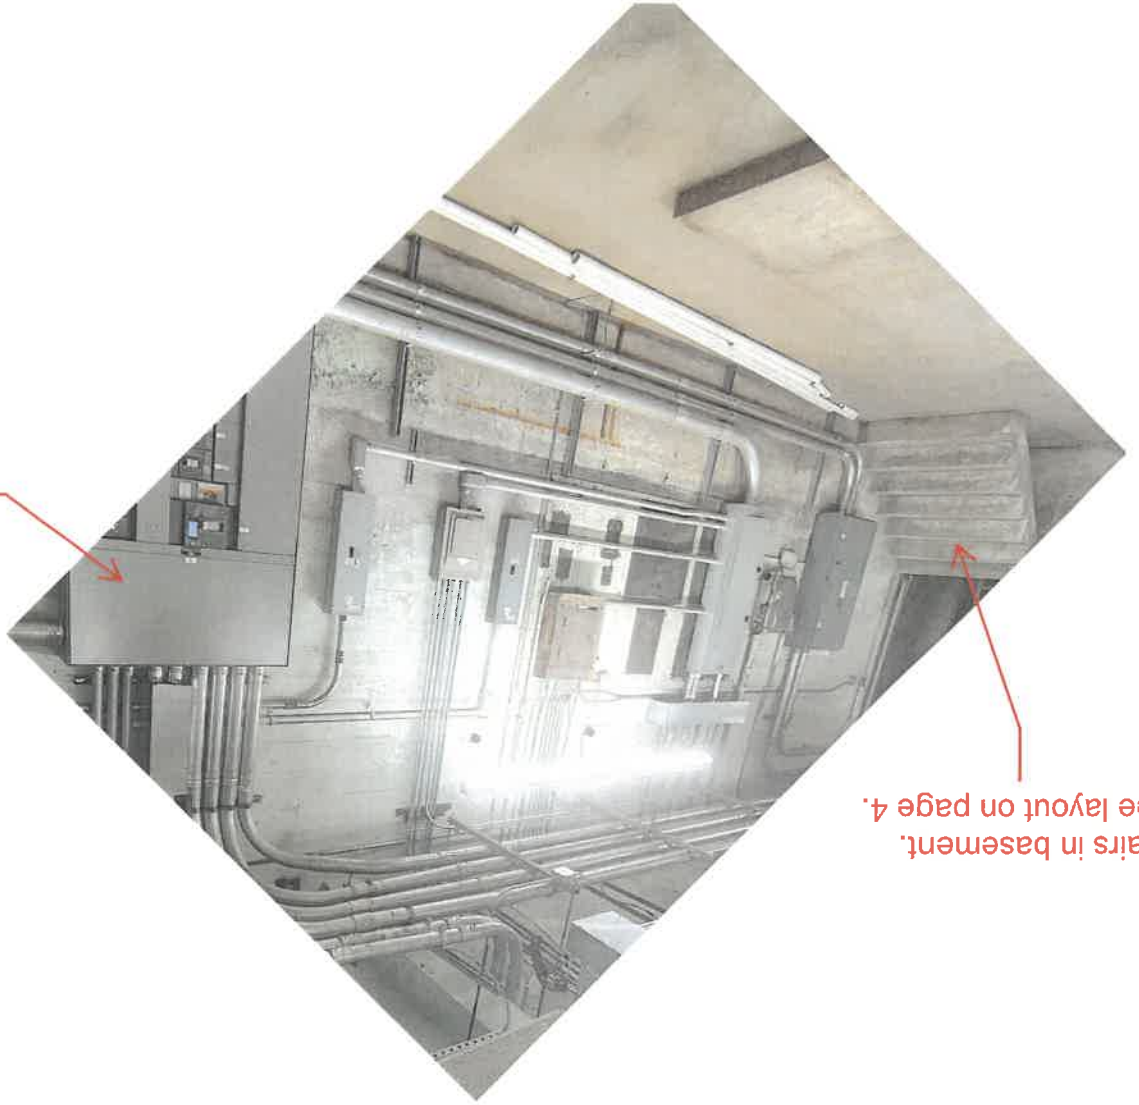
Stairs in basement.
See layout on page 4.

Response: Basement was not modeled in Revit for this project. See enclosed sketched at end of this addenda for rough estimate for the layout of the basement and panel MDP.
