DOTHAN CITY BOE

**TRANSPORTATION CENTER
MANAGEMENT PLAN**

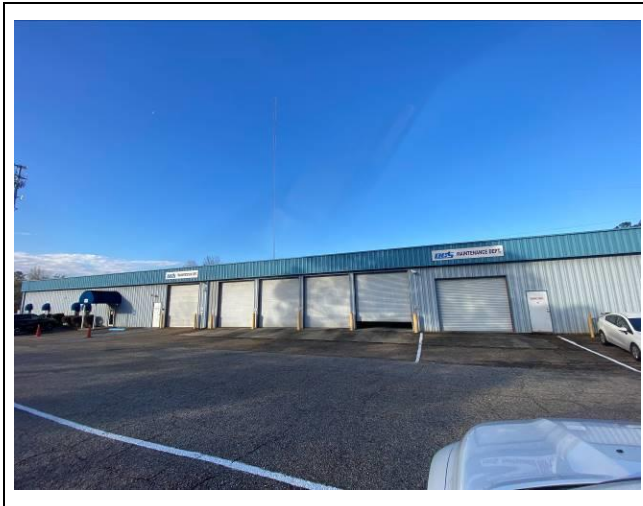
Photo #1. Typical Exterior Building Materials observed along main entrance to Transportation Center.

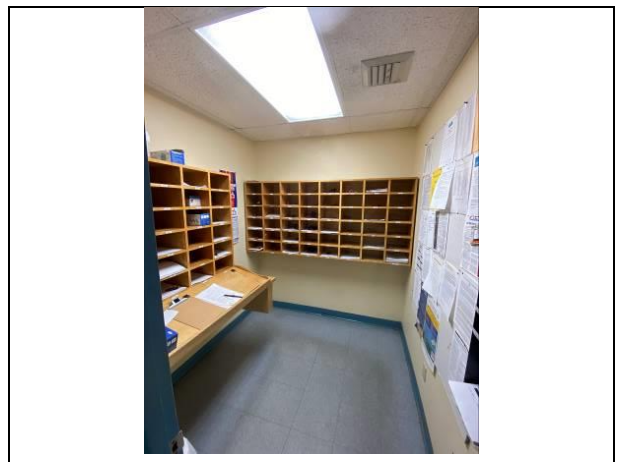
Photo #6. View of assumed ACBM blue cover base and white (2'X4') ceiling tile observed in mail room of office area.

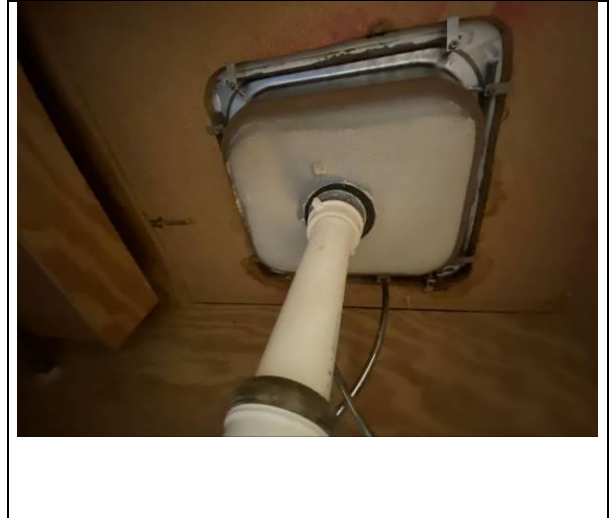
Photo #8. View of assumed ACBM white under sink coating on sink in the office area.

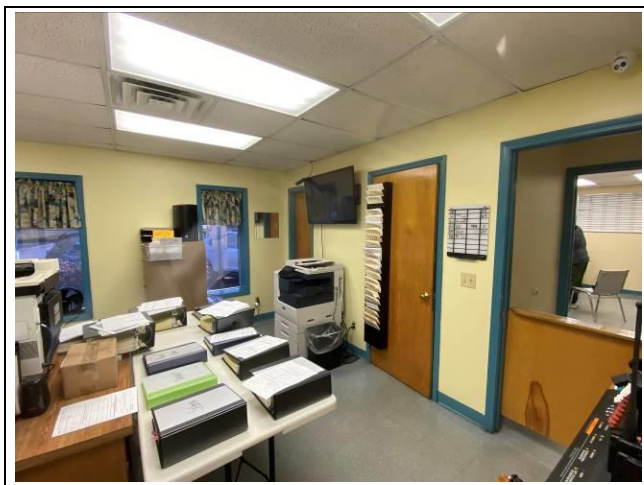
Photo #9. View of typical finishes observed within the front office area.

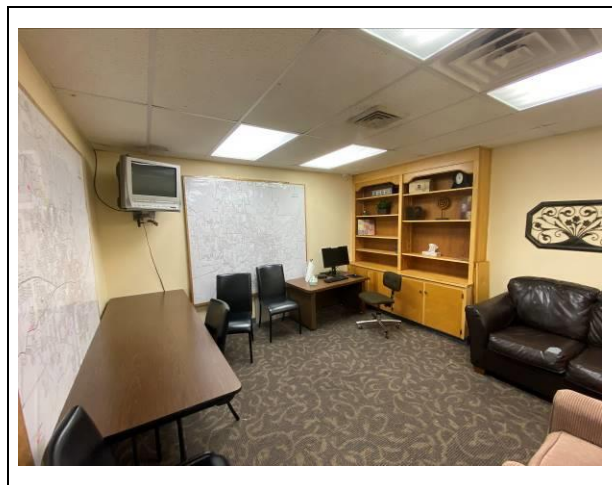
Photo #10. View of assumed ACBM green/orange/purple carpet in office.

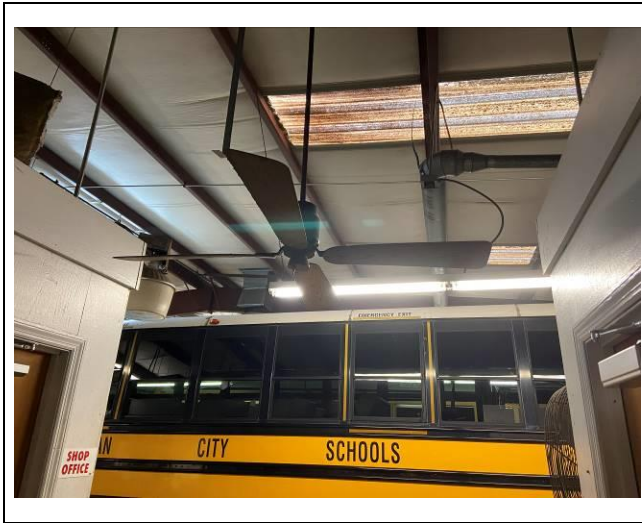
Photo #13. View of assumed ACBM white covered building insulation found throughout the entire building.

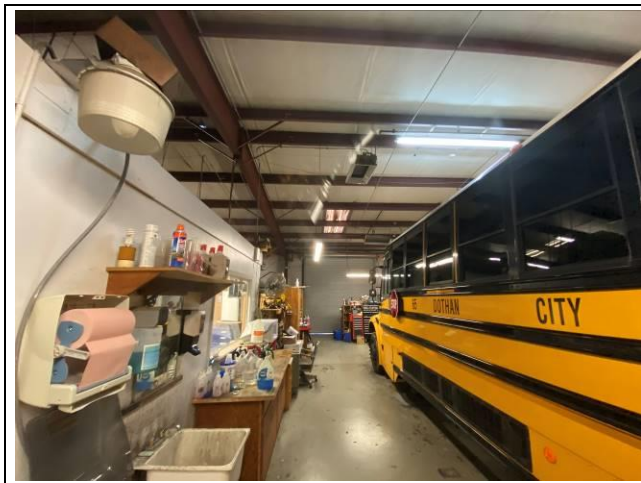
Photo #15. View of typical interior finishes observed in the office of the shop.

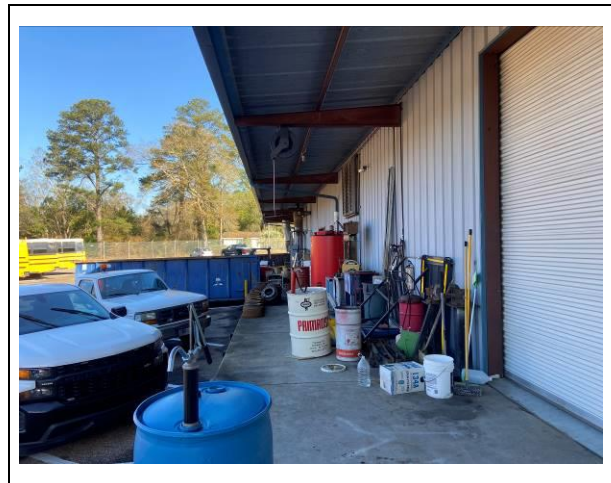
Photo #16. View of typical metal exterior siding observed around the building.

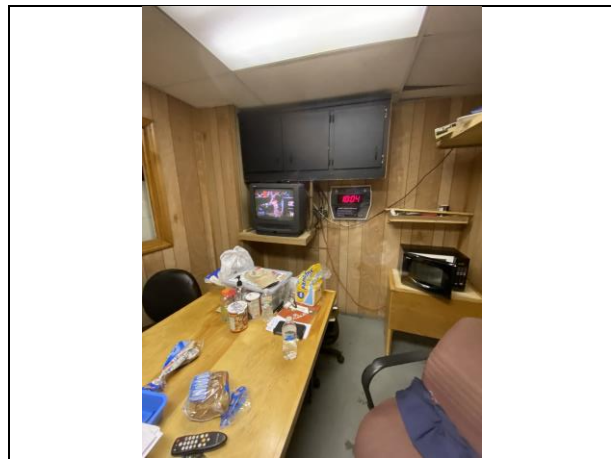
Photo #18. View of assumed ACBM observed in the Shop breakroom.
