# On-Site Testing

## GMAX Impact Evaluation

| Customer: | Fairfield Public Schools/ Ludlowe High School | | | | |
| Site Address: | 785 Unquowa Road | | Field Info | Ludlowe Synthetic Turf Field | |

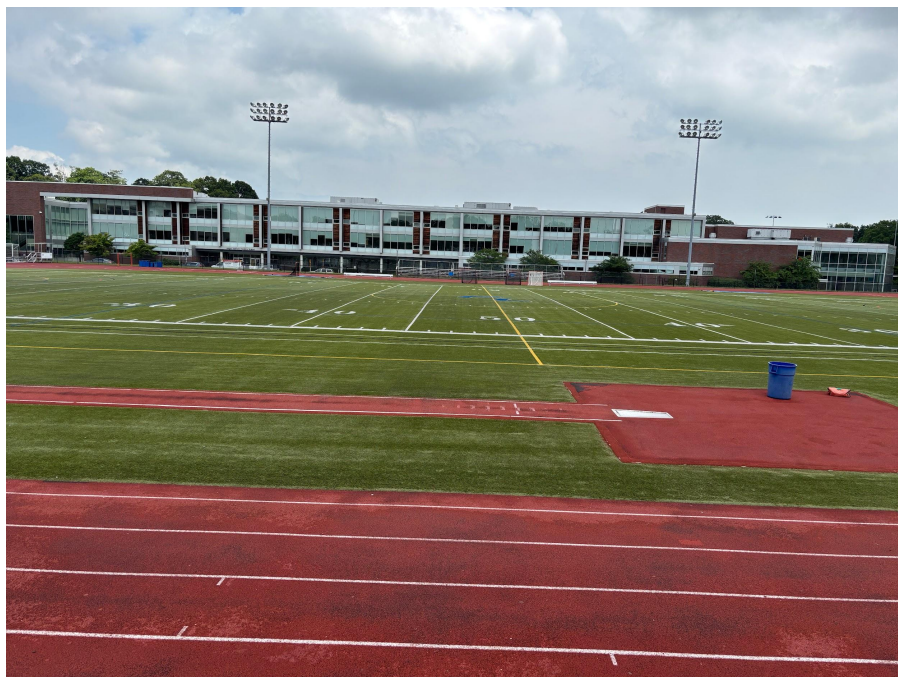
## Site Photo

The field is still in playable condition. The fibers are beginning to mat. There are several seams that have seperated it is too wet for glue today. I plan to come back Friday July 3rd to make those repairs.

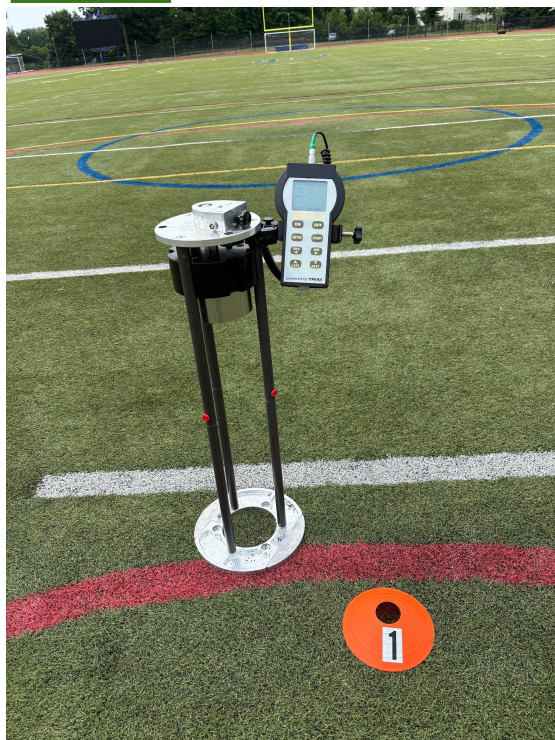
## Location #1

| Location # | Drop #1 G's | Drop #2 G's | Drop #3 G's | GMAX Average (G's) | Infill Depth (mm) | Surface Temp (°F) |
|---|---|---|---|---|---|---|
| Location #1 | 179.00 | 183.00 | 191.00 | 187 | 24.00 | 81.00 |

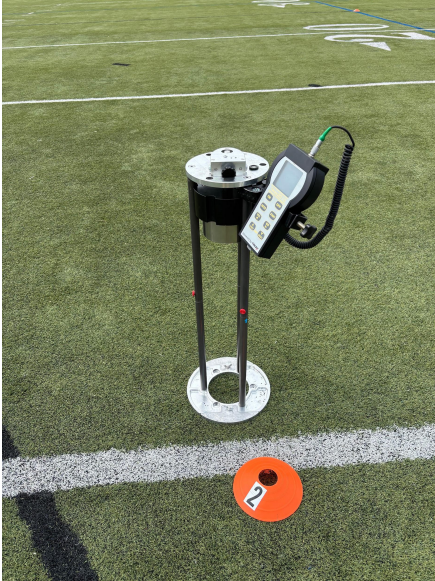
## Location #2

| Location # | Drop #1 G's | Drop #2 G's | Drop #3 G's | GMAX Average (G's) | Infill Depth (mm) | Surface Temp (°F) |
|---|---|---|---|---|---|---|
| Location #2 | 133.00 | 142.00 | 145.00 | 143.5 | 31.00 | 78.00 |

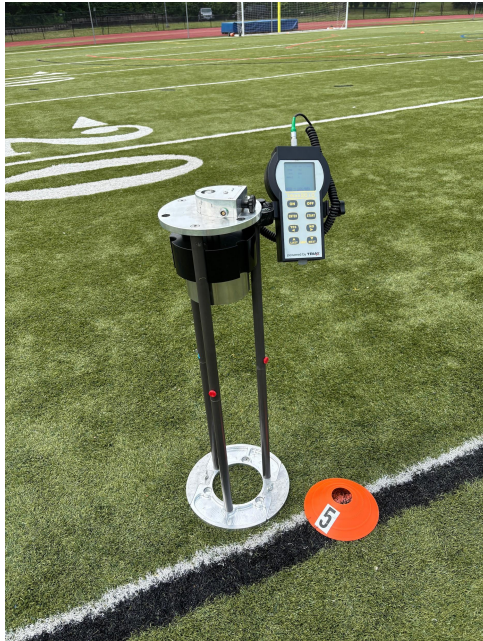
#### Location #5

| Location # | Drop #1 G's | Drop #2 G's | Drop #3 G's | GMAX Average (G's) | Infill Depth (mm) | Surface Temp (°F) |
|---|---|---|---|---|---|---|
| Location #5 | 158.00 | 167.00 | 164.00 | 165.5 | 25.00 | 83.00 |

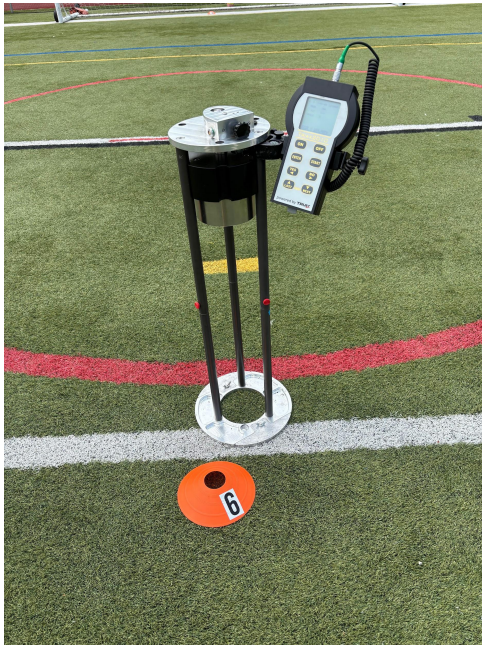
**Location #6**

| Location # | Drop #1 G's | Drop #2 G's | Drop #3 G's | GMAX Average (G's) | Infill Depth (mm) | Surface Temp (°F) |
|---|---|---|---|---|---|---|
| Location #6 | 178.00 | 183.00 | 186.00 | 184.5 | 29.00 | 85.00 |

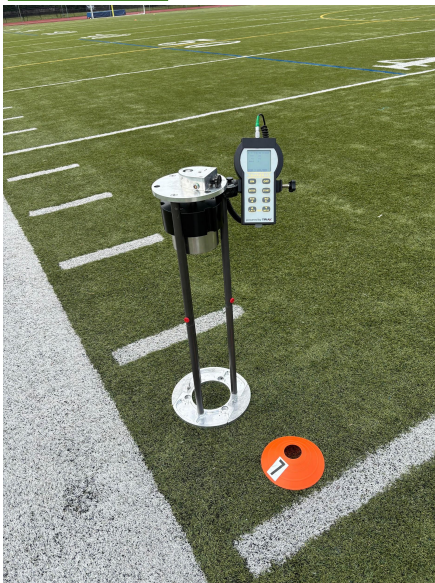
**Location #7**

| Location # | Drop #1 G's | Drop #2 G's | Drop #3 G's | GMAX Average (G's) | Infill Depth (mm) | Surface Temp (°F) |
|---|---|---|---|---|---|---|
| Location #7 | 137.00 | 134.00 | 146.00 | 140 | 32.00 | 77.00 |

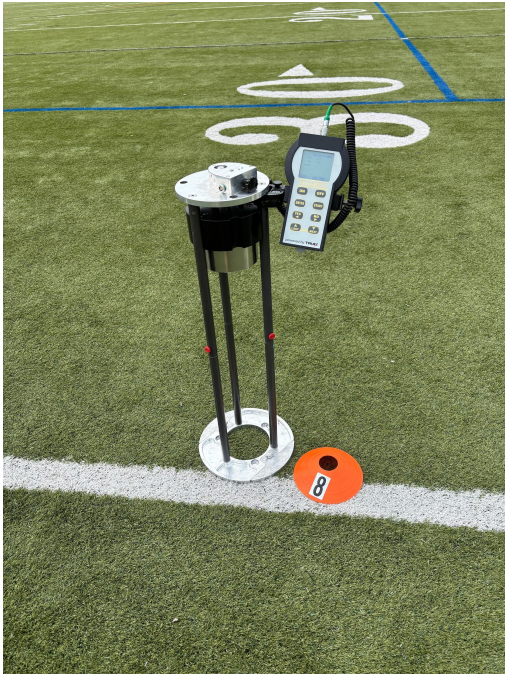
**Location #8**

| Location # | Drop #1 G's | Drop #2 G's | Drop #3 G's | GMAX Average (G's) | Infill Depth (mm) | Surface Temp (°F) |
|---|---|---|---|---|---|---|
| Location #8 | 140.00 | 151.00 | 154.00 | 152.5 | 30.00 | 78.00 |

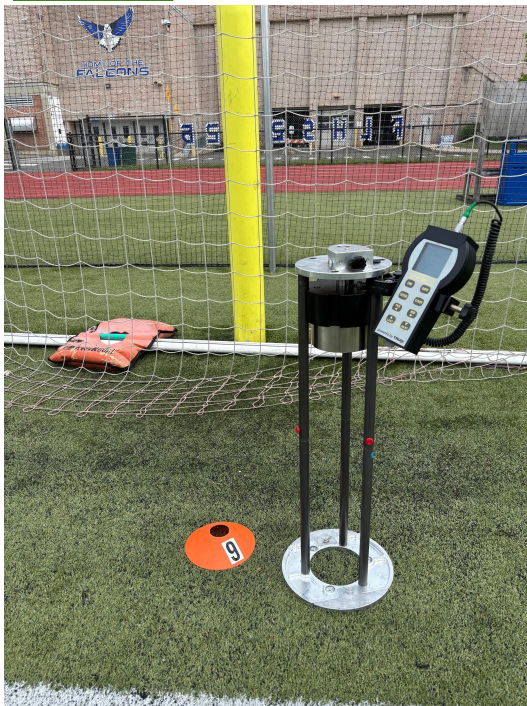
**Location #9**

| Location # | Drop #1 G's | Drop #2 G's | Drop #3 G's | GMAX Average (G's) | Infill Depth (mm) | Surface Temp (°F) |
|---|---|---|---|---|---|---|
| Location #9 | 117.00 | 119.00 | 120.00 | 119.5 | 27.00 | 91.00 |

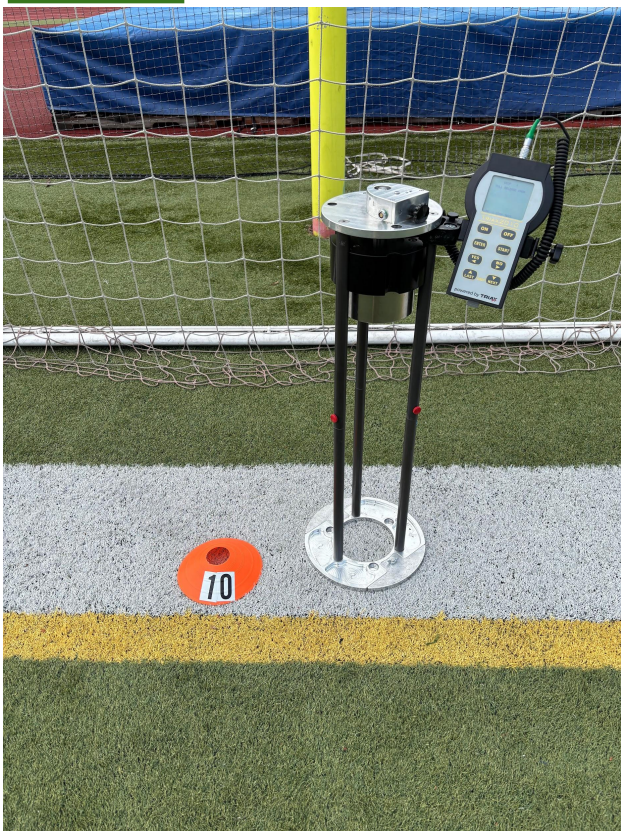
### Location #10

| Location # | Drop #1 G's | Drop #2 G's | Drop #3 G's | GMAX Average (G's) | Infill Depth (mm) | Surface Temp (°F) |
|---|---|---|---|---|---|---|
| Location # 10 | 152.00 | 166.00 | 164.00 | 165 | 31.00 | 79.00 |
