# **PALM ELEMENTARY SCHOOL**

## **Shallow Soil Investigation**

Hacienda Heights, California  
Langan Project No. 721066701

**20 August 2026**

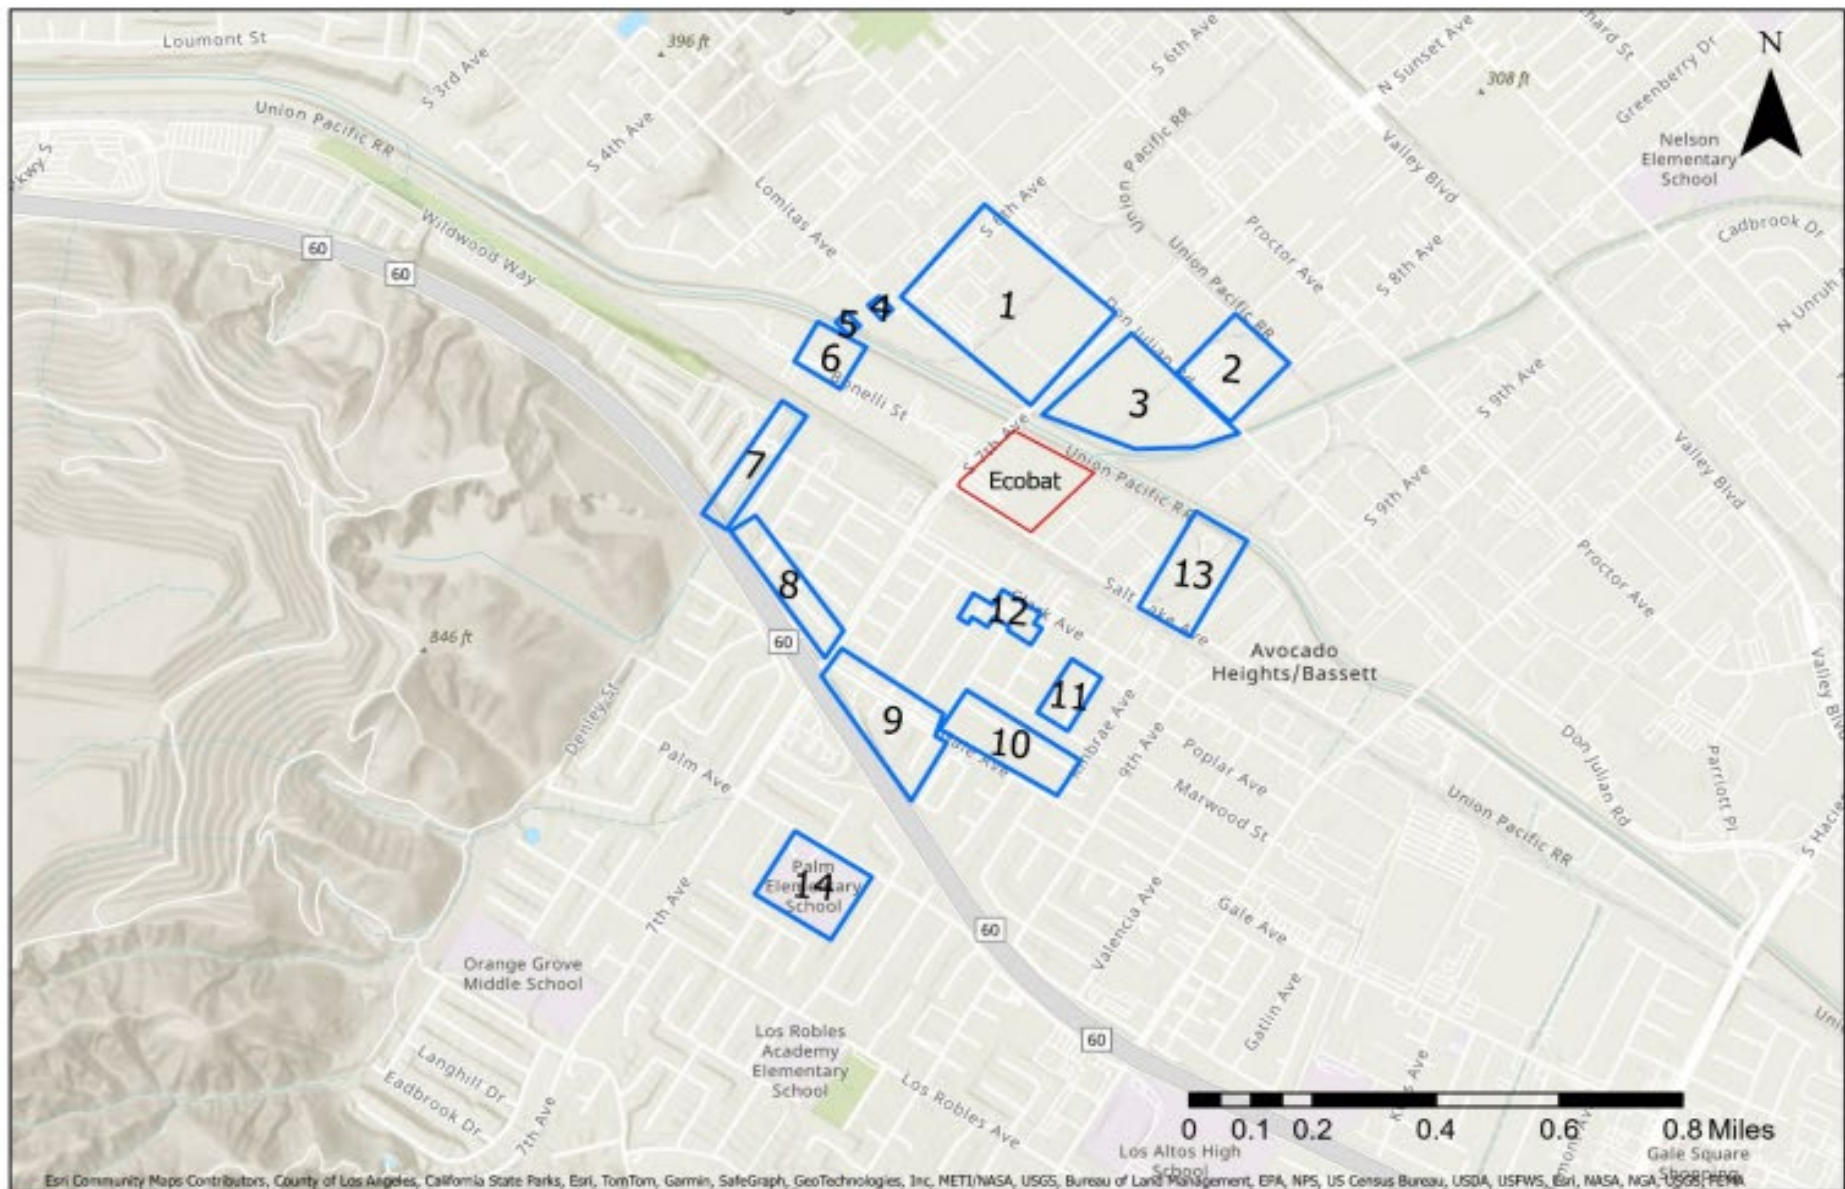
DTSC requested systematic shallow-soil sampling across 14 identified areas surrounding Ecobat, including Palm Elementary.

| <p>Ecobat</p> <p>Recommended Areas</p> | <p><b>DTSC</b><br/>Department of Toxic Substances Control</p> <p>Drawn by: BB 02-05-2024<br/>Revised by: JD 04-25-2024</p> | <p><b>Ecobat (former Quemetco) Facility</b></p> <p><b>Fourteen Recommended Sampling Areas</b></p> |
