## **ADDENDUM NO. 2**

To the Contract Documents for:  
**TUSD Kimball High School – 2-Story CR Building – Increment 1**  
Tracy Unified School District

# **Hazardous Building Materials Survey Report**

## Geotechnical Engineering and Geologic Hazard Report

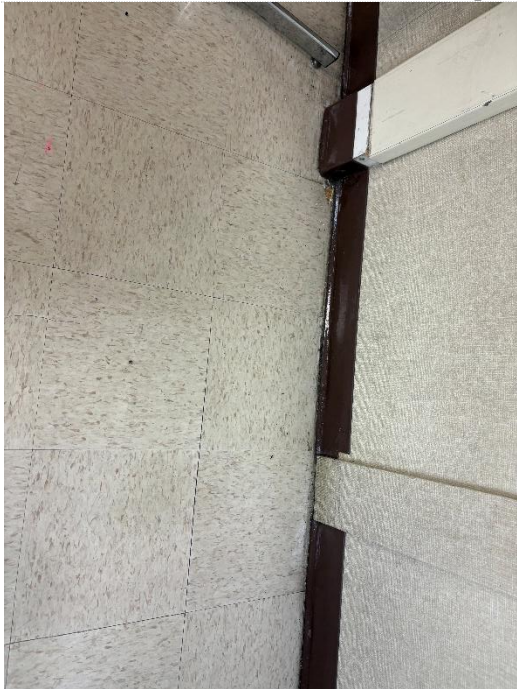
Photo #1 Black Baseboard

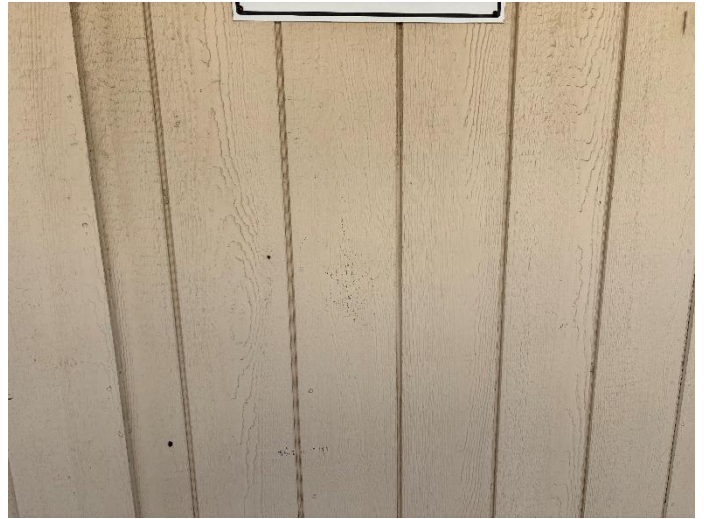
Photo #2 Beige Paint on Wood Siding

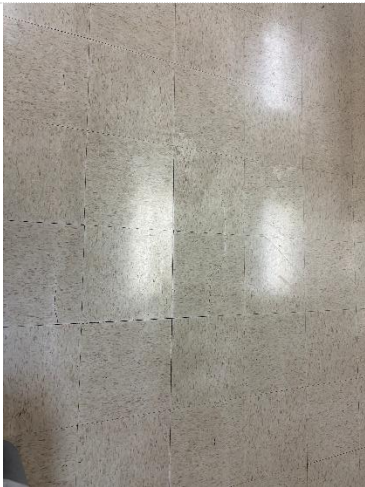
Photo #3 Vinyl Flooring
