# Stillwater Township Elementary School

December 8, 2026 Referendum

September 15, 2026

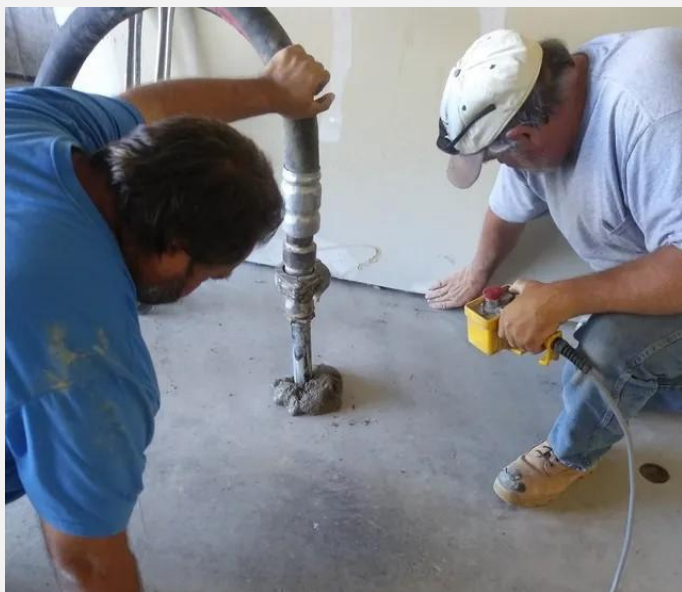
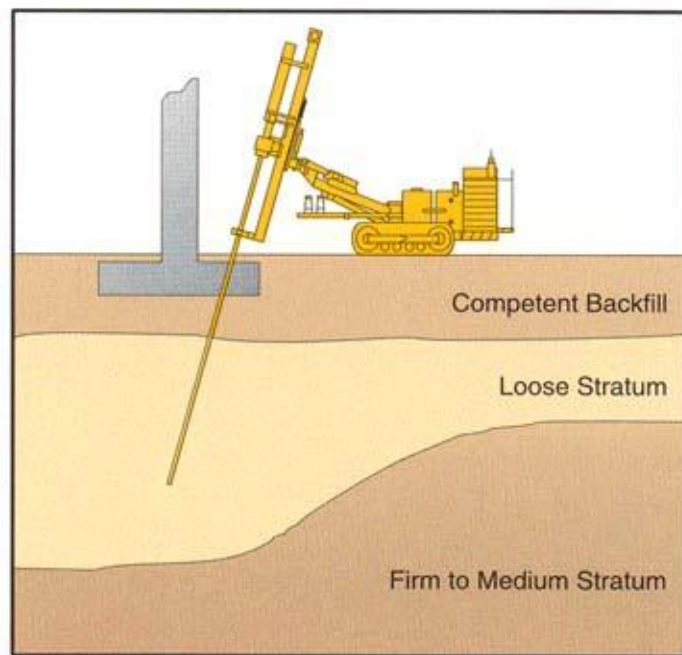
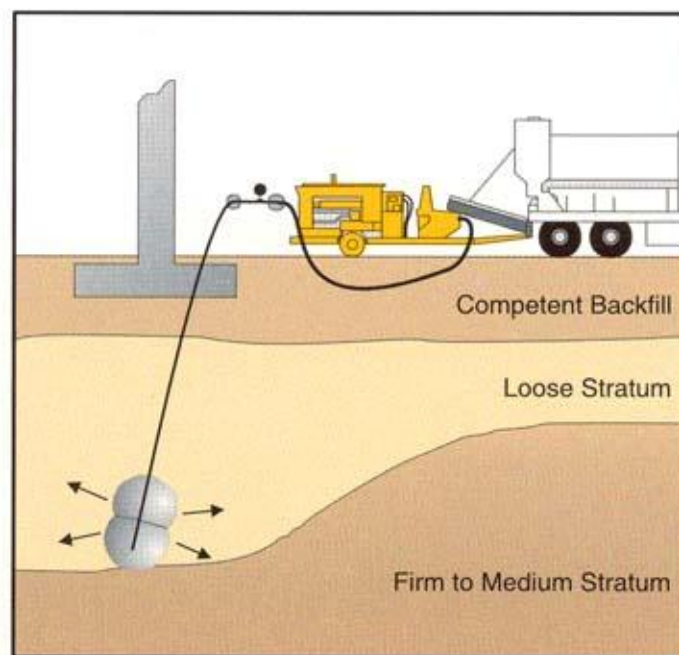
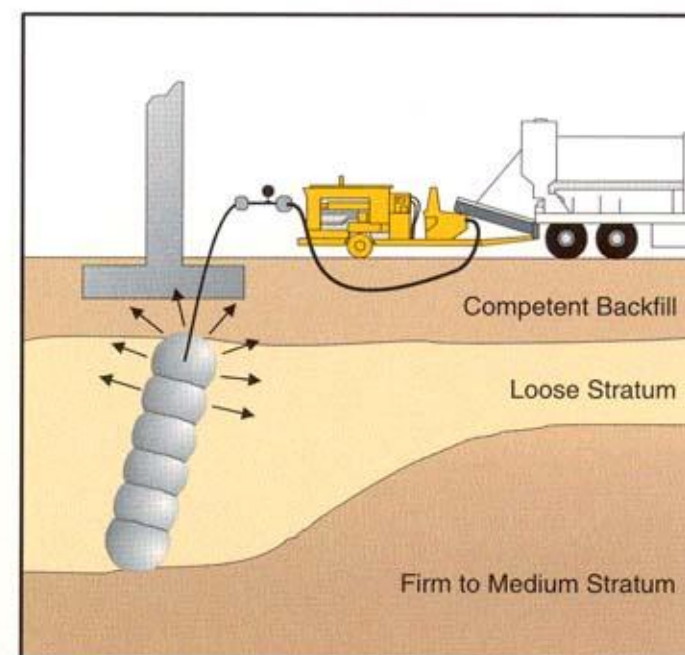
# COMPACTION GROUTING

● ± 100 Grout Locations  
every 8'

- Secondary row at areas of special concern.
- 4" diameter hole through the floor slab.

- ◆ Observations: Soils below foundations “loose to very loose”
- ◆ Recommendations: Stabilization required to prevent further settlement. Install compaction grouting.
