# FACILITY CONDITION ASSESSMENT

## **DLR Group**

Cleveland Elementary School  
524 Palisade Street, No. 2056  
Pasadena California, 91103

September 9, 2022

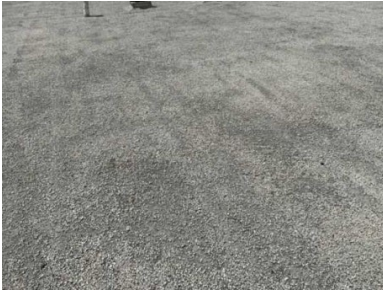
### Roofing in Poor condition.

Built-Up  
Building A, Cleveland Elementary Cleveland  
Elementary School Roof

Complaints of leaking, roof worn down, and water pooling in spots. - AssetCALC ID: 3984295

Unifomat Code: B3010  
Recommendation: **Replace in 2023**

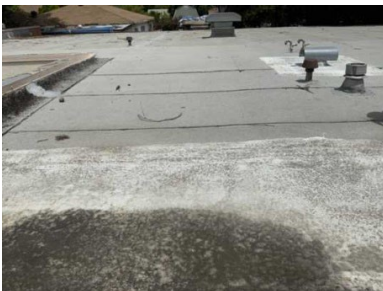
### Roofing in Poor condition.

Modified Bitumen  
Building B, Odyssey Charter Cleveland  
Elementary School Roof

Complaints of leaking, warn, and pooling in spots. - AssetCALC ID: 3984468

Unifomat Code: B3010  
Recommendation: **Replace in 2024**

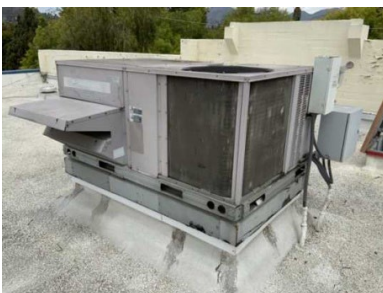
### Packaged Unit in Poor condition.

RTU, Pad or Roof-Mounted  
Building A, Cleveland Elementary Cleveland  
Elementary School Roof

Unifomat Code: D3050  
Recommendation: **Replace in 2024**
