# FACILITY CONDITION ASSESSMENT

## **DLR Group**

Blair School  
1201 South Marengo Avenue  
Pasadena, California 91106

September 10, 2022

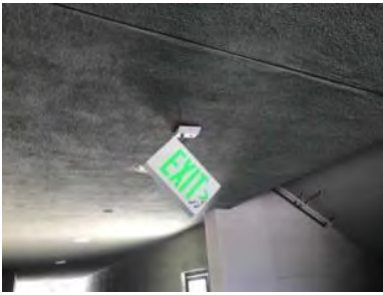
### Emergency and Exit Lighting in Failed condition.

Exit Sign, LED  
High School Building Blair School 2nd floor

Broken fixture, Repair is required. - AssetCALC ID: 3897688

Uniformat Code: D5040  
Recommendation: **Replace in 2022**

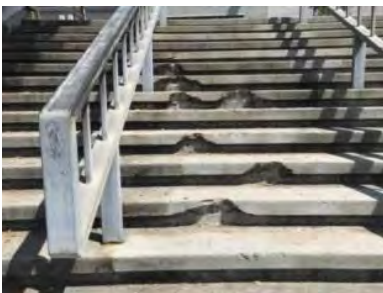
### Stairs in Poor condition.

Concrete/Masonry, Exterior  
Amphitheatre Blair School Exterior stairs

Broken and damaged stair steps. Repair is required. - AssetCALC ID: 3897956

Uniformat Code: B1080  
Recommendation: **Repair in 2022**

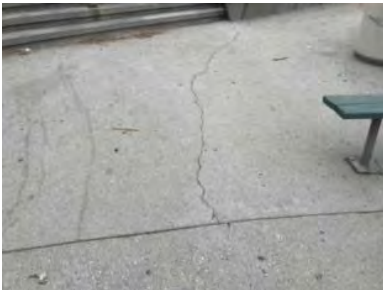
### Structural Flooring/Decking in Poor condition.

Concrete  
Amphitheatre Blair School Amphitheater

Isolated areas of cracks. Repair is required. - AssetCALC ID: 3898012

Uniformat Code: B1010  
Recommendation: **Repair in 2022**

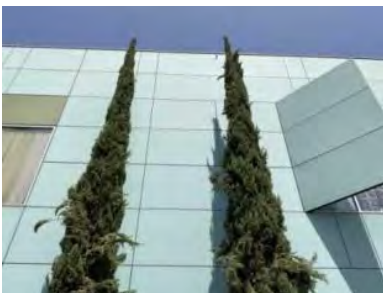
### Exterior Walls in Poor condition.

Metal Cap Flashing  
Middle School Building Blair School Building

Cap is missing from exterior finish leaving the moisture barrier membrane exposed to the sunlight. The moisture barrier membrane is detaching at these locations. - AssetCALC ID: 3898735

Uniformat Code: B2010  
Recommendation: **Replace in 2023**

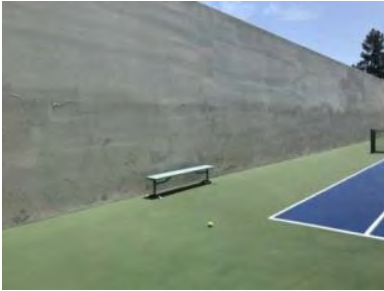
### Exterior Walls in Poor condition.

any painted surface  
Site Blair School Tennis courts

New fresh paint is required. - AssetCALC ID: 3898013

Uniformat Code: B2010  
Recommendation: **Prep & Paint in 2023**

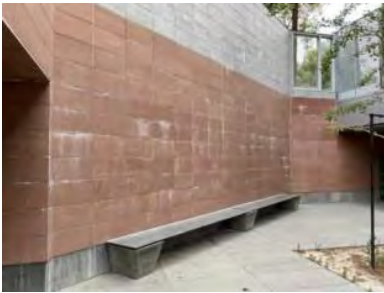
### Wall Finishes in Poor condition.

Ceramic Tile  
Middle School Building Blair School Building  
Exterior

Efflorescence found on wall near tunnel. Possible water intrusion through wall at planter. - AssetCALC ID: 3898615

Uniformat Code: C2010  
Recommendation: **Replace in 2024**

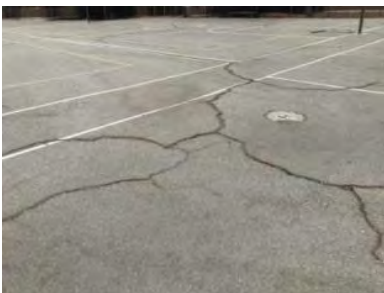
### Roadways in Poor condition.

Pavement, Asphalt  
Site Blair School Basketball court

Isolated areas of cracks, repair is required. - AssetCALC ID: 3898015

Uniformat Code: G2010  
Recommendation: **Repair in 2022**

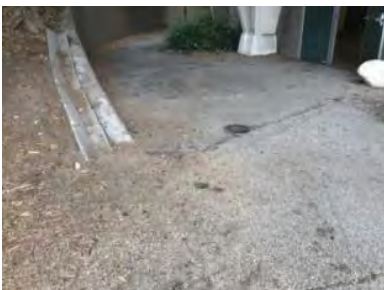
### Roadways in Poor condition.

Pavement, Asphalt  
Site Blair School Site

Isolated areas of cracks and uneven surface. Repair is required. - AssetCALC ID: 3898036

Uniformat Code: G2010  
Recommendation: **Repair in 2022**

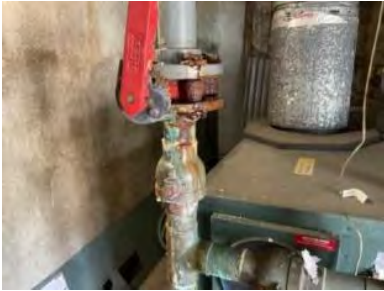
### Piping and Valves in Poor condition.

Gate Valve, Domestic Water  
Pool Building Blair School Mechanical room

Water is leaking from above valve. Recommend replacing valve and surrounding piping. - AssetCALC ID: 3898696

Uniformat Code: D2010  
Recommendation: **Replace in 2023**

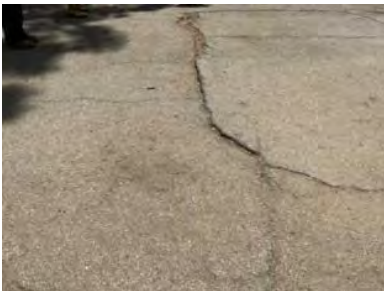
### Parking Lots in Poor condition.

Pavement, Asphalt  
Site Blair School Site

Large cracking in asphalt around basketball courts and pool area. Potential tripping hazard. - AssetCALC ID: 3898740

Uniformat Code: G2020  
Recommendation: **Mill & Overlay in 2023**

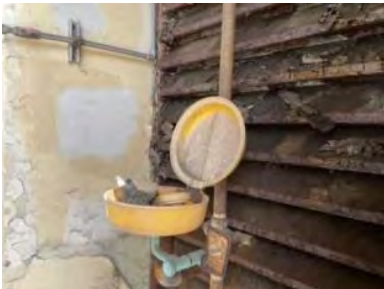
### Emergency Plumbing Fixtures in Poor condition.

Eye Wash & Shower Station  
Pool Building Blair School Pool building

Eyewash system is corroded and dirty. Items are stored in bowl. - AssetCALC ID: 3898712

Uniformat Code: D2010  
Recommendation: **Replace in 2022**

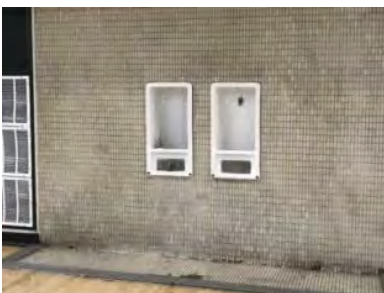
### Drinking Fountain in Poor condition.

Wall-Mounted, Single-Level  
Gymnasium Blair School Throughout building

Fixture is not working. Replacement is required. - AssetCALC ID: 3897962

Uniformat Code: D2010  
Recommendation: **Replace in 2023**

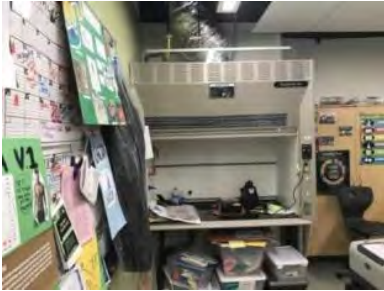
### Laboratory Equipment in Failed condition.

Exhaust Hood, Constant Volume 6 LF  
High School Building Blair School Workroom A-315

The unit is not operational. Repair is required. - AssetCALC ID: 3897749

Uniformat Code: E1040  
Recommendation: **Replace in 2022**

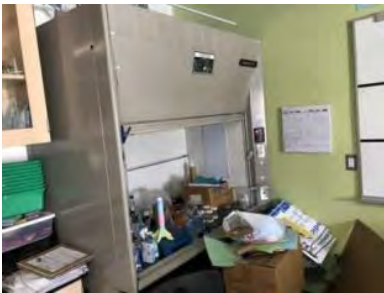
### Laboratory Equipment in Failed condition.

Exhaust Hood, Constant Volume 6 LF  
High School Building Blair School Workroom A-318

The unit is not operational. Repair is required. - AssetCALC ID: 3897812

Uniformat Code: E1040  
Recommendation: **Replace in 2022**

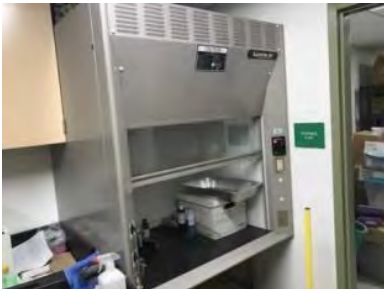
### Laboratory Equipment in Failed condition.

Exhaust Hood, Constant Volume 6 LF  
High School Building Blair School Workroom A-316

The unit is not operational. Repair is required. - AssetCALC ID: 3897720

Uniformat Code: E1040  
Recommendation: **Replace in 2022**

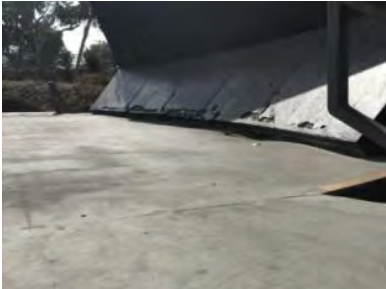
**Recommended Follow-up Study:**  
**Structural, Superstructure**

Structural, Superstructure  
Amphitheatre Blair School Stage

Settlement and deteriorated edges were observed at the south side of the exterior stage of the AMPHI-Theatre. A professional engineer must be retained to analyze the existing condition, provide recommendations and, if necessary, estimate the scope and cost of any required repairs. - AssetCALC ID: 3897979

Settlement and deteriorated edges were observed at the south side of the exterior stage of the Amphitheater. A professional engineer must be retained to analyze the existing condition, provide recommendations and, if necessary, estimate the scope and cost of any required repairs. The cost of this study is included in the cost tables. Due to the ambiguity of the required repair scope at the time of this assessment, the cost for any possible subsequent repairs is not included.

Unifomat Code: P2030  
Recommendation: **Evaluate/Report in 2022**

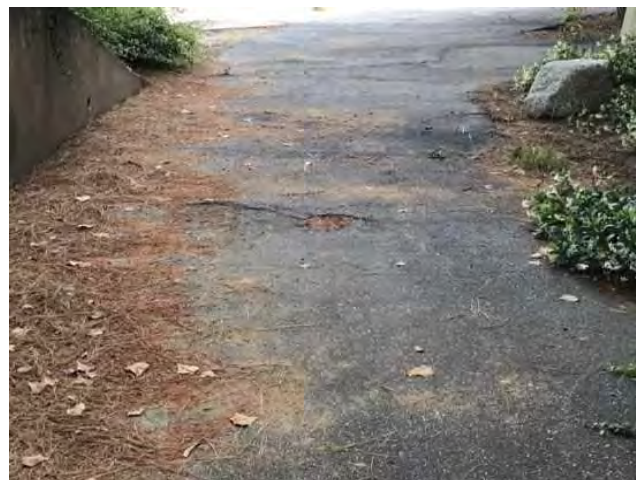
48 - DETERIORATED ROADWAYS
