**INVITATION FOR BIDS**  
**ARTIFICIAL TURF MAINTENANCE AND REPAIRS**  
**Solicitation IFB #CCSD-TURF110826**

The purpose of this IFB is to obtain corrective maintenance and localized repairs at the Mountain Crest, Ridgeline, Sky View, and Green Canyon high school stadium fields. Bidders shall use the attached Firefly assessments to recommend and price appropriate repairs that improve field condition and support the goal of one to two additional seasons of service.

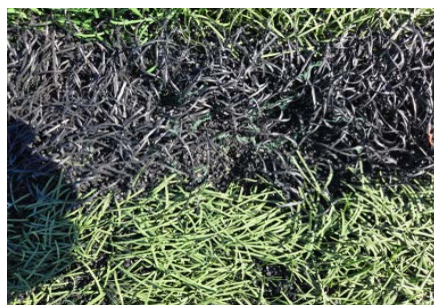
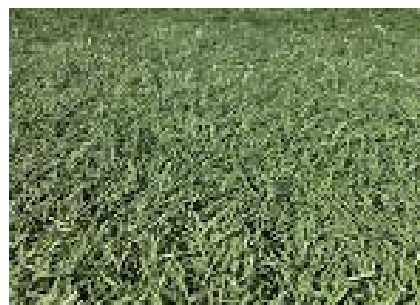
Areas with reduced infill depth are more susceptible to accelerated fiber degradation from UV exposure and increased mechanical fiber wear and pull-out (Items A & B). These high-traffic areas should receive routine hand maintenance and infill replacement to restore the designed infill depth and prevent further deterioration. Once fiber loss becomes excessive and can no longer be effectively managed through maintenance, localized turf removal and repair should be considered. In addition, targeted grooming to reorient and stand the fibers upright (item C) should be prioritized to reduce matting, improve surface performance, and maximize the remaining service life of the field.

The field is performing well but would benefit from a proactive maintenance program to preserve its current condition. Routine decompaction should be completed to relieve infill consolidation, followed by targeted infill replenishment in high-use areas to maintain consistent infill depths. Routine grooming and periodic performance testing are recommended to monitor long-term changes before more significant deterioration occurs.

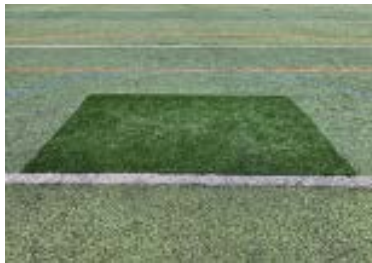
Overall, the field exhibited few, if any, significant concerns beyond those previously identified. That said, the numerous repaired areas throughout the surface will inherently introduce localized variations in performance characteristics. Fiber matting should be addressed through targeted grooming, and infill should be replenished in high-traffic areas where the existing fiber condition can effectively retain additional material. These maintenance measures will help improve surface consistency and extend the remaining service life of the field.

Corrective maintenance should focus on restoring impact performance and surface consistency. A thorough decompaction should be completed to relieve infill consolidation, followed by infill redistribution and targeted replenishment in worn areas. Given the elevated impact values and reduced force reduction, restoring the resiliency of the infill system should be prioritized. Routine grooming and periodic performance testing are recommended to evaluate the effectiveness of maintenance activities.

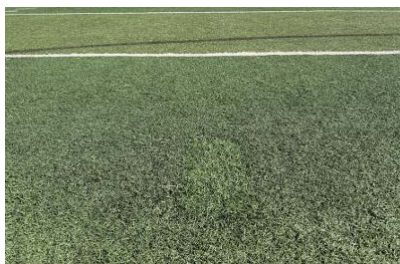
Areas exhibiting localized infill loss should be replenished with the appropriate infill blend to restore a more uniform surface and improve consistency across the field (Item A). Areas with localized fiber loss should be repaired promptly to prevent further expansion of the damaged areas (Item B). Due to infill depths that were both lower and more variable than those observed at comparable sites, the fibers should first be groomed to a more upright orientation (Item C) to maximize the effectiveness of infill replenishment. Following these maintenance efforts, the field should be closely monitored to determine whether the improvements are sufficient to extend its remaining service life or if more extensive repairs will be required.

The field would benefit from a comprehensive maintenance program consisting of decompaction, infill redistribution, and targeted infill replenishment. Testing results indicate that End A exhibits consistently lower infill depths than End B, suggesting that infill has migrated or has been depleted more rapidly in this area. Redistributing existing infill across the field, followed by replenishment where necessary, is recommended to restore a more uniform infill profile and improve overall surface performance. If practices or warm-up activities routinely favor End A, consideration should be given to periodically alternating the primary direction of play or practice orientation to distribute wear more evenly across both halves of the field. Routine grooming, seasonal decompaction, and periodic performance evaluations are also recommended to maintain consistent playing characteristics and extend the service life of the turf system.

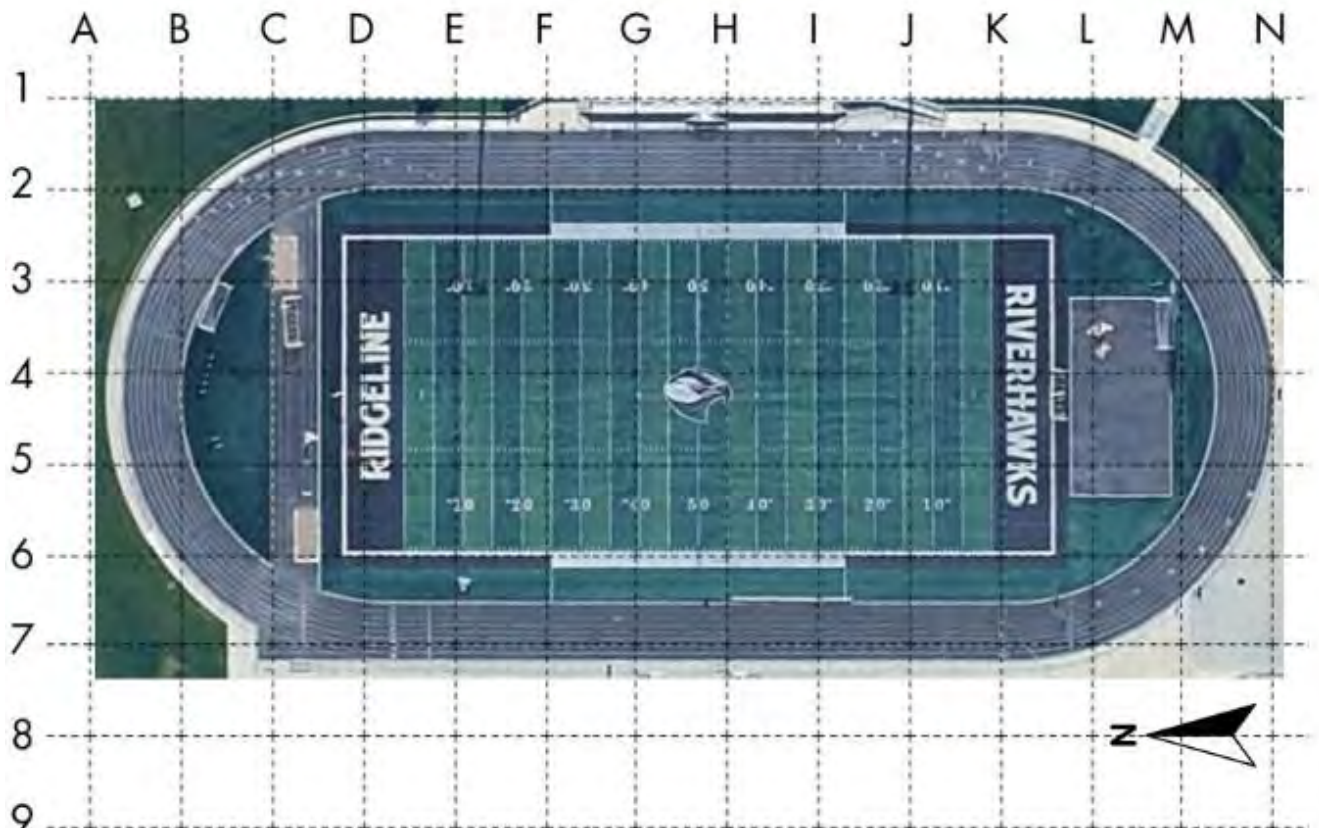
## Surface Regularity – EN 13036-7

This test evaluates the planarity and evenness of a surface. A 3-meter straight edge is used to check for positive and negative deviations greater than 10 mm across the entire field of play. A reference map can be found below.

| X | Y | Depth (mm) | Length, X (ft) | Width, Y (ft) | Deviation Type | Comments |
|---|---|---|---|---|---|---|
| C.5-M | 2-6.5 | | 360 | 180 | FL- Loose Fibers | Across entire field |
