Phase I Environmental Site Assessment

ISSAQUAH SCHOOL DISTRICT PROPERTY

Issaquah, Washington

Project No. 20180070V002
October 12, 2021

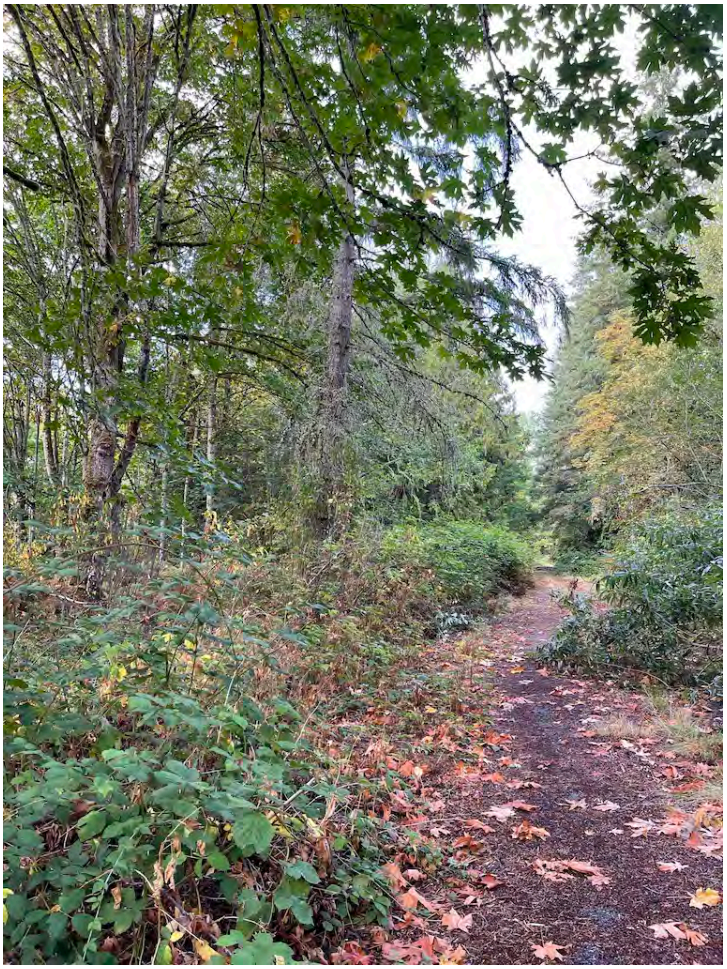
Looking northeast at the northeastern portion of the former Trinity Lutheran College Campus and the trees that line it.

Looking northwest from the northwest parking lot at the northwestern parcel of the Subject Property.

Looking northeast at the wooded eastern parcel and part of Providence Loop from the western extent of the eastern parcel.
