November 3, 2017

Kennewick School District No. 17
Attn: Keith Colee, Maintenance and Operations Manager
1000 West Fourth Avenue
Kennewick, Washington, 99336

RE: Winter 2016 Drinking Water Sampling Results
MTS Building, 622 North Kellogg Street, Kennewick, Washington

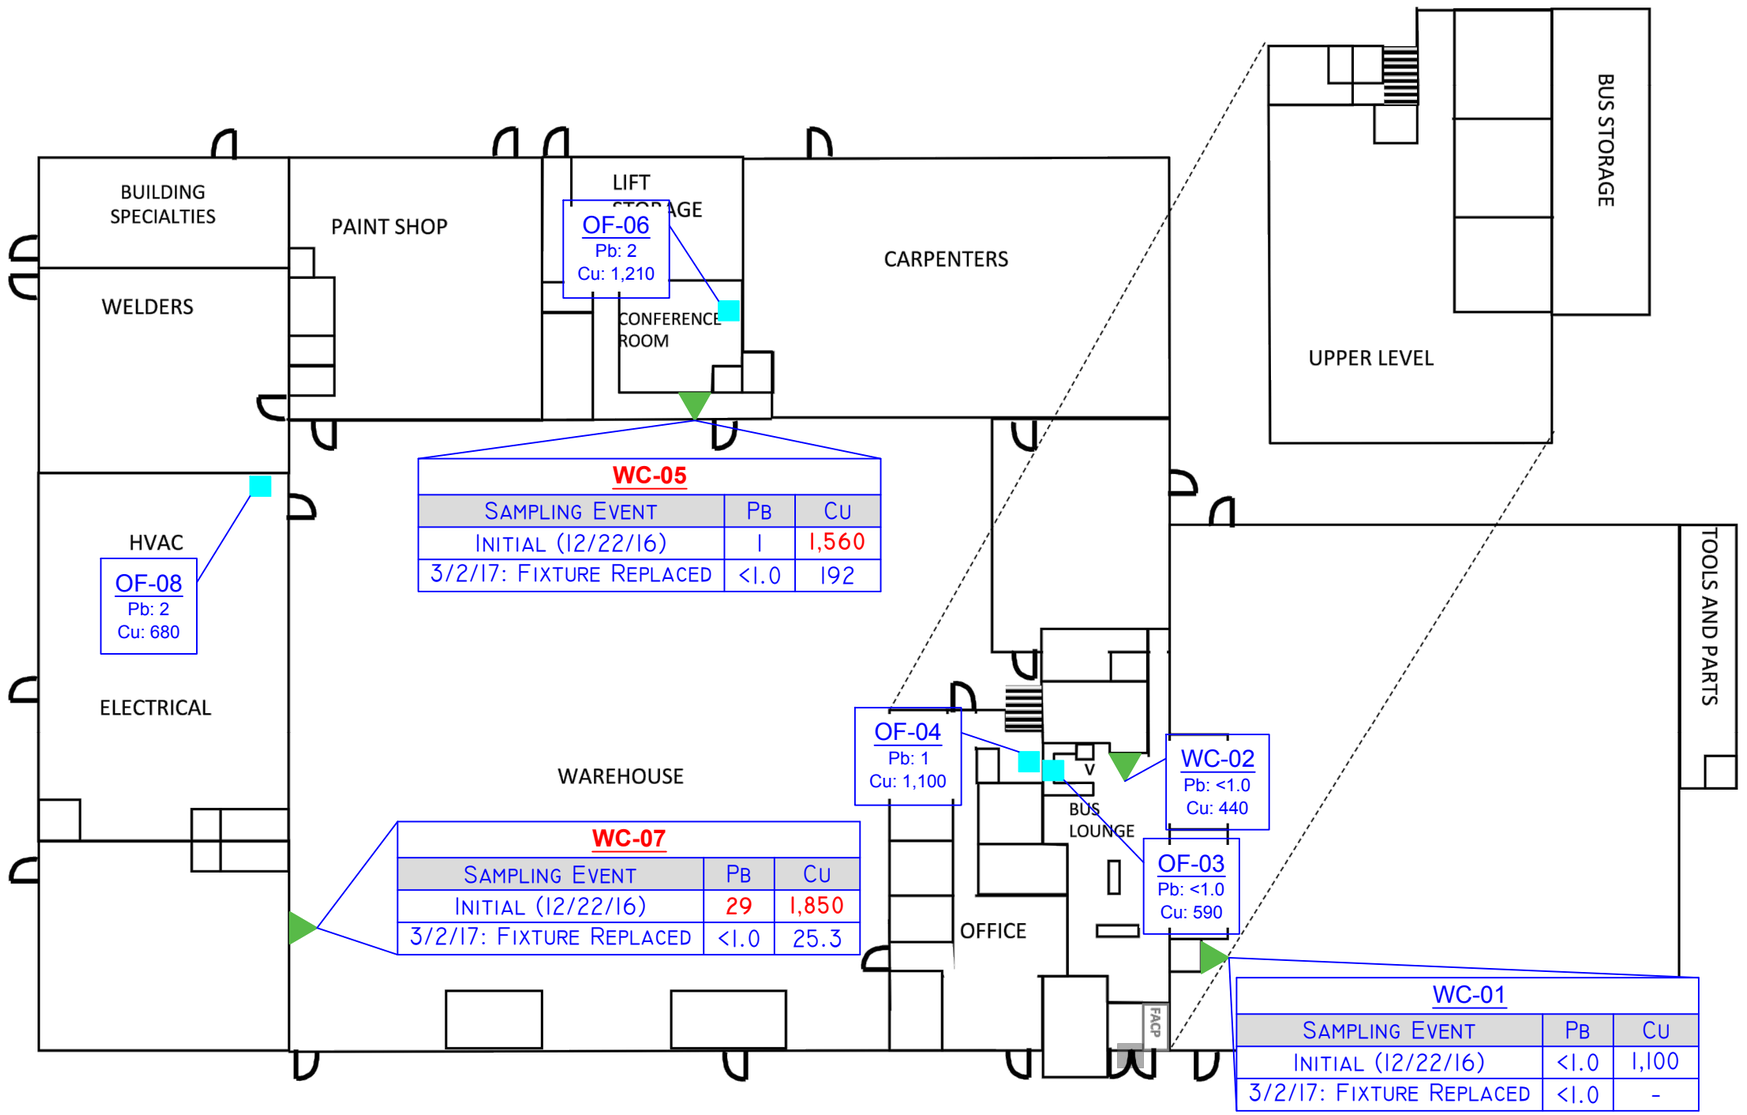
FIGURE 1

Fulcrum completed initial sampling on December 22, 2016. Initial results identified one sample with a lead concentration of 29 micrograms per liter (µg/L), above the Environmental Protection Agency (EPA) action level of 15 µg/L, and two samples with copper concentrations above the EPA action level of 1,300 µg/L. Upon receipt of results, the District removed the identified fixtures from service pending remediation and further testing.

-Samples in **BOLD RED** indicate fixture locations where the initial concentrations of lead or copper were above the respective action level.

The fixture identified with an elevated lead concentration and two of the same style were replaced and preconditioned by running cold water continuously through the fixtures for 24 hours, as specified in WAC 246-366A-130. Following replacement and preconditioning, Fulcrum returned to the building on March 2,
