March 25, 2024

North Kansas City School District
2000 Northeast 46th Street
Kansas City, Missouri 64116

Project: Limited Lead in Drinking Water Testing
Address: 1900 Northeast 46th Street, Kansas City, Missouri 64116

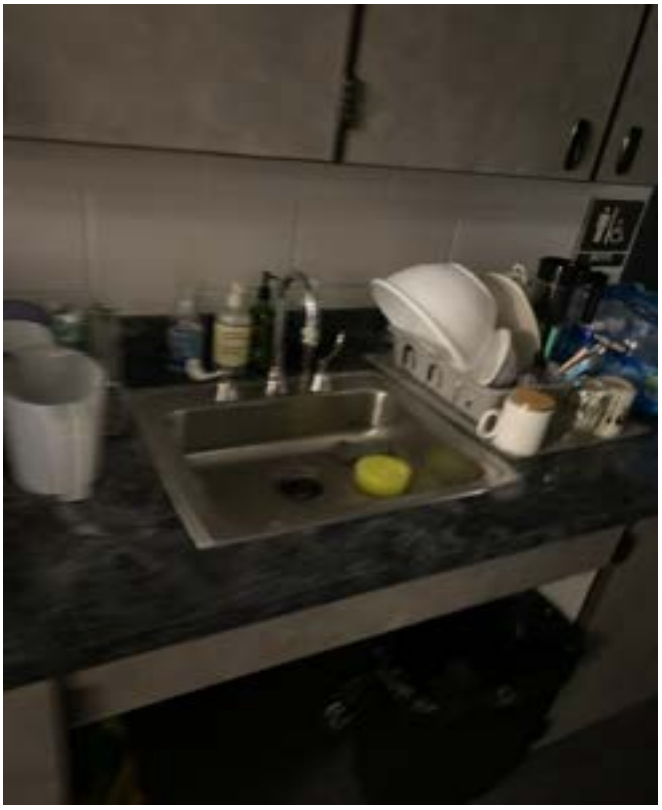
1/25/2024 - 1900-3 - Doolin Center - Basement North Entry Hallway

Client Sample ID: 1900-3-FD
Sample Matrix: Drink Wtr
Lab Sample ID: 3HA0124-03
Collected By: Bradley Young
Collection Date: 01/25/2024 1:27

Determination of Total Metals	Result	RL	Units	DF	Note	Prepared	Analyzed	Analyst
200.8								
Lead, total	<0.4	0.4	ppb	2		02/27/24 1617	02/29/24 0336	RVV

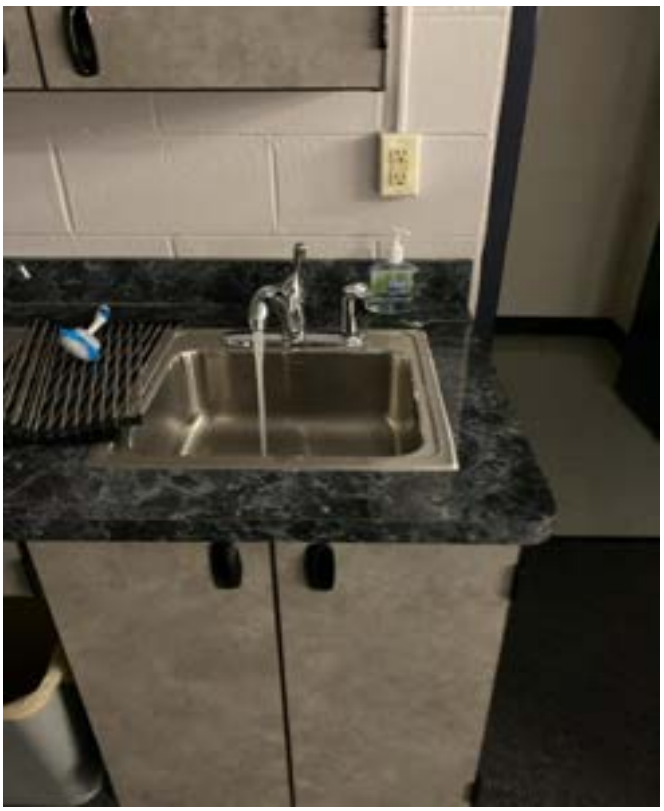
1/25/2024 - 1900-6 - Doolin Center - Staff Lounge-Middle

Determination of Total Metals	Result	RL	Units	DF	Note	Prepared	Analyzed	Analyst
200.8								
Lead, total	**1.1**	0.4	ppb	2		02/27/24 1617	02/29/24 0345	RVV
