August 14, 2024

Project: Limited Lead in Drinking Water Testing
Address: 8211 Sterling Avenue, Raytown, Missouri 64138

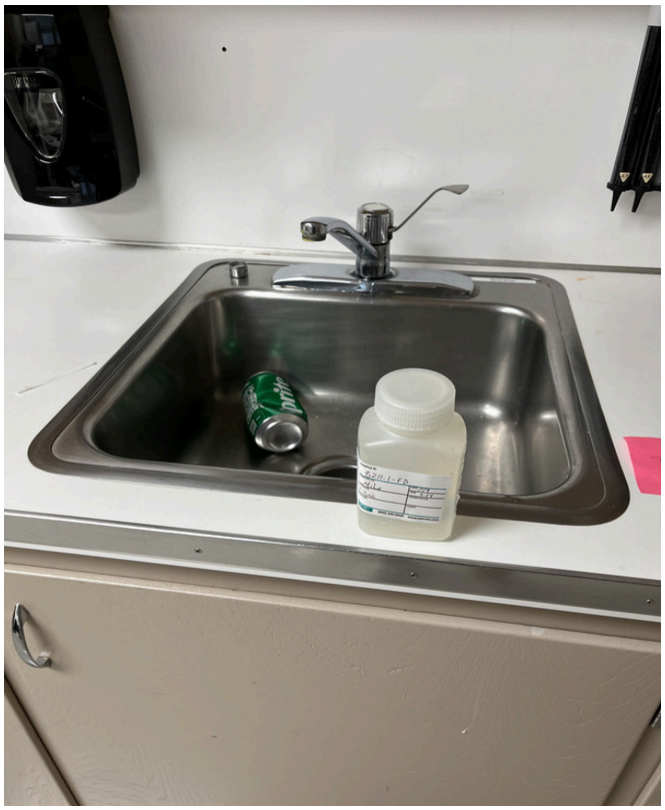
7/9/2024 - 8211-1 - Raytown South High - Clinic

Sample #	Location	Source Under Test	Test Type	Lead Result (ppb)
8211-1-FD	Raytown South High - Clinic	Sink Tap	First Draw	1.6
8211-2-FD	Raytown South High - Near Room 1	Drinking Fountain	First Draw	<0.4
8211-3-FD	Raytown South High - Near Room 8	Drinking Fountain	First Draw	<0.4
8211-4-FD	Raytown South High - Near Room 11	Drinking Fountain	First Draw	<0.4
8211-5-FD	Raytown South High - Near Little Theater - Left	Drinking Fountain	First Draw	1.4
8211-6-FD	Raytown South High - Near Little Theater - Right	Drinking Fountain	First Draw	9
8211-7-FD	Raytown South High - Across from Room 122	Bottle Filler	First Draw	<0.4
